J. Other Remarks/Recommendations/Documentations:

1st Quarter 2021 Air and Water Sampling Activities

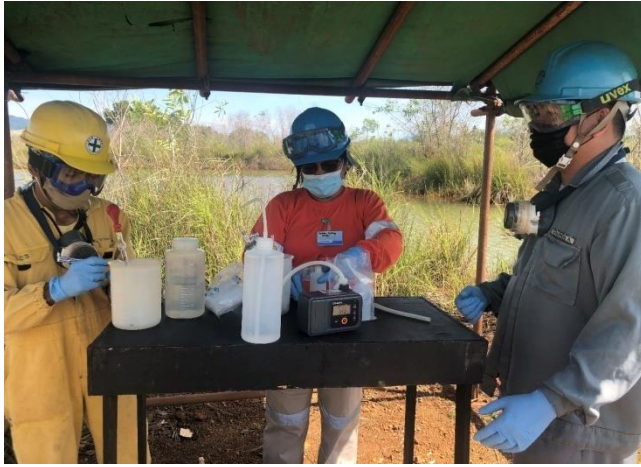
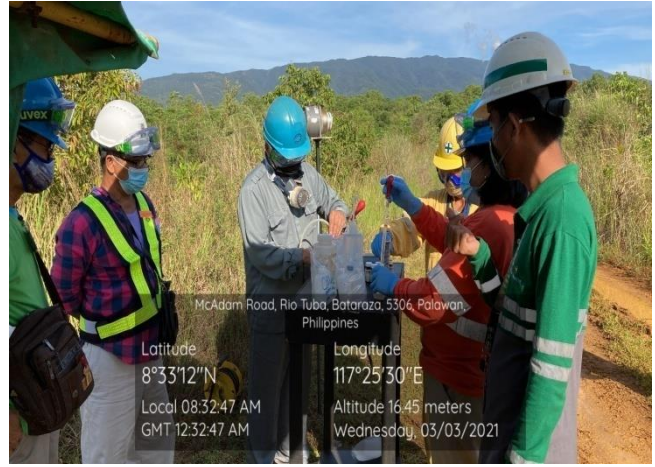
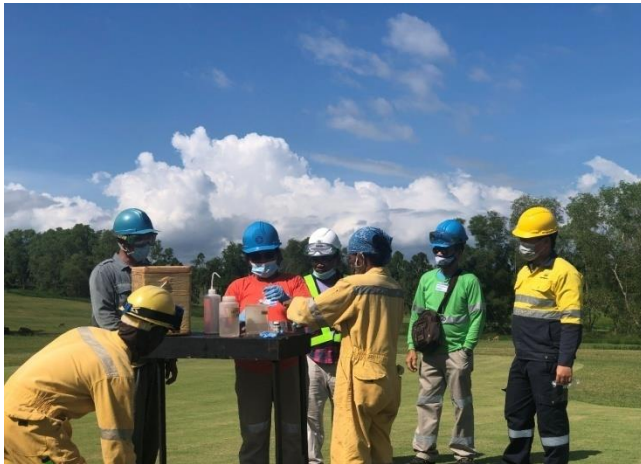
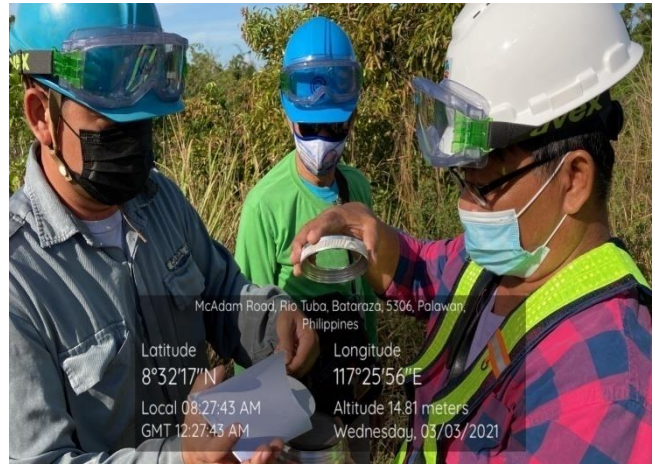
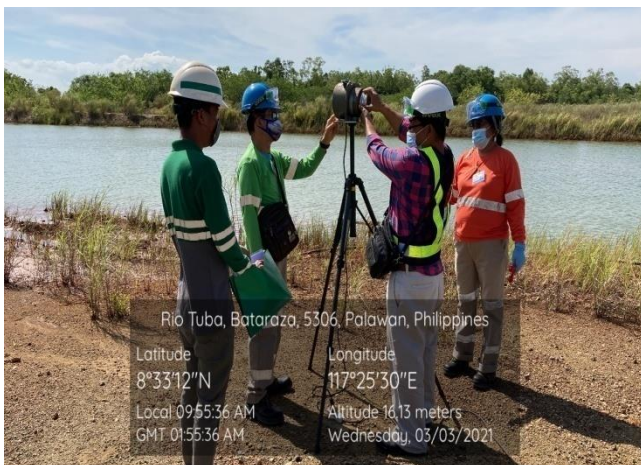
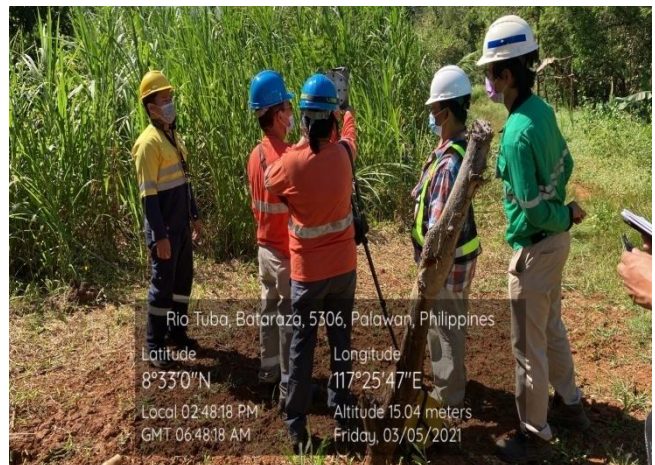
Figures 1-3: NOx & SOx Sampling - Sampling for gas emission was conducted on March 3, 2021 in three (3) stations namely Tagpisa, Upper Kinurong and Bulanjao Golf Course; Figures 4-5: Total Suspended Particles (TSP) sampling conducted on March 3 and 5, 2021 in, Upper Kinurong, Tagpisa and GSSI compound.

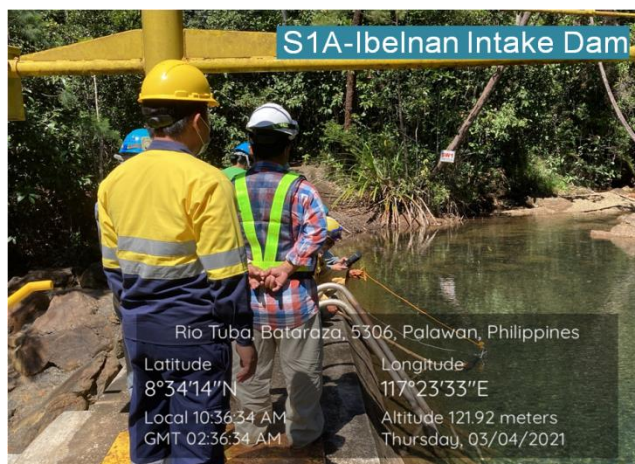
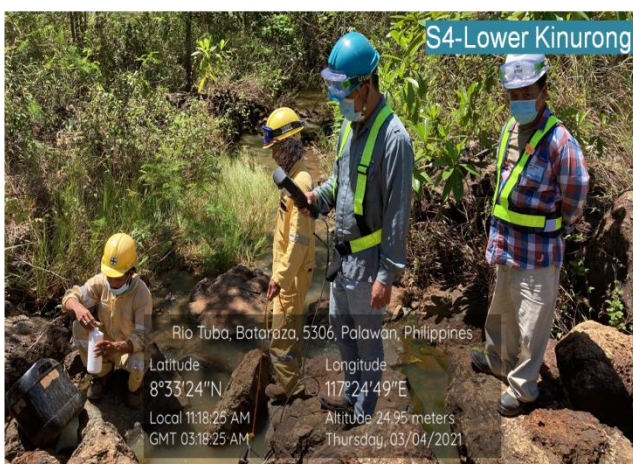
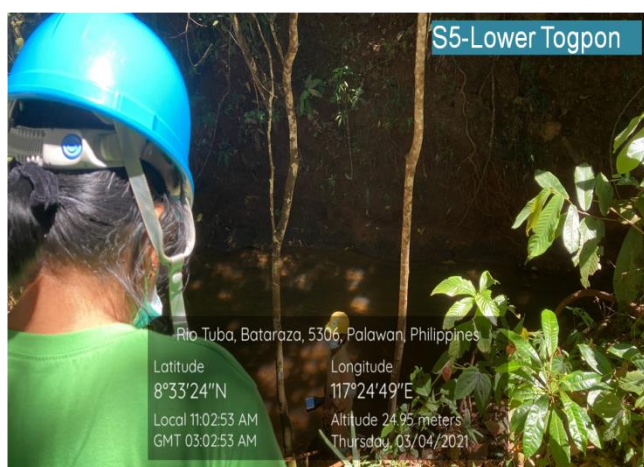
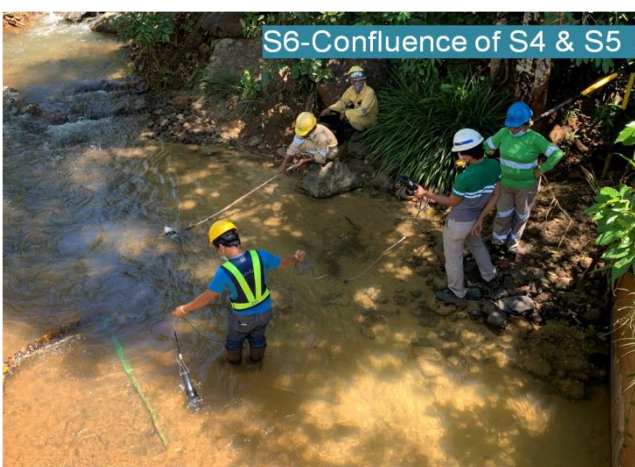
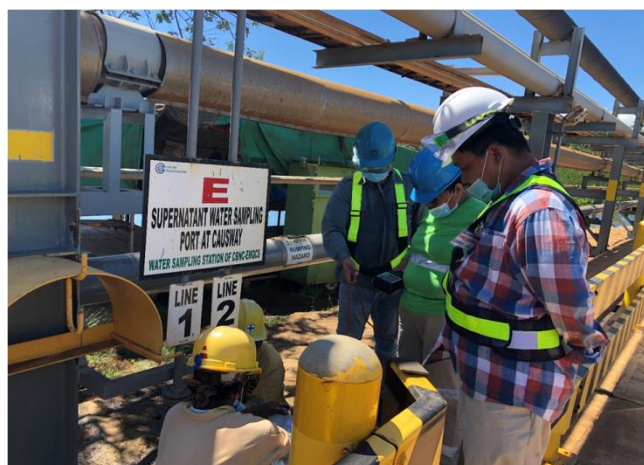
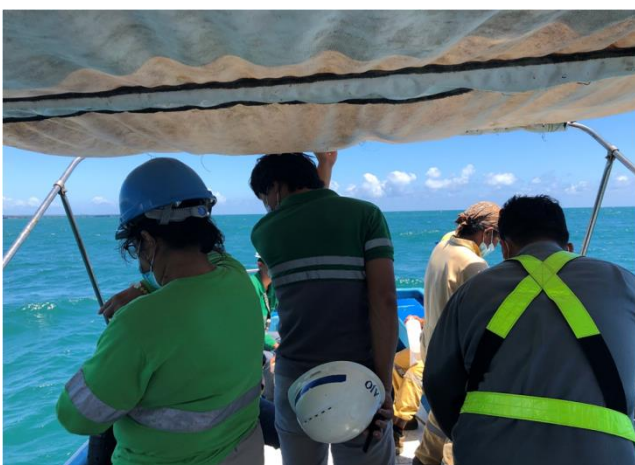
Figures 1-6: Collection of water samples and in-situ measurement of water quality conducted on March 4, 2021 in all sampling stations. Water samples for laboratory analysis were properly packed and delivered to OMLI.

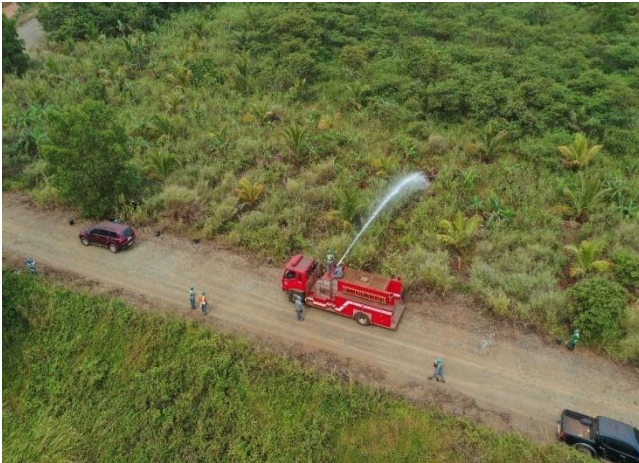
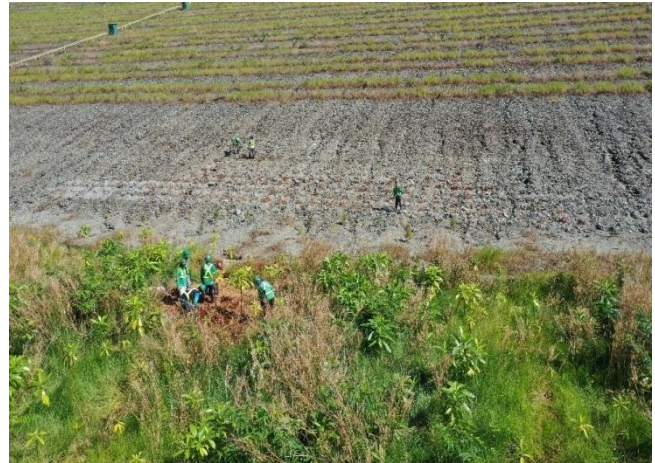
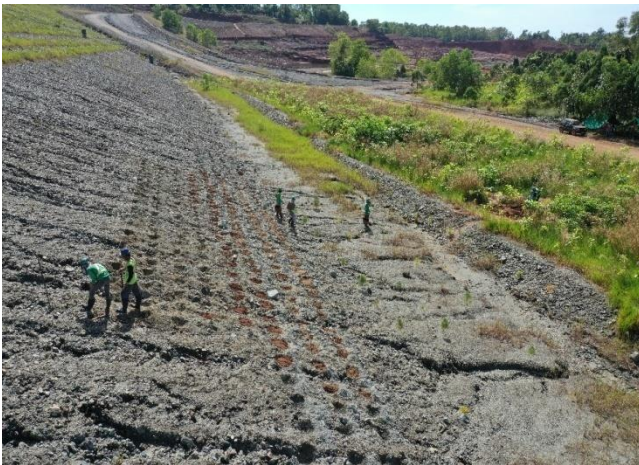
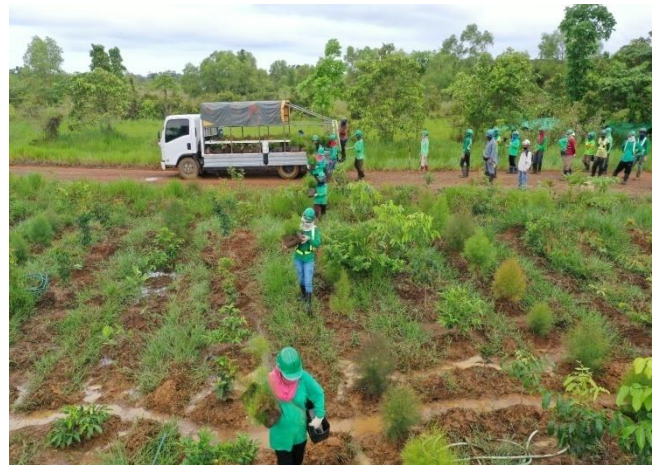
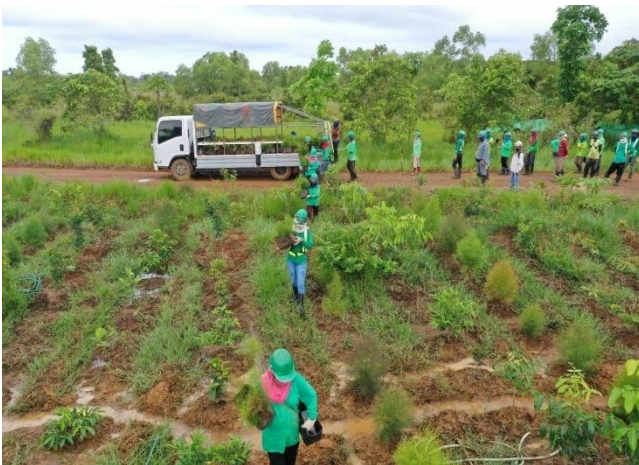
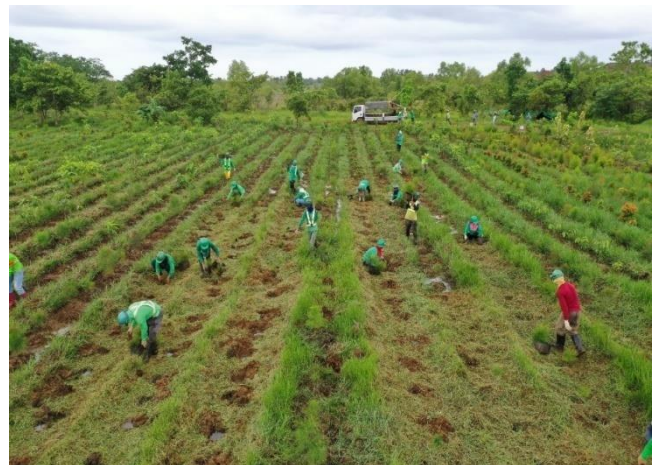
Figures 1-3: TSF-2 South Dam Slope Grass planting activity; Figures 4-6: Enrichment and Enhancement Planting

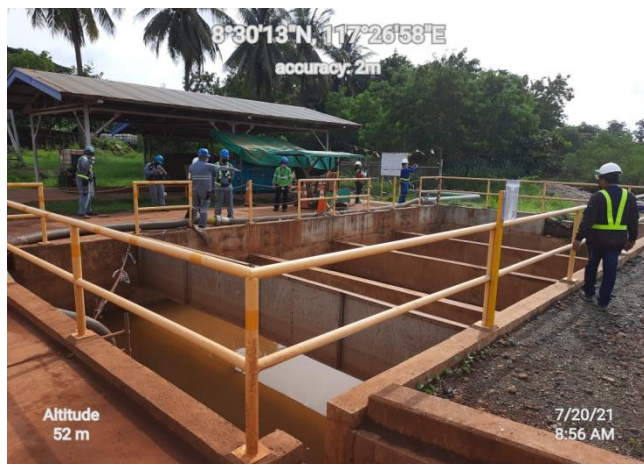
Maintained Silt Collector Sump

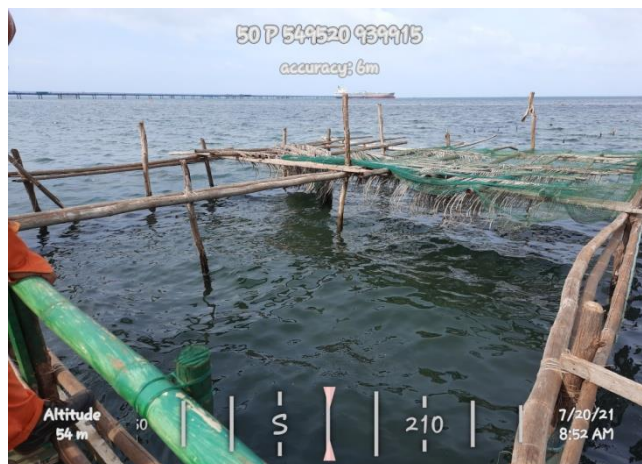
Bio – indicator project – fish pen at west causeway

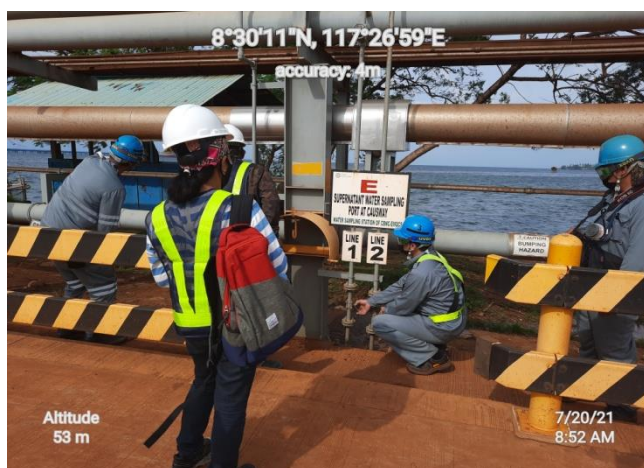
Sampling Station E with Supernatant discharge

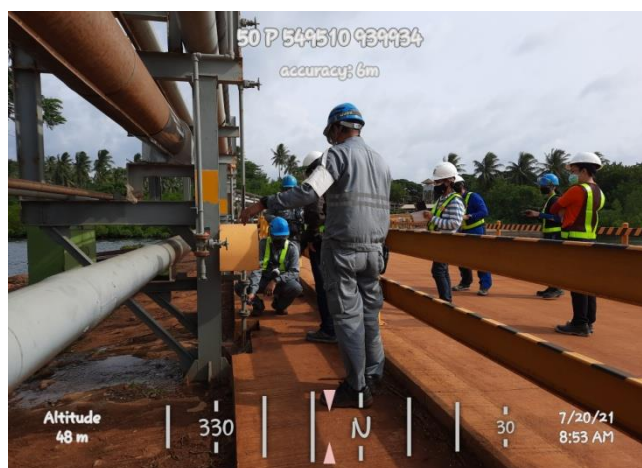
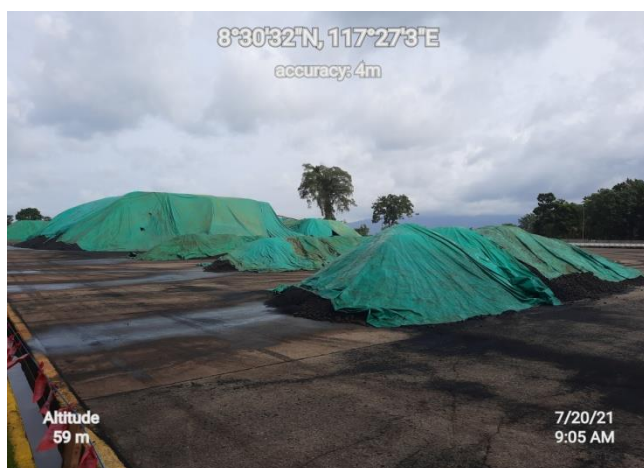
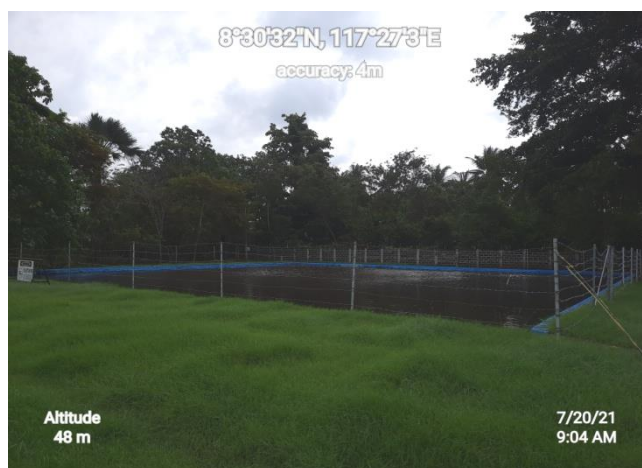
Covered coal stockpiles and maintained coal siltation pond and drainage

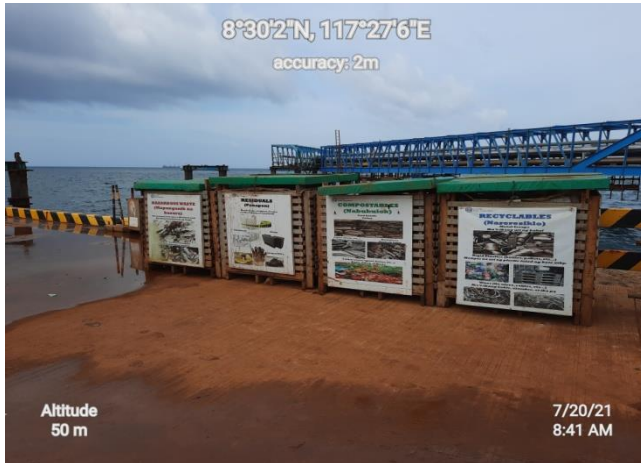
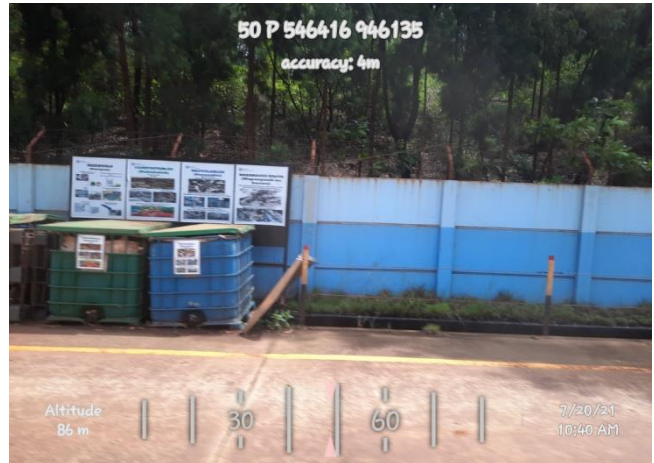
Waste bins/containers at various working areas within and outside (causeway) the plant site

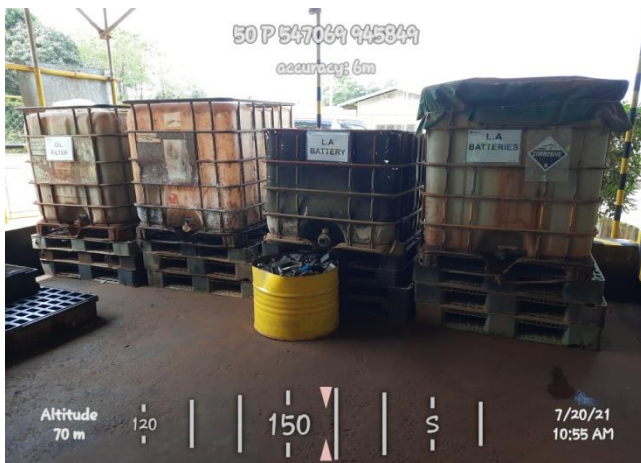
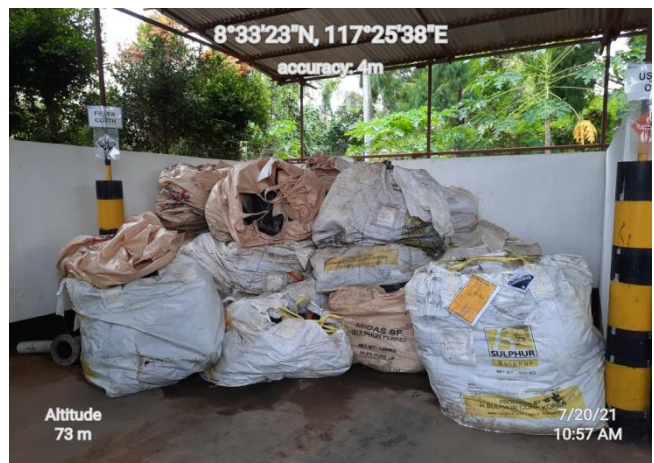
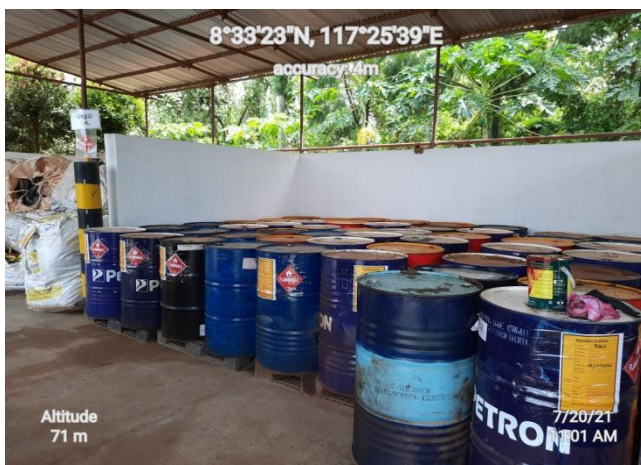
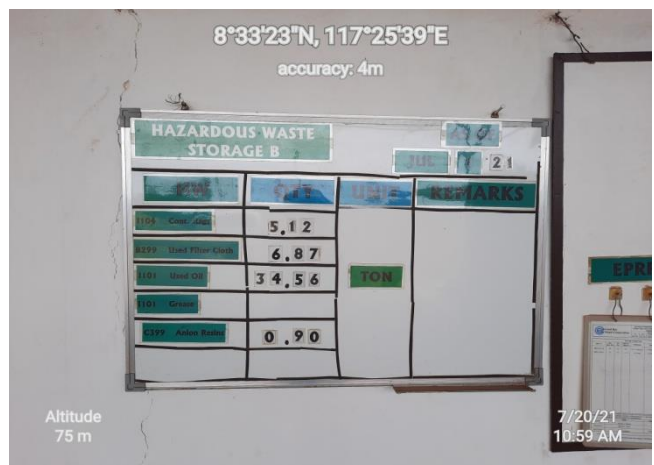
Hazardous Waste Storage Facility (A and B) – wastes are properly stored, labelled, and accounted for as reflected in the monitoring board

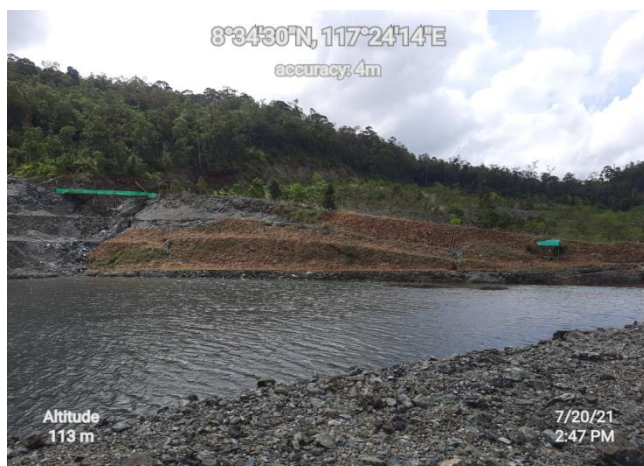
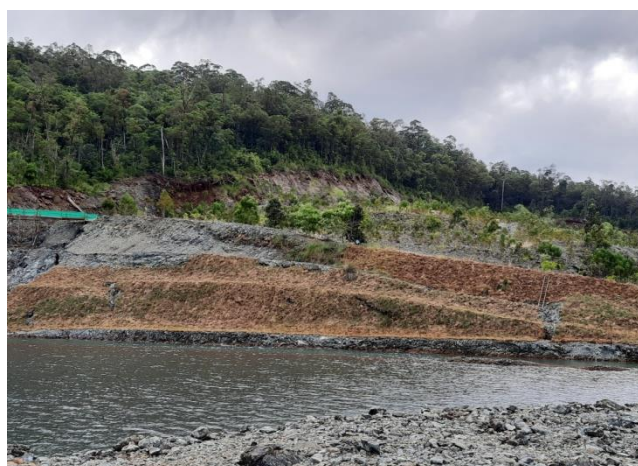
Visual status of Rock Quarry Reforestation wherein the slopes of the rock quarry will be planted with grasses to introduce biomass – per report of the company, 800 square meters was already planted.

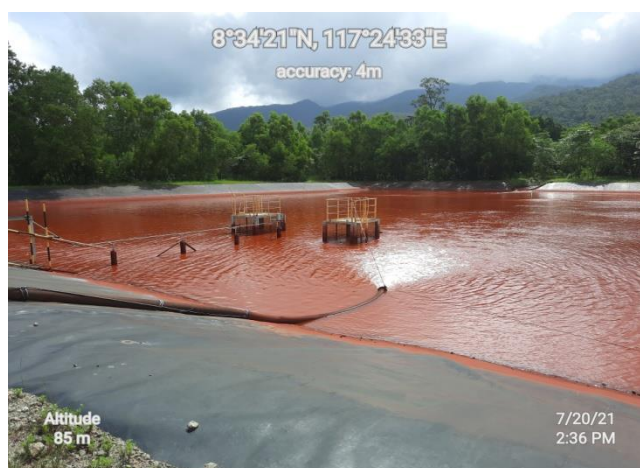
Visual Status of Return Water Pond

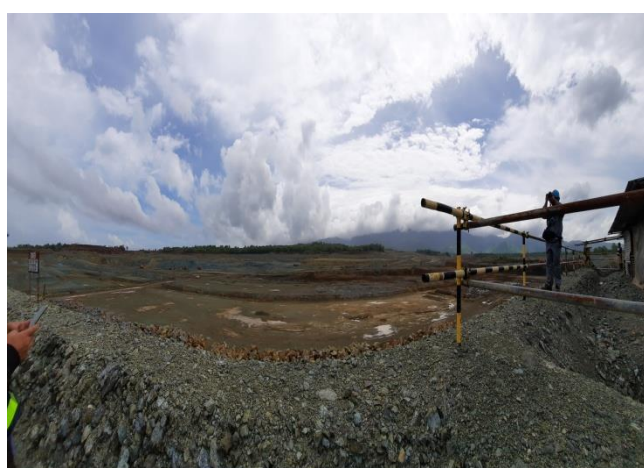
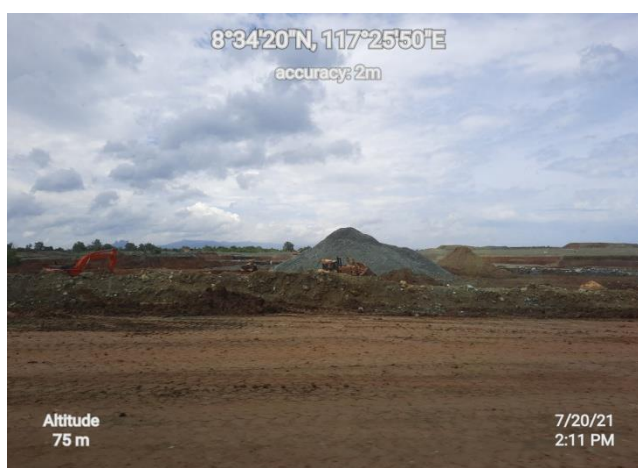
On-going activities at TSF-3
