MEMORANDUM

SUBJECT : **UPDATES ON THE DAMAGES CAUSED BY TYPHOON
ODETTE (RAI) ON THE DENR FACILITIES WITHIN THIS
JURISDICTION AS OF DECEMBER 21, 2021**

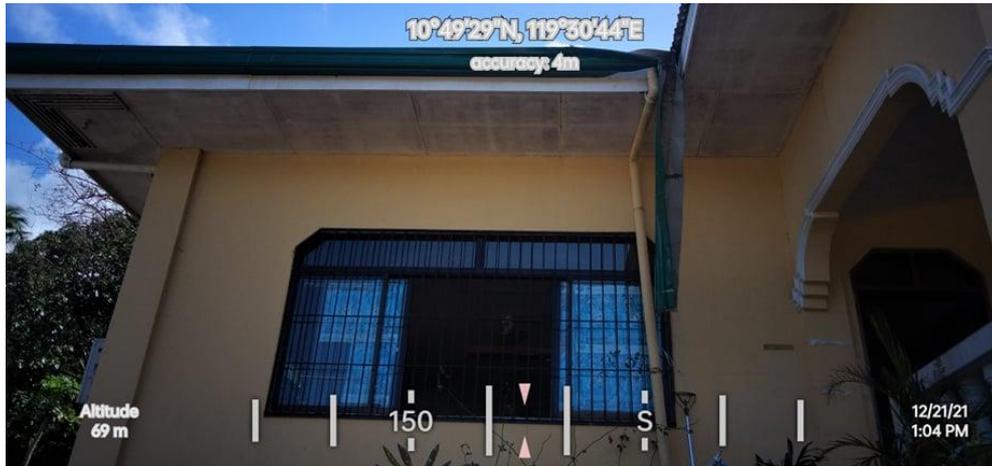
Partially damaged gutter of CENR Office in Taytay, Palawan

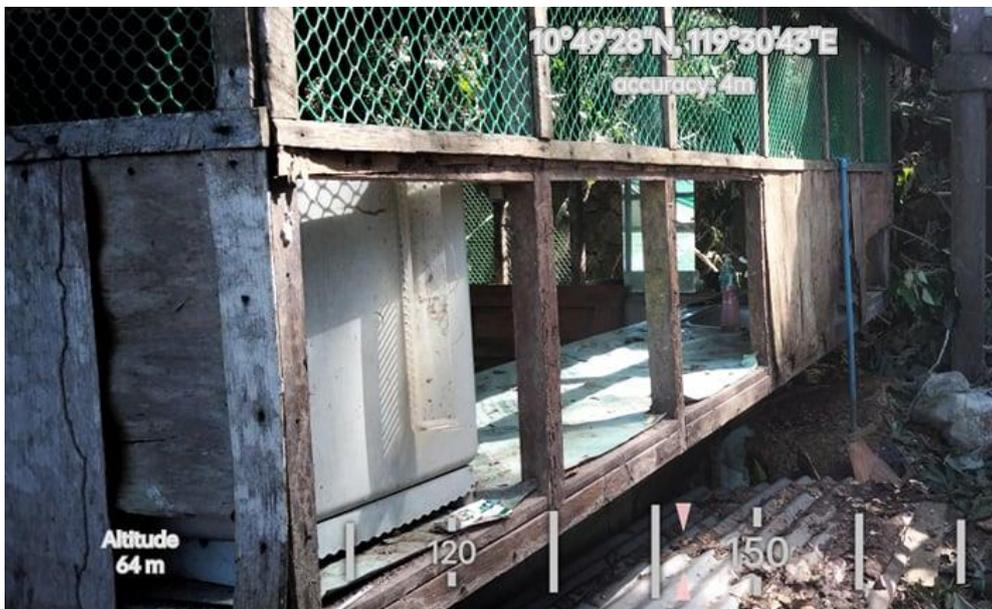
Partially damaged wall of pantry of CENR Office in Taytay, Palawan

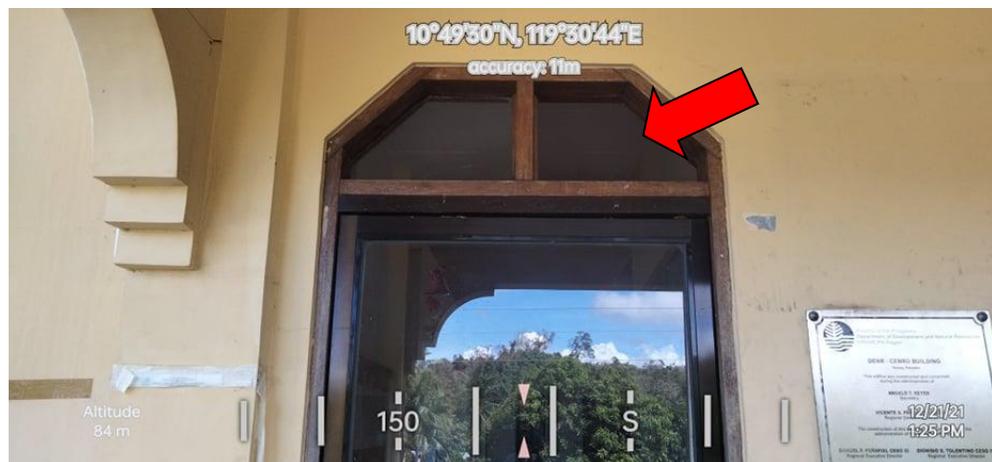
Broken glass pane above the main door of CENR Office in Taytay, Palawan

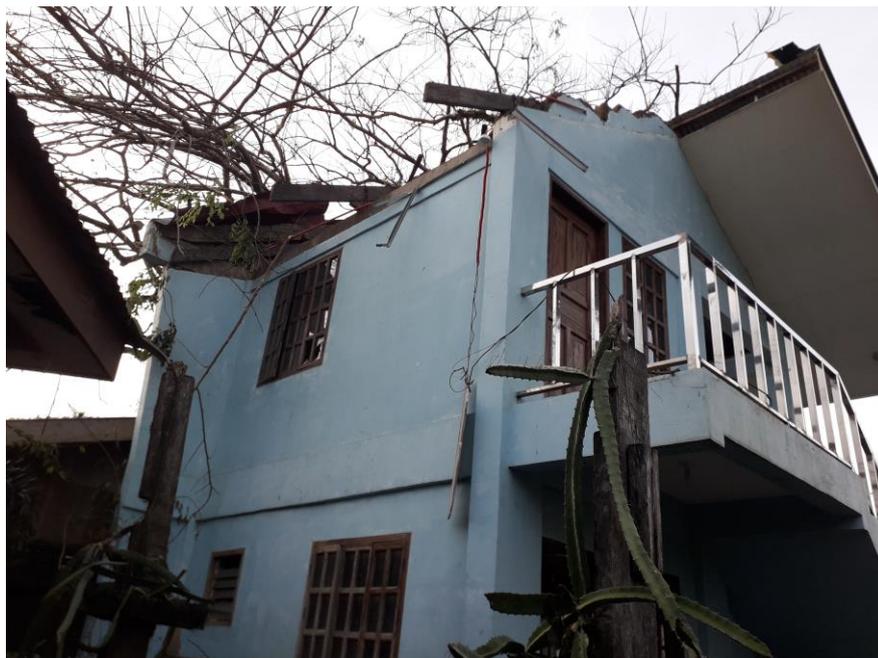
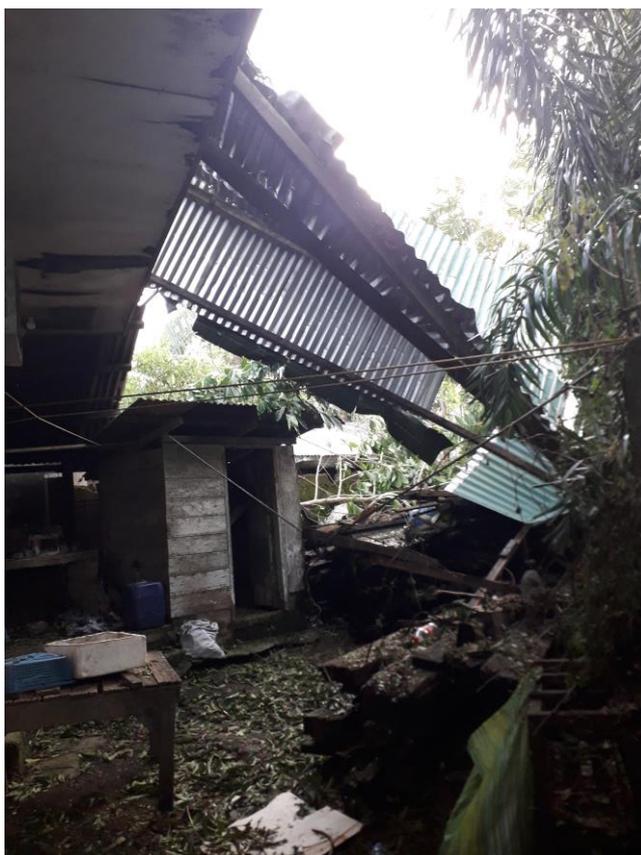
Half of the roof of MSPLS Visitor Center / FPMS 1 in Sitio Montevista, Bgy. Poblacion, Taytay, Palawan was blown by the strong wind

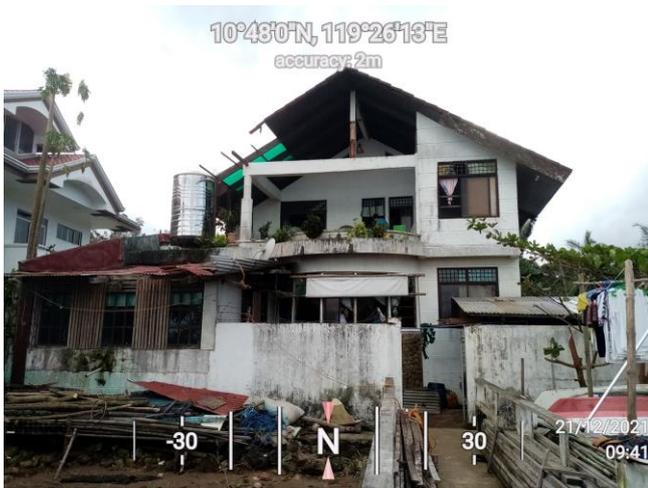
(A)

The partially damaged roof at the back portion (A & B), roof (C) and window glass pane (D) of PAMO-MSPLS Building in Bgy. Old Guinlo, Taytay, Palawan

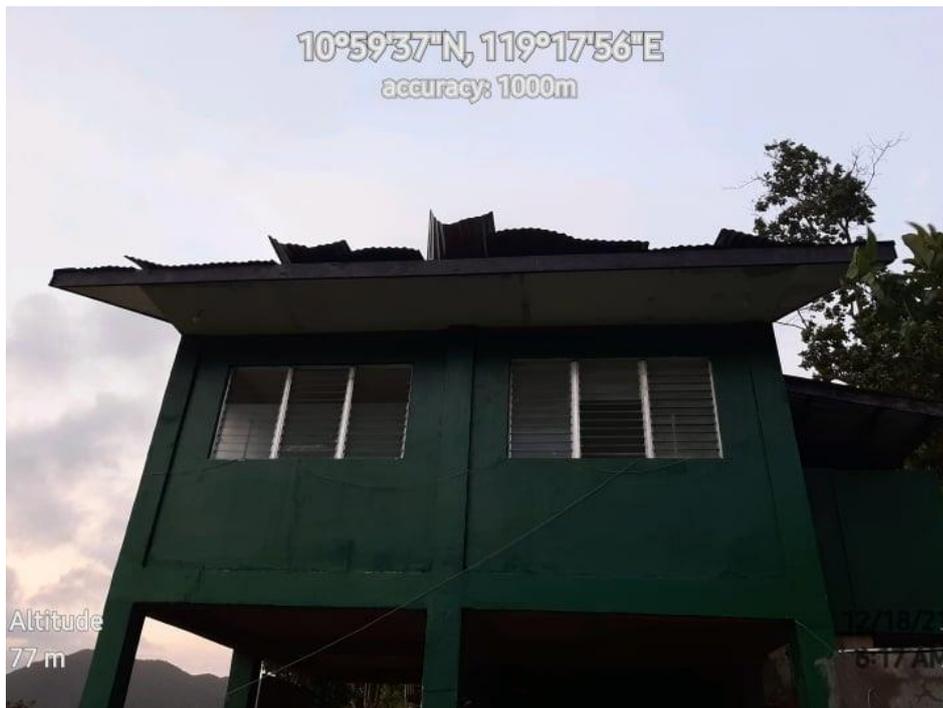
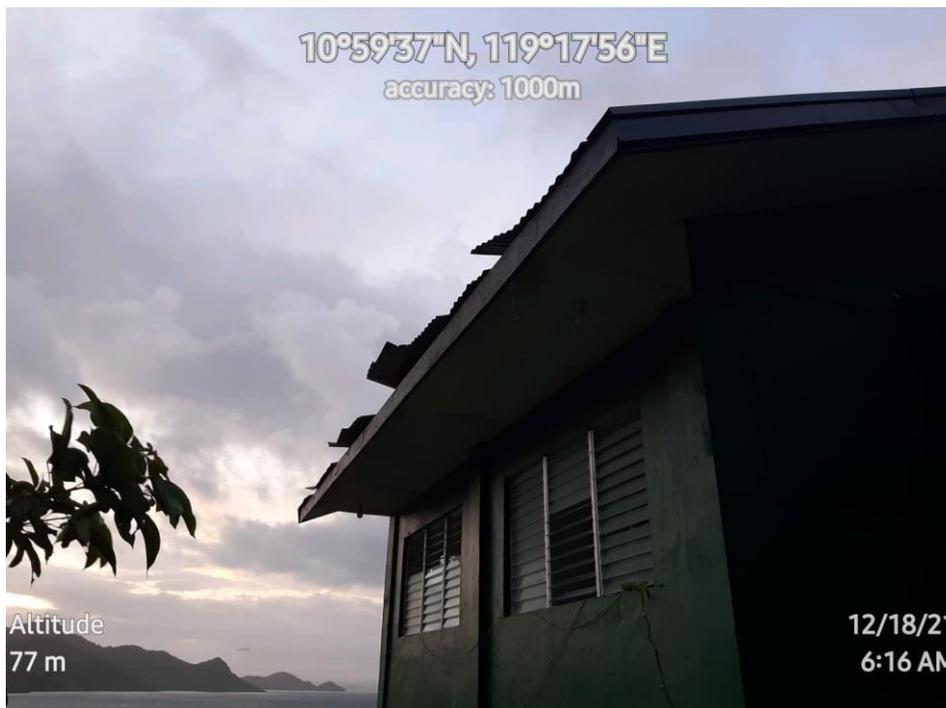
Partially damaged tin roof of the Park Ranger Station in Bgy. Tumbod, Taytay, Palawan

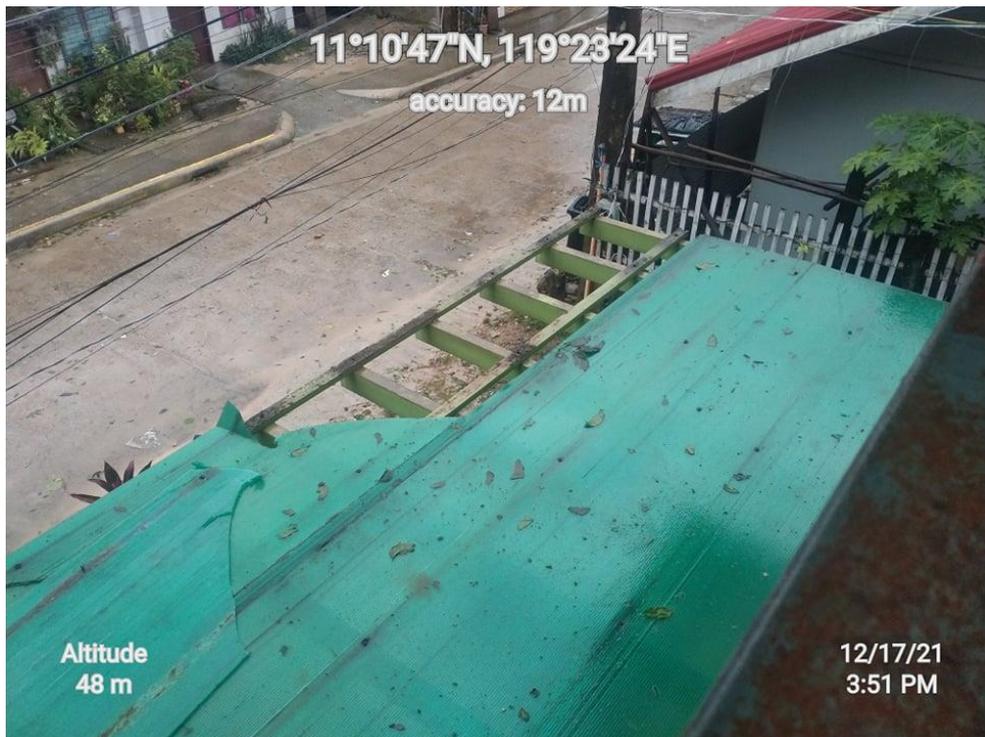
Partially damaged polycarbonate roof of the PAMO-ENTMRPA located along Calle Real, Bgy. Masagana, El Nido, Palawan

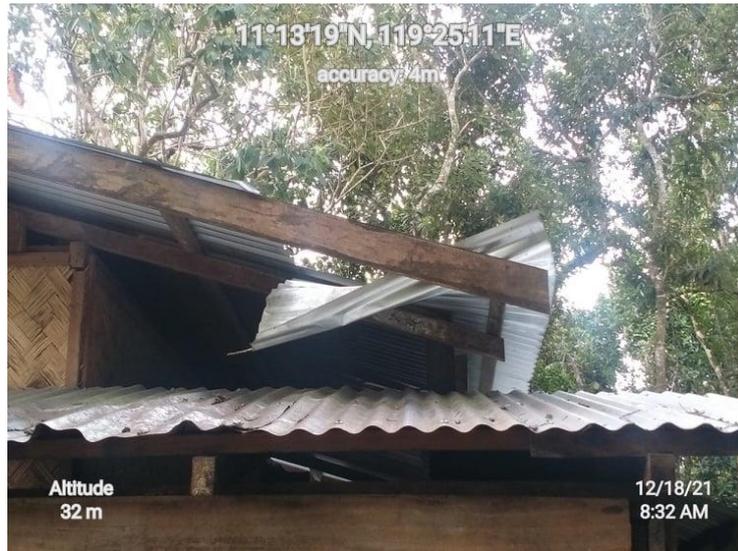
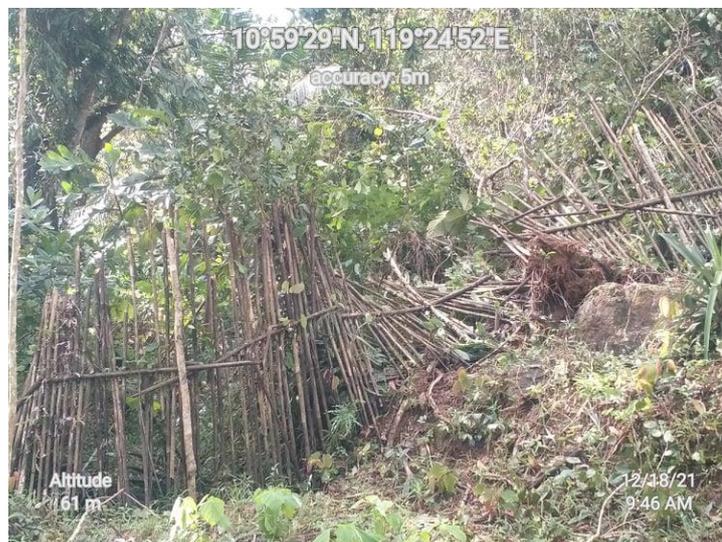
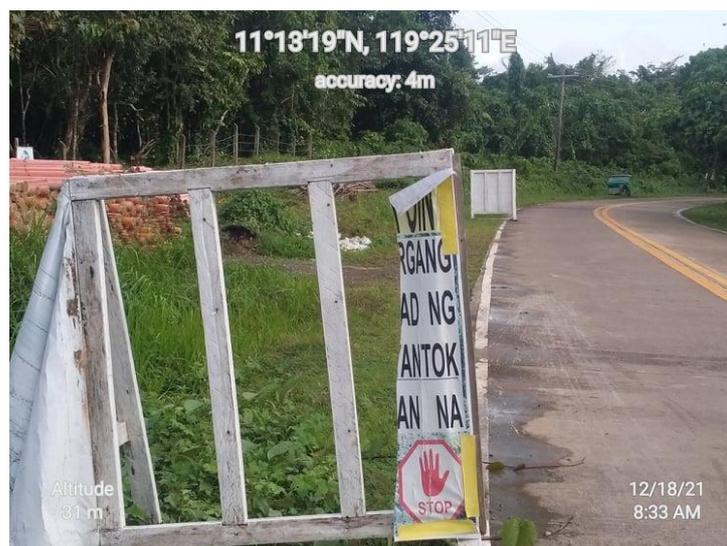
Partially damaged roof, fence and torn signage of FPMS II located in Bgy. Bagong Bayan, El Nido, Palawan

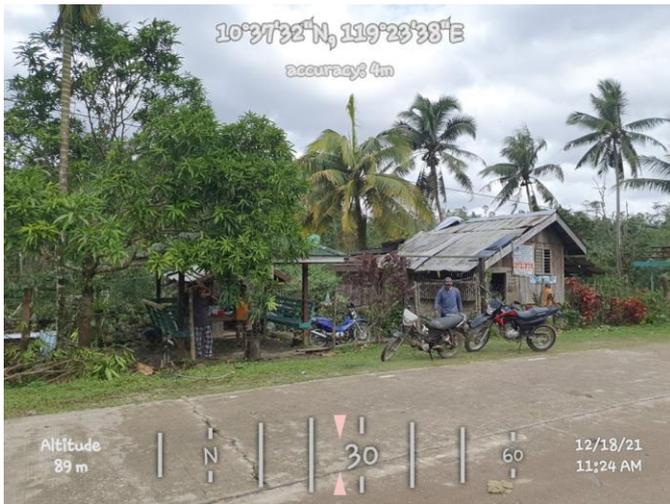
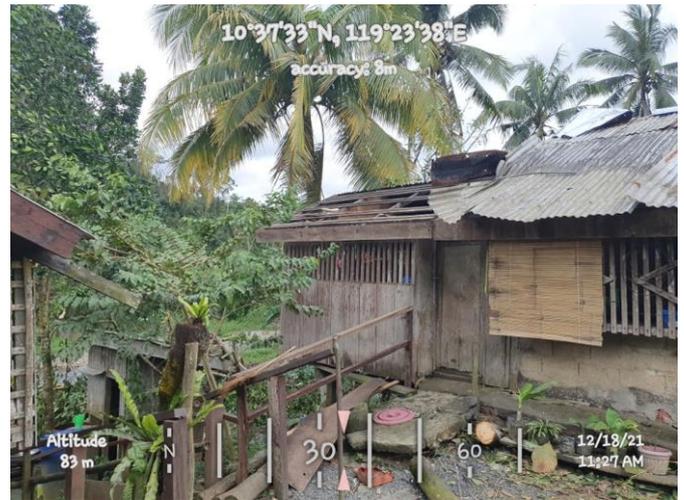
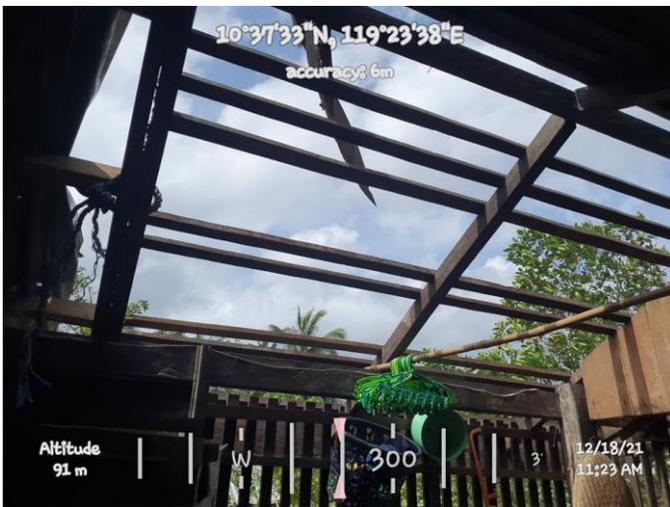
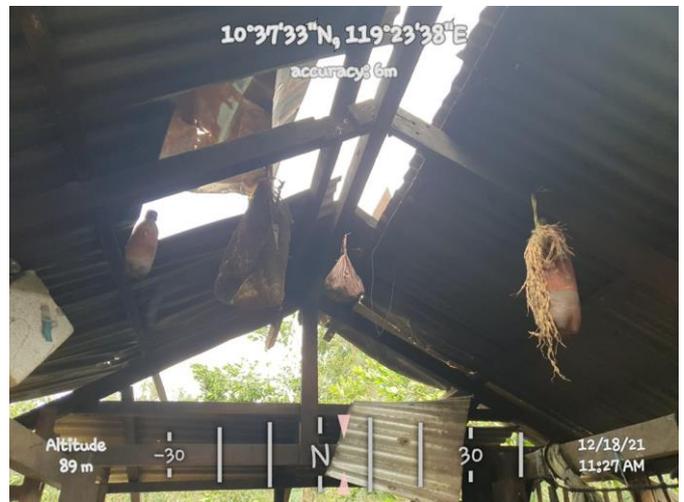
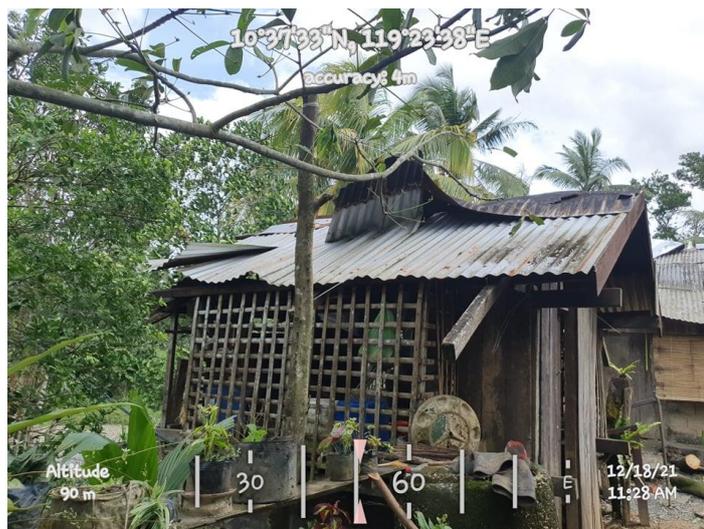
Damaged roof of the station and kitchen of FPMS III located at Sitio Ibanglely, Bgy. Abongan, Taytay, Palawan
