Republic of the Philippines Provincial Government of Palawan PROVINCIAL DISASTER RISK REDUCTION AND MANAGEMENT OFFICE Capitol Complex, Puerto Princesa City

AFTER ACTIVITY REPORT

Title of Activity	HAZARD, VULNERABILITY, AND CAPACITY ASSESSMENT OF BAROTUAN NATIONAL HIGH SCHOOL, BRGY. BAROTUAN, EL NIDO, PALAWAN			
Date	AUGUST 26, 2021			
Venue	PUROK A, BRGY. BAROTUAN, EL NIDO PALAWAN			
Overview	The safety of both the learners and the teachers in the school establishments are of primary concerns for PDRRMO and the PGP. Thus, assessment of hazards, vulnerabilities, and capacities of the schools is one of the thrusts of the office as it is also one of the concerns by the Governor.			
	A team of PDRRMO staff is usually sent to the schools, especially prioritizing those with reported incident of hazard occurrence and with indications of imminent danger. Using the PDRRMO HVCA Assessment Tool, the team surveys the general location of the target area and inspects the hazard prone buildings and other infrastructures. The tool would also take note of the pertinent information and detailed condition of the school.

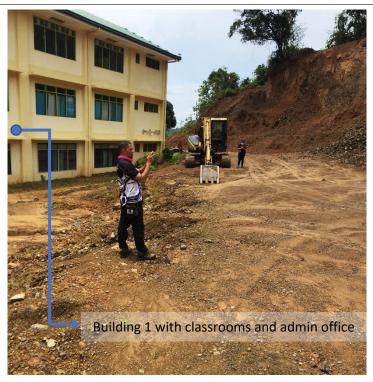
The Assessment team observing the problematic slope. On the left, the school building only about 10meters from the mountain slope (northside of the school premises) with an approximate slope height of around 15-60ft. No slope protection, temporary drainage or safety measures, lines and signages present or installed during the date of assessment.

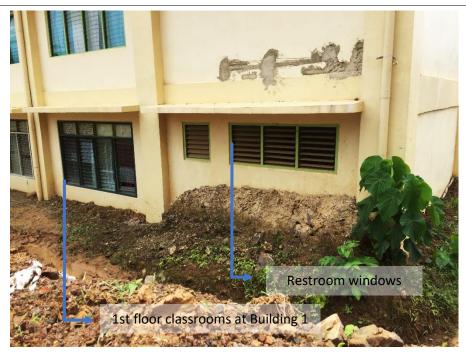
The side of Building 1 during the date of assessment with large accumulations of mud, dirt and gravel. Recent reports indicate the accumulation has gotten higher almost entering the classrooms. The mud has effectively clogged the drainage system rendering this restroom useless and dangerous for usage.

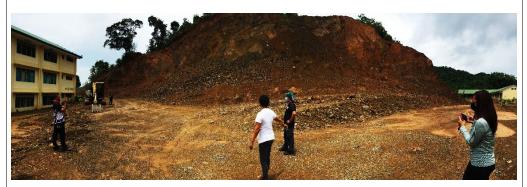
A panoramic view of the expanse of the hazardous slope. Its size compared to the three-story Building 1, people and the backhoe during the assessment date. As observed, no slope protection, temporary drainage or safety measures, lines and signages present or installed during the date of assessment.

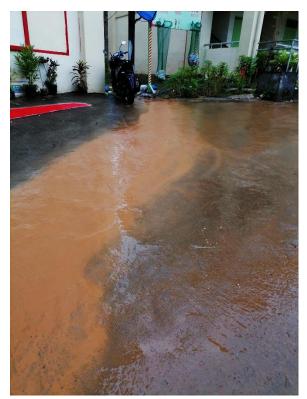
The parking space with evident slipping hazard. Accidents regularly happen in this area since the start as the contractor did not install a temporary waterway to redirect rain runoff from their operations away from the school premises. The runoff consists of both water and silt from the massive slope.

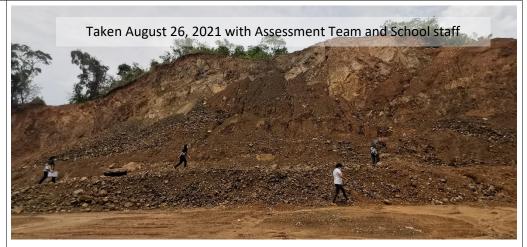
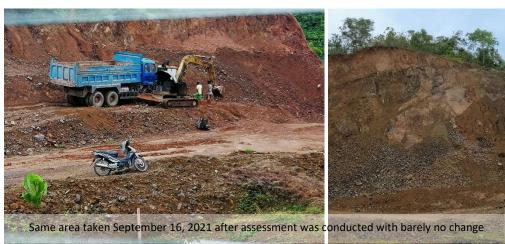
The same slope with barely no change in volume after almost a month of assessment. This photo was provided on Sept. 16, 2021 by the school administration as barely no sense of urgency is being implemented by the contractor. As observed, still after almost a month, no safety measures on both the site and its workers are installed and imposed.

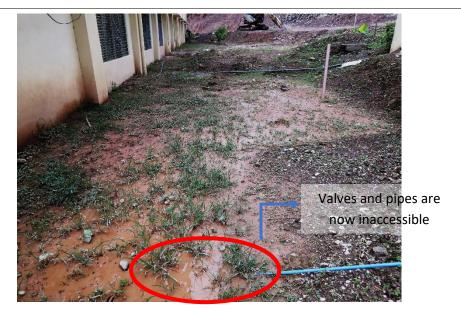
Pipes buried along with its valves by the accumulation of mud, gravel and water from the slow-running operations of removing/leveling the hazardous slope.

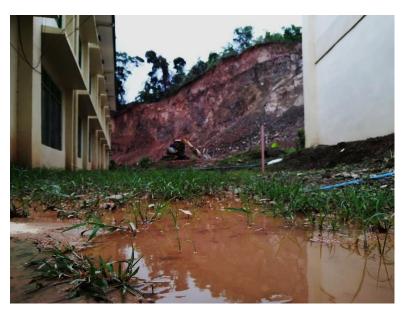
Water becoming stagnant as drains are completely blocked and flow is collected towards the school buildings. This accumulation of water may become a breeding ground for dengue-carrying mosquitoes, thereby becoming an alarming health hazard to the school population as well as contractor workers.

- The stagnant water must be removed, a proper drainage must be installed and bulkheads/revetments/ slope protection must be constructed to protect school structures before the return of the learners to the school to avoid imminent danger of diseases brought by mosquitoes, landslide, flooding, and slipping risks especially to the nearest school buildings adjacent to the steep slope and the reclaimed area at the back.

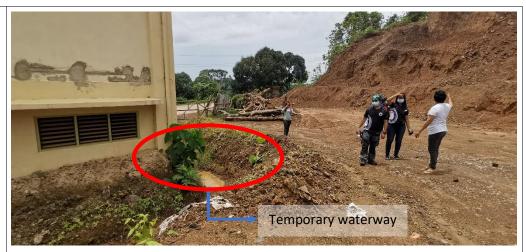
The water pools by the school buildings due to the basins formed from the poor attempt on an ineffective temporary drainage dug along the building sides. Blocked in many parts, the water ends up being collected in the area instead, and becoming stagnant. Recently now, around October 2021, the building wall is buried by more soil and debris accumulation and is nearly entering the windows.

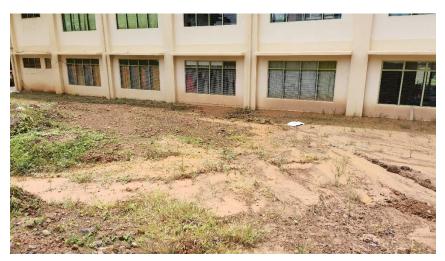
Mud pushed down from the slope onto the nearest buildings, only a foot away from entering first floor classrooms and windows during the date of assessment. Recent reports on October 2021 indicate that the mud is nearly entering the windows.

- Municipal DRRM Office of El Nido
- Provincial Engineering Office
- If the above-mentioned recommendations are not favorable, then a
 retaining wall/bulkhead should be constructed spanning the entirety of the
 school buildings. This action should be able to withstand the potential
 extent of the effect of the hazard to the elements at risk.
