**SUBJECT** : **STATUS REPORT OF ESTABLISHED ARBORETUM  
PROJECT AT SITIO IGSUSO, BRGY. TUBILI,  
PALUAN, OCCIDENTAL MINDORO**

SUBJECT : **STATUS REPORT OF ARBORETUM PROJECT AT  
SITIO IGSUSO, BRGY. TUBILI, PALUAN, OCCIDENTAL  
MINDORO.**

**Table A. Status of Arboretum**

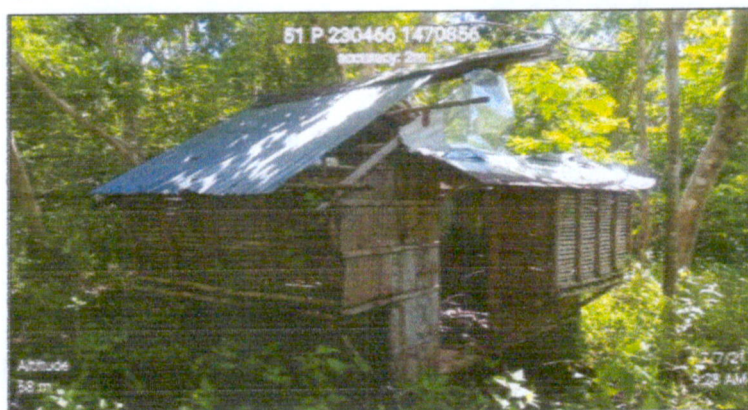
**Bunkhouse damaged by typhoons**

Based from the ocular inventory conducted, average survival rate is 86%. This office recommends funding for the continuous maintenance and protection of Arboretum.
