SUBJECT : **REPORT ON THE ALLEGED ILLEGAL SMALL-SCALE
QUARRY IN NEW AGUTAYA SAN VICENTE, PALAWAN**

November 08, 2021

SUBJECT : **REPORT ON THE ALLEGED ILLEGAL SMALL-SCALE QUARRY IN NEW AGUTAYA SAN VICENTE, PALAWAN**

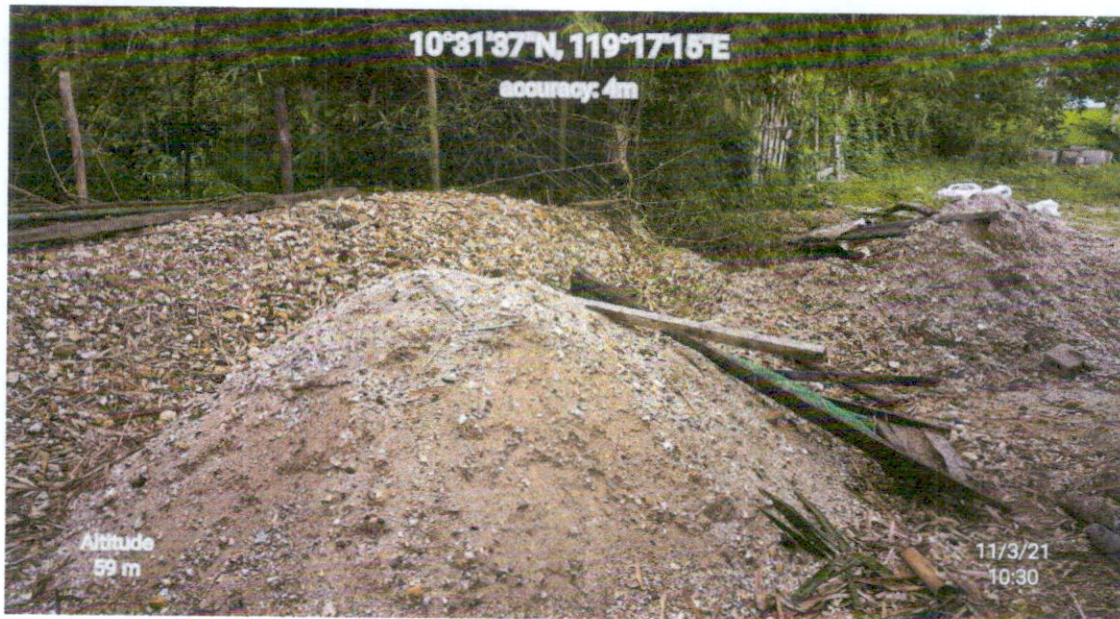
3. No actual extraction / quarrying operation were observed along Inanding River. However, mounds of sand and gravel and tools utilized for making hollow blocks were noticed on the property of Mr. Naph Pangilinan (Figure 1 and 2). When asked about if he has a permit to extract the sand and gravel, he insisted that it's his right not to disclose this information. He also stated that his operation on his property ceased when the pandemic began.

Figure 1. Mounds of sand and Gravel in Mr. Pangilinan's property

1. Based on the field findings and the information gathered regarding the subject matter, the extraction of sand and gravel in Inanding River and Little Baguio without Mining Perits from the Provincial Mining regulatory Board is deemed illegal and therefore guilty of committing **Theft of Minerals** pursuant to **Section 103 of RA No. 7942**, which provides:

A **Cease and Desist Order** must be issued to the concerned constituents of Mrs. Norlita C. Zabalo, Punong Barangay of Barangay New Agutaya.

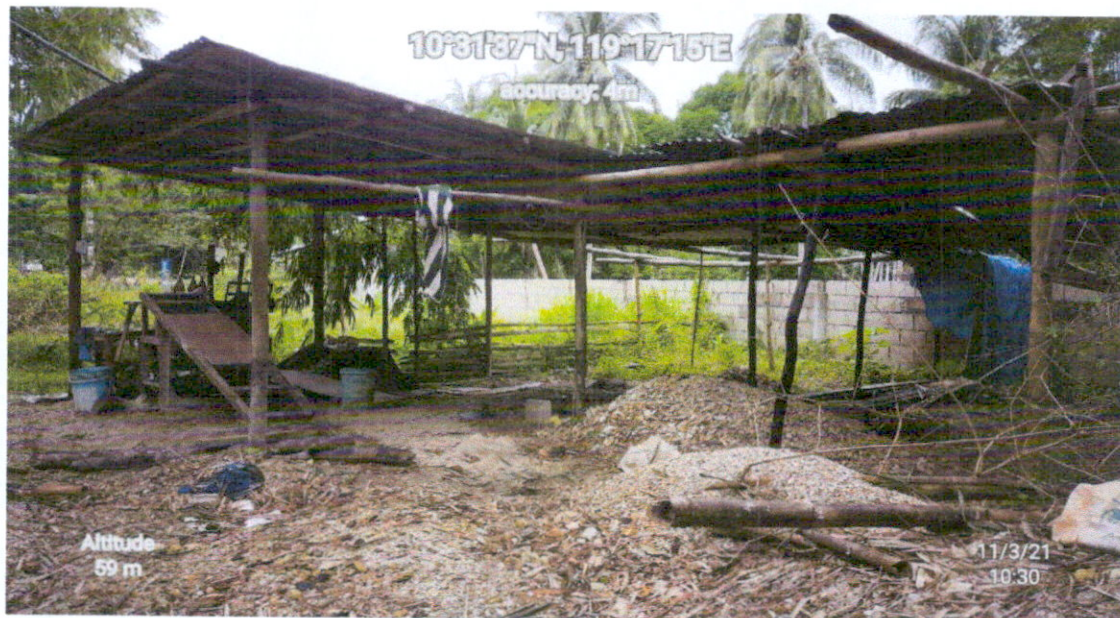
Figure 2. Devices used for making Hollow-Blocks in Mr. Pangilinan's Property

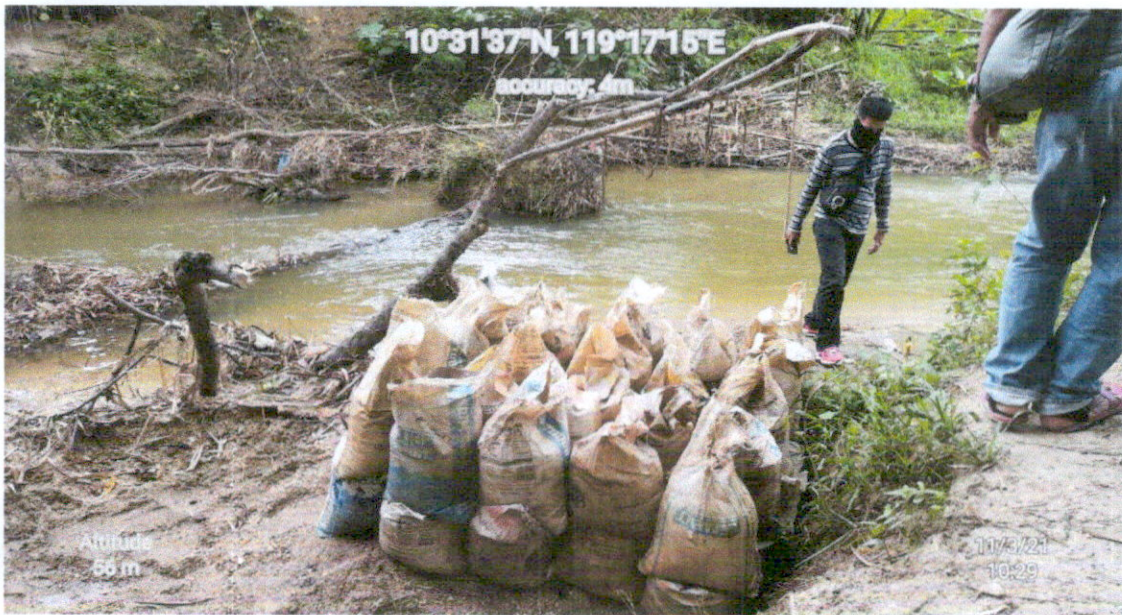
Figure 3. Sacks of Sand and Gravel along Inanding River

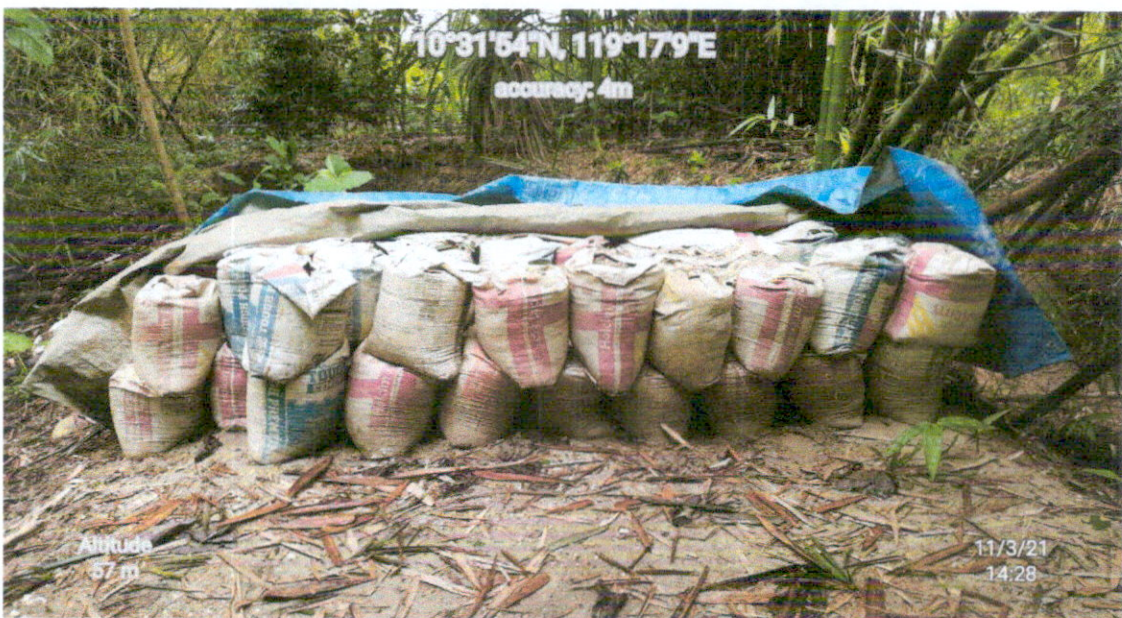
6. During the investigation in Little Baguio River, the team immediately noticed pile of sacks filled with sand (Figure 4). Deep extraction holes along the river are also visible (Figure 5). No actual operation during the investigation was observed.

Figure 4. Sacks of Sand and Gravel along Little Baguio River

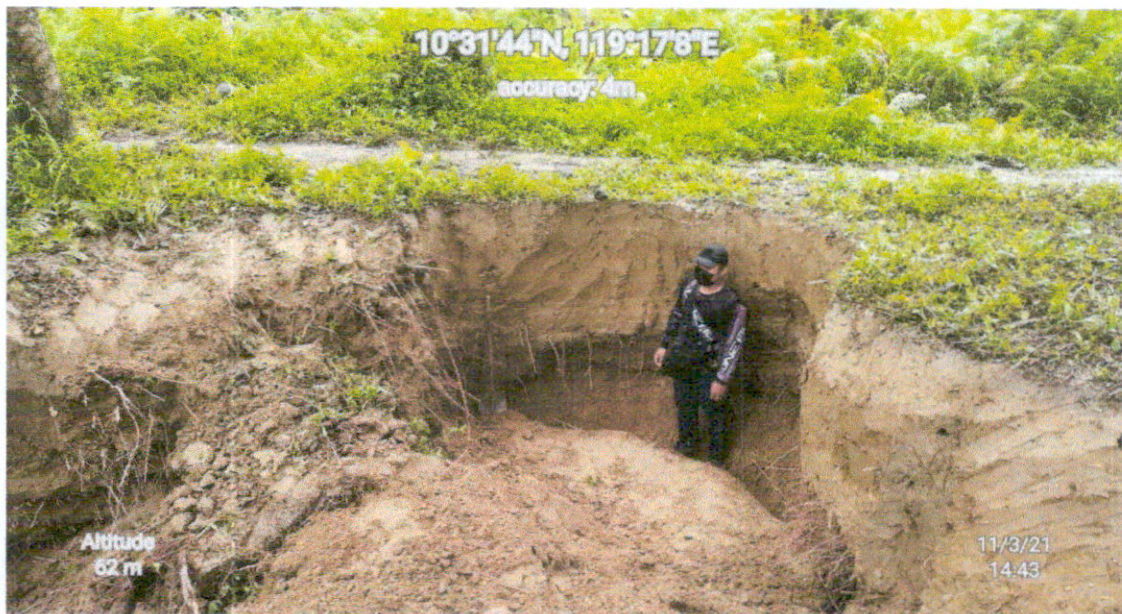
Figure 5. Extraction holes located near Little Baguio River

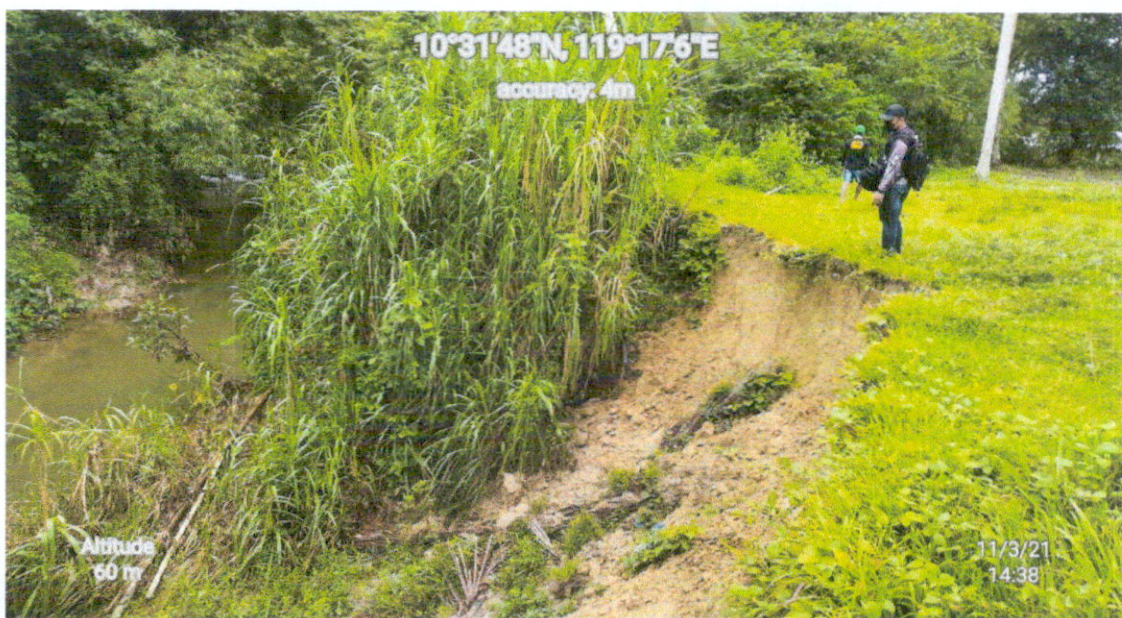
7. Several slope failures along the river were noticed (Figure). Indicating compromised stability and high susceptibility to erosion.

Figure 6. Slope Failure along Little Baguio River

2. Individual or a Corporation may apply for a clearance for dredging in mitigation for flooding and for commercial material extraction securing MPPs by the DENR-MGB, for the processing and disposition of dredged materials upon clearance by the DPWH.
3. Barangay officials should be aware of the environmental crimes being committed within their jurisdiction. Accordingly, strict implementation of environmental laws must be incessantly observed.
4. Strengthen monitoring in the area by PMRB Roxas is recommended.
