Ocular Inspection Report CY 2021  
(Open/ Controlled Dumpsite)

City/ Municipality, Province	Taytay, Palawan
Date of Inspection	August 12, 2021
Time of Inspection	1:44 PM
Person(s) Contacted	Rolly Fontamillas, Staff MENRO-LGU Taytay
Contact details of LGU	
Phone No.	09171902623
Email address	lgutaytaypalawan.ph@gmail.com
Inspection Team	Ma. Teresa Riziel I. Caya, EMB-MIMAROPA
	Rodel M. Dorado, CENRO-Taytay

Location of Open/ Controlled Dump	So. Batikan, Brgy. Poblacion, Taytay, Palawan
Geo-coordinates	10.85948, 119.49576
Elevation	MENRO staff has no information
Land ownership	
Total land area of open dumpsite (hectares)	
Waste Dump Area Used (hectares)	About 320 square feet or 00.297 ha.
Height of Waste from Ground Level (meters)	N/A
Depth of Waste from Ground Level (meters)	4
Estimated Volume of Waste Disposed	No information
Approximate Distance from Municipal Hall (km)	4.56
Distance from Nearest Settlement (m/km)	1 km
Date Started Operation	April 2021
Date of End of Operation	Still operational
Distance from Nearest Water Body	832 meters
Slope Range	MENRO staff has no information
No. of Waste Pickers	None
Weight of waste generated per day (kgs)	MENRO staff has no information
No. o

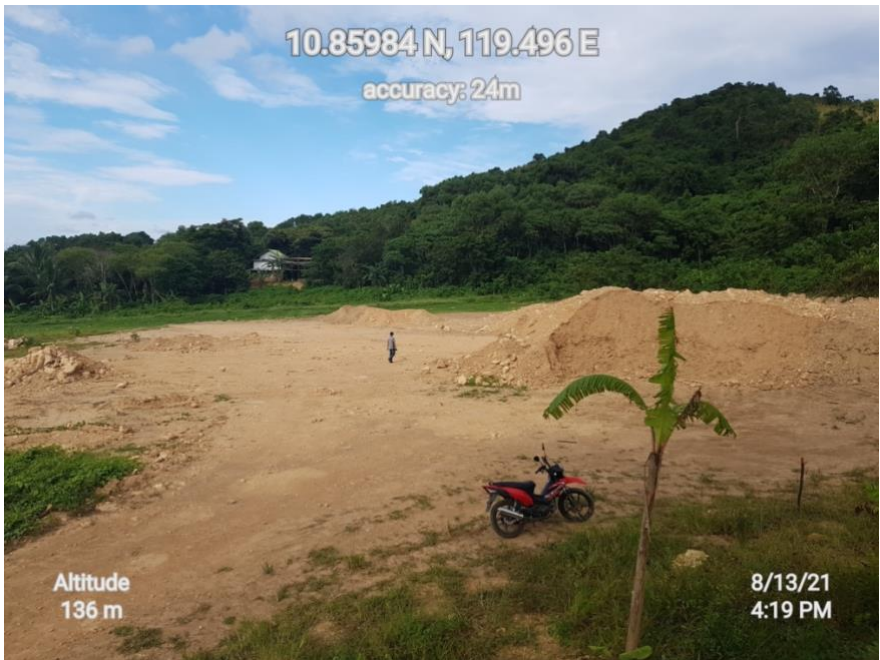
REQUIREMENTS	FINDINGS
A fence shall be constructed around the dumpsite to prevent unauthorized entry of waste pickers, children, and illegal settler and stray animals	No fence

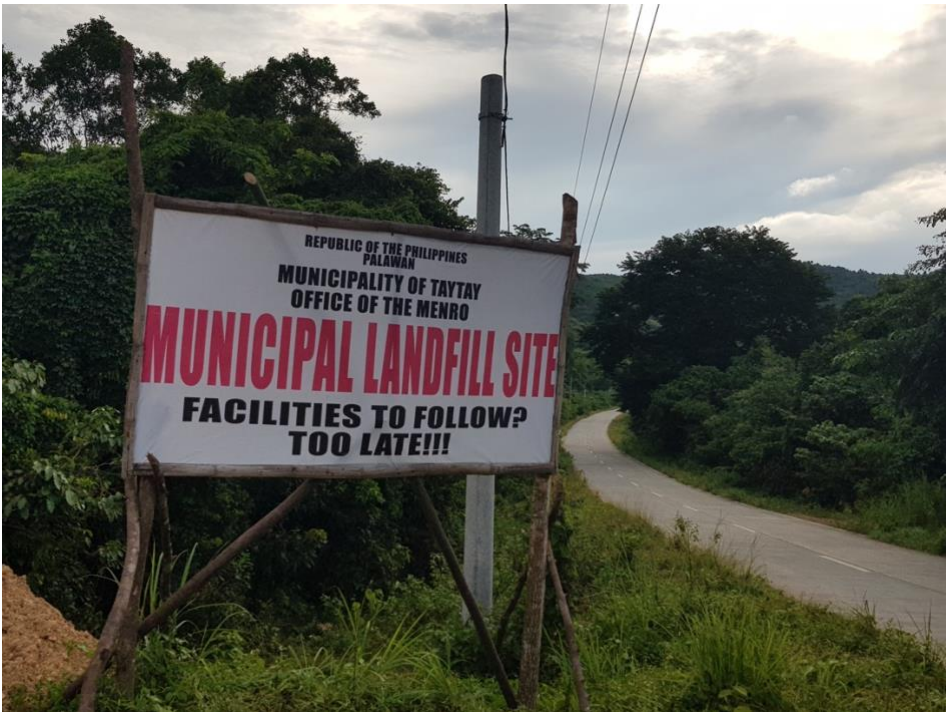
REQUIREMENTS	FINDINGS
An appropriate sign containing the following messages should be put up at a conspicuous place near or at the entry of the dumpsite: Name of Dumpsite, Status of Operation, Prohibition of burning, squatting, children and animal access.	The signage only mentions the name of the site.

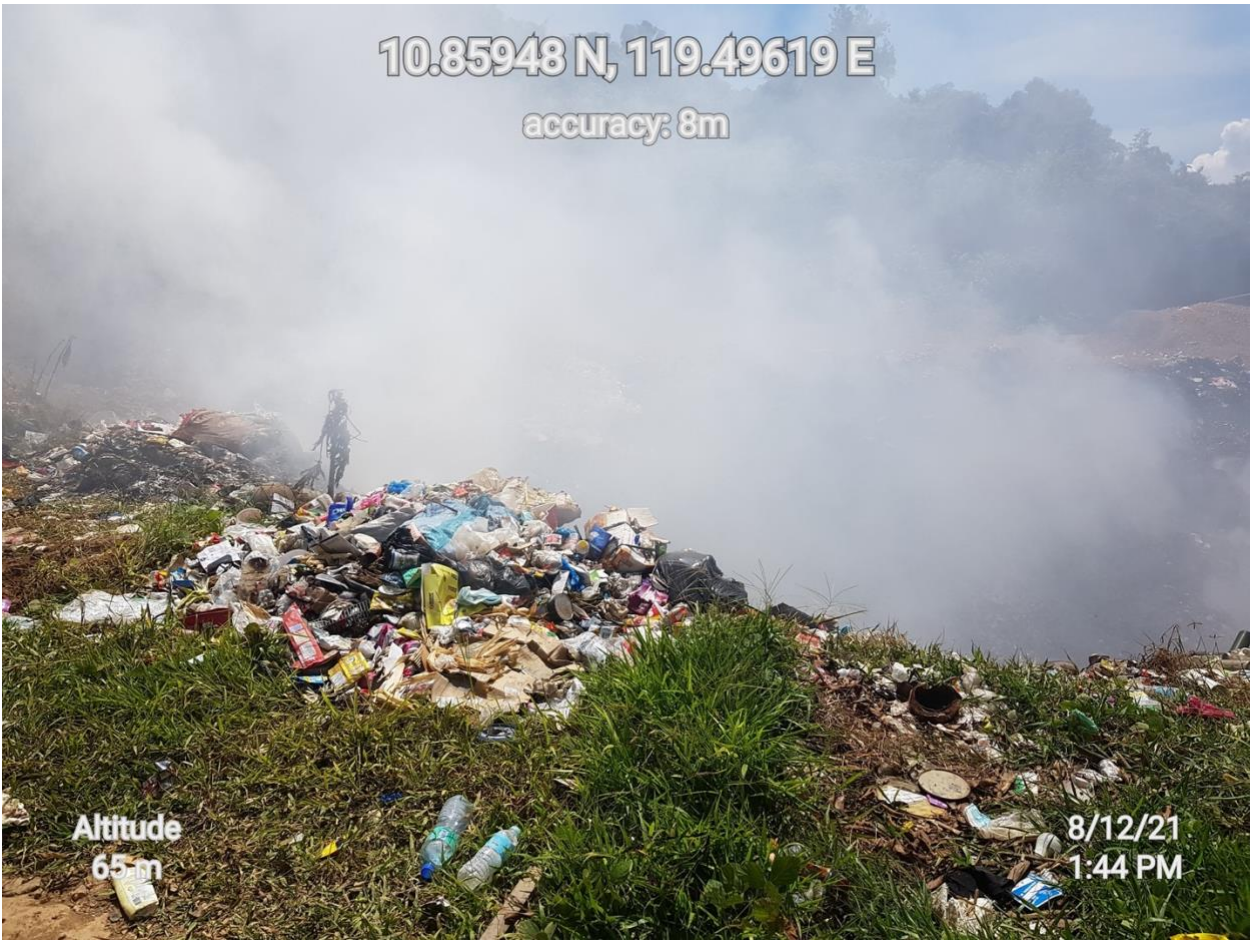
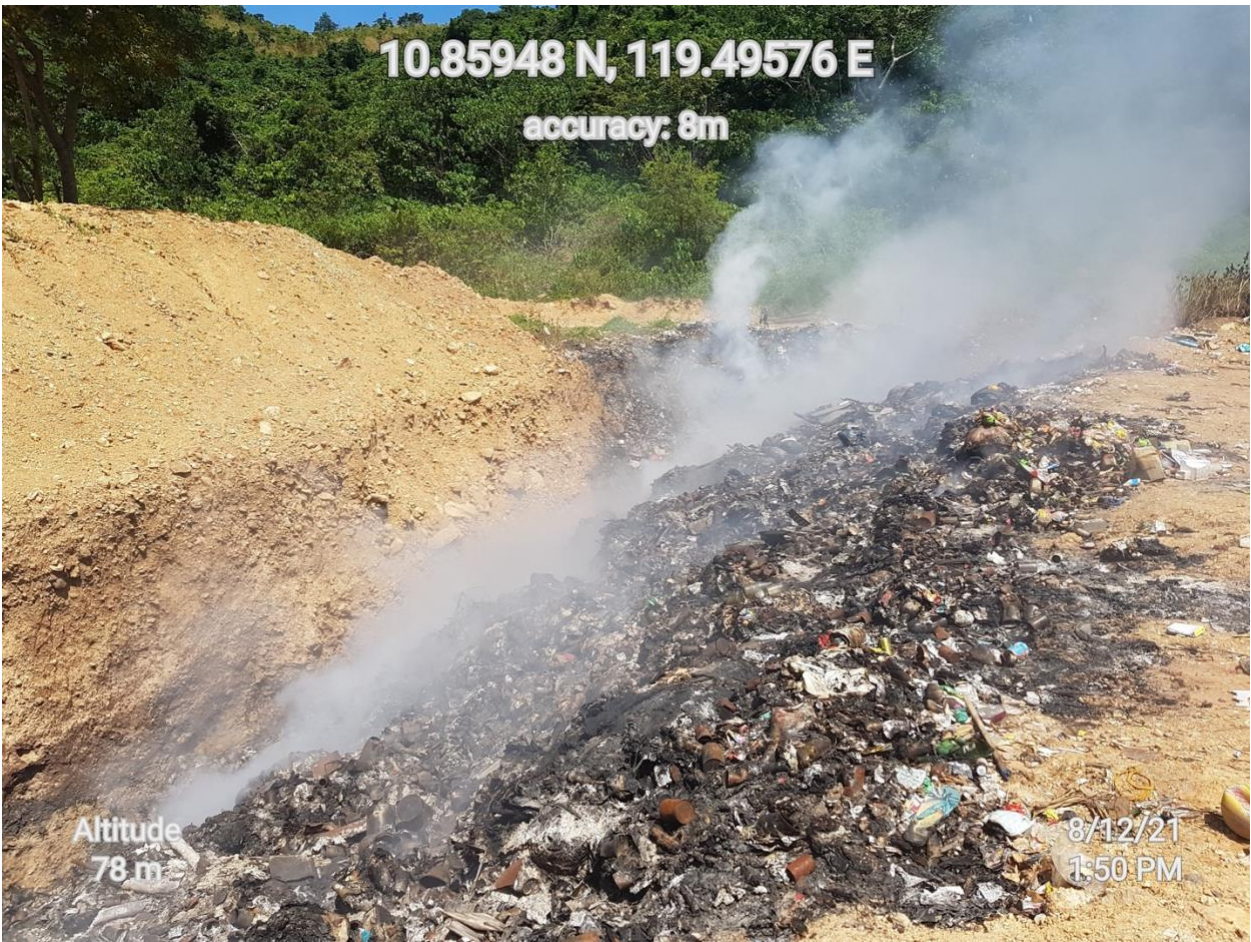
REQUIREMENTS	FINDINGS
Burning of Waste must be prohibited at the dumpsite.	Burning of wastes was observed on August 12, 2021.

According to Mr. Rolly Fontamillas of MENRO Taytay, the fires started on Monday, August 9, 2021, but he is unaware of the actions taken by their office to put out the fires. He said the exact reason of the fire is unknown as the site is not fenced and waste pickers that enter could have thrown a cigarette in the pile of garbage. It was observed that plastic bags and bottles, pieces of metals, and cans are in the pit.

Issuance of NOV for violation of Section 48, (3) and (4) of RA 9003

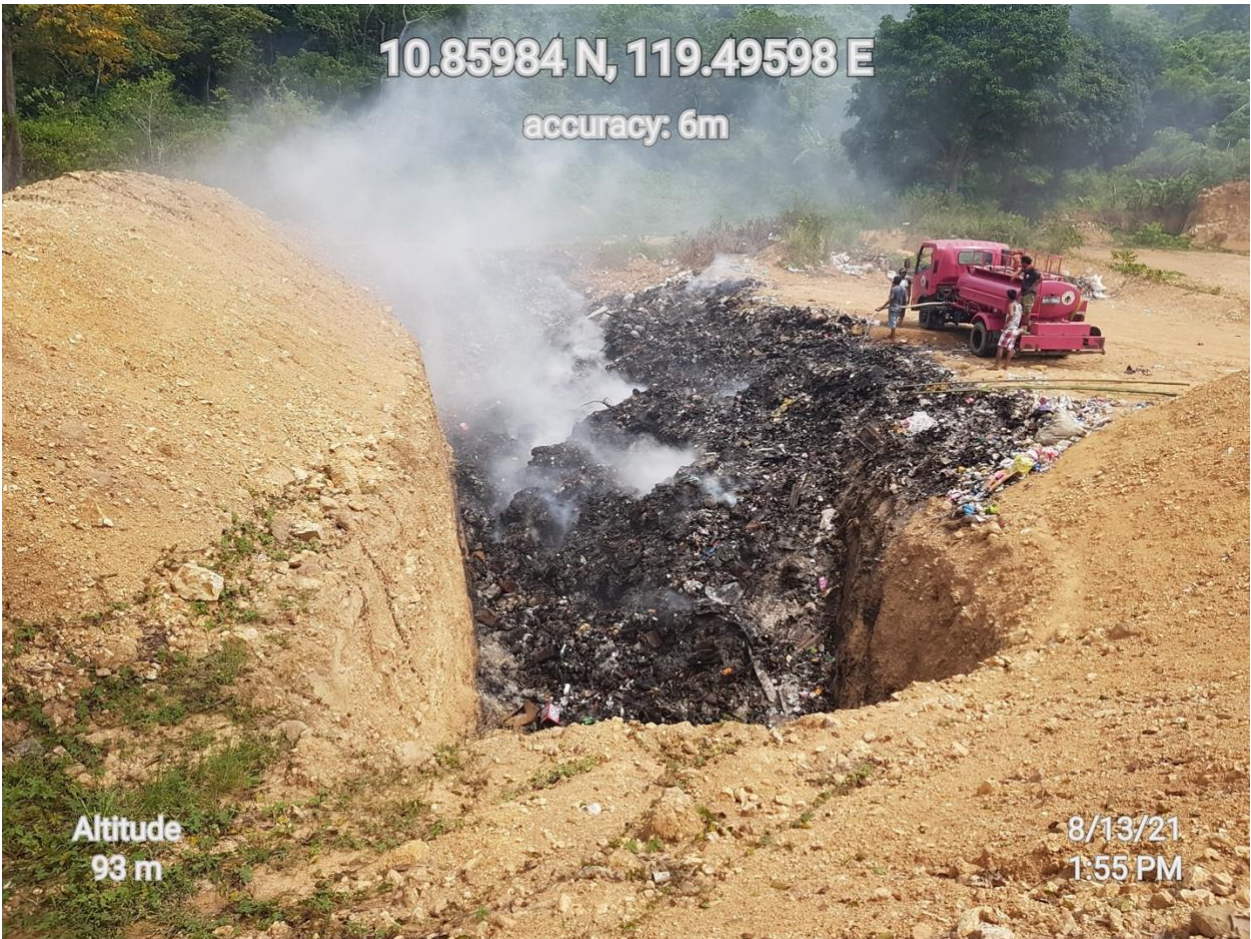
At 1:41 pm on August 13, 2021, the undersigned arrived at the site with MENRO Staff Cesar S. Astoriano. It was observed that there are still small fires at the bottom of the pit. It took the MDRRMO fire truck four tries and until 4:24 pm to have the fire under control. However, as there is still smoke coming from the pit, the MENRO and MDRRMO staff will douse the garbage with water again on August 14, 2021.

First attempt by the MDRRMO and MENRO staff to put out the fire

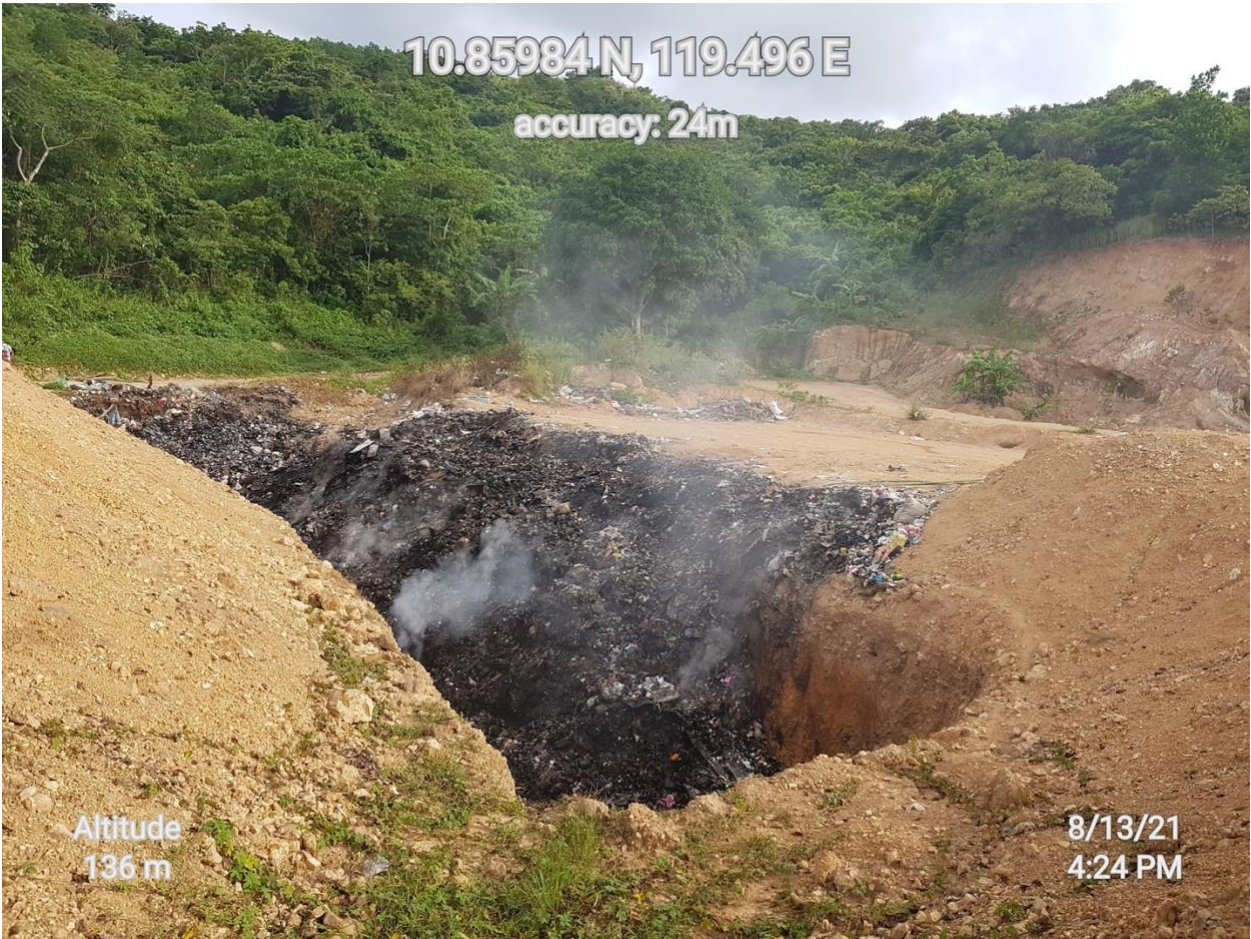
The smoke is relatively smaller after two hours
