SUBJECT : INVESTIGATION REPORT ON RIVER DREDGING SAND AND GRAVEL EXTRACTION IN CORON, PALAWAN

22 March 2022

SUBJECT : INVESTIGATION REPORT ON RIVER DREDGING SAND AND
GRAVEL EXTRACTION IN CORON, PALAWAN

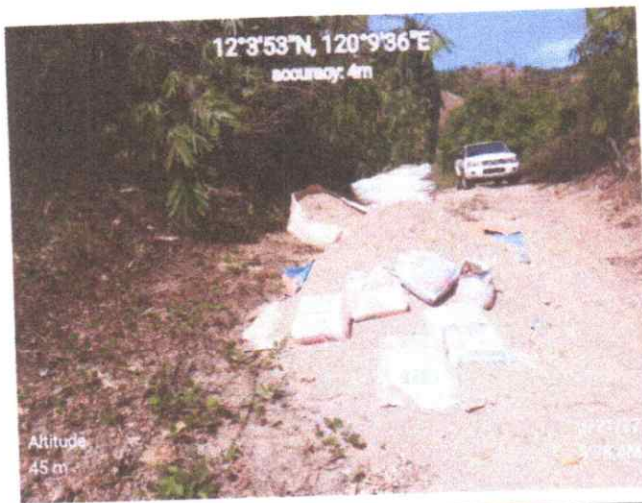
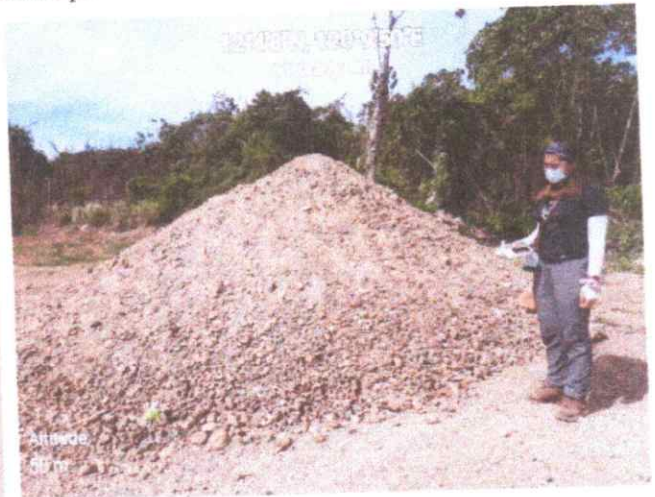
Photo Documentation 01
Brgy. Guadalupe

4. Upon arrival in the subject area, no ongoing extraction was observed. However, there are sacks of sand, *salandra*, and a backhoe in the area. Moreover, stockpiles of sand and gravel, possible recent excavation along the riverbank, and probably recent truck tracks were noted. These may suggest that there is an ongoing quarry activity in the area (*see Photo Documentation 01*).

Observed bags and stockpiles of sand and gravel in the area.

1. The CDO released last 24 March 2021 should be reiterated to BCT Construction Inc. If proven still conducting an excavation, the company is recommended to be penalized.

4. Lastly, it is suggested that the company also rehabilitate the area to minimize the flooding in the area.

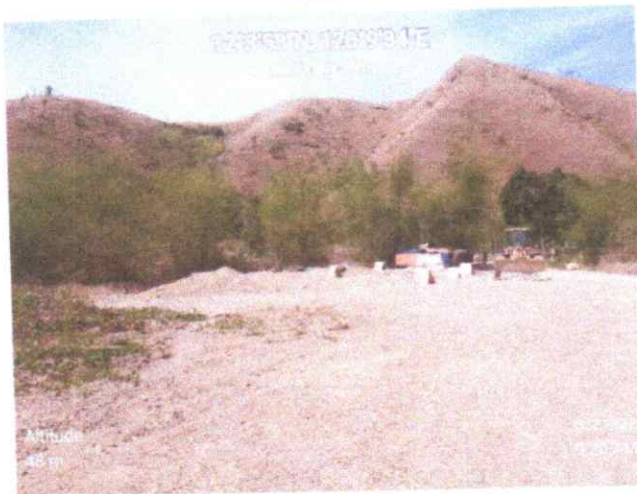
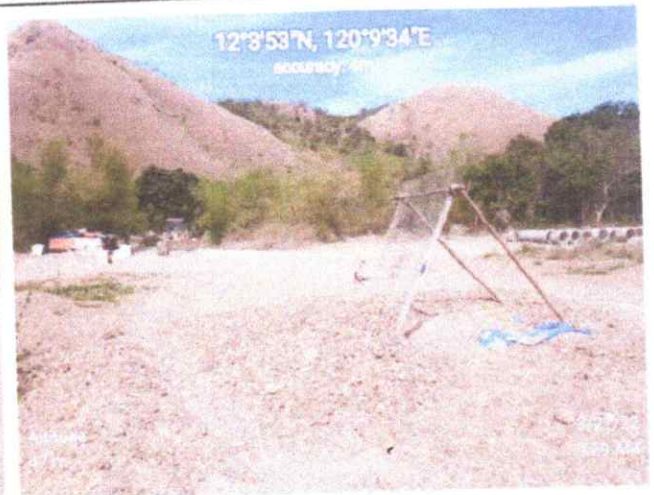
Salandra, parked backhoe, stockpiles of sand and gravel.

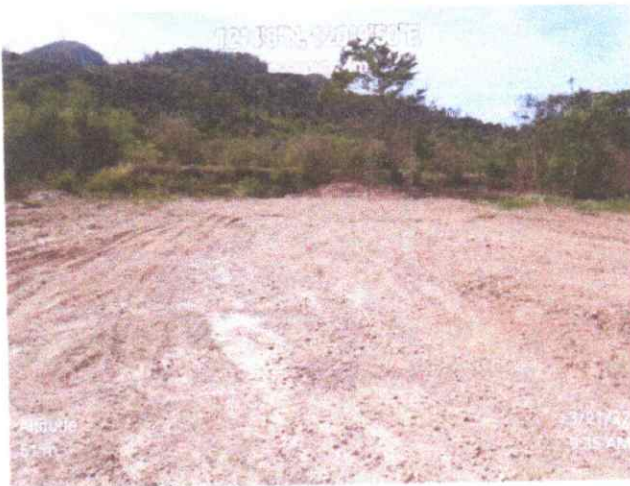
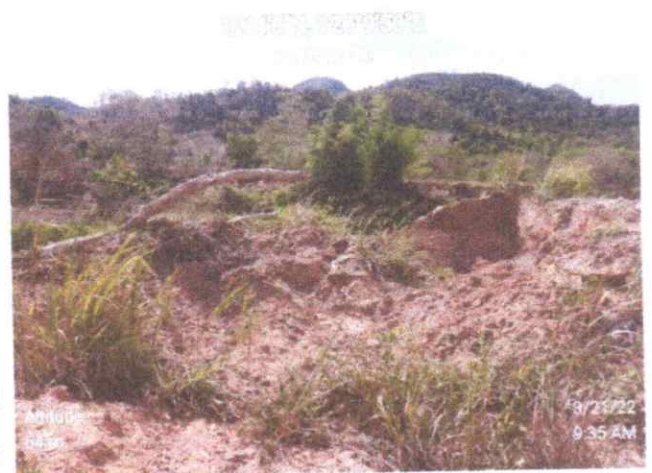
6. Currently, some part of the river is blocked by sediments. As a result, the flow of the river is slightly jammed. This may cause to exacerbate the flooding in the Umay River.

Possible recent truck tracks and excavation along the riverbank.

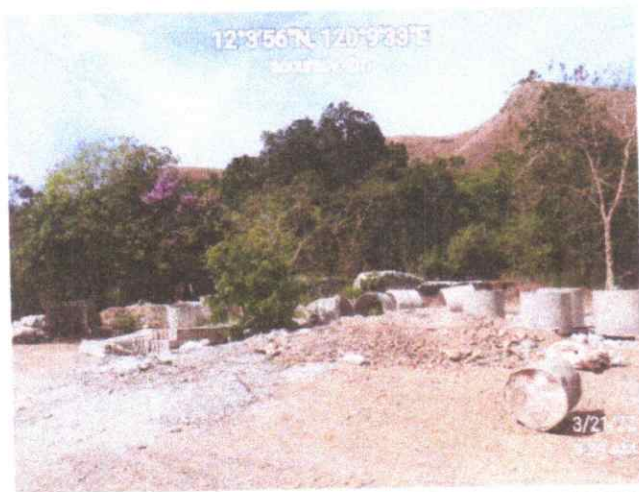
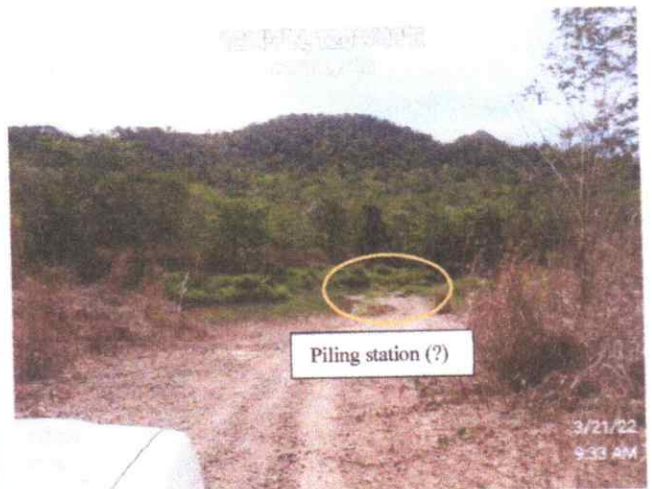
5. Based on the information gathered from the locals at the time of inspection, these sand and gravel are used for making culverts and posts for DPWH road projects. These materials were observed in the area (*see Photo Documentation 01*).

The extracted materials are used to make posts and culverts. Encircled in the right photo is a possible former piling station.

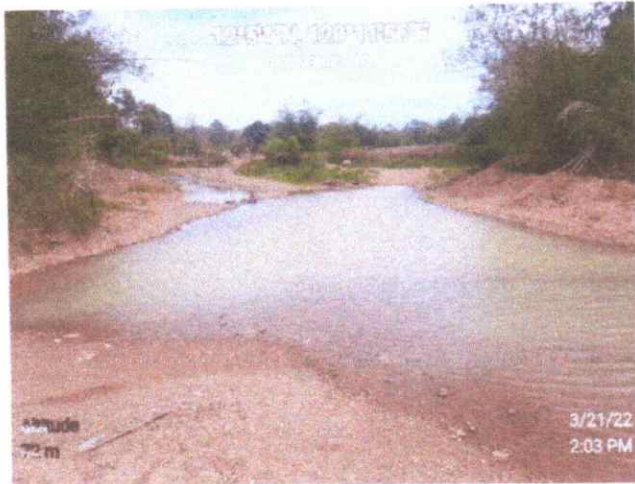
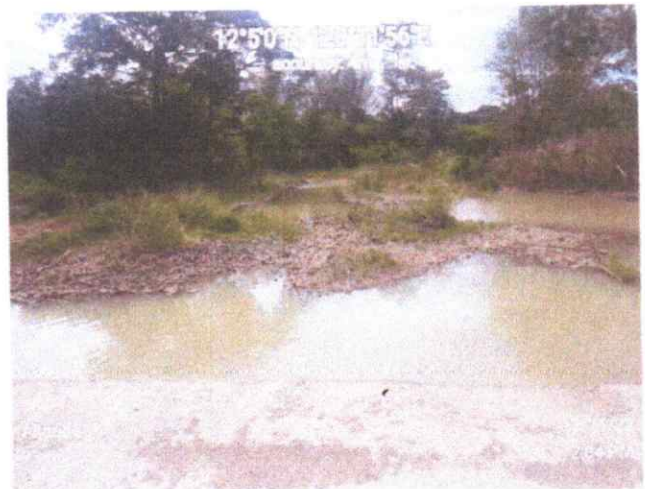
Photo Documentation 02 Brgy. San Nicolas

1. The subject area is geographically situated at 12° 05' 01" N, 120° 11' 56" E. It is ~15 km away from CENRO and can be reached within a 20-minute drive.
2. Based on the information gathered, this area is quarried by Kap. Nacachi. The sand and gravel excavated are for the NHA housing project in San Nicolas. At present, they are in stopped operation.
3. This was confirmed during the investigation as no quarry equipment nor sacks of sand and gravel are observed in the area. However, the area is left abandoned. As a result, the flow of the river is blocked by sediments. This may heighten the flooding in the area (*see Photo Documentation 02*).

SAG excavation in Brgy. San Nicolas. Piles of sand and gravel were left in the river channel, blocking its natural flow, upon ceasing of quarry operations.

1. Based on the investigation, the operator is suggested to rehabilitate the area to lessen flooding in the subject area.

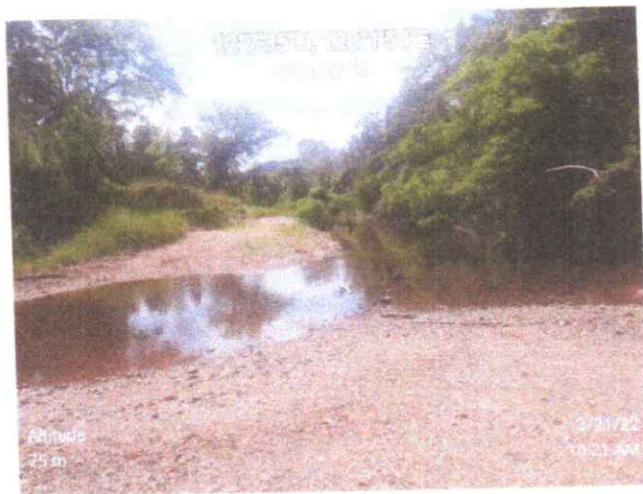
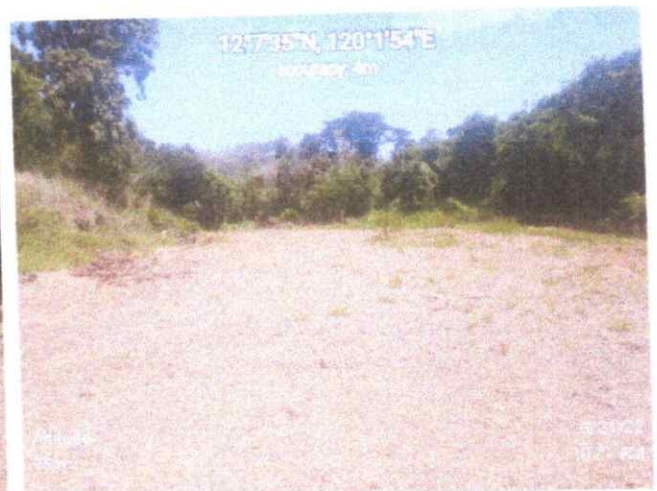
Photo Documentation 03
PACECO, Brgy. Decalachao

4. This was confirmed upon arrival in the area. No quarry equipment nor *salandra* were observed. However, old truck tracks were noted. Additionally, old piling stations were present.

5. Unfortunately, the operator left the area without rehabilitating it (*see Photo Documentation 02*). This operator was not also confirmed as no concrete evidence was found.

6. As a result, the river is blocked by the leftover piles of sediments. The present dimension of the river is also compromised. This may pose a hazard to the residents near the area as river swelling will be rapid during the rainy season (*see Photo Documentation 02*).

Former river quarry in PACECO, Brgy. Decalachao. The flow of Papualan River was blocked by the probably a former stockpile. Third photo was during the courtesy call in the barangay.

1. Further investigation to confirm the company that formerly operated in this area. The PMRB is also requested to help investigate this site
2. At present, there is no valid quarry permit holder in PACECO. The company therefore extracted illegally sourced mineral/mineral products (refer to Section 116 Chapter XII of DAO 2010-21). Furthermore, if proven that the company operated without a quarry permit, the company violated Section 103 of RA 7942.
3. It is recommended that the company should rehabilitate the area to minimize flooding.

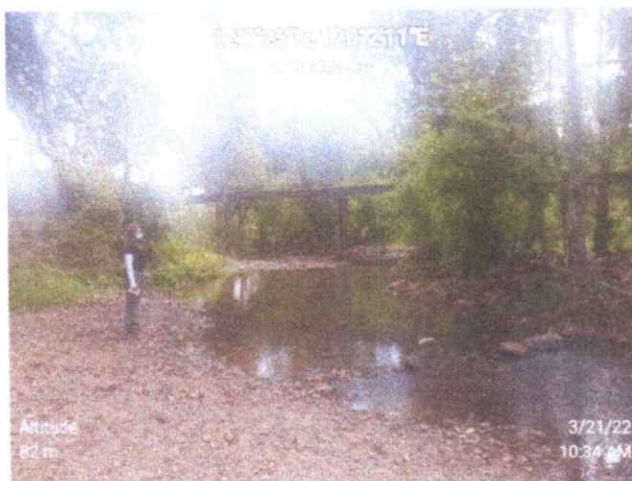
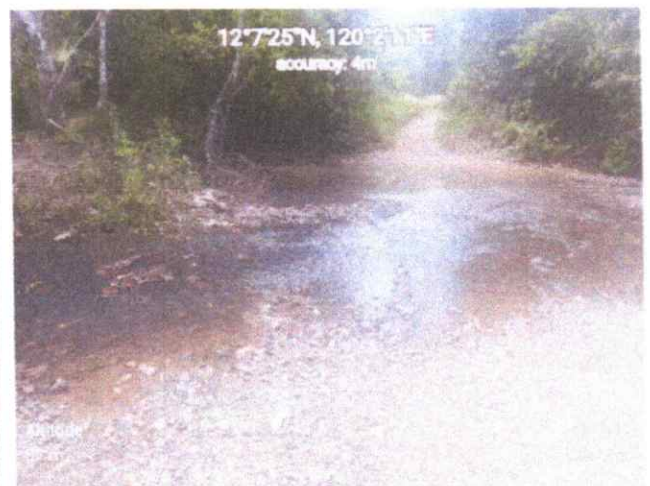
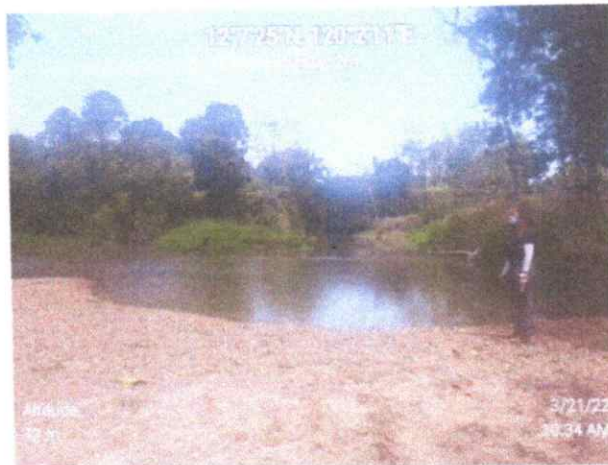
Photo Documentation 03
Papualan River, Brgy. Decalachao

2. As previously stated by Kgw. Palanos, there was no quarry and dredging in Brgy. Decalachao. This, however, contradicts the previous report of the former MGB and EMB embedded last 2021. MGB and EMB were able to document the illegal operation of BCT Construction Inc. in Papualan River.
3. On 22 June 2021, BCT Construction Inc. was issued a CDO for violating Section 103 of RA No. 7942 and extracting illegally sourced minerals/mineral products (Section 116 of DAO 2010-21).
4. Based on the investigation, the company has still haven't done rehabilitation in the area. The company hasn't fixed the bridge that was damaged during the transport of excavated material. Moreover, the river is still blocked by old stockpile sediments and the river depth is still shallow. As the area is prone to flooding, the area must be rehabilitated immediately (*see Photo Documentation 03*).

Former river quarry in Papualan River, Brgy. Decalachao. The same situation was observed to what the former MGB and EMB embedded reported in 2021. No rehabilitation was conducted by the company.

1. Based on the investigation, BCT Construction Inc. is recommended to rehabilitate the area to decrease the effect of flooding in the area.

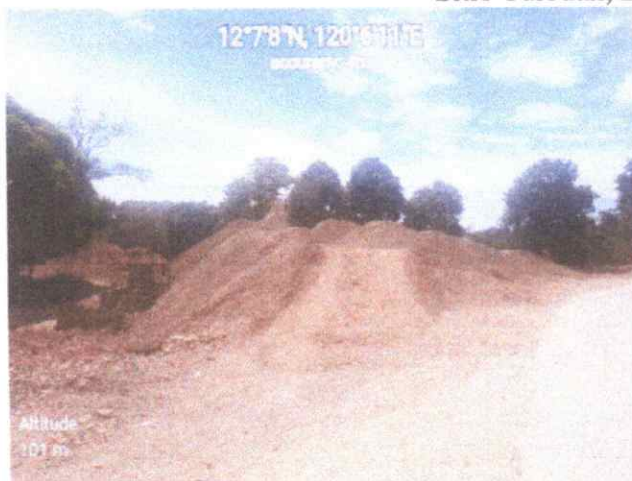
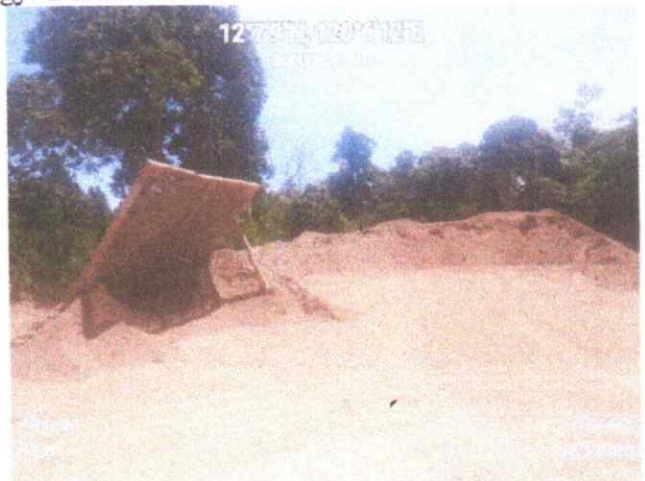
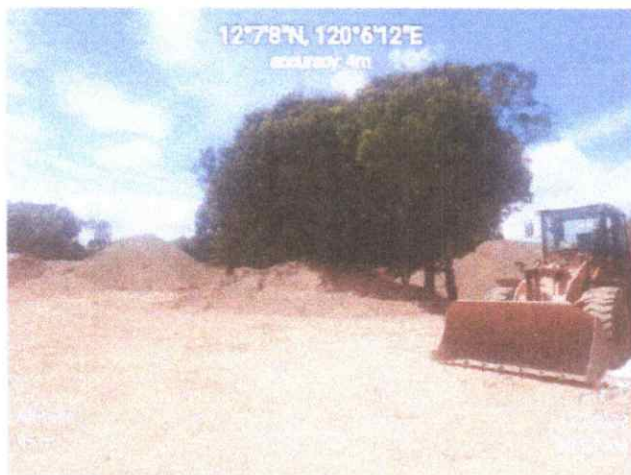
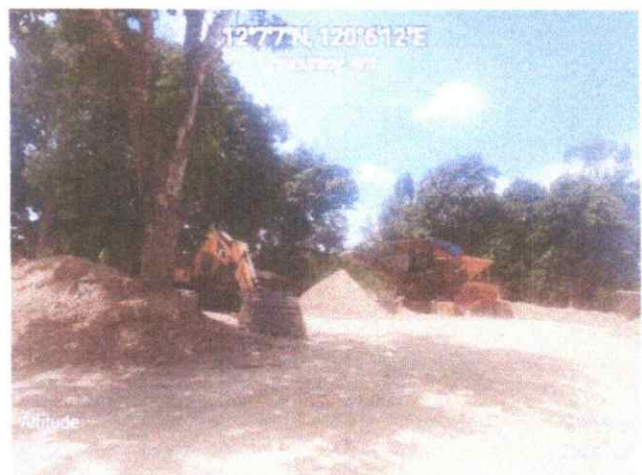
Photo Documentation 04
Sitio Tulbuan, Brgy. Decalachao

3. The undersigned also discovered that the sand and gravel extracted here are delivered to Sitio Tulbuan, Brgy. Decalachao. At Tulbuan, segregating equipment, backhoe, and *salandra* are observed. Huge piles of SAG are also present (*see Photo Documentation 04*).

Stockpiles of SAG excavated from San Jose. This is for the new international airport in Busuanga. Heavy equipment on standby and stockpiles of sand and were among that was noted in the area.

1. Based on the present list of quarry permit holders of PMRB, BCT Construction Inc. have no legal rights to extract sand and gravel in Brgy. San Jose. This violates Section 103 of RA 7942.
2. Since there is no permit, the extracted materials in the areas are considered illegally sourced mineral/mineral products (*refer to Section 116 Chapter XII of DAO 2010-21*).
3. Additionally, an improper extraction method is observed during the ocular inspection. It is recommended that the entire area be inspected further to evaluate other possible violations.
4. The contractor is also advised to first secure the necessary permits before conducting extraction of sand and gravel.
5. As the regulatory board, Provincial Mining Regulatory Board (PMRB-Coron) should help MGB to monitor such activities to ensure that the company complies with the law.

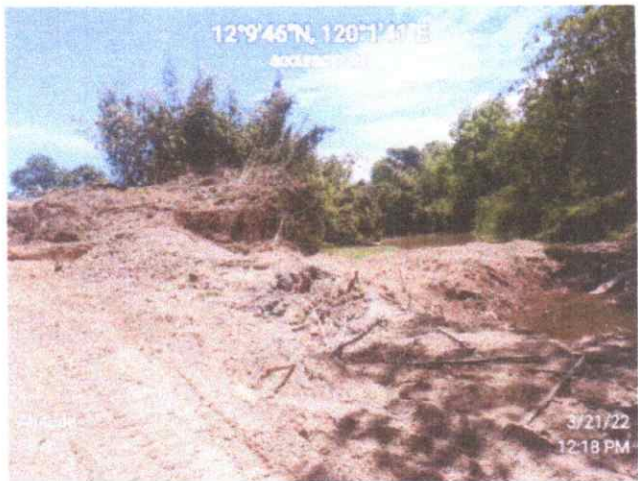
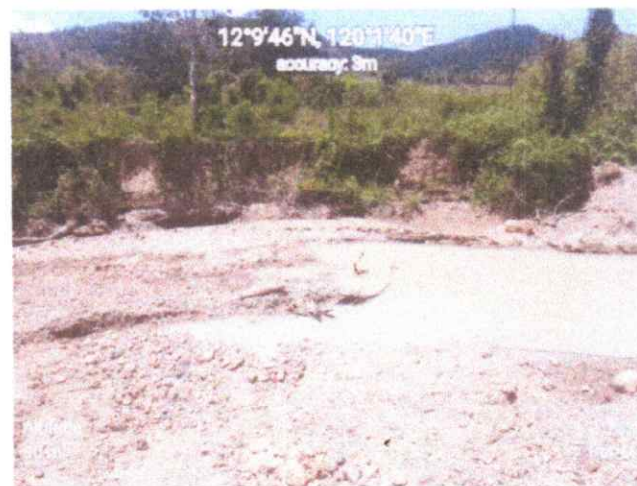
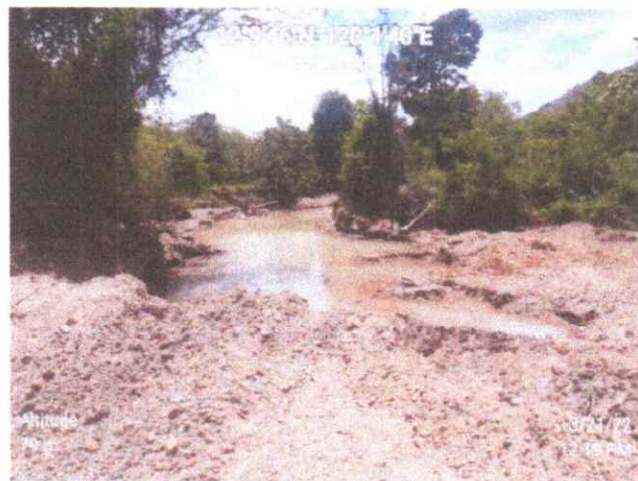
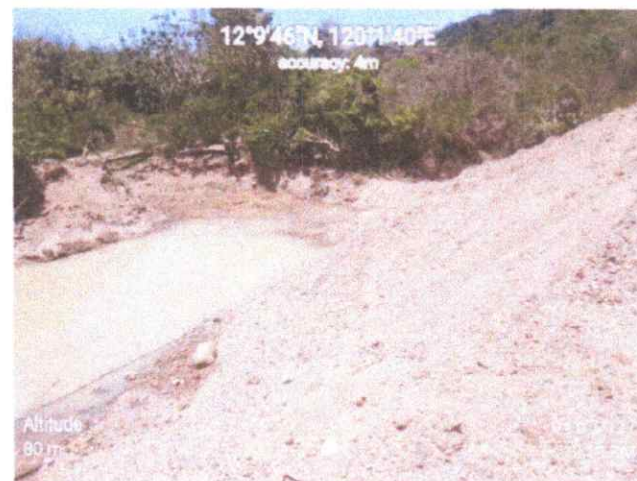
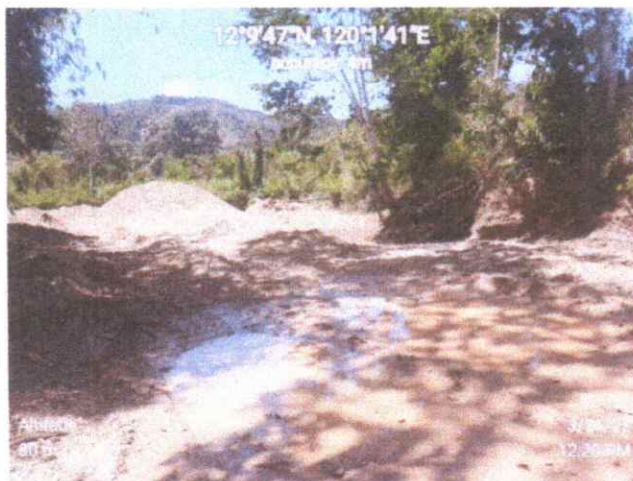
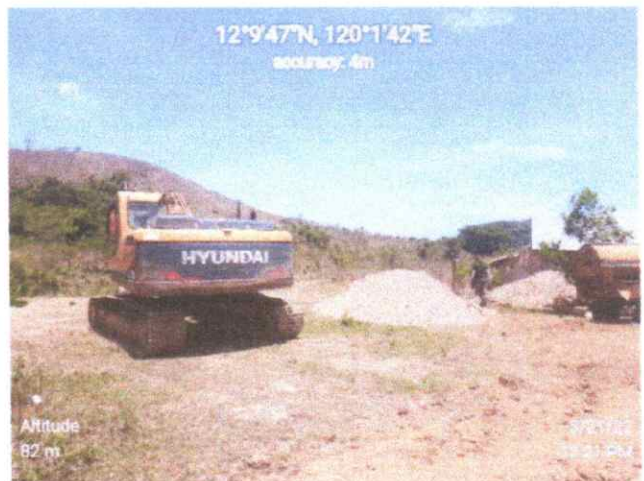
Sitio Babuy and Kawayan, Brgy. San Jose

4. During the investigation, there was no ongoing excavation of the area. A parked backhoe, however, was observed. Stockpiles of sand excavated riverbanks and blocked river are among those we saw (*see Photo Documentation 04*). No ECC was also posted near the area.

5. In this area, the river is heavily disrupted. It was even cut as the excavated materials were dumped in the river. This result in some part of the river being stagnant. Trees along the riverbank were also damaged (*see Photo Documentation 04*).

SAG excavation in Brgy. San Jose. The river flow is highly disrupted by the haphazard extraction and dumping/stockpiling of SAG. Trees and other vegetation were also damaged by the operation.
