**MEMORANDUM**

**SUBJECT :** **FIELD INVESTIGATION REPORT ON THE INCIDENT OF SLURRY LEAK AT THE HIGH PRESSURE ACID LEACH PLANT OF CORAL BAY NICKEL CORPORATION DUE TO NORMAL WEAR (PRESENCE OF SMALL HOLE) OF THE DISCHARGE PIPE FROM THE AUTOCLAVE**

**SUBJECT** : **FIELD INVESTIGATION REPORT ON THE INCIDENT OF SLURRY LEAK AT THE HIGH PRESSURE ACID LEACH PLANT OF CORAL BAY NICKEL CORPORATION DUE TO NORMAL WEAR (PRESENCE OF SMALL HOLE) OF THE DISCHARGE PIPE FROM THE AUTOCLAVE**

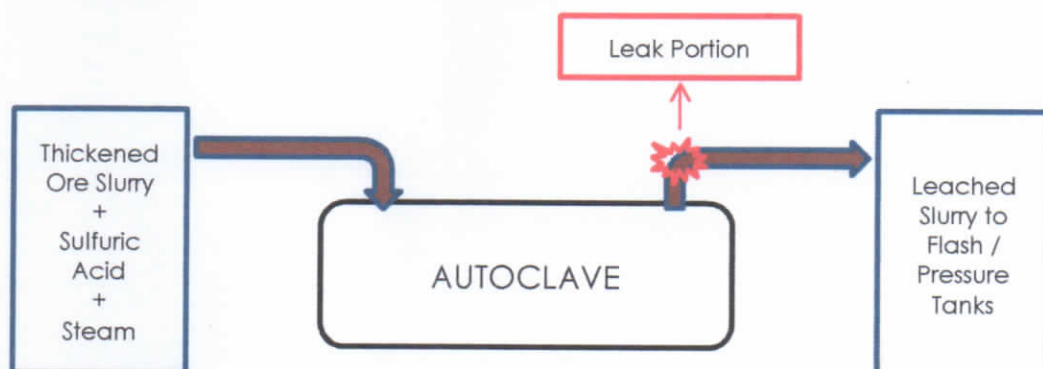
Figure 1. Diagram showing the slurry leak incident.

On March 16, 2022 at 1:21 p.m., a slurry leak was observed at the discharge pipe, a pipe which transports leached slurry from the autoclave to the flash/pressure tanks of HPAL Plant - Line 2.

Based on the assessment, the leak is located on the discharge pipe elbow. Although the said discharge pipe is replaced every six (6) months during preventive maintenance shutdown which is scheduled every May and November of the year, the discharge pipe elbow wore prematurely that caused the slurry leak. The contributing factors to the normal wear of the discharge pipe are:

At 1:30 p.m., the slurry leak was deemed to be contained through the closing of Autoclave Line 2 discharge valve and emergency shutdown of the Line 2 – HPAL Operation to eliminate the source of pressure. The ERT convened again for a post-incident meeting to reconfirm the safety of all personnel and the condition of one (1) personnel that was brought to the hospital.

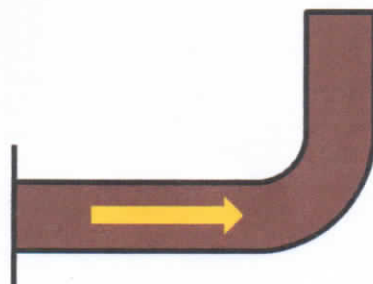
Fig. 2.a. Discharge pipe elbow without accumulated scales

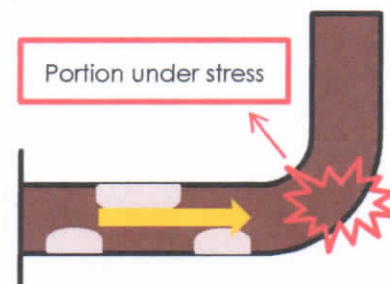
1. the accumulation of scales inside the pipe that causes the jet motion of slurry which is in effect, concentrating the stress on the portion of the discharge pipe elbow; and
2. the abrasive property of the slurry flowing through the pipe.

Fig. 2.b. Discharge pipe elbow with accumulated scales

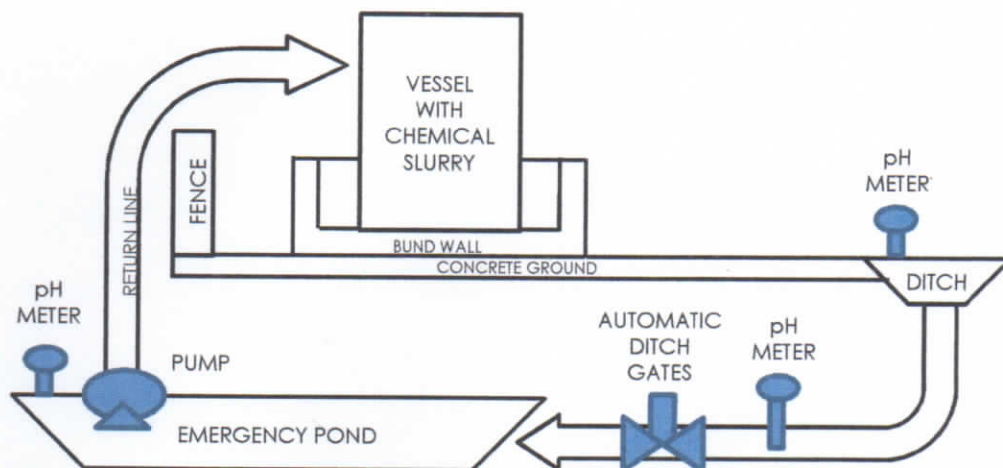
Figure 3. Diagram showing the series of mitigating measures.

The slurry leak was contained immediately due to the safety and environmental controls that was being implemented and installed by the company. The bundwalls that surround the vessel with slurry served as the secondary containment of the spilled slurry. The plant complex and ditch system is concrete paved which prevented the seepage of slurry on the ground. The ditch system has automatic gates and pH probes that can be monitored on site and at the DCS. An emergency pond will also cater the spilled slurry if it will escape the above-cited mitigating measures and said slurry will be recovered through a pump system.

The company immediately conducted the recovery of spilled slurry and clean-up of the area affected by the incident. The concrete ditch where the slurry accumulated was isolated and dumped with limestone. Recovered slurry was pumped and brought to the Final Neutralization Plant for its treatment and discharge to the Tailings Storage Facility No. 2.

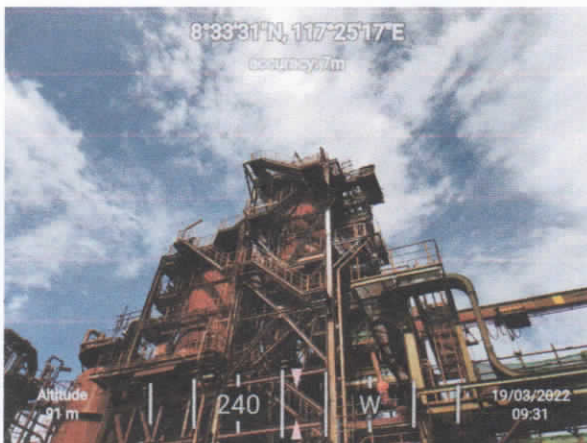
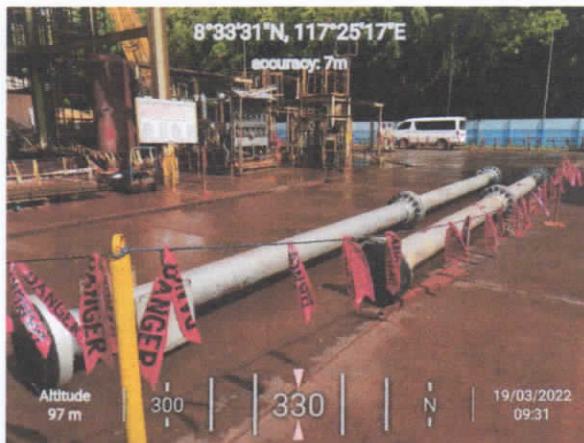
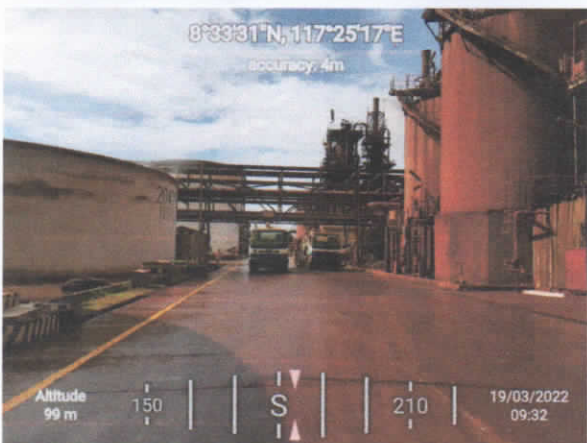
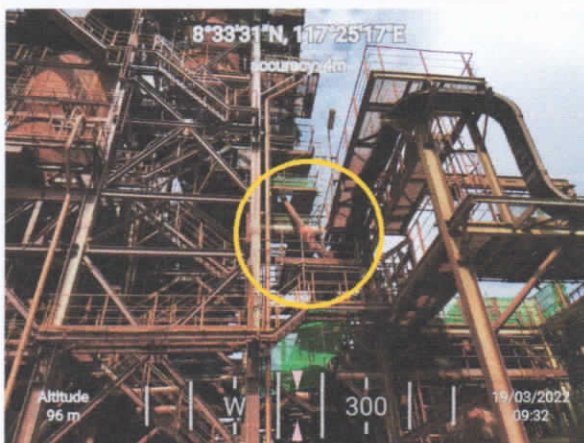
### On-going Clean-up of Affected Areas and Replacement of Discharge Pipe

On-going clean-up of stains on the concrete access roads, structures, and equipment that was affected by the slurry leak was observed and the damaged discharge pipe of the HPAL Plant – Line 2 is undergoing replacement.

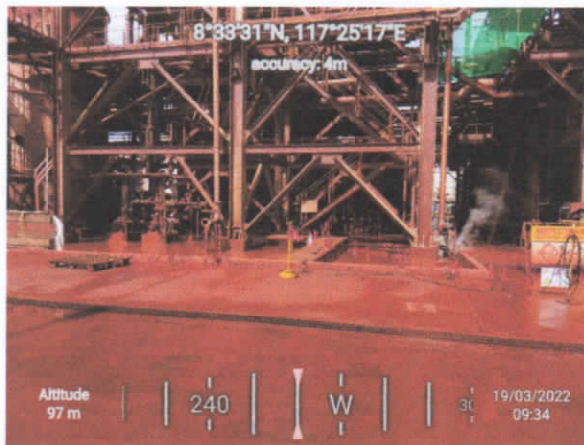
Bund walls surround the vessel containing chemical slurry.

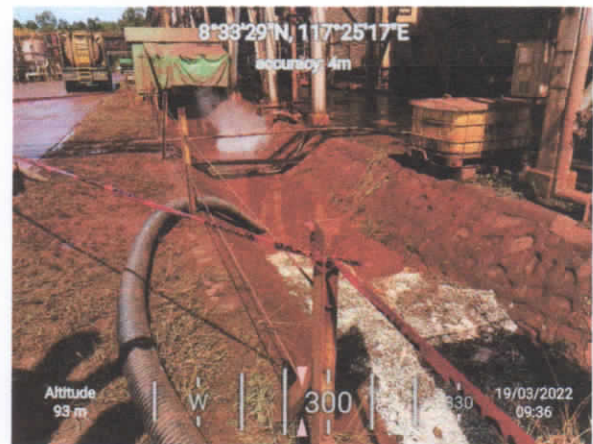
The ditch where the slurry accumulated was isolated and dumped with limestone.

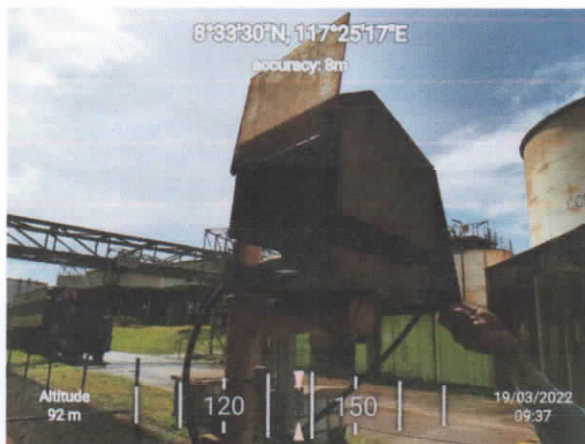
A pH meter is near the ditch system to monitor its level.

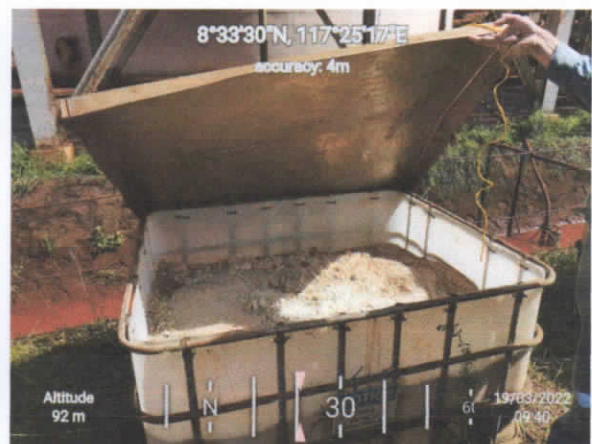
A container with limestone is also near the ditch system.

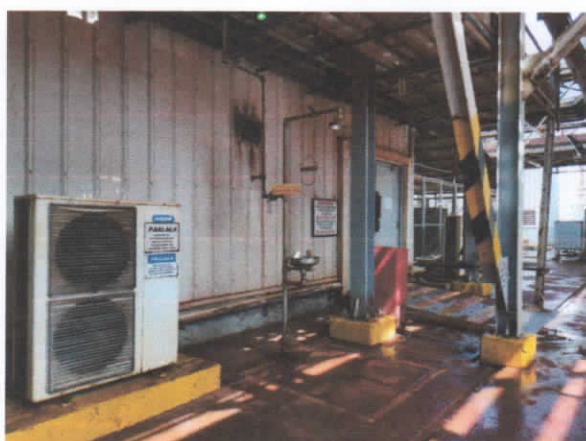
The emergency shower used by the employee that was exposed to the spilled slurry.

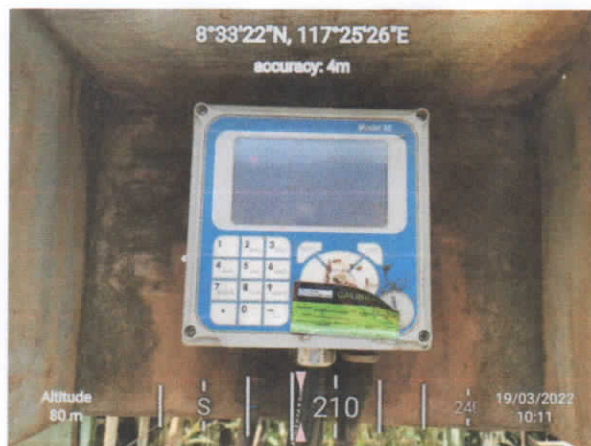
Another PH meter is installed near the emergency pond.

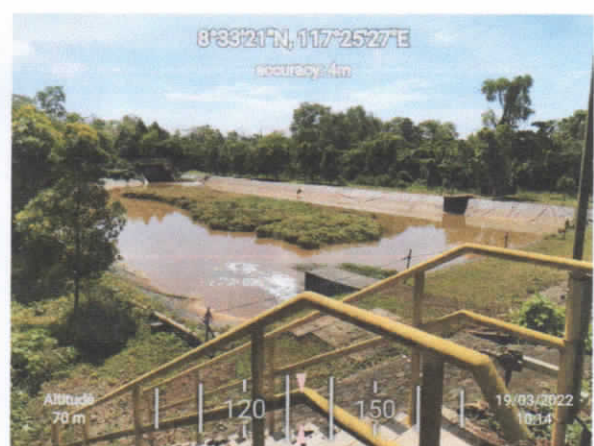
The emergency pond will cater the spilled slurry if it will escape the series of controls.
