1.0 LAND RESOURCES

1.1 Progressive Rehabilitation - Backfilling & Land Preparation of Mines-out Areas/Topsoil Management

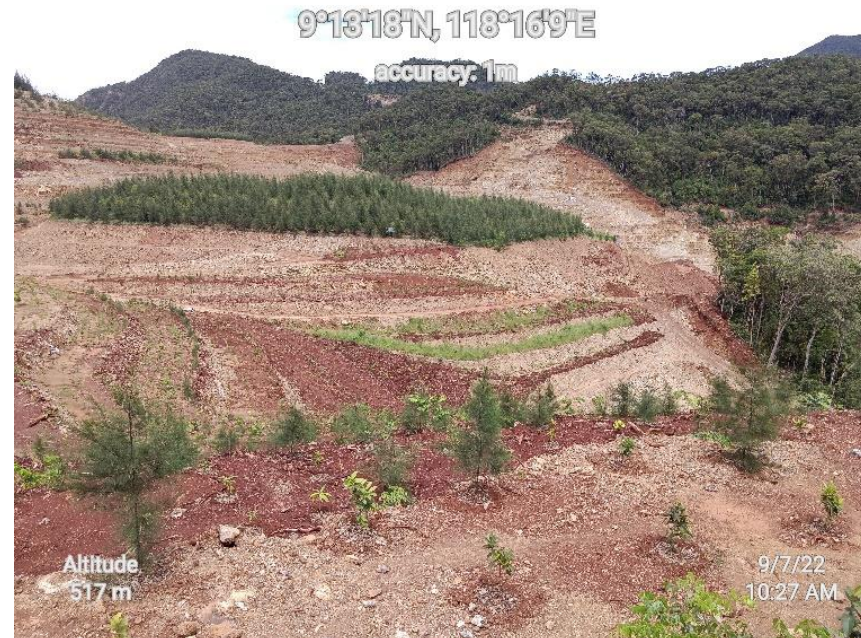
- Reasons for the nonaccomplishment:
Certain areas were not conducive for land preparation due to weather conditions and lack of equipment
- Catch up to the target hectarage for the progressive rehabilitation

Photo 1. Rehabilitated area at Block A Rehab Area 7 – 0.74 ha. accomplished for the quarter

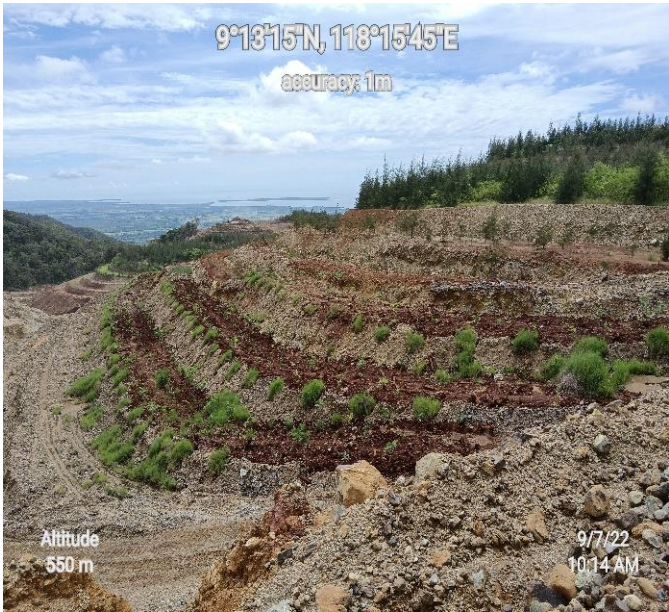
Photo 2. Rehabilitated area at Block A Area 5 – 0.19 has accomplished for the quarter

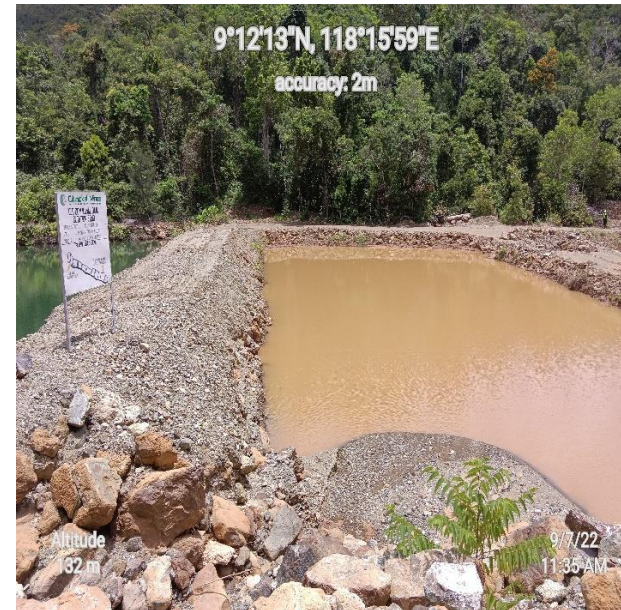
1. One SP (Block B SP2) not desilted due to weather conditions.
2. Maintain the silt control structures and monitor the amount of silt deposit (desilting purposes).

Photo 3. Good condition of the Old Communal series of Siltation Pond

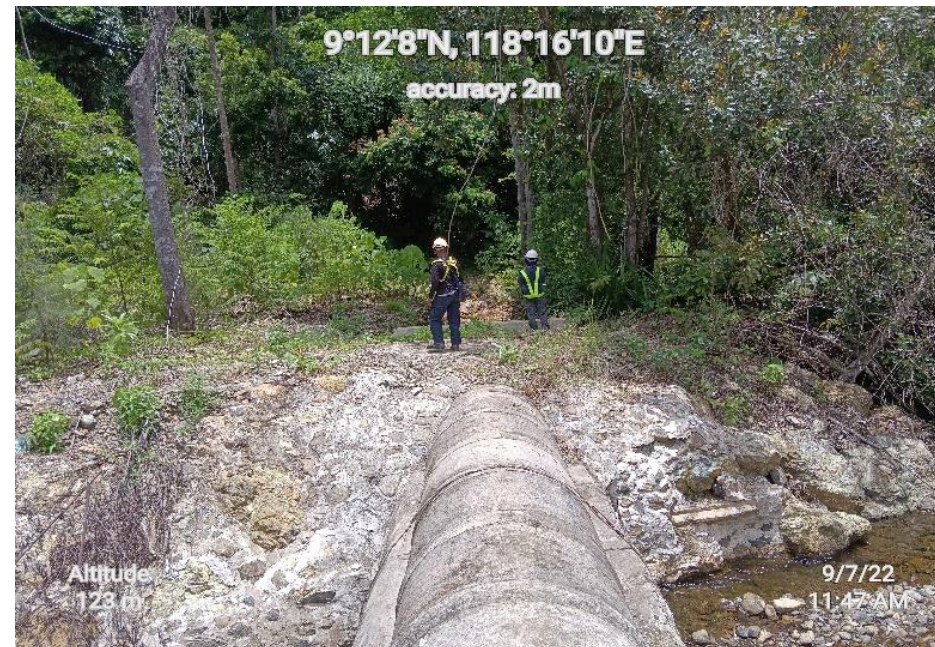
Photo 4. Interceptor canal diverting the discharge of the Old Communal Dam Siltation pond to the New Communal Dam siltation pond

1. Continue to maintain and monitor all drainage systems.

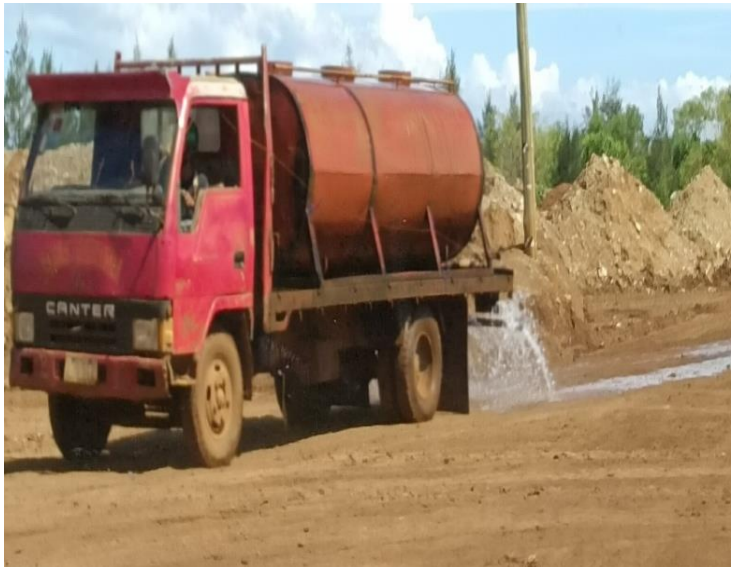
Photo 5. Observed road sprinkling activity along the haul road going to the pier site

- 1. Continue regular water sprinkling activities in the mine site to reduce dust emission.

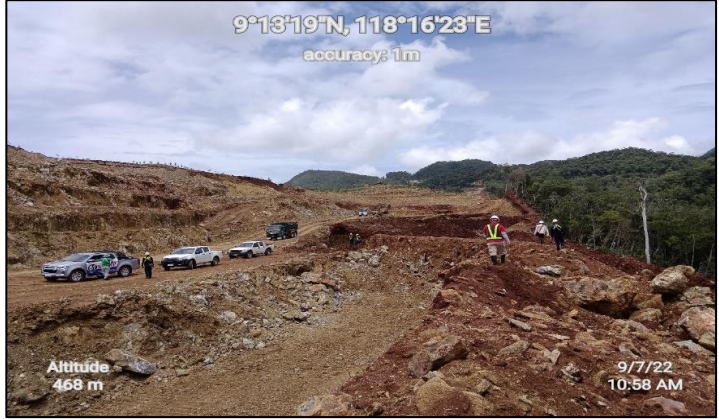
<p>The temporary bundwall at the Block A active area was deemed as unstable and prone to soil erosion.</p>	<p>Recommended for compaction to ensure stability of the bundwall.</p>

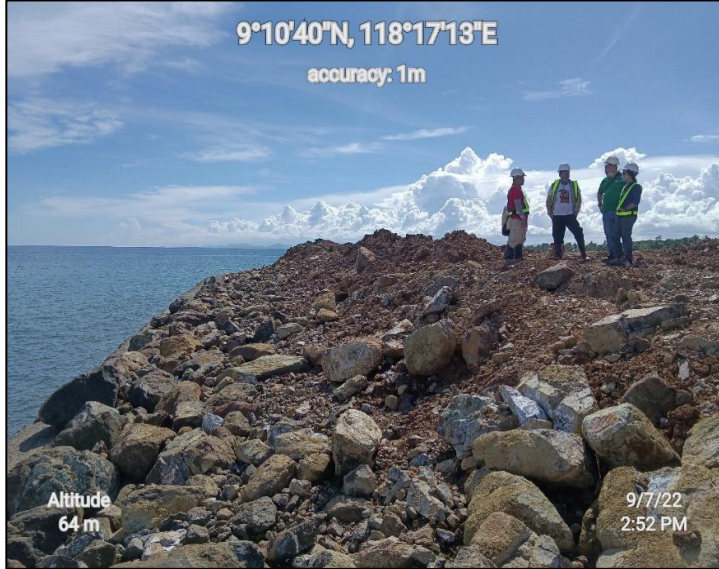
<p>9°13'19"N, 118°16'23"E accuracy: 1m</p> <p>Altitude 468 m</p> <p>9/7/22 10:58 AM</p>
<p>(Reiteration on the 1st Quarter 2022 MMT recommendation) Use recycled canvass sheet to cover the port side of the loading area to prevent soil erosion caused by large waves.</p>	<p>Seek alternative solutions to address the soil erosion during monsoon season.</p>
