# **BNC**

**MMT Monitoring of 2<sup>nd</sup> Quarter Accomplishments  
September 13 – 16, 2022**

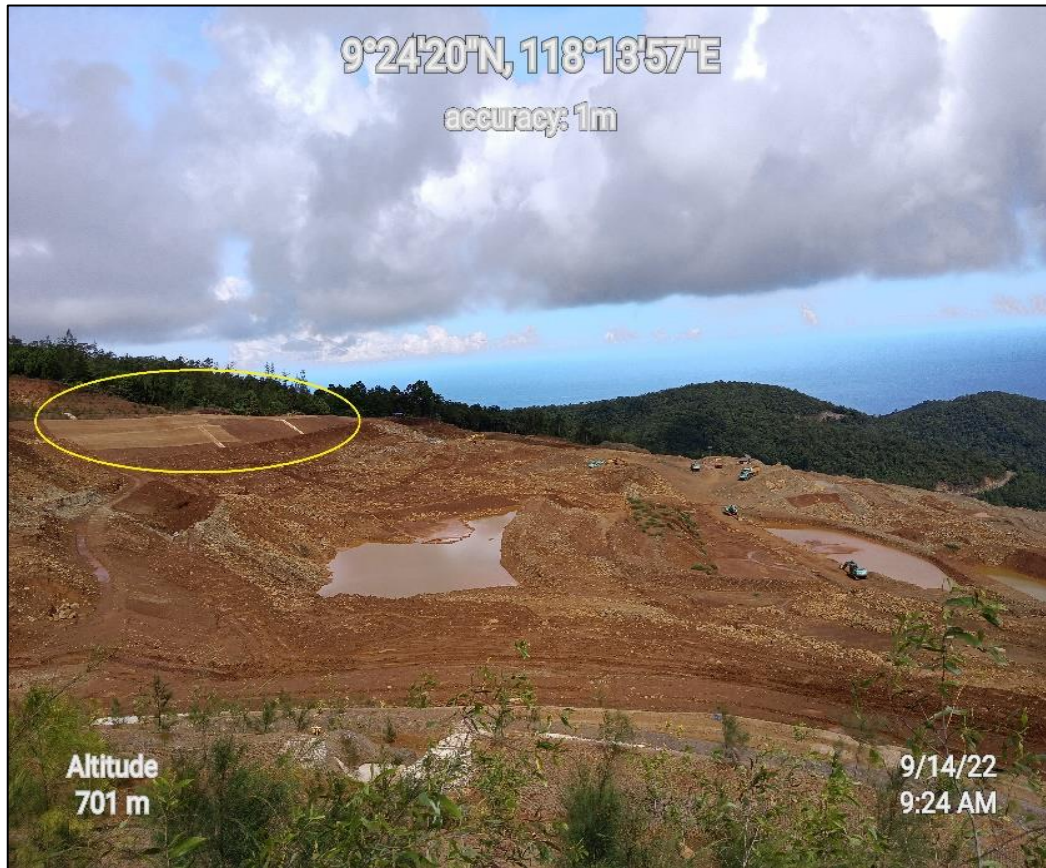
**Photo 2.** Areas 6 (encircled) and 7 scheduled for rehabilitation in 2022.

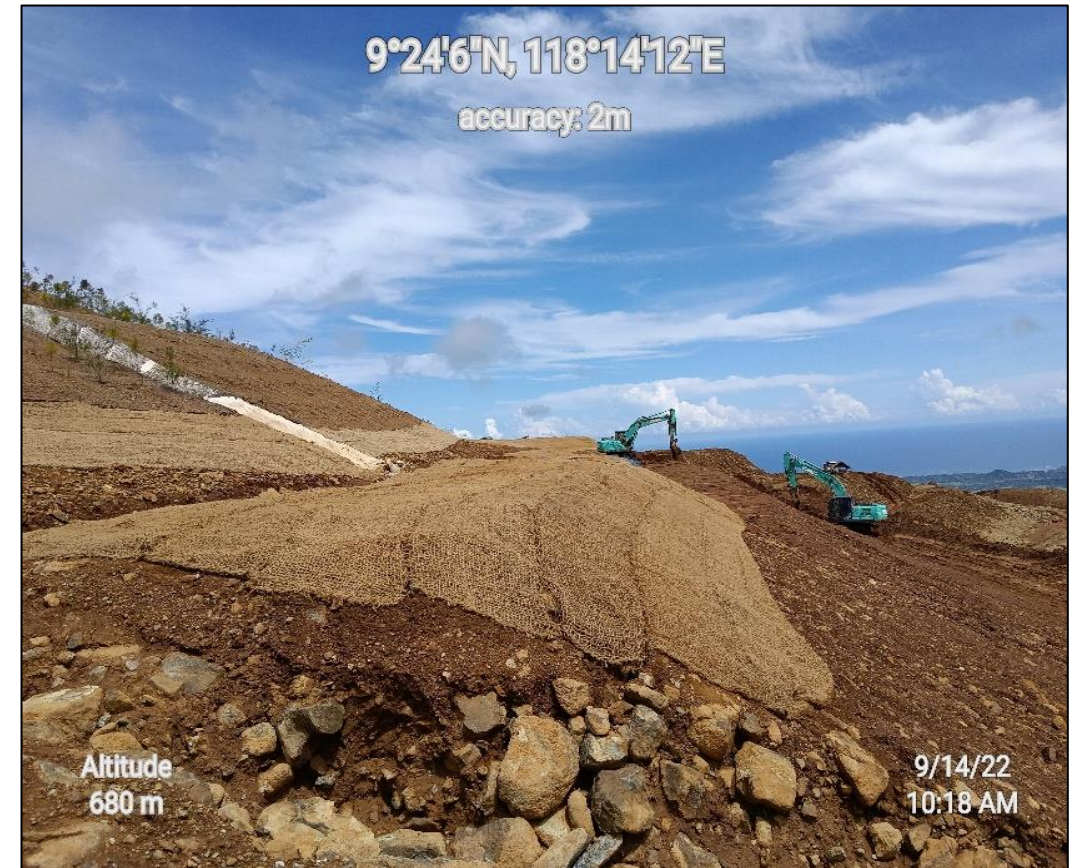
**Photo 3.** Ongoing Preparation of Area 11.

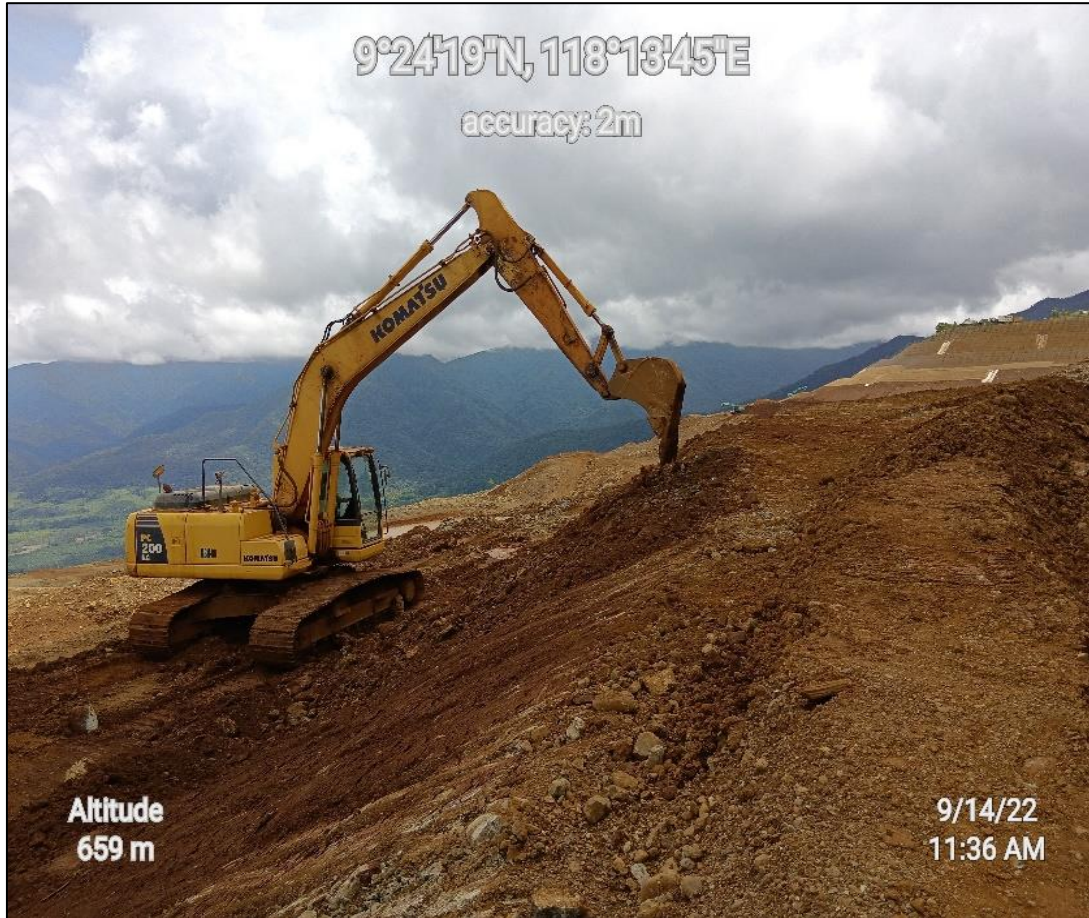
**Photo(s) 4.** On-going land preparation at Rehabilitation Area 6

2. Ongoing land preparation (benching, matting, installation of geotextile & coco wire net) observed for the rehabilitation of the mined out area	Fast track the land preparation to catch up with the target hectarage for the year.

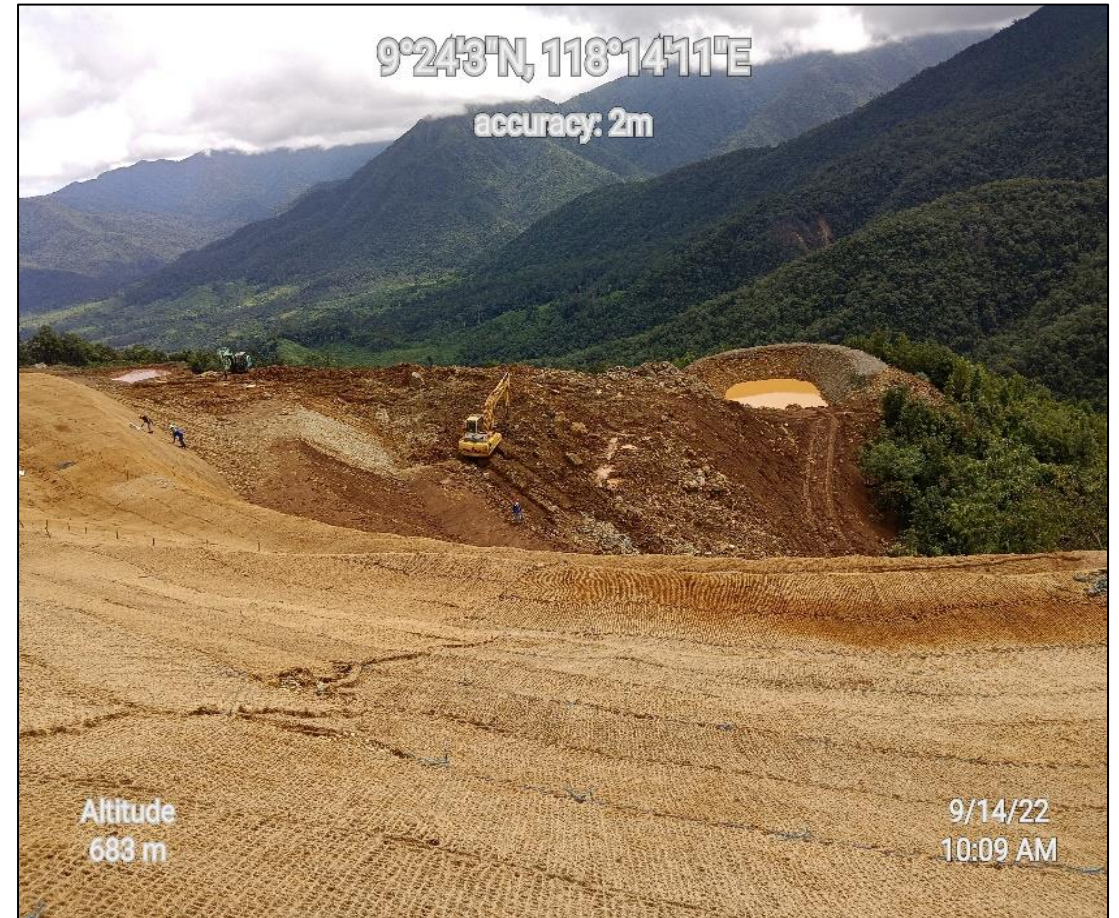
**Photo(s) 5.** On-going land preparation at Rehabilitation Area 12

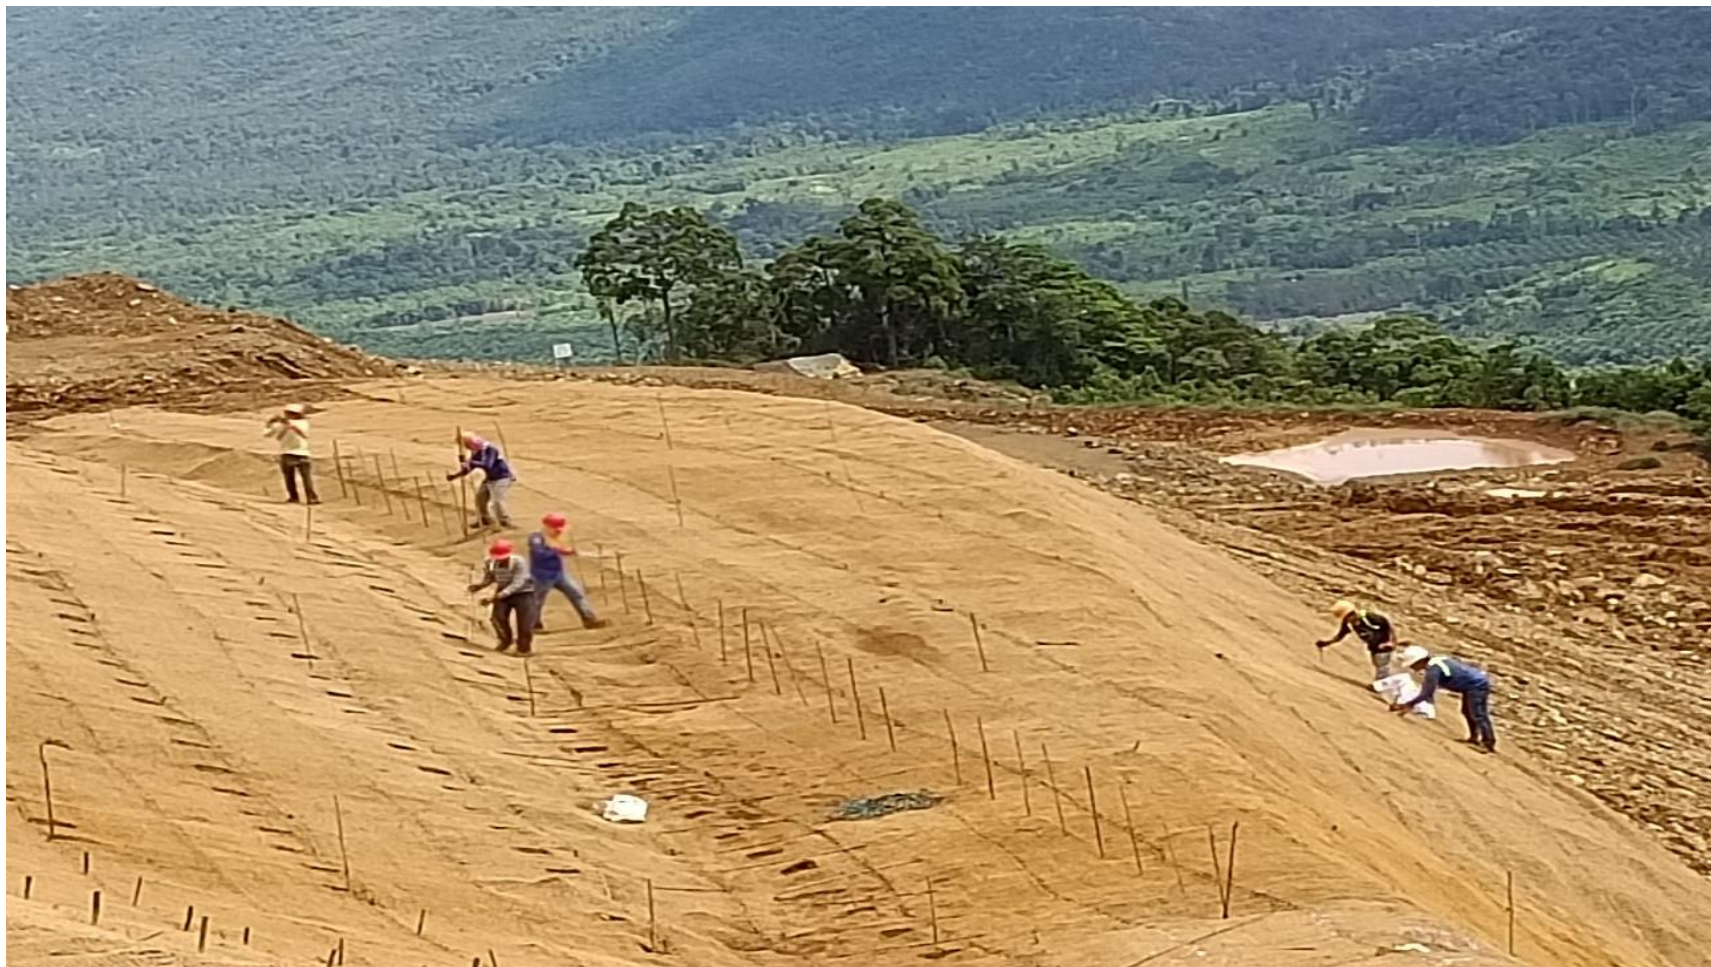
**Photo(s) 6.** On-going digging of planting holes observed at Rehabilitation Area 12

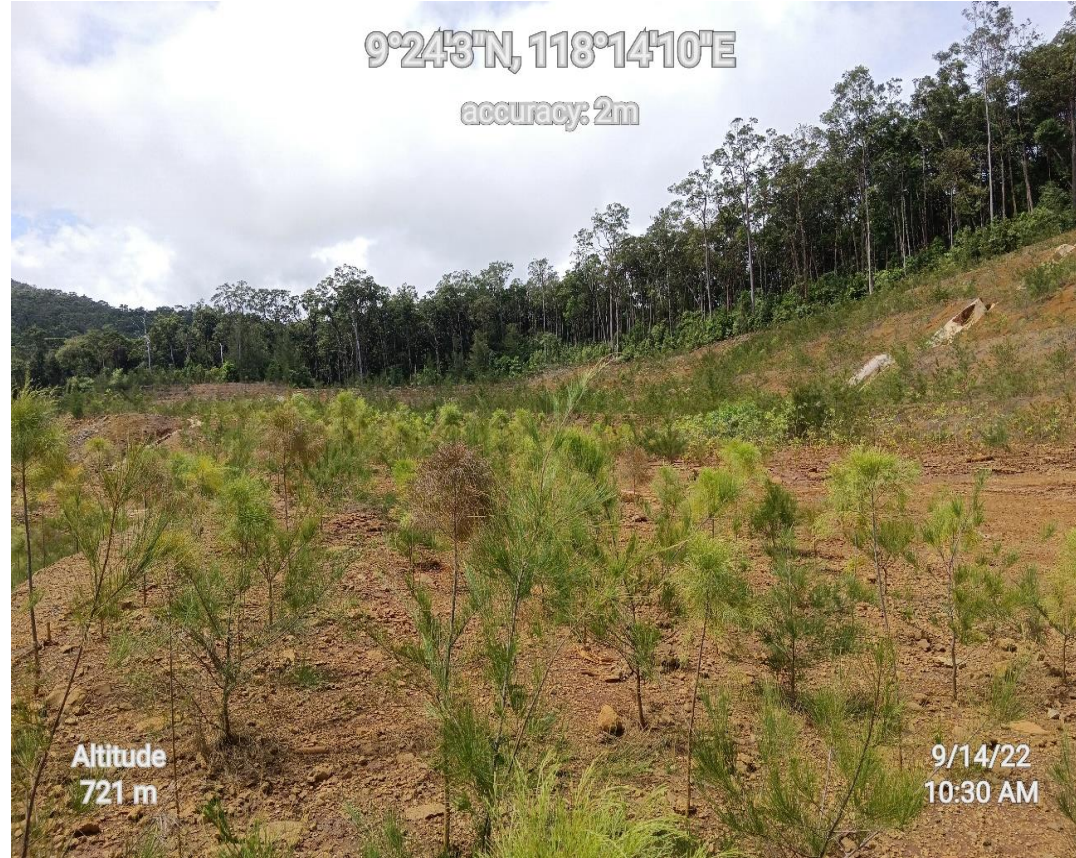
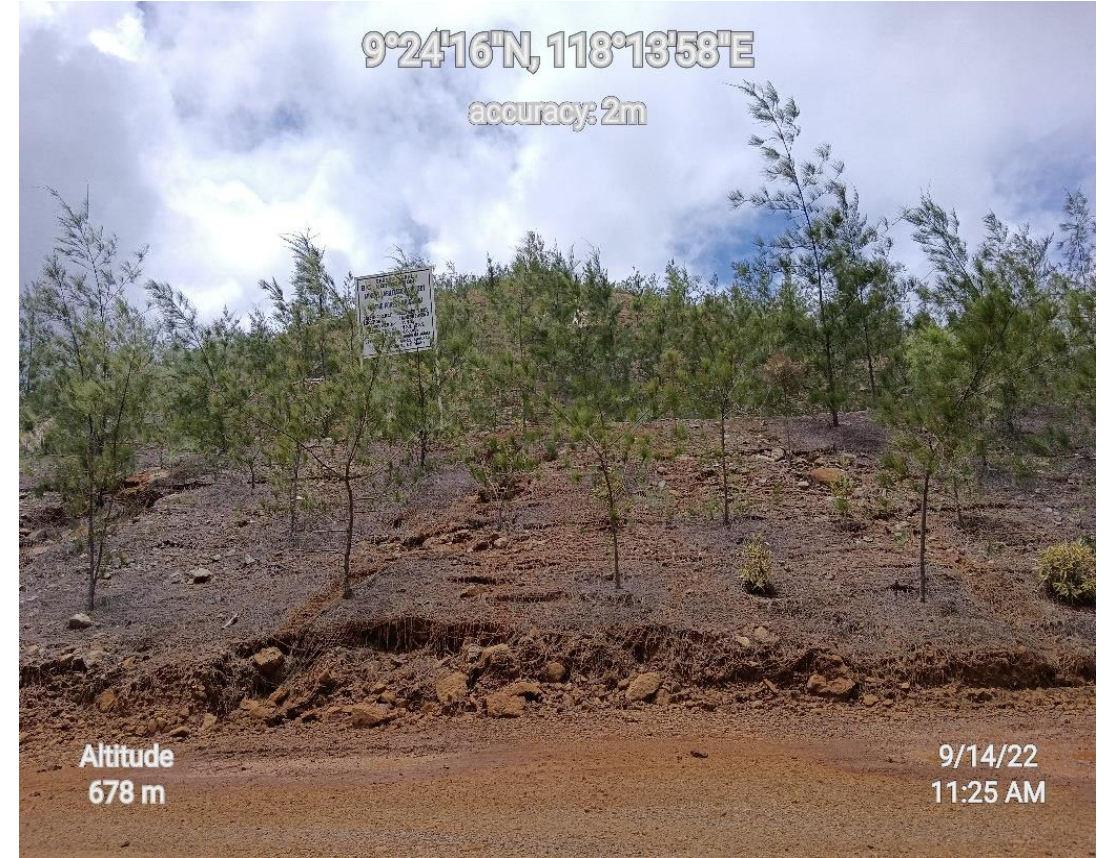
**Photo 7 & 8.** Observed thriving indigenous tree species (mahogany, batino, agoho, etc.,) planted at the Rehabilitation Area 11 (left) and Area 3 (right)

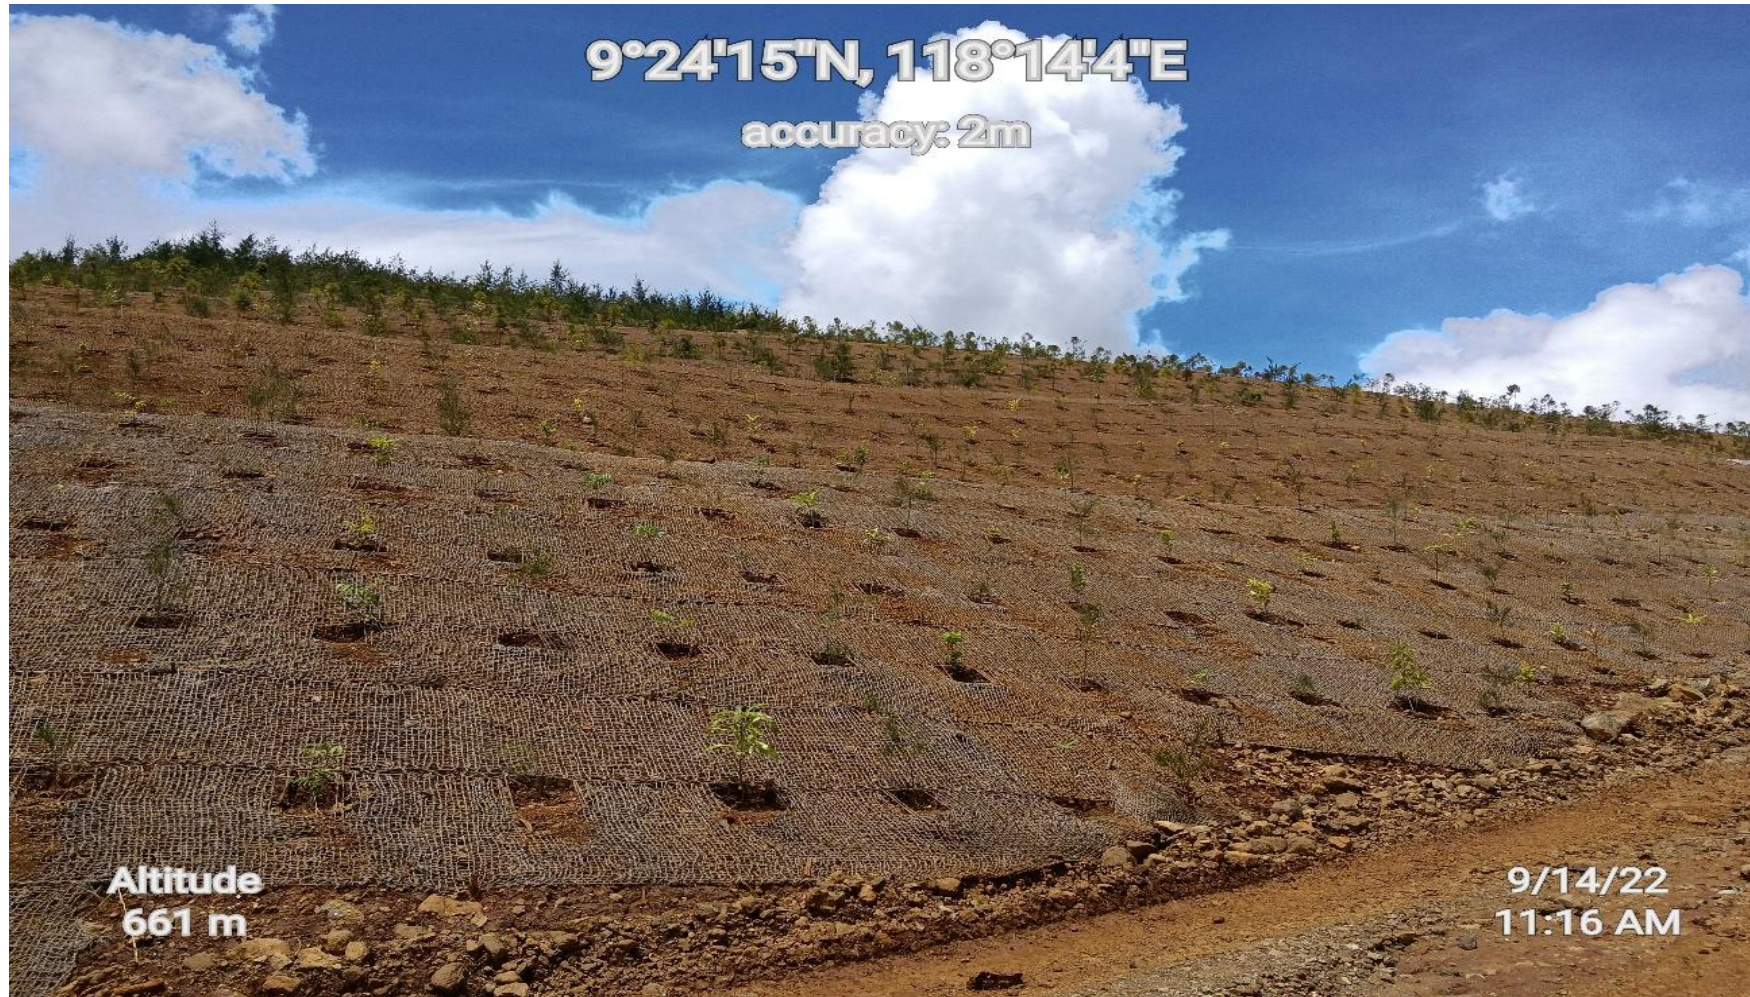
**Photo 9.** Planted seedlings (mahogany, batino etc.) at the Rehabilitation Area 2 and Area 12(2<sup>nd</sup> Quarter)

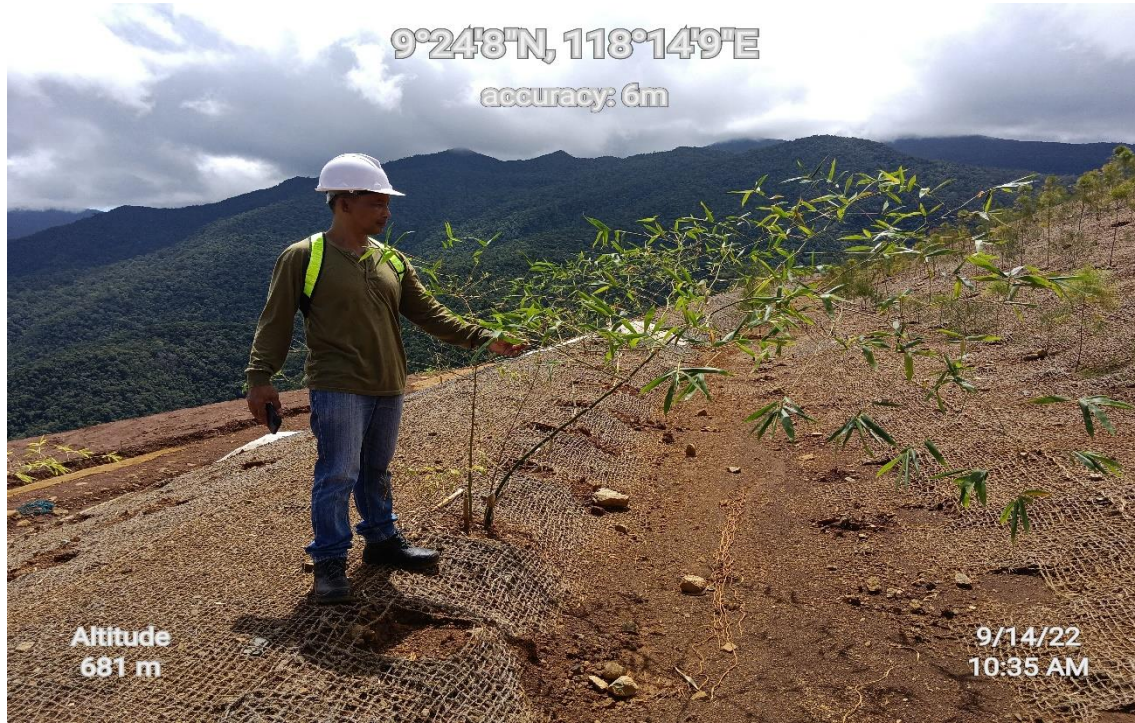
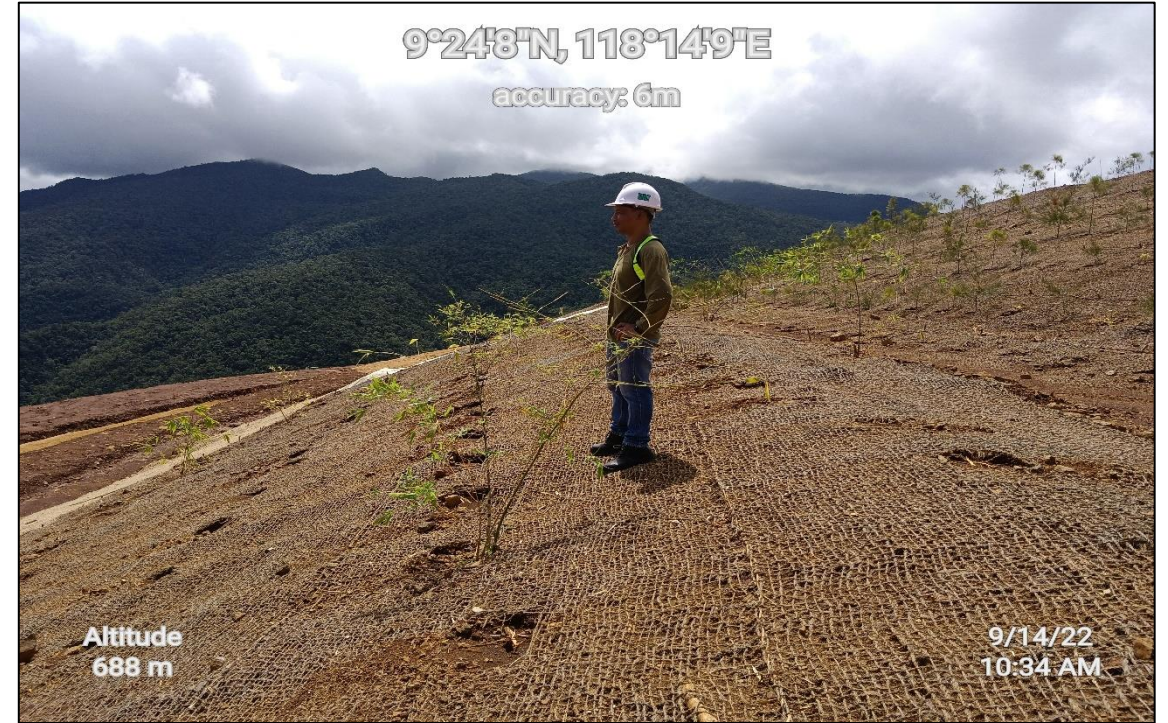
**Photos 10 & 11.** Bamboo Plantation at Area 12.  
Kawayan-Bayog (left) and Kawayan- Tinik (right)

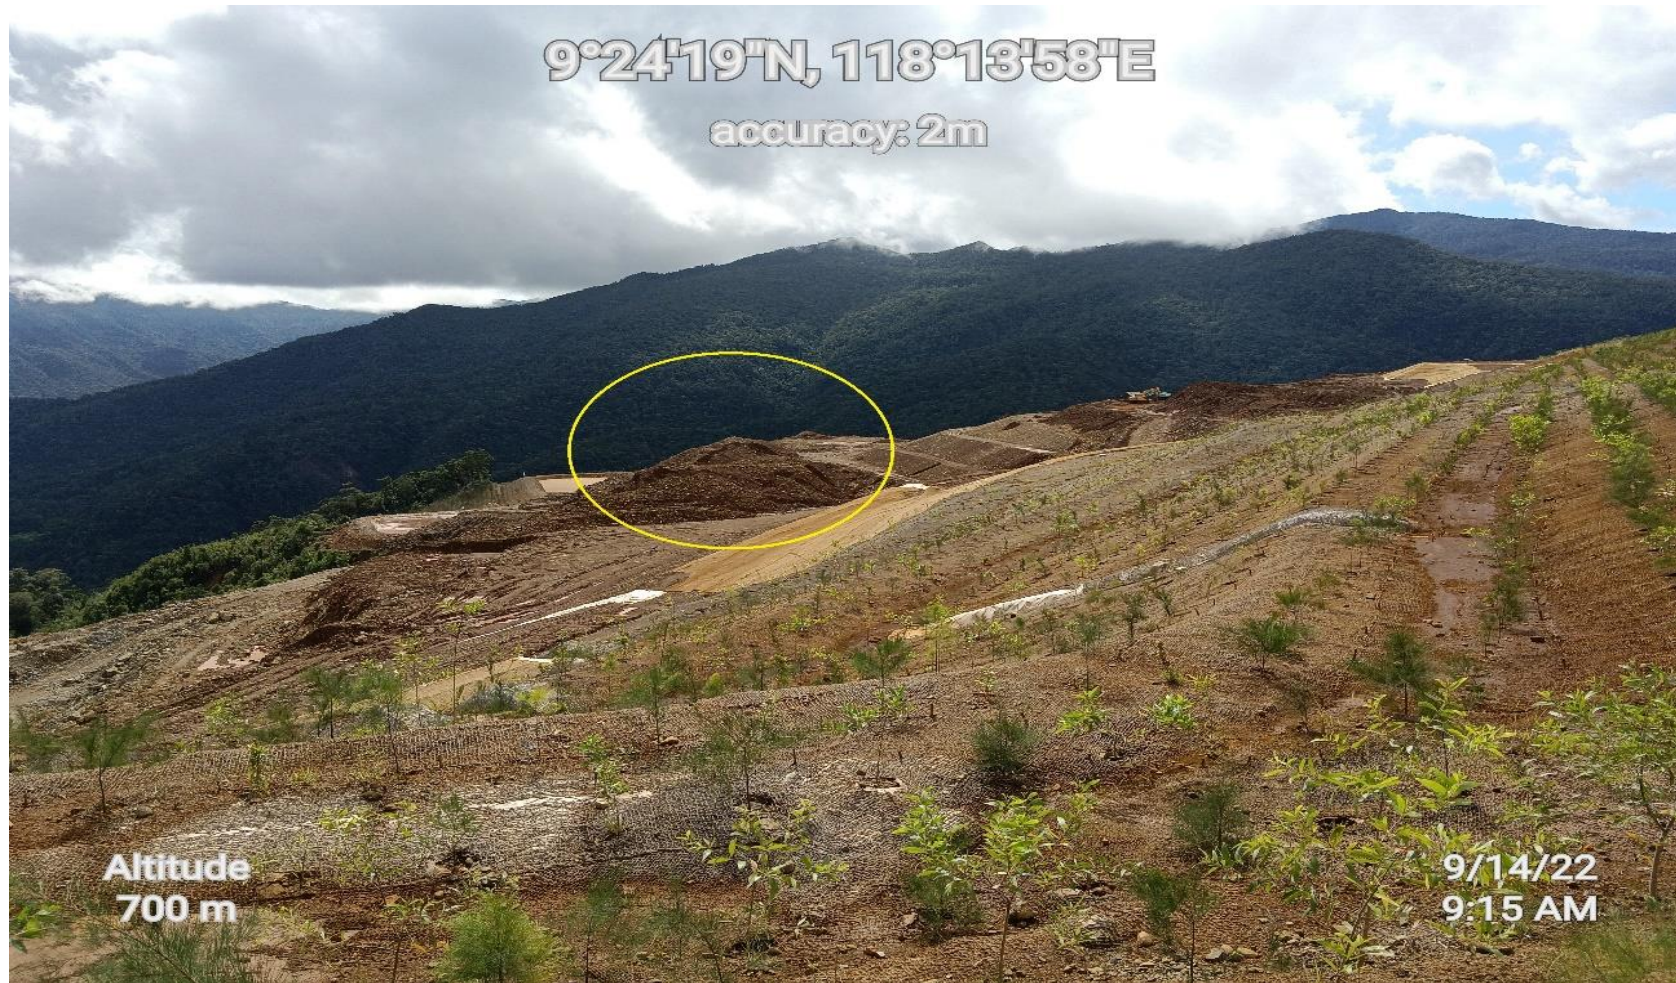
**Photo 12.** Stockpile of top soil and subsoil material in Area 20.

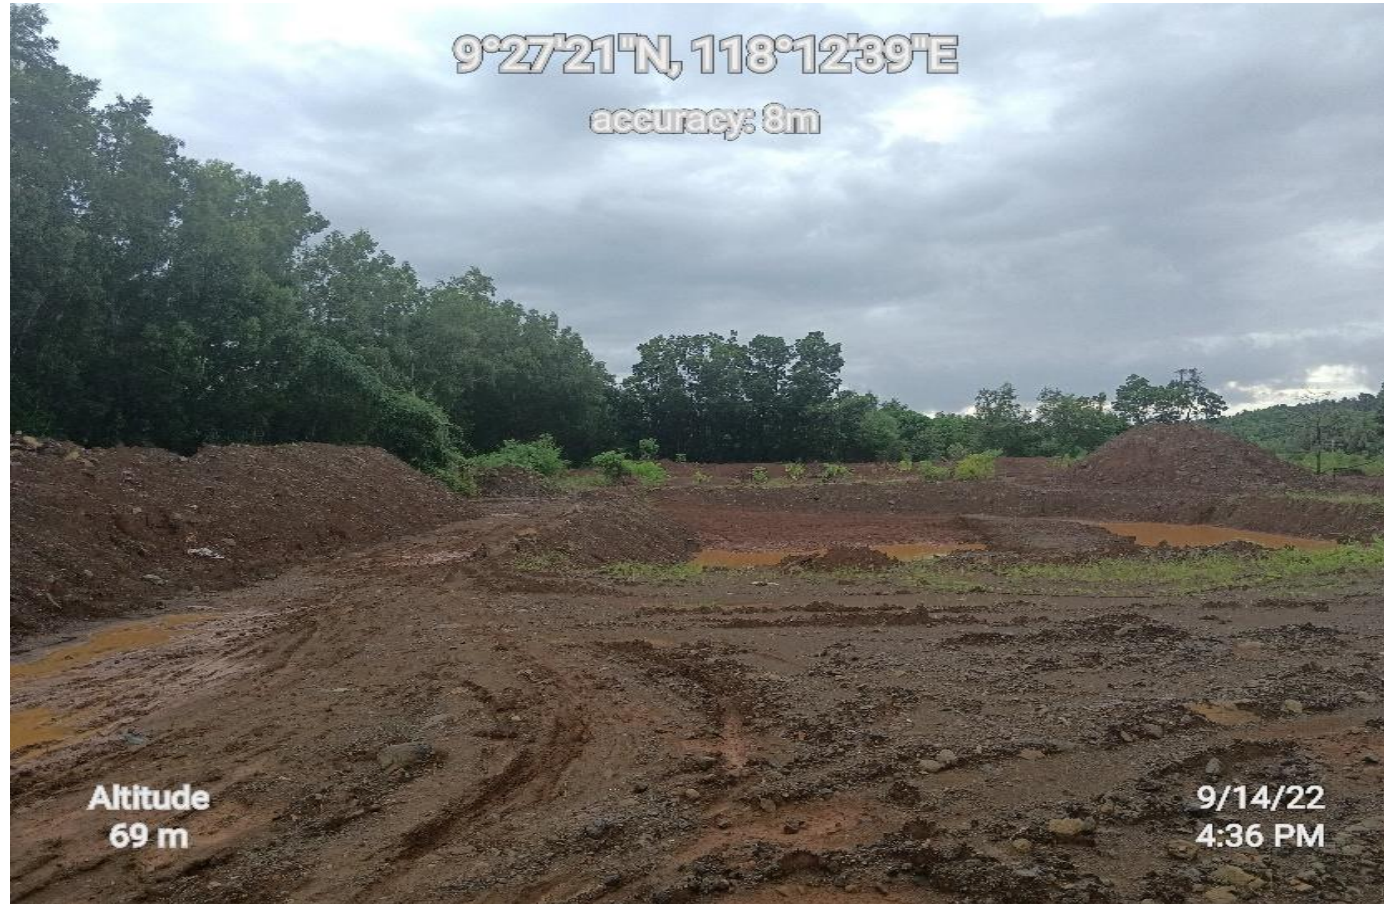
**Photo 13.** Dumping and drying area of desilted materials from siltations ponds.

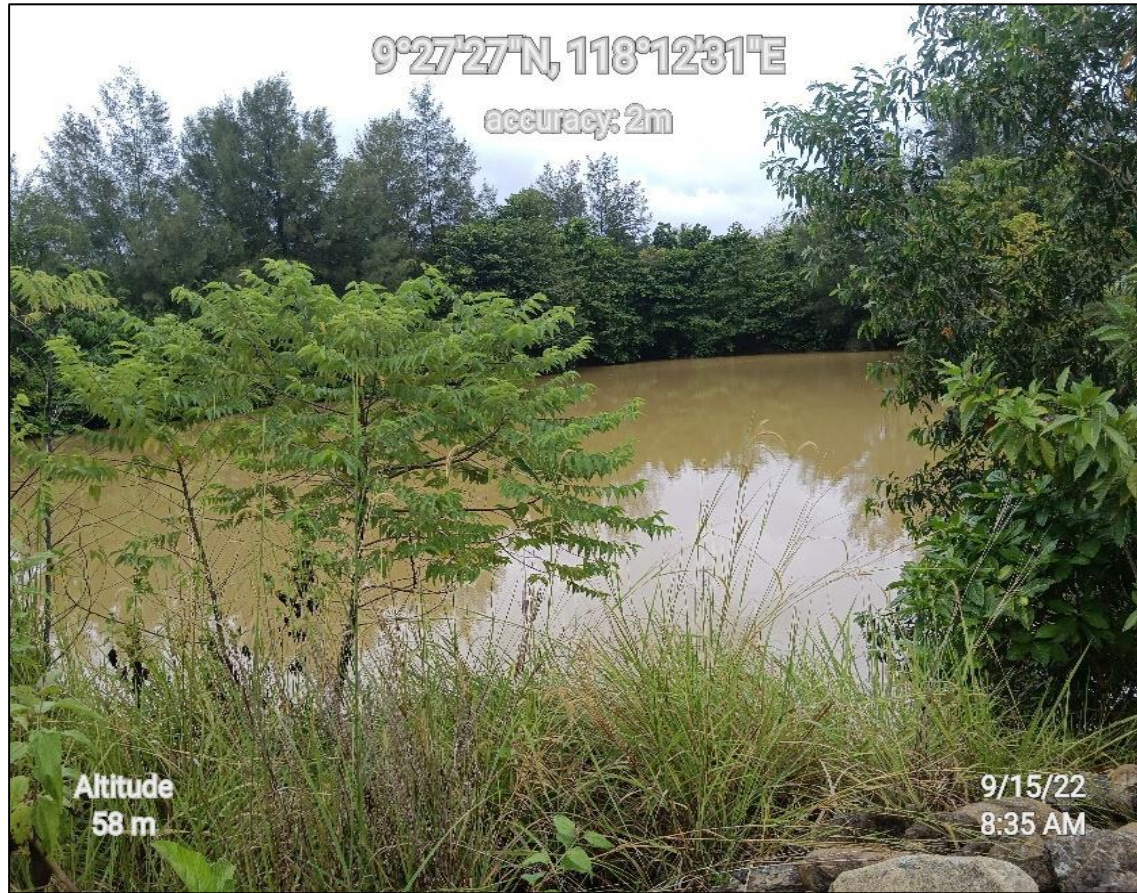
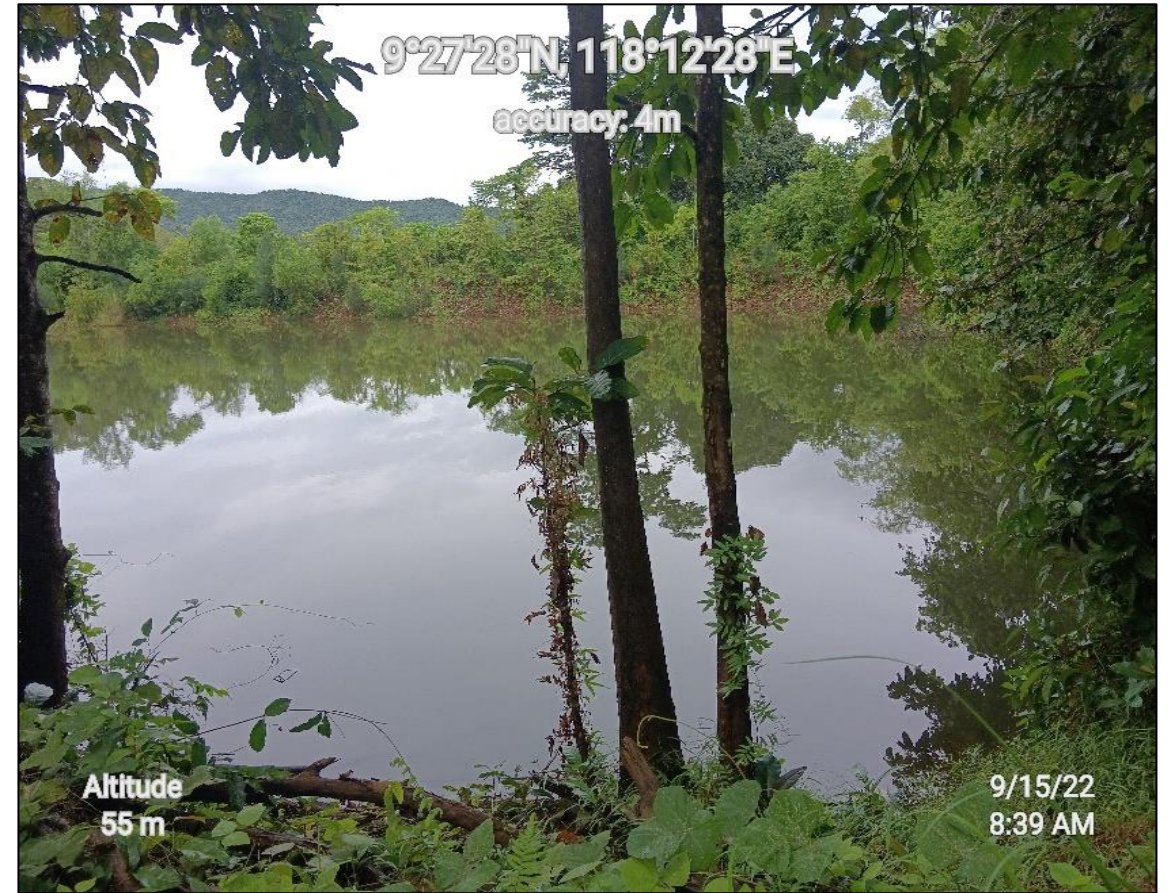
**Photo 14.** Series of siltation pond in Badlisan observed to be in good condition.

FIELD FINDINGS/OBSERVATIONS/COMMENTS	RECOMMENDATION
1. Good condition of the siltation pods observed during the monitoring	Continue monitoring and maintenance of all silt control structures

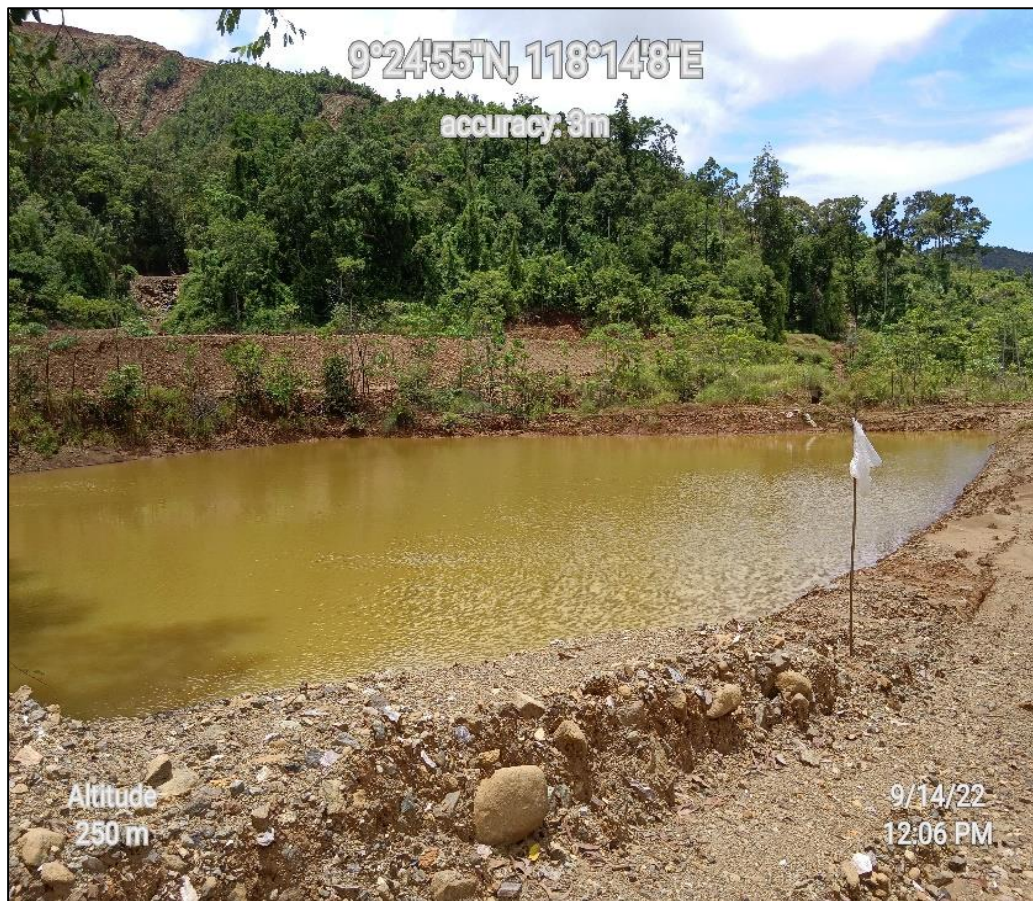
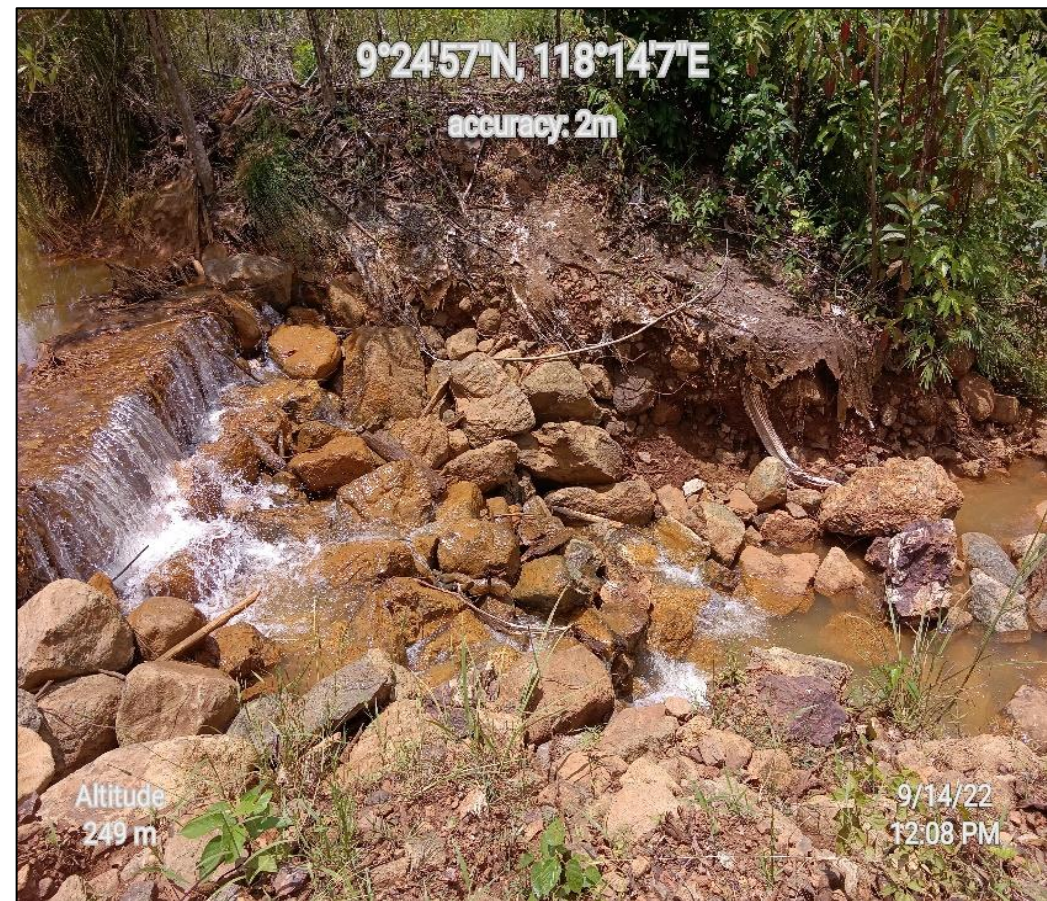
**Photo 15.** Series of siltation pond in KM. 7 observed to be in good condition.

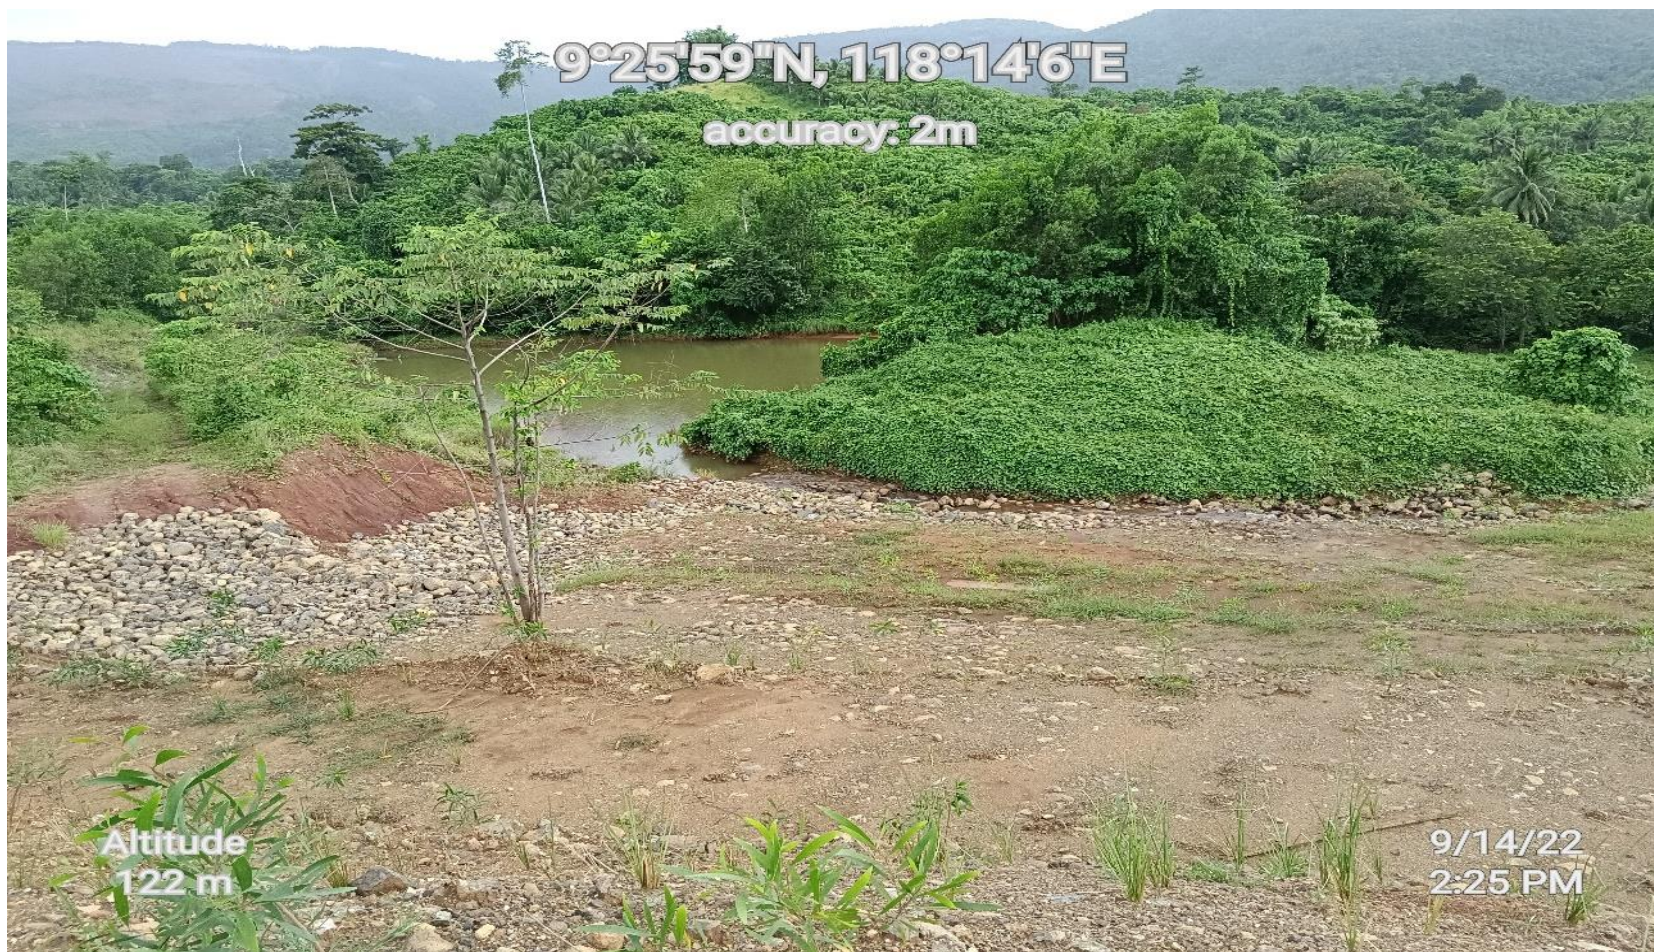
**Photo 16.** BSW1 siltation pond observed to be in good condition.

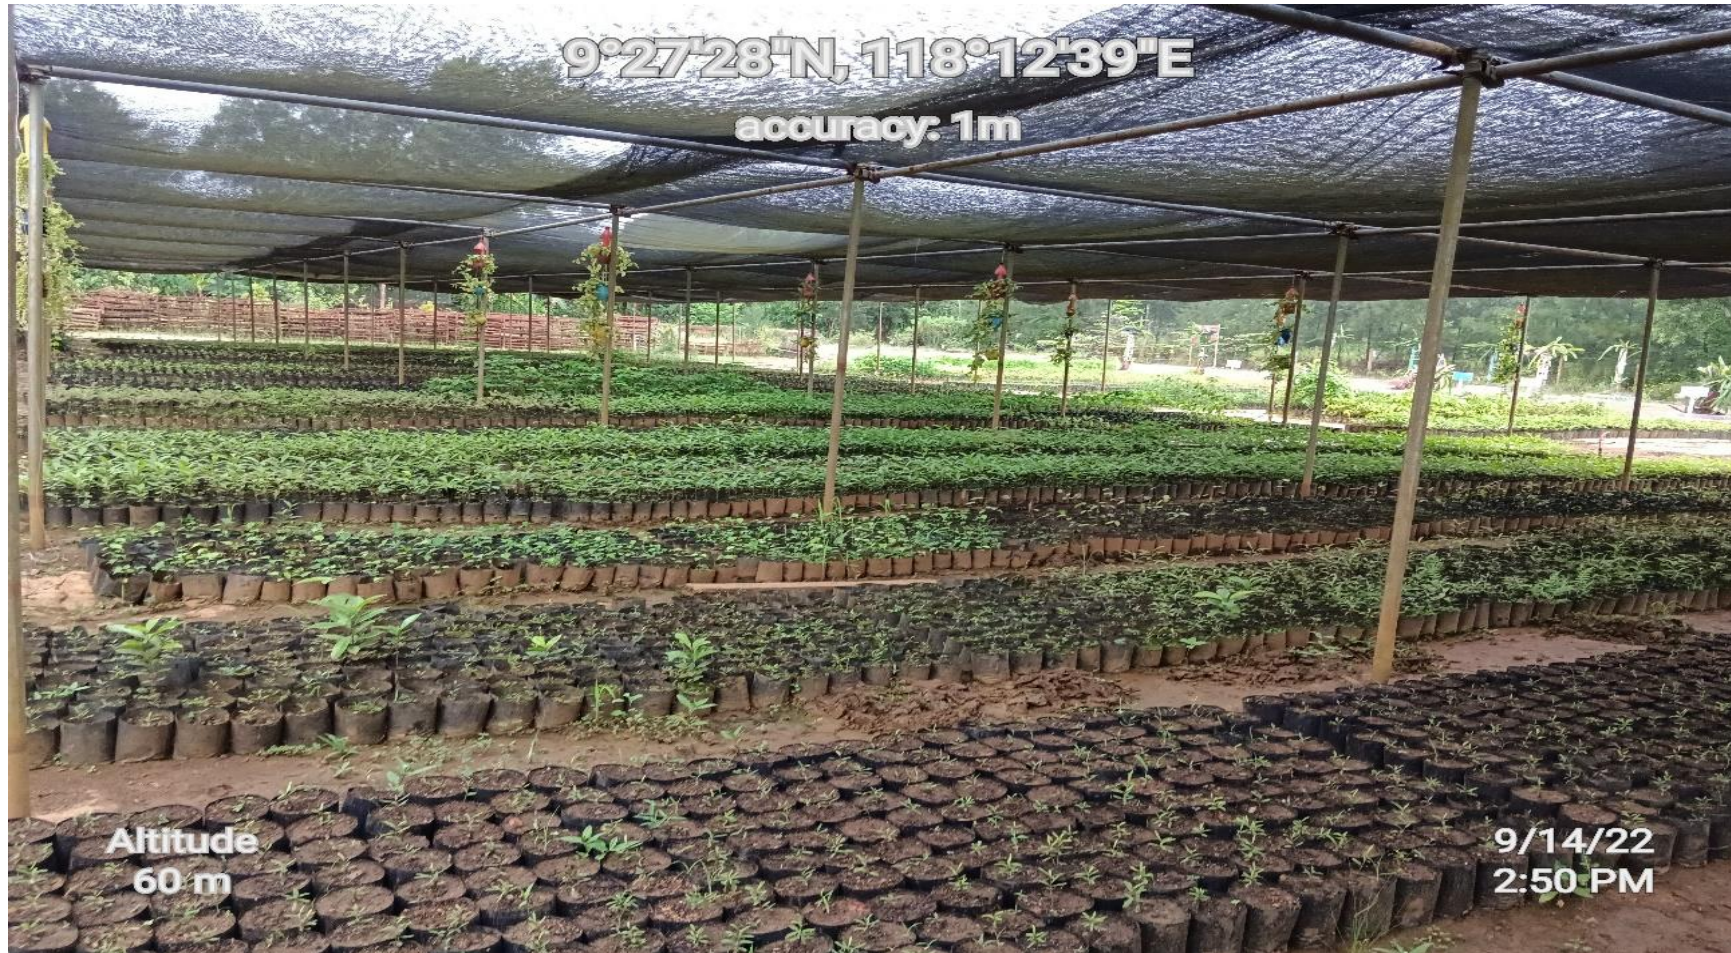
**Photo 17.** Production of different species of indigenous seedlings at the Nursery.

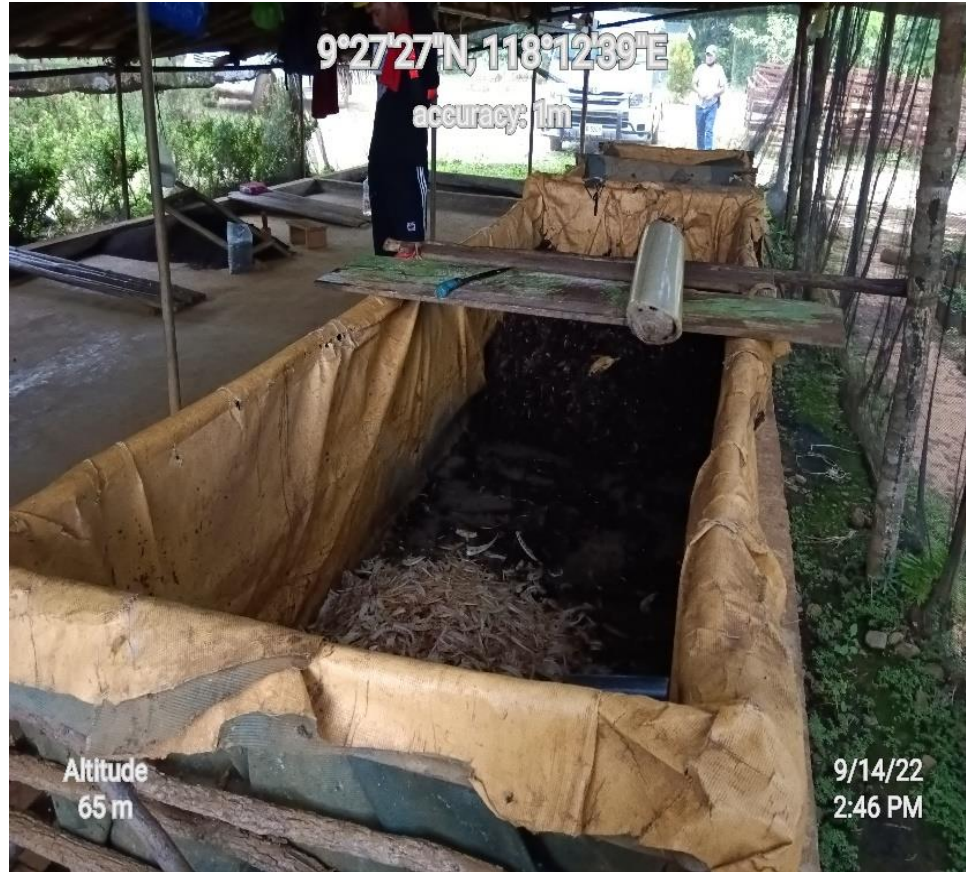
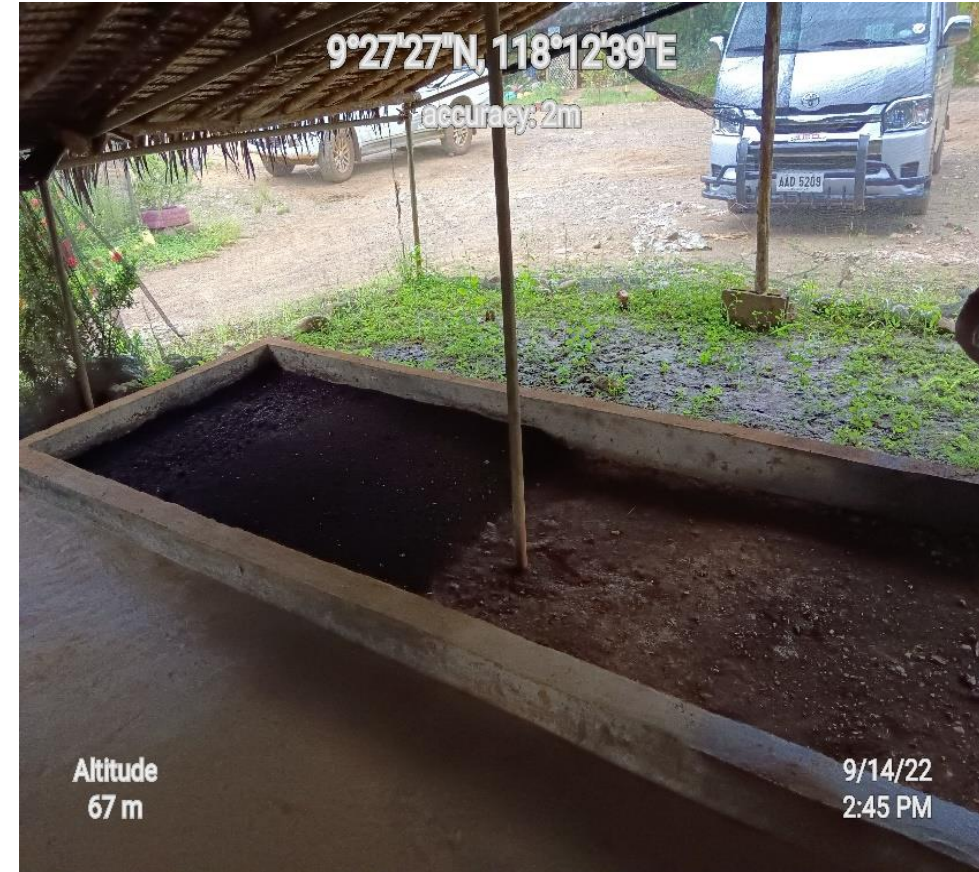
**Photo 18 & 19.** Production of vermin cast at BNC's nursery.
