# **BNC**

**MMT Monitoring of 2<sup>nd</sup> Quarter Accomplishments  
September 13 – 16, 2022**

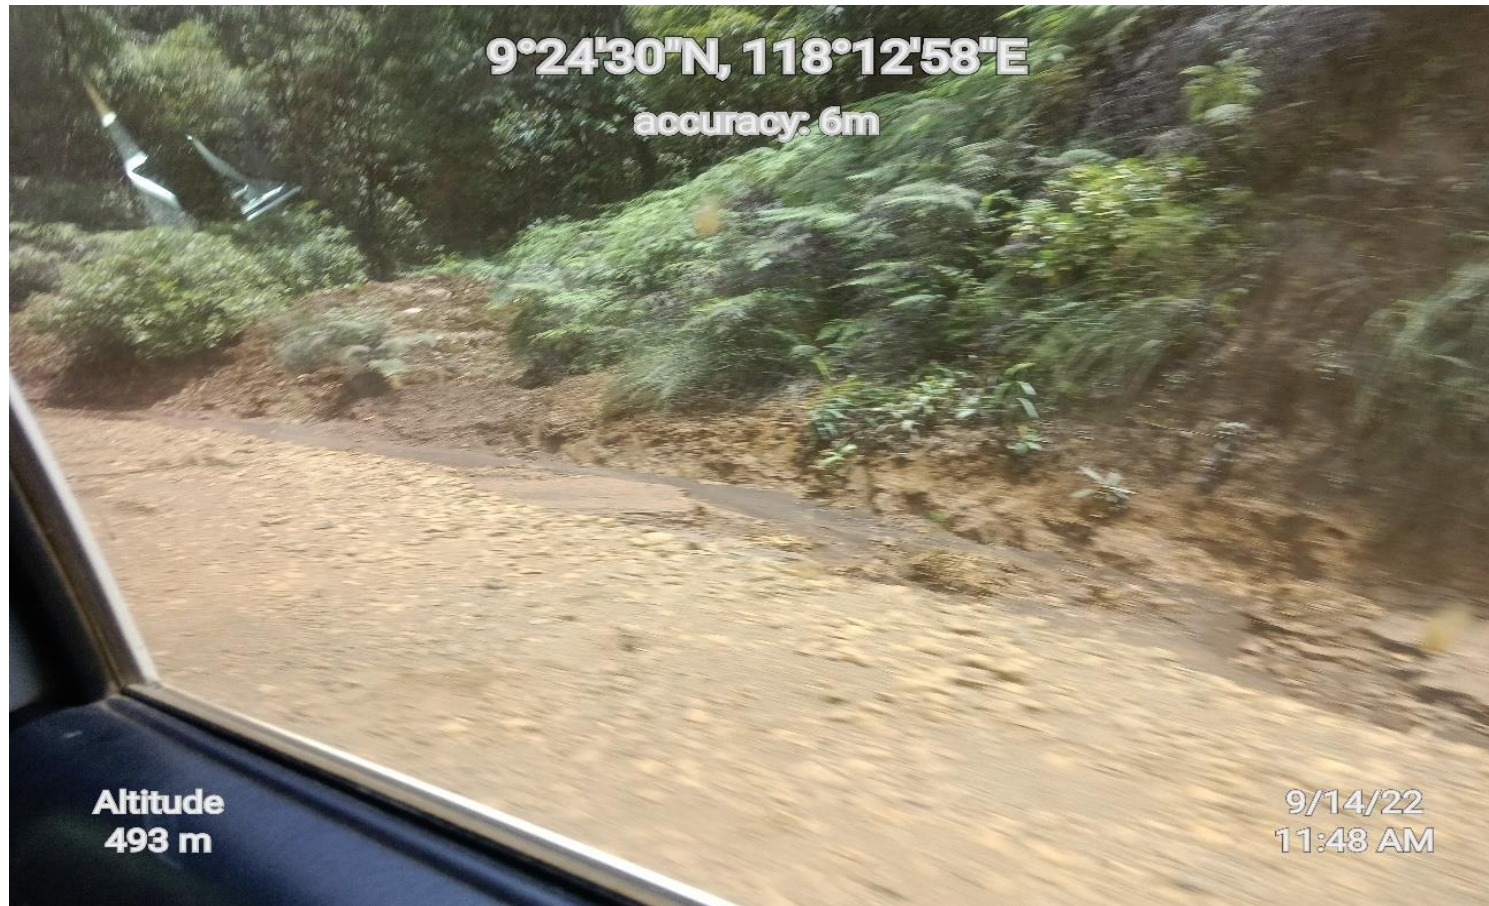
**Photo 20.** Observed accumulated silt at haul road drainage.

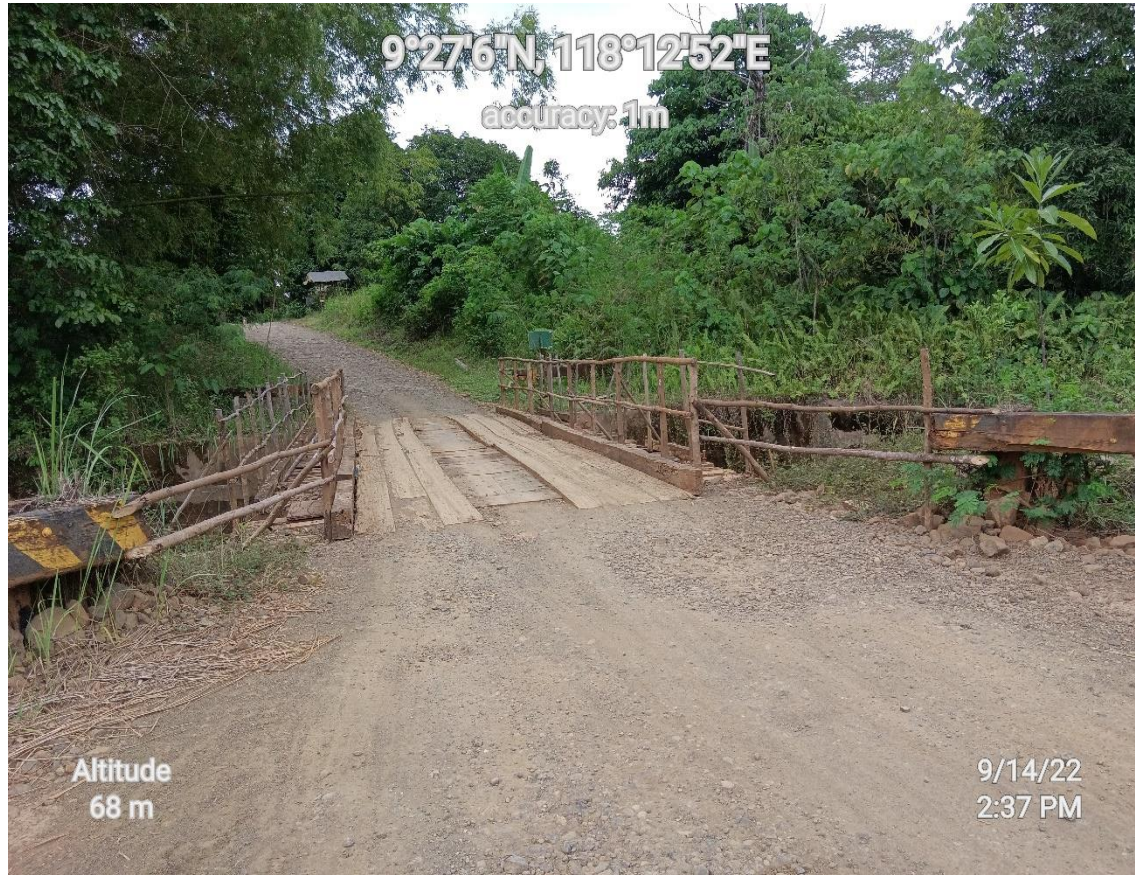
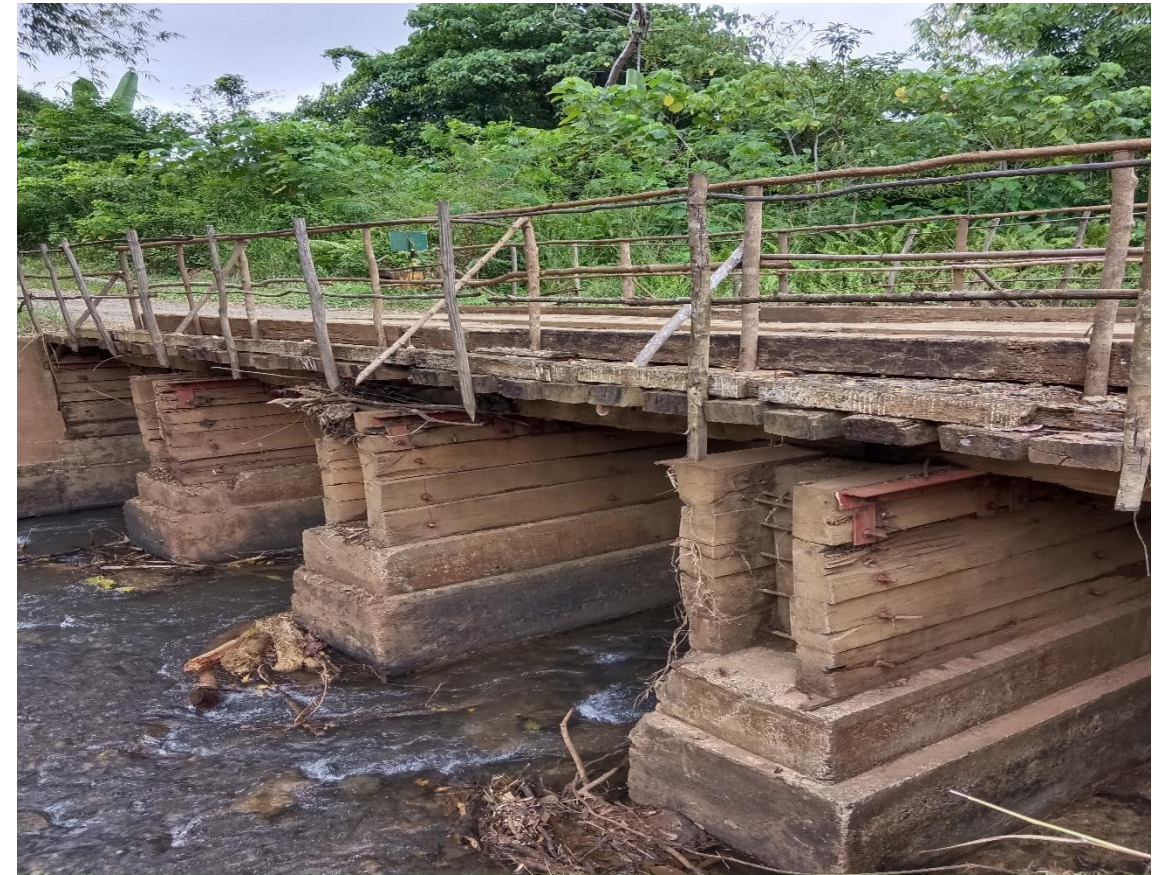
**Photo 21.** Barangay Berong is requesting for the reconstruction to improve of the Marangreg River Bridge.
