SUBJECT: REPORT ON THE ASSESSMENT/INVESTIGATION ON THE

ALLEGED DAMAGE/DESTRUCTION OF SEA GRASS AND

OTHER MARINE RESOURCES

SUBJECT: REPORT ON THE RAPID ASSESSMENT/INVESTIGATION ON

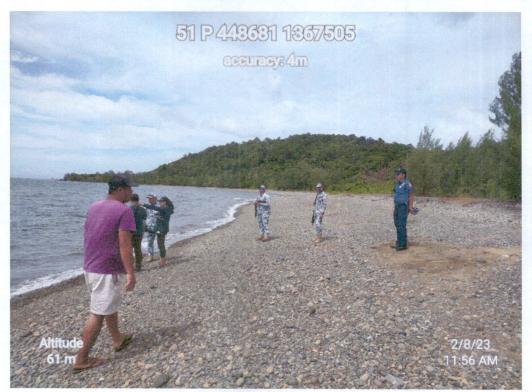
Figure 3. Ocular observation of the surrounding area together with San Fernando MPS and PCG-Magdiwang and Cajidiocan Substation and Kgd Romero

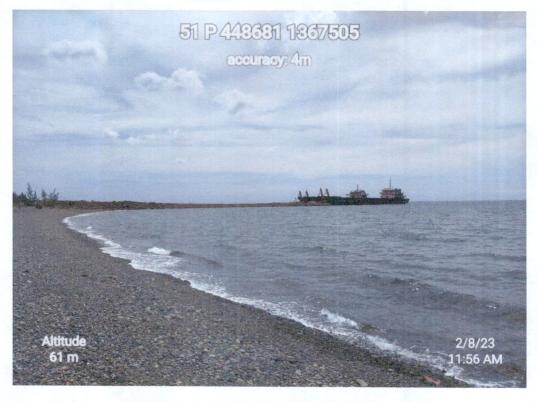
Initially, the team conducted ocular observation of the surrounding area of the constructed causeway located at Sitio Bato, Barangay España, San Fernando, Romblon. The shoreline extending towards Northwest is consists of loose particles of rocks and gravel. Moreover, the shoreline extending towards Southeast of the causeway project also consists of loose particles of rocks and gravel.

Figure 4. View of the causeway, LCT type vessel and shoreline extending towards northwest of thecauseway

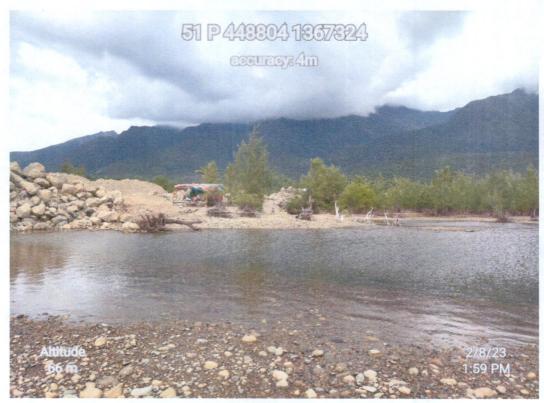
Figure 5. Shoreline extending towards southeast of the causeway

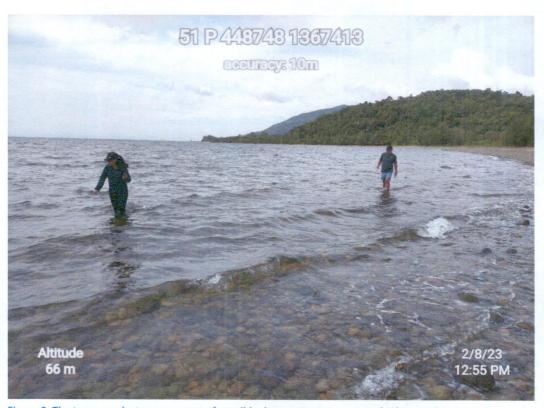
Figure 6. The team conducts assessment of possible damage to sea grass and other marine resources

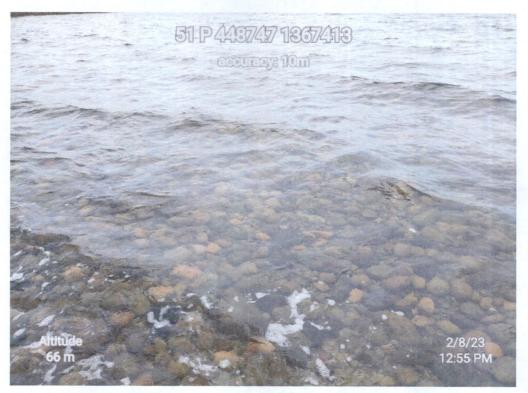
Results of the assessment/investigation revealed that rocks, rocks with algae and sand were existent in the surrounding area of the causeway. There were no sea grass and corals found at the alleged damaged area particularly at the vicinity of the causeway.

Figure 7. Rocks and pebbles

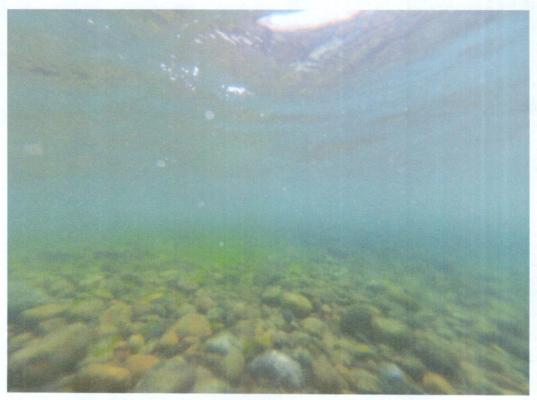
Figure 10. Rocks and rubbles

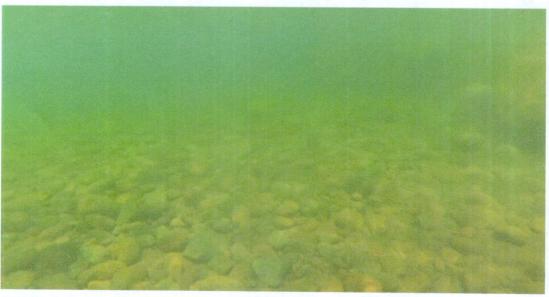
Figure 11. Rocks and pebbles
