## PROGRESS REPORT (DENR CENRO BROOKE'S POINT PALAWAN) As of January 5, 2023 (9:50 AM)

Source: Brooke's Point EOC (Situation Report 07)

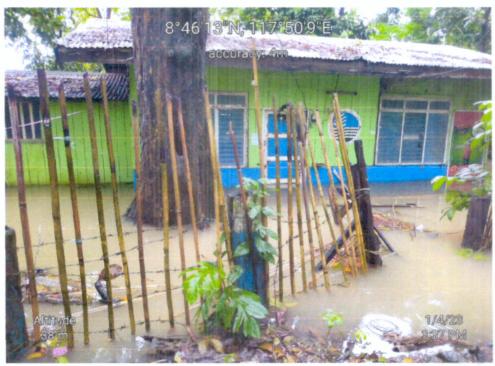
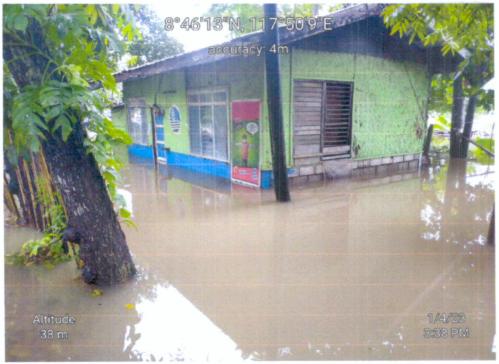
LADA PATROL BASE STATION

Coral Reef Assessment	f.2 Issued by CENRO	f.1 issued by CENRO	Permit (wrp)	<ol> <li>f. Wood recovery</li> </ol>	plantations	Greening Program	e. Established National	d. Protected Areas	(natural/planted)	Mountains	Upland Hills and	<ul> <li>c. In Forestland in</li> </ul>	(mangroves)	b. In coastal areas	areas	centers and adjacent	areas/city/town	lowland/built-up	places in	<ul> <li>a. In public land/public</li> </ul>	Fallen/uprooted trees	4) Inventory of	partially damaged (No.)	3) Residential houses	damaged (No.)	and facilities partially	2) Government buildings			
																								Reported no. of houses totally damaged: 14		flood	Lada Patrol Base Station partially submerged	Ipilan: 136	Samarınıana: 155	
																				•							d in			
												1
