**PULOT NICKEL MINING PROJECT**

# **STATUS OF COMPLIANCES**

## **FOR 3<sup>RD</sup> QUARTER 2022 MMT FIELD VALIDATION**

DECEMBER 15, 2022

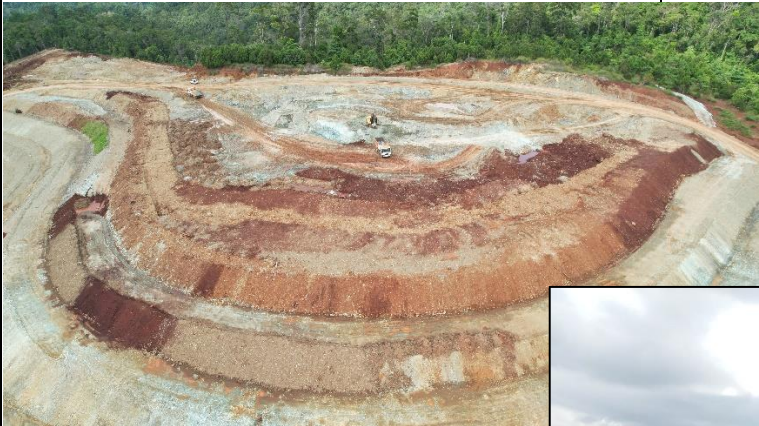
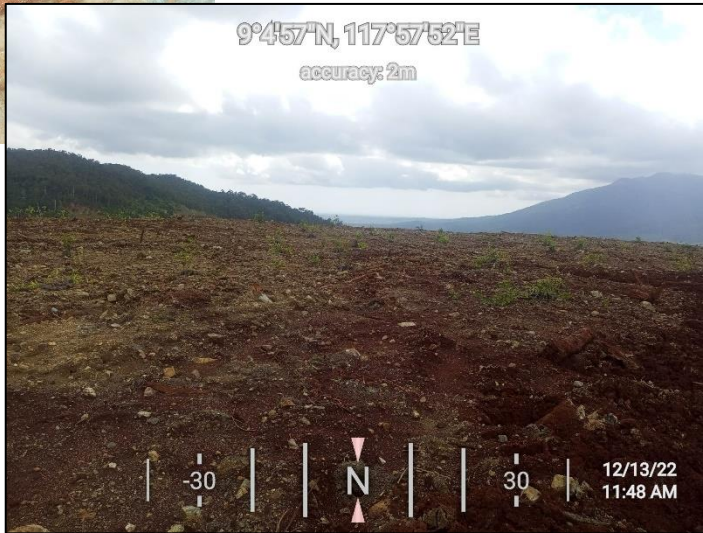
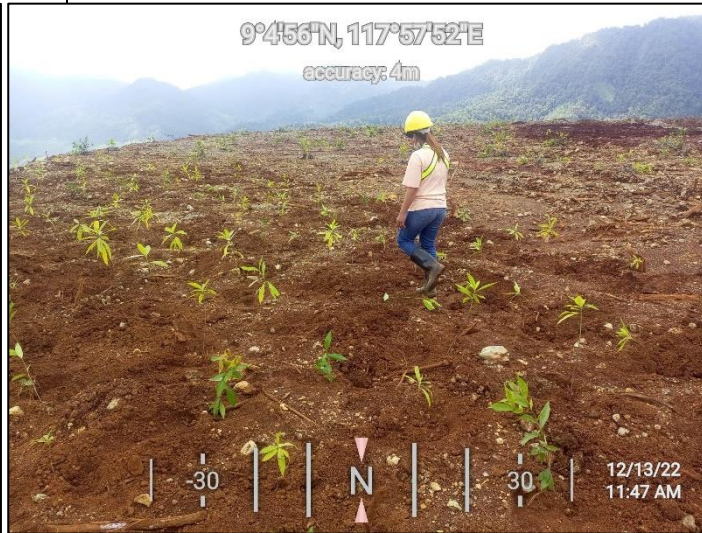
Findings and Observations	Recommendations	Status
<p>1. Unaccomplished activities are as follows:</p> <ul style="list-style-type: none"> <li>• Rehabilitation of mined-out areas;</li> <li>• Construction of environmental facilities</li> </ul>	<p>Ensure completion of target activities in the remaining quarter especially the land preparation at Block C5.</p>	<p>Unattained activities/projects will be implemented. However, some projects like rehabilitation (Recontouring and planting stage), still on-going. As of December 13, 2022, <b>4 has.</b> of block C5 Rehab has been planted. The remaining 5.78 has. will be carry over to the 1<sup>st</sup> Q of 2023.</p>

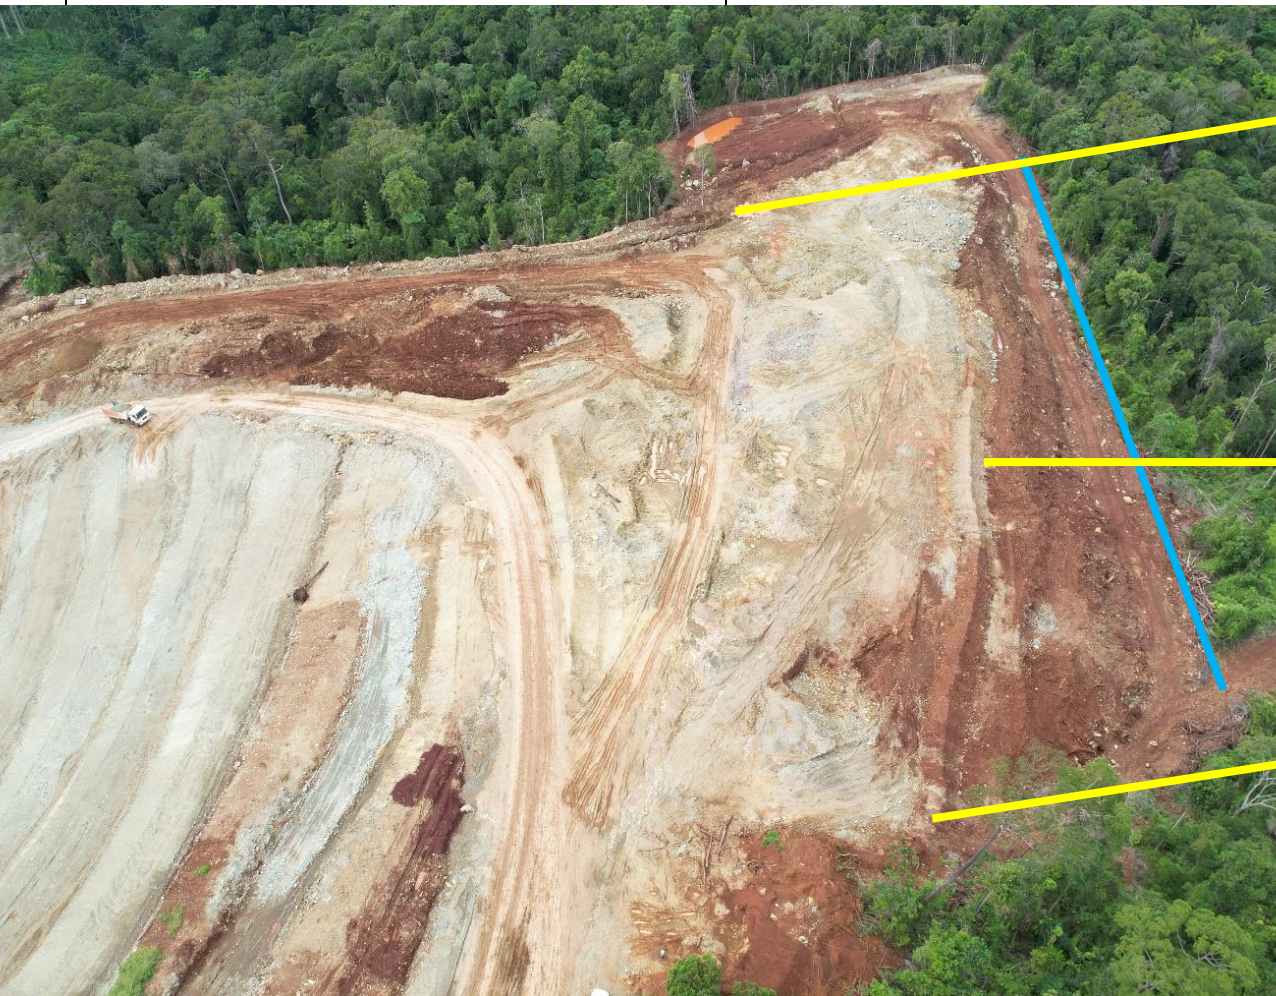
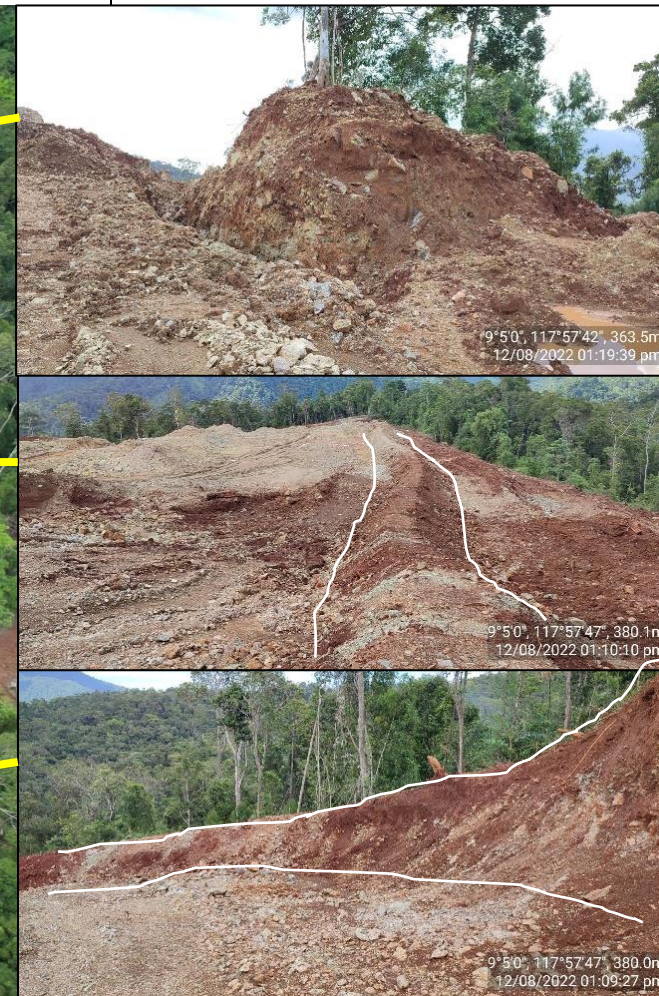
Findings and Observations	Recommendations	Status
2. Bund wall observed only at the northwestern portion of Block 3 (one of the areas covered by STCEP).	Extend construction of bund wall up to the northeastern portion of Block C3.	Installed initial bund walls. Secondary bund walls will be added to mitigate natural run-offs.

Blue line indicates area for installation of secondary bund walls

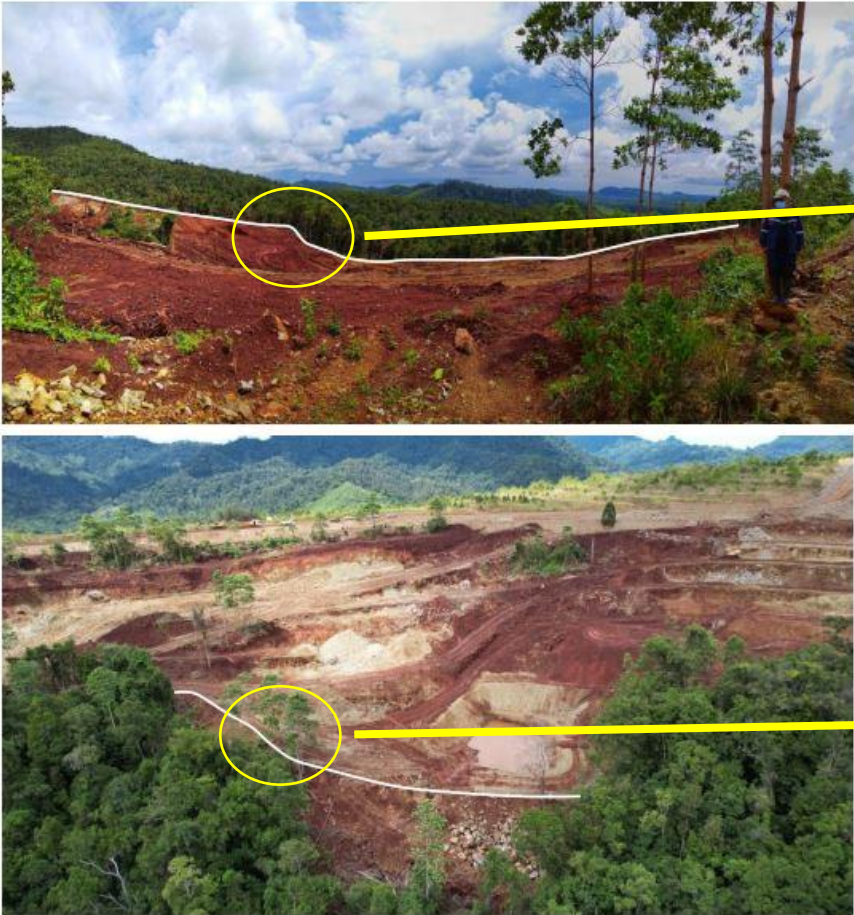
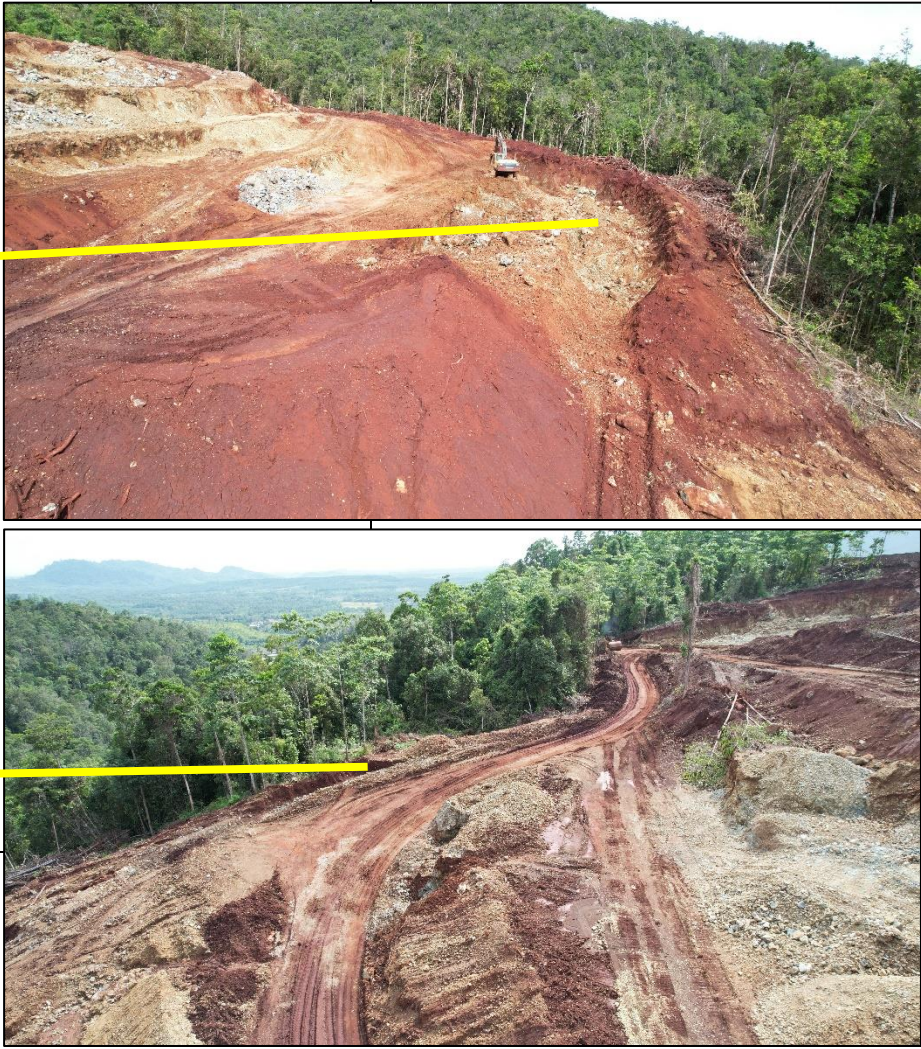
Findings and Observations	Recommendations	Status
<p>3. Indistinct bund wall at Block 2 (active mine area and covered by STCEP)</p>

<p>Reconstruct bund wall along the current perimeter (shown by the white line) ensuring its stability at all times. Increase the capacity of the constructed SCS in Block 2.</p>

<p>Bund walls were already installed. Improvements of the SCS were considered as the need arises.</p>

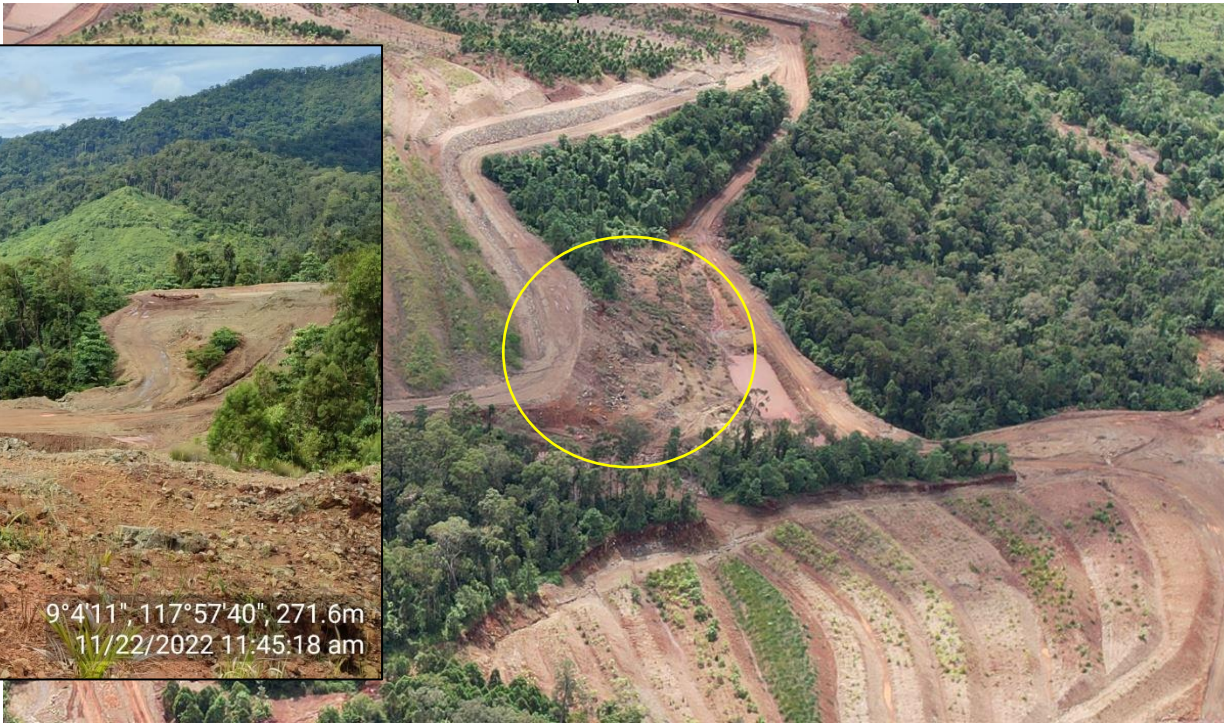
Findings and Observations	Recommendations	Status
<p>4. Minimal grass cover observed at the remaining 1.03 – hectare TRP</p>	<p>Subject the area for progressive rehabilitation per Section 5 of DAO No. 2018 -19.</p>	<p>It is already declared by the mining operations for rehabilitation. Development of the area will be on the year 2023.</p>
  <p>9°4'11", 117°57'40", 271.6m 11/22/2022 11:45:18 am</p>

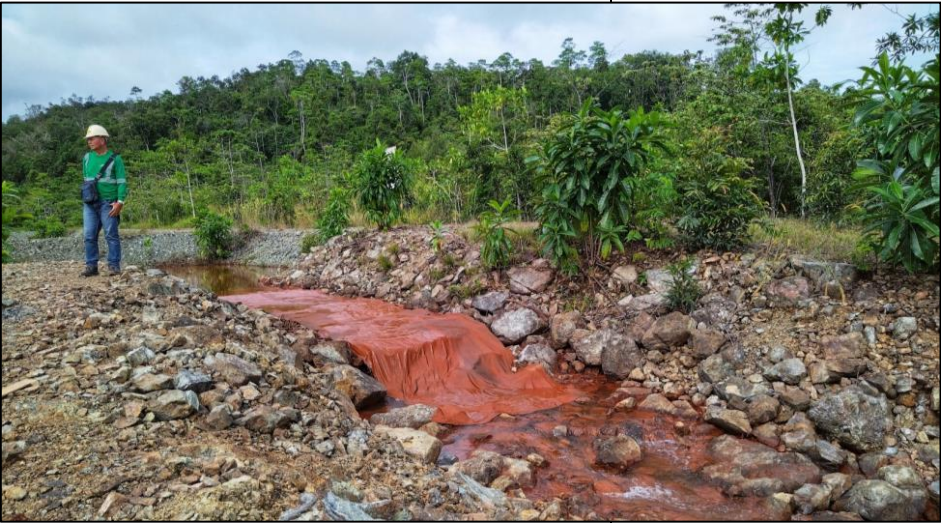
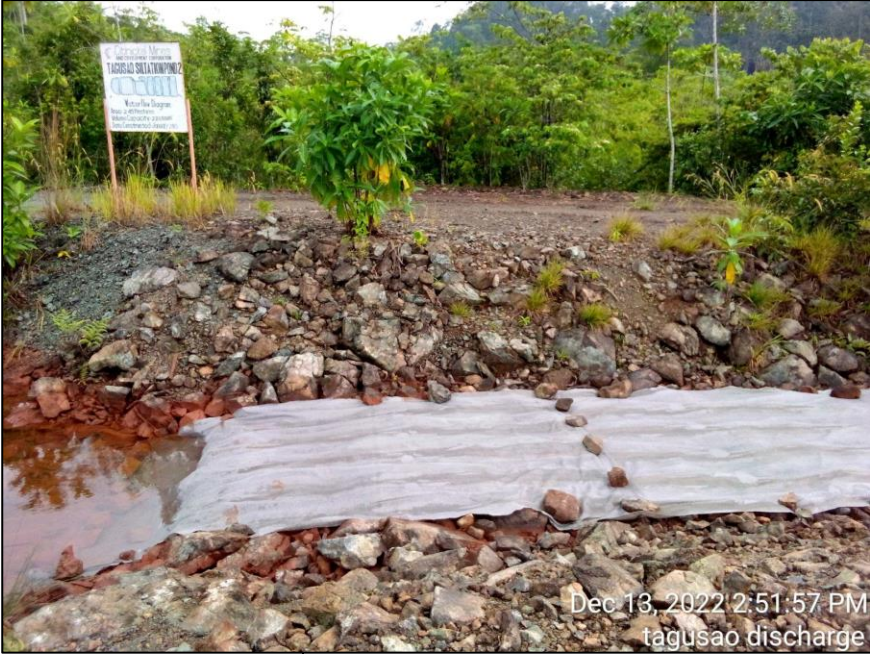
Findings and Observations	Recommendations	Status
<p>5. Placed geotextile at Tagusao Siltation Pond does not cover the sides of the drainage canal (exit point).</p>

<p>Rectify the geotextile positioning at all siltation pond discharges ensuring that the channel embankment are covered.</p>

<p>Installed new geotextile or filter cloth.</p>
