Subject: Report on Oil Spill Incident in the Port of Puerto Princesa on September 29, 2023

PLW-23100222

Environmental Incident Report

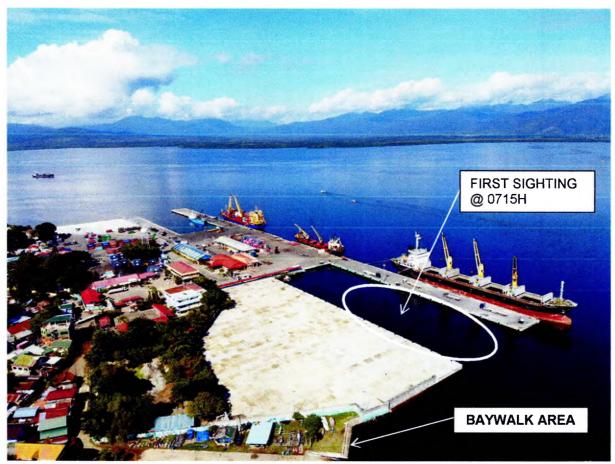
Aerial view of the port showing the first sighting of the oil spill

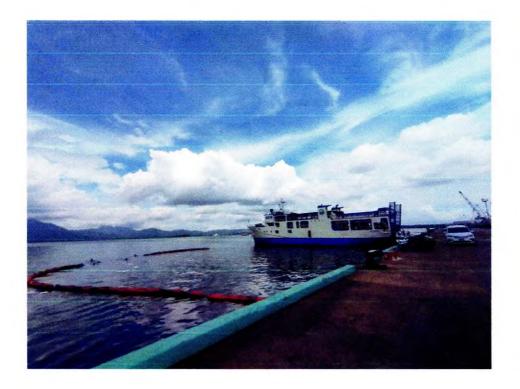
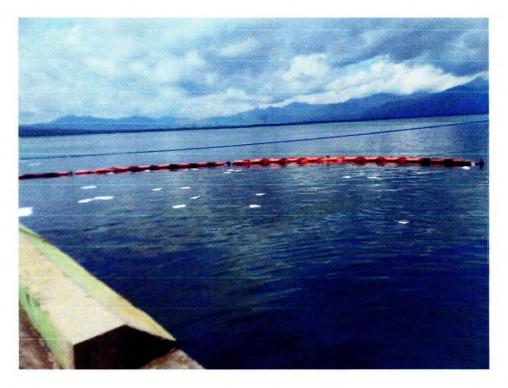
Spill booms at berths 9 and 10

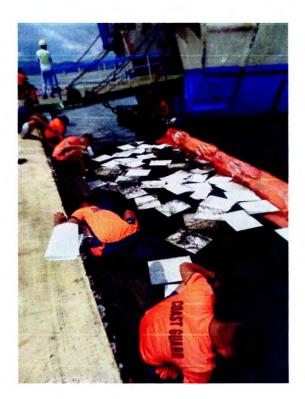
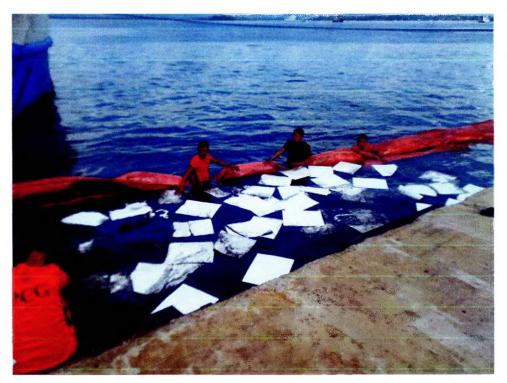
Absorbent pads to captivate the oil spill

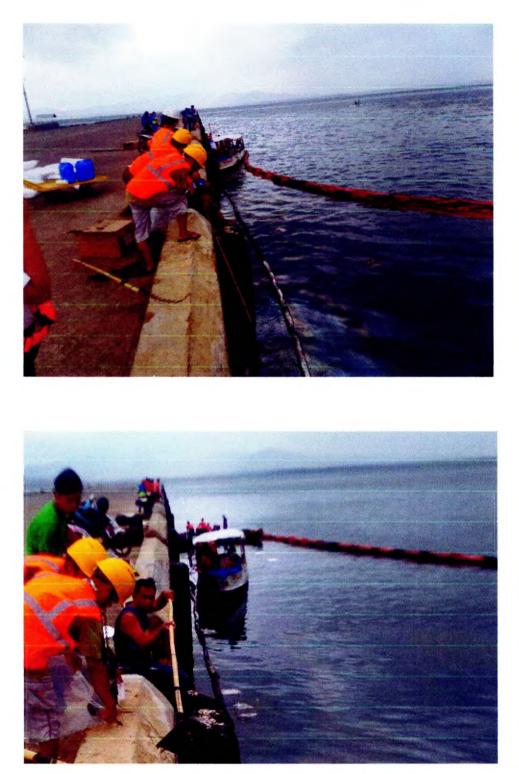
PPA personnel assisting in the retrieval of oiled absorbent pads
