September 19, 2023

SUBJECT : SUBMISSION OF SPOT /INCIDENT REPORT RE: AGROUND OF
CARGO VESSEL M/ V LADY ALINA OWNED BY KARMAMINE
TOO INC. COMPANY AT VICINITY OF CORON BAY, CORON,
PALAWAN.

SUBJECT : **SPOT / INCIDENT REPORT RE: AGROUND OF CARGO VESSEL M/V LADY ALINA OWNED BY KARMAMINE TOO INC. COMPANY SITED AT WATER OF VICINITY OF CORON BAY ISLAND, CORON, PALAWAN.**

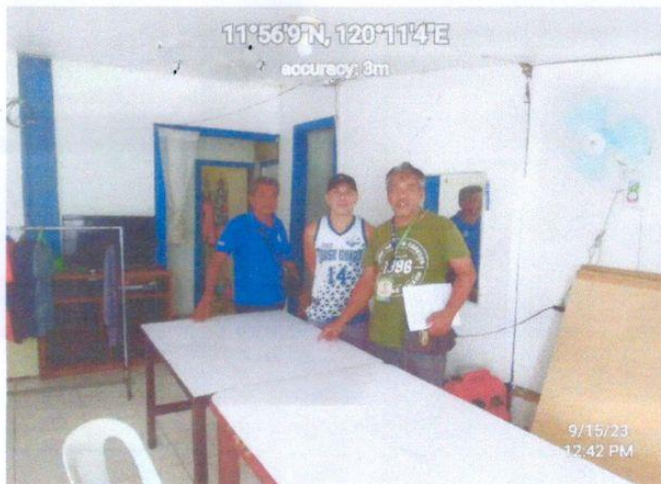
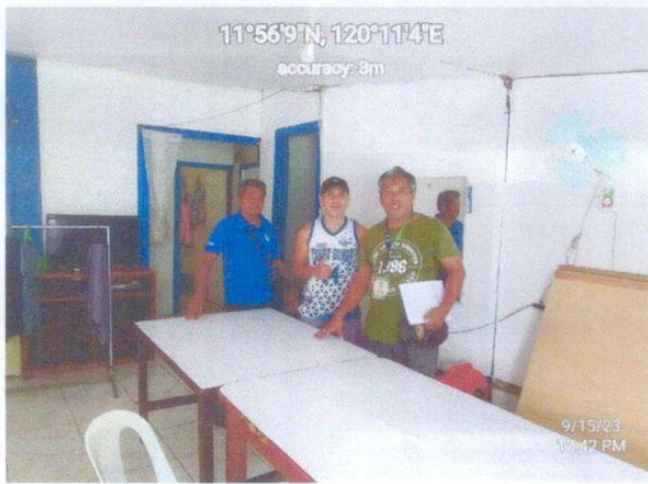
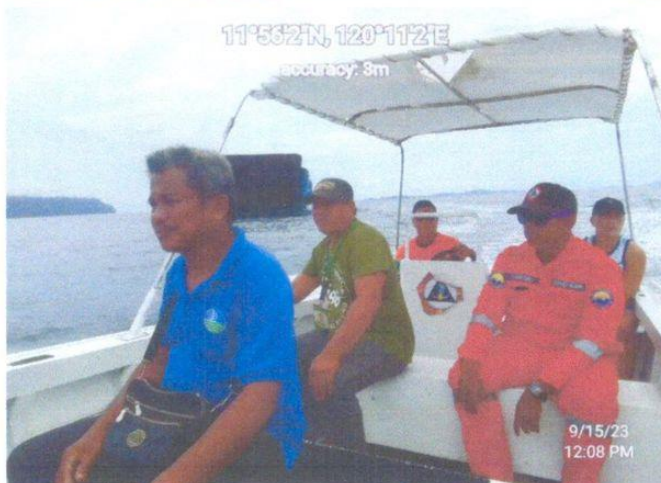
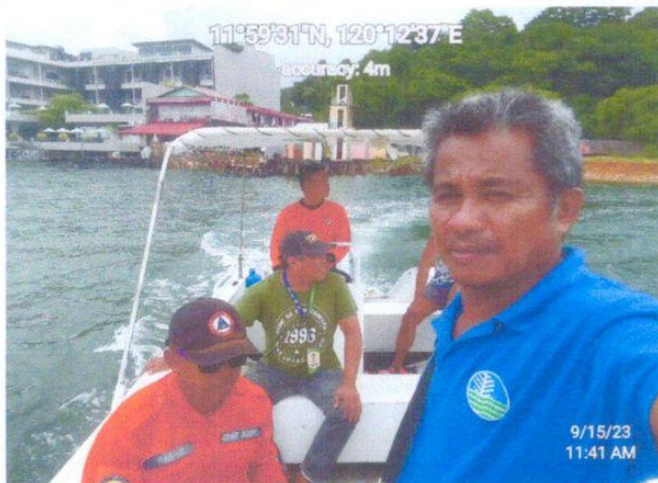
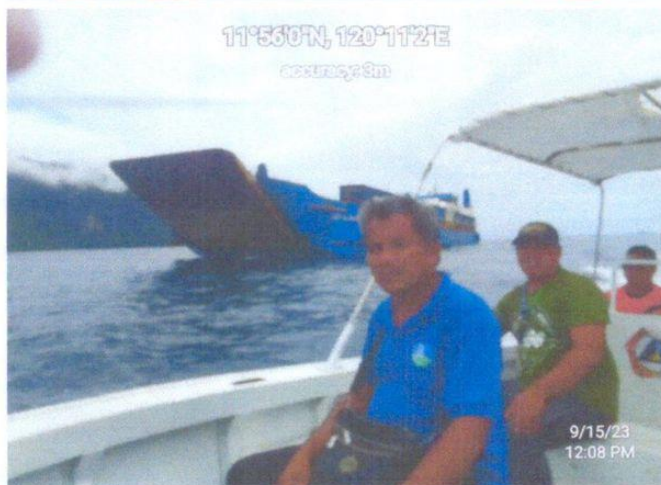
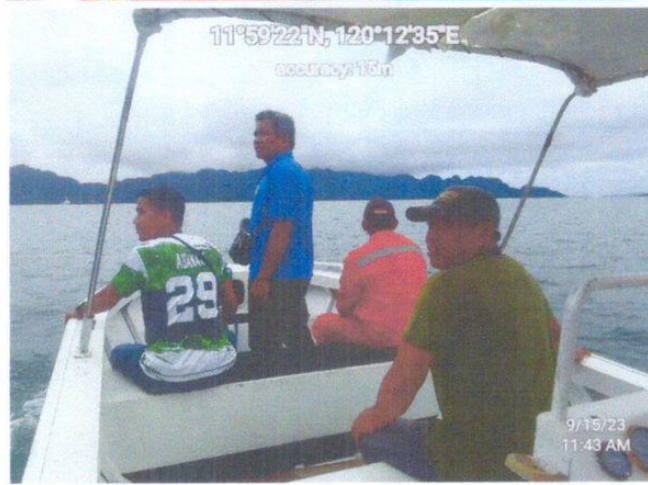
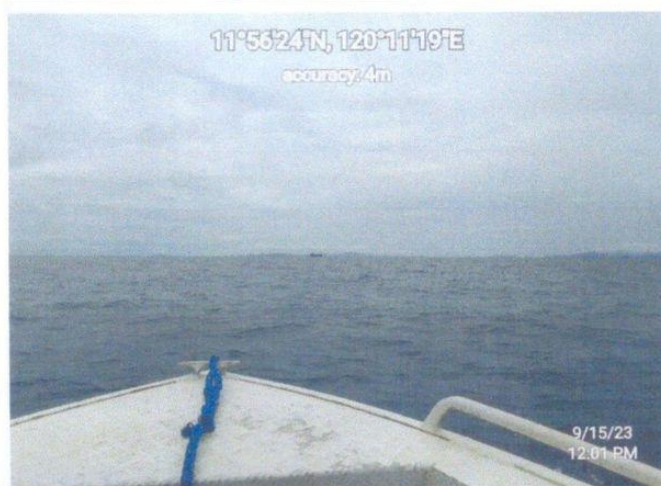
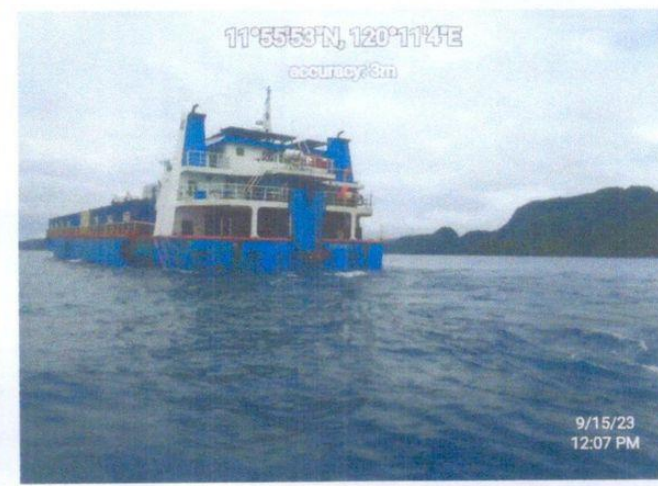
4. That the M/V LADY ALINA were also conducted assessment by the PCG, PCSDS and DENR- EMB Coron for the possible presence of Oil Spill or leak if there any and it come out that negative traces of Oil Spill/ Leak.

Geotag pictures were taken during the on-site assessment or investigation of a possible oil spill by the Enforcement and Monitoring Section of DENR-CENRO-Coron, together with the Philippine Coast Guard-Coron, on the M/V Lady Alina that caught aground on September 14, 2023, at Shallow Water in Coron Bay, Palawan.

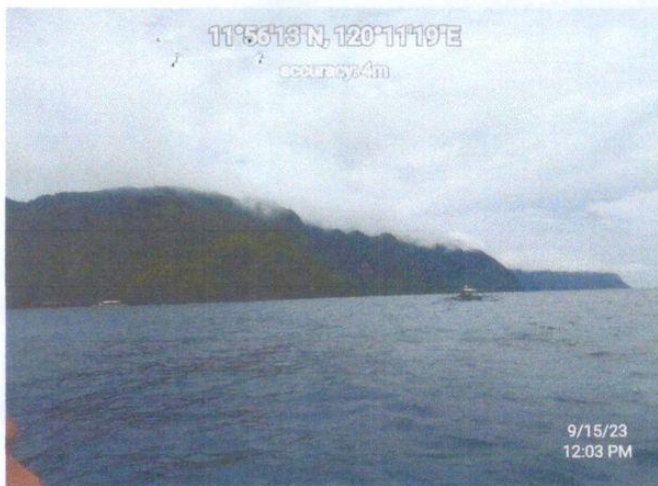
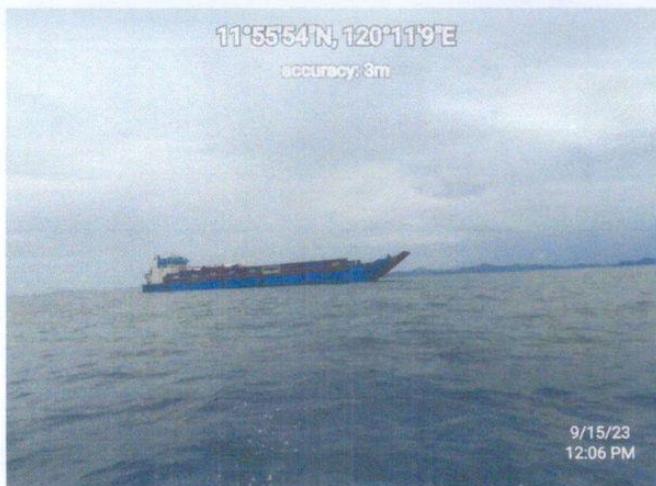
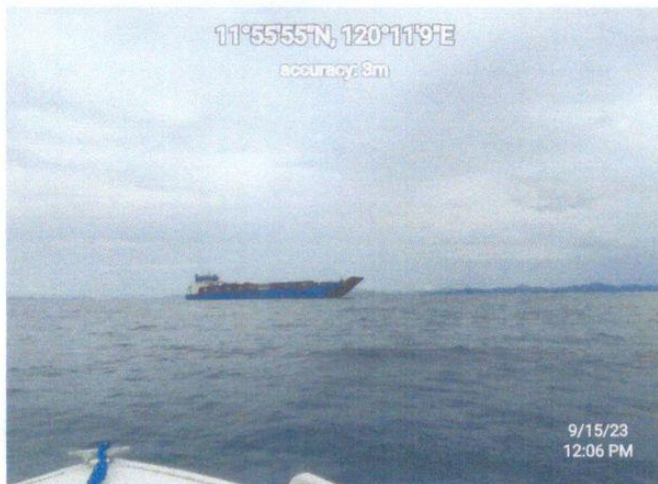
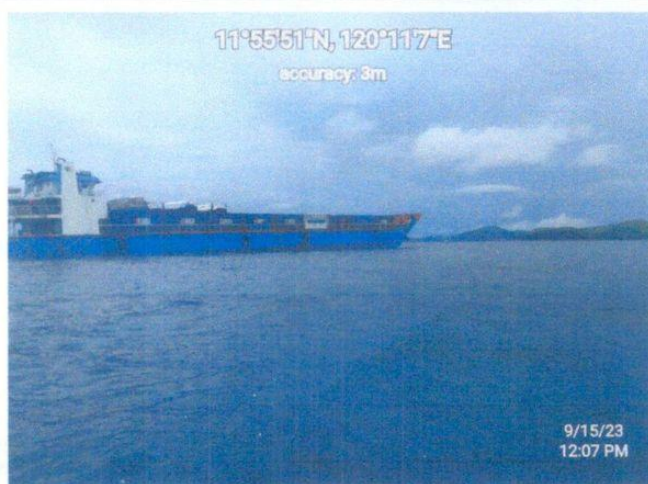
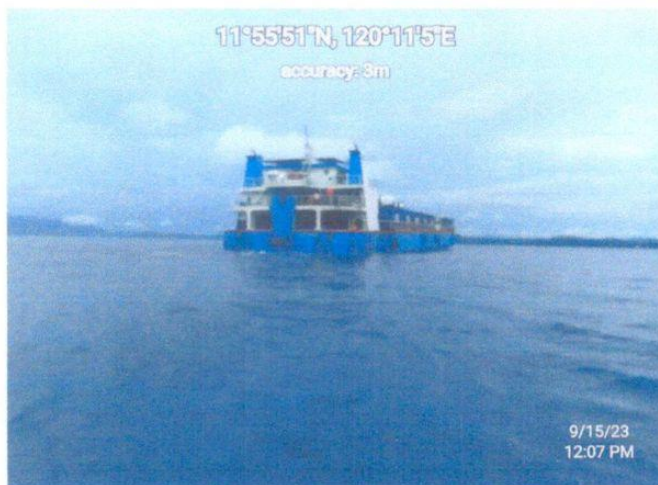
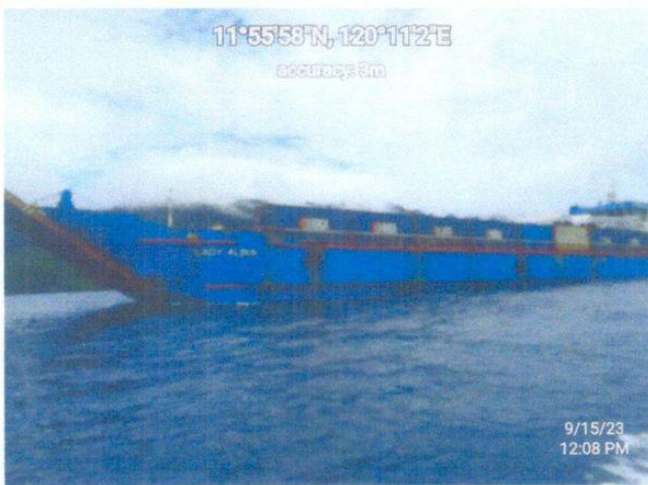
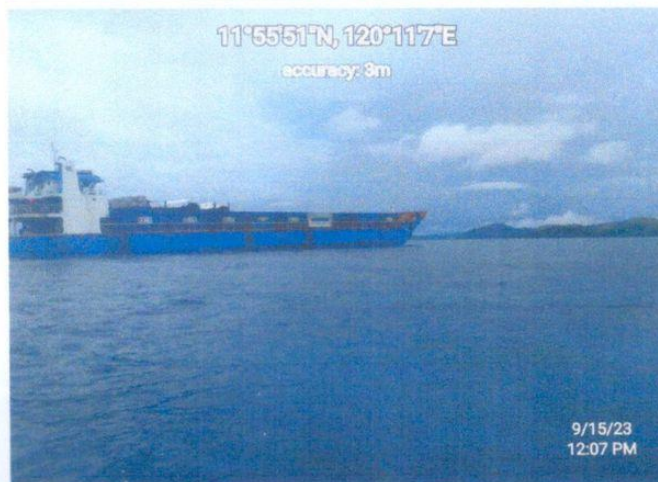
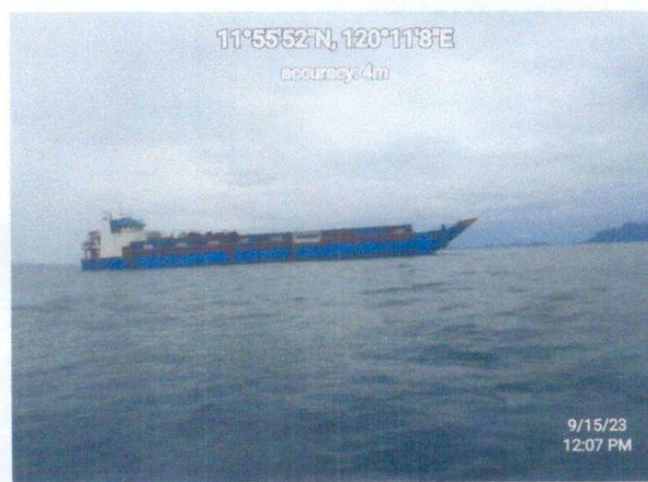
Geotag pictures were taken during the on-site assessment or investigation of a possible oil spill by the Enforcement and Monitoring Section of DENR-CENRO-Coron, together with the Philippine Coast Guard-Coron, on the M/V Lady Alina that caught aground on September 14, 2023, at Shallow Water in Coron Bay, Palawan.

3. O/A 1620H SAME DATE CMA THE TM SIGHTED THE AGROUND VES AT VIC WATERS OFF SW CORON ISLAND X THE TEAM IMMEDIATELY APPROACHED HER FOR NECESSARY ASSISTANCE AND CNDTD ASSESSMENT FOR POSSIBLE PRESENCE OF OIL SPILL SLANT LEAK X AFTER SEVERAL HOURS OF INSPECTION CMA THE TEAM NOTICED NEGATIVE TRACES OF OIL SPILL SLANT LEAK X

5. O/A 1530H SAME DATE CMA WHILE UNDERWAY AT THE VIC WATERS OFF CORON ISLAND X THE SAID VESSEL ENCOUNTERED UNEXPECTED STRONG WINDS AND HEAVY RAINFALL WITH ZERO VISIBILITY WHICH DRAGGED THE SAID VESSEL TO SHALLOW WATER CAUSING HER TO AGROUND X LIKEWISE CMA THE MASTER OF THE SAID VESSEL DECIDED TO EXTRACT HER TOMORROW MORNING WHILE WAITING ON THE HIGHEST TIDE X THE TEAM ADVISED THE MASTER OF THE VES TO FILE ALFA MARINE PROTEST TO PROPER STN FOR PROPER PROCEDURE AND DOCUMENTATION AFTER THE EXTRACTION X
