SUBJECT: ONSITE VISIT ON THE PROPOSED CONCRETING OF THE

BARANGAY ROAD LOCATED AT BARANGAY DEBANGAN,

TAYTAY, PALAWAN

ONSITE VISIT ON THE PROPOSED CONCRETTING OF THE

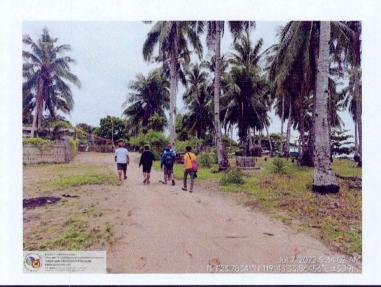
- 4. The area where the road will be built is situated in a generally flat ground near the foot of a hill and near the shore. The concrete road will be built under unconsolidated materials mostly composed of alluvial sediments. (Photo 2)

Photo 2: Photo of the barangay road.

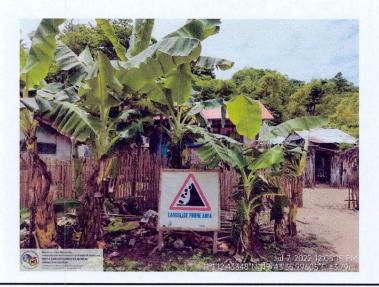
- 5. Areas near the side of the mountain are most likely at risk of landslide. This is evident by the landslide hazard sign seen along the road. (Photo 3)

Photo 3: A landslide prone sign observed at the area close to foot of the hill.

- 1. Based on the field findings and observation, parts of the barangay where the road is situated are susceptible to landslide or mass wasting and flooding. Also, due to its close proximity with the shore, hazards posed by the sea (e.g. strong waves, storm surge), may also affect the integrity of the concrete road.
- 2. Since the project will be built under loose sediments, proper engineering measures are recommended to prevent the possible erosion along the concrete road. Drainages shall also be built along the road and along the creek to divert the flowing water.
- 3. Furthermore, pursuant to Batas Pambansa Blg. 265 or the *Act Prohibiting the Extraction of Gravel and Sand from Beaches*, extraction of aggregates within the area suggested by the barangay are hereby prohibited.

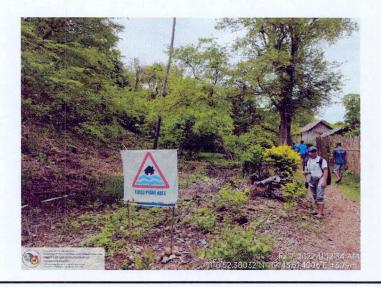
- 6. A dry creek was also observed during inspection. According to the barangay captain, the said creek only runs during the rainy seasons and sometimes overflows when rainfalls are heavy. A flood hazard sign can also be seen near the creek. (Photo 4)

Photo 4: A flood prone sign erected along a dry creek.

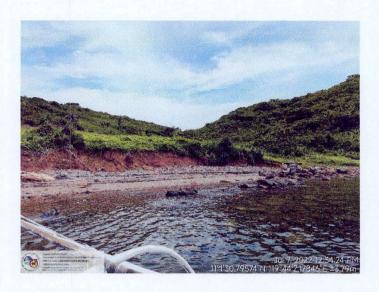
- 8. The source area is located at the northern part of the island. It is a narrow strip of coastline characterized by sand to boulder sized sediments. (Photo 5)

- 9. The said area is also where the barangay got their aggregates from the construction of other projects previously done on the barangay.

Photo 5: A beach area at the northern part of the island where the aggregates will be extracted.
