SUBJECT : SUBMISSION OF REPORT ON THE CONDUCT OF
MONITORING OF MONUMENTS ON DEMARCATED
BOUNDARIES OF MT. GUITING – GUITING NATURAL PARK,
SIBUYAN ISLAND, ROMBLON

SUBJECT : **REPORT ON THE CONDUCT OF MONITORING OF
MONUMENTS ON DEMARCATED BOUNDARIES OF MT.
GUITING – GUITING NATURAL PARK, SIBUYAN ISLAND**

**PHOTODOCUMENTATION DURING THE CONDUCT OF MONITORING OF
MONUMENTS ON DEMARCATED BOUNDARIES OF MT. GUITING – GUITING
NATURAL PARK, SIBUYAN ISLAND**

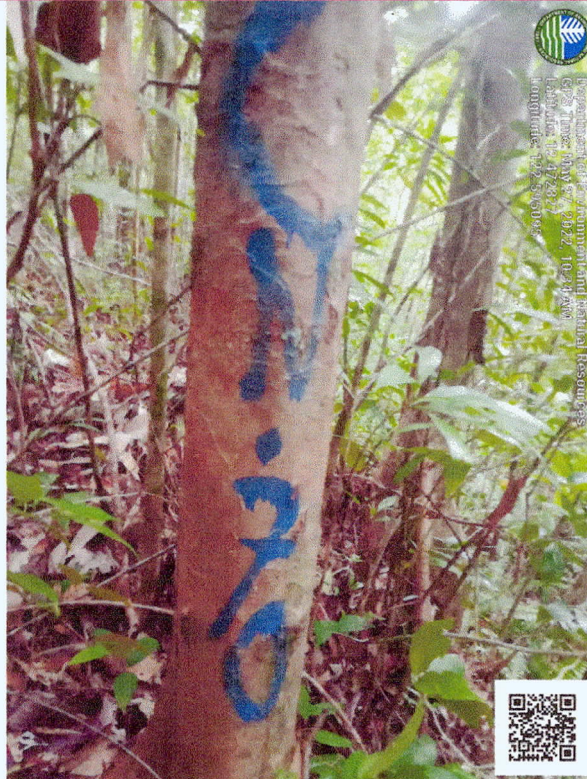
The destroyed Monument Corner no. 70 at Brgy. Cantagda, Cajidiocan, Romblon.

Out of the 132 monuments installed, only one (1) was destroyed. It is recommended to re-construct the said monument located at Brgy. Cantagda, Cajidiocan, Romblon. During the inspection, the DENR patrollers had observed the destruction of some signages in areas like Brgys. Cantagda, and Lumbang Weste, Cajidiocan, and Taclobo, Panangcalan, San Fernando. After an investigation/discussion, some of the Indigenous Peoples sees the signages as an intimidation/threat of their Ancestral Domain. Thus, the DENR personnel conducted an extended IEC with the IP community, the IPs raised the issue that hopefully, the signages would also contain their logo, and include in the sign that aside from entering the Protected Area, they are entering an Ancestral Domain as well. Thus, this Office recommends to include the maintenance of signages and its fund allotment for the future target activities of this Office.
