REPORT ON MONITORING AND EVALUATION OF FLA NO. (IV-29) 00001-A AND FLA NO. (IV-29) 00001-B ISSUED TO RIO TUBA NICKEL MINING CORPORATION REPRESENTED BY IOSE S. SARET FOR COMMERCIAL (REACH RESORT) AND

CENRO Brooke's Point conducted inspection and monitoring on September 14, 2022 on Foreshore Lease Agreements (FLAs) issued to Rio Tuba Nickel Mining Corpaoration located at Brgy. Rio tuba, Bataraza, Palawan.

REPORT ON MONITORING AND EVALUATION OF FLA NO. (IV-29) 00001-A AND FLA NO. (IV-29) 00001-B ISSUED TO RIO TUBA NICKEL MINING CORPORATION REPRESENTED BY JOSE S. SARET FOR COMMERCIAL (BEACH RESORT) AND INDUSTRIAL (PIER SITE) PURPOSES LOCATED AT BARANGAY RIO TUBA,

This pertains to the monitoring and Evaluation of the above-mentioned FLA of RioTuba Nickel Mining Corporation RTNMC conducted dated September 14, 2022 by the undersigned personnel.

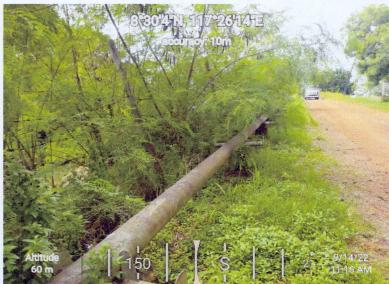
- c. Long metal pipe line estimated more or less 200 meters in length extended to the sea was seen in the area. According to Raymond F. Militar, Toolkeeper/timekeeper, the said pipe line was use in loading of fuel;

Metal Pipe line intended for loading of fuel

- 3. The long metal pipe built in with bridge estimated more or less 200 metres in length seen extended outside the area of FLAG (IV-29)0001-B shall be applied proper tenurial instrument for the construction;

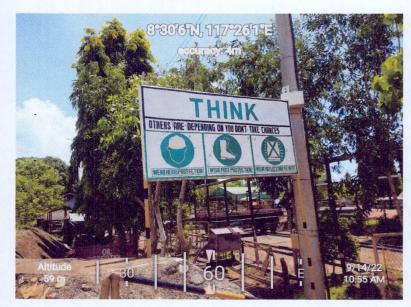
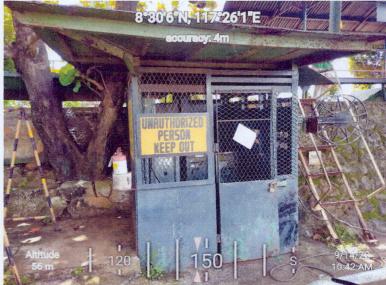
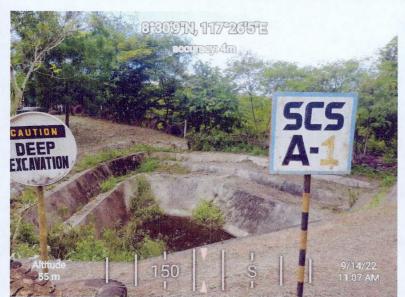
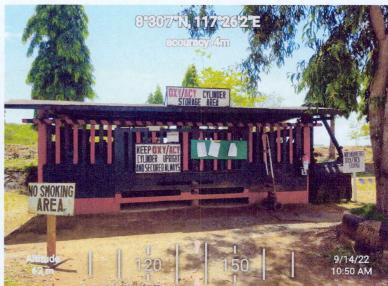
- e. Some of the warnings and advertisement materials such bulletin board, billboards and signage's was observed installed in different places within the FLA area, the paint had faded and some of them have been damages because other material used in the installation are made by lumber.

Signage's within the area of FLA 00001-B AREA

- 5. Those warnings and advertisement materials such bulletin board, billboards and signage's was observed installed in different places within the FLA area should be repaired and repainted so that they are recognizable and visible to passer-by and those who will conduct monitoring

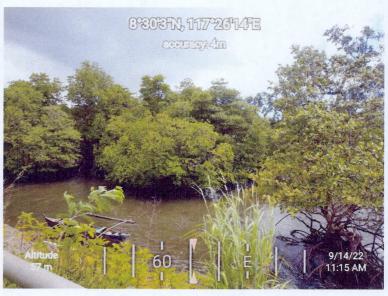
- g. Large portion of mangrove stand/plantation within FLA No. (IV-29) 00001-B area was noticeably well protected and conserved.
- h. Accordingly to Mrs. Rita Airene Lozano the said annual rental on FLA No. (IV-29) –B amounting of Php 30,000.00 is schedule for payment this month of September 2022.

Mangrove stand

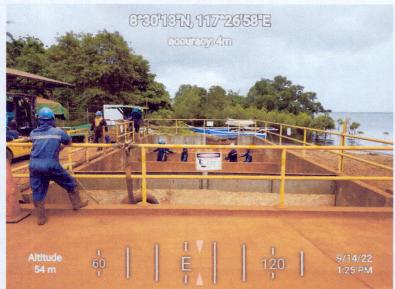
- c. During monitoring and inspection we notice that the CBNC personnel conducted desilting or removing silt and laterite in their concrete siltation pond.

Concrete Siltation Pond

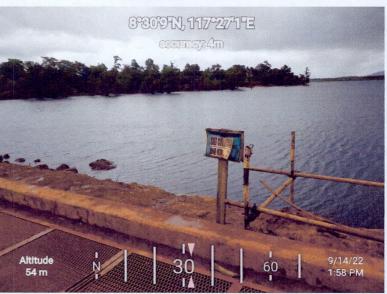
- a. The FLA No. (IV-29) 00001-A area is situated adjacent/near Coral Bay Nickel Corporation (CBNC) compound;
- b. According to Ranie Chiva, Pier Site Warehouse CBNC the silting facility was constructed by CBNC which serves as surface run-off and silt reservoir that eventually collected using water pumps back to the main siltation pond located within the CBNC compound to prevent silt directly pass through the shore. In addition, there was also series of silt collector to help and minimize the silt pass through directly to siltation pond;

Silt collector

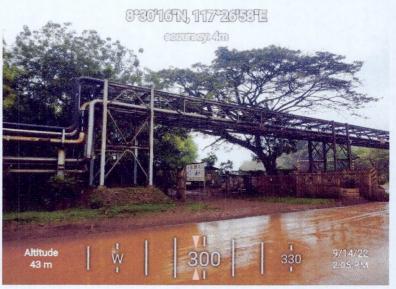
- f. The concrete causeway and steel posts with built-in metal pipelines were constructed traversing the FLA 00001-A area by CBNC which covered by a separate *Miscellaneous Lease Agreement* (MLC-045305-01-D) estimated 2 kilometres from source (dolphin area) to the major tank;

- i. As per our monitoring and inspection wherein the area of metal pipe line is located we observed that is grassy and covered with the branches of the growing species of ipil-ipil tree.

Steel posts with built-in metal pipe lines

- 6. The perimeter area of long metal pipe line of RTNMC must be observed and conduct regularly maintenance through brushing and weeding.
- 7. However, if the RTNMC comply the necessary requirements and details pertaining to the said conversion of FLA and the estimated cost of the constructed structure please provide a copy for reference.

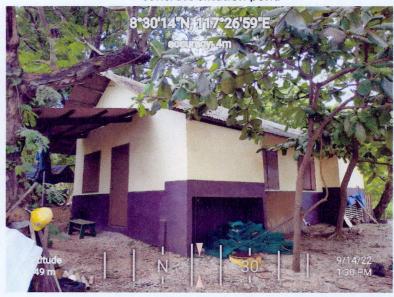
- d. The established semi-concrete houses near the mangrove area accordingly, were constructed as AFP/Maritime quarters;
- e. There was a newly renovation semi concrete seen for security department;

Newly repair Semi concrete house for security Department

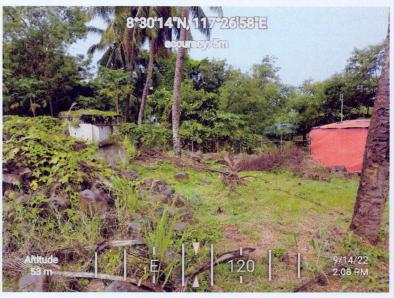
- f. The previously waiting shed/rest area utilize by CBNC has been demolished because according to Ranie Chiva the purpose and designed of the said rest area is considering prefabricated and also for temporary.

Previously waiting shed/rest area

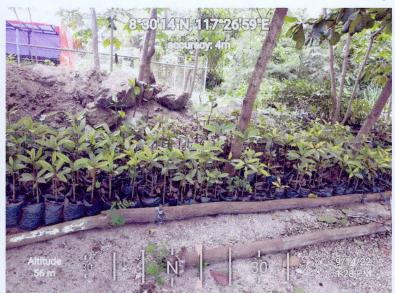
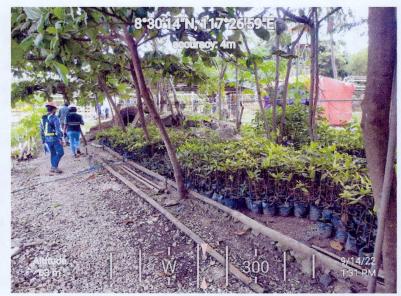
- g. Improvements thereon are well maintained and the subject FLA area including the adjacent mangrove stand was well protected and conserved. It was also observe that the company well already protected and maintained the potted mangrove propaggules near the guard house which is intended for enrichment planting;

Mangrove seedlings near the guard house

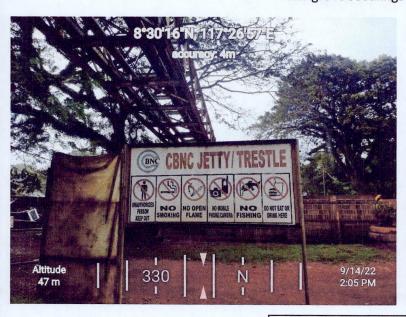
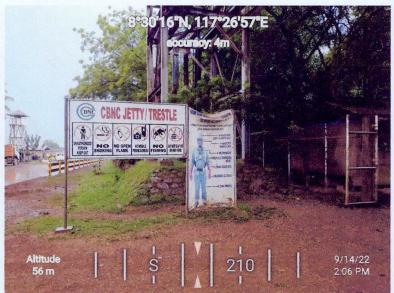
- j. Some of the warnings and advertisement materials such bulletin board, billboards and signage's was observed installed in different places within the FLA area, the paint had faded and some of them have been damages because other material used in the installation are made by lumber.

Signage's within  $\underline{FLA~00001}$ -A  $\underline{AREA}$
