SUBJECT : INITIAL REPORT OF EARTHQUAKE INCIDENT AT
ODIONGAN, ROMBLON ON MAY 20, 2023

INITIAL REPORT OF EARTHQUAKE INCIDENT

SUBJECT : Initial Report: Magnitude 4.8 Earthquake

**Initial Inspection Report
(Post Disaster Assessment)
May 20, 2023**

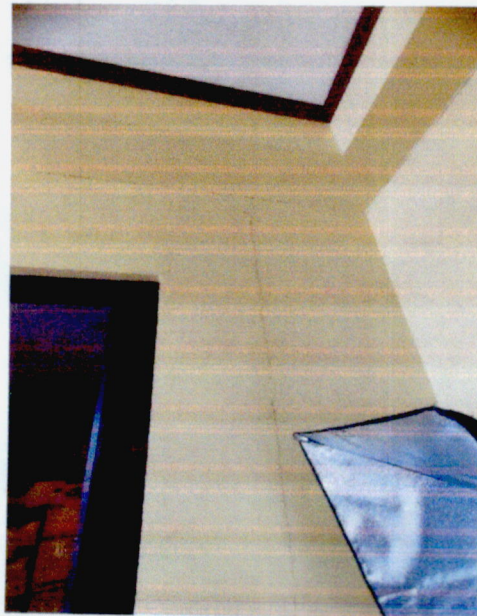
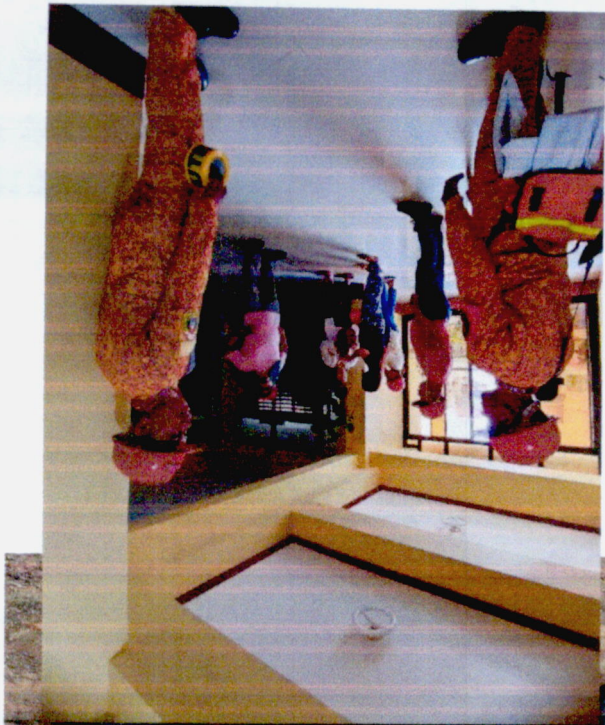
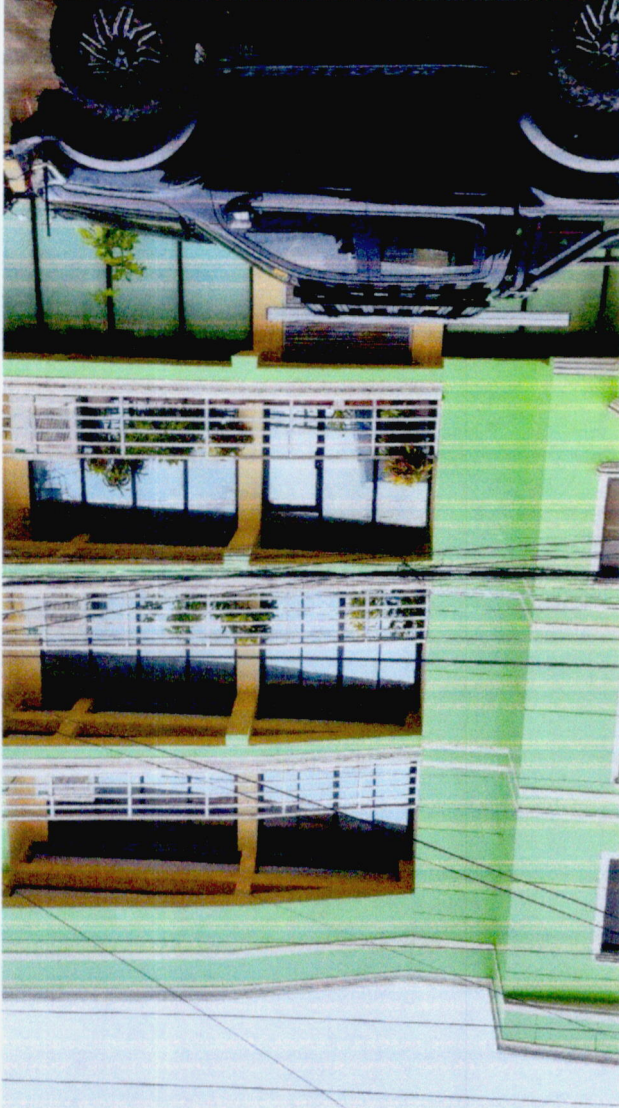
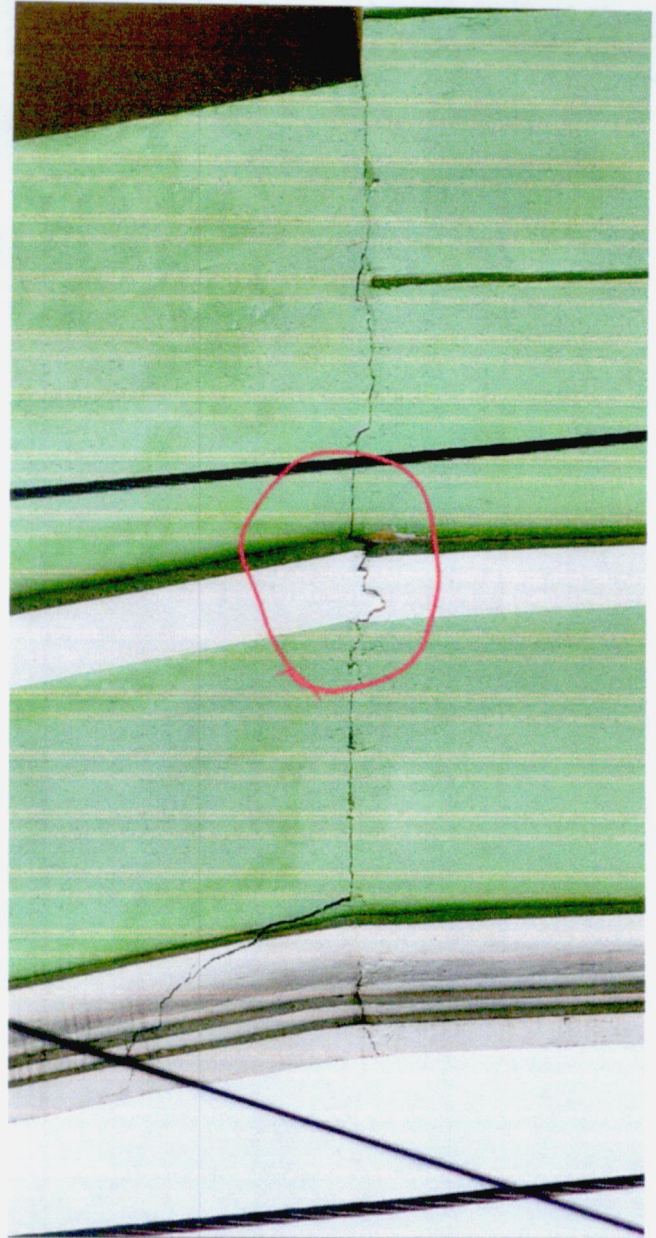
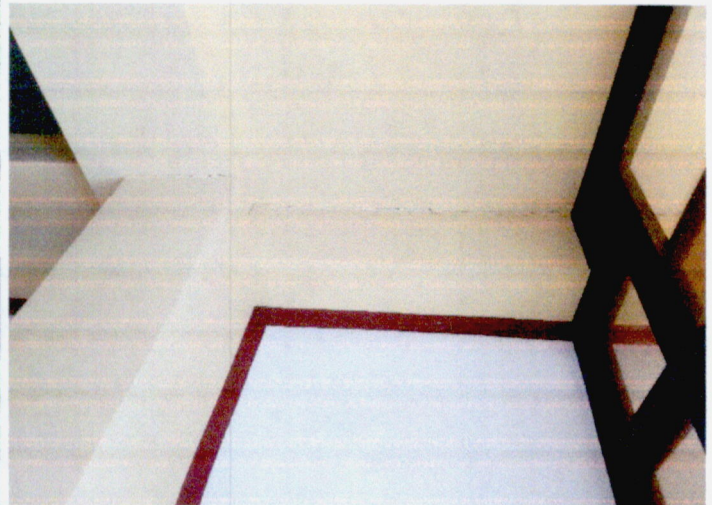
**ST. VINCENT FERRER MULTI- PURPOSE
COOPERATIVE**

- Only cracks were discovered in the connection between the old and new buildings.
- Some partition walls have noticeable cracks.
- Because of vibration/building movement, floor tiles on the fourth floor popped up.

- Examine the structural designs and analyses of old and new structures.

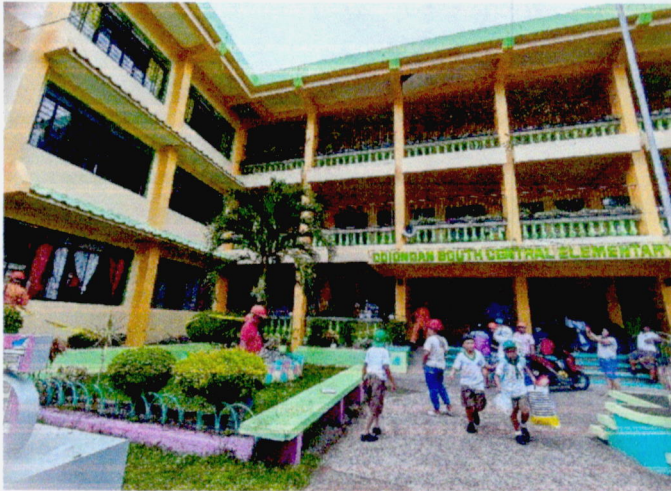
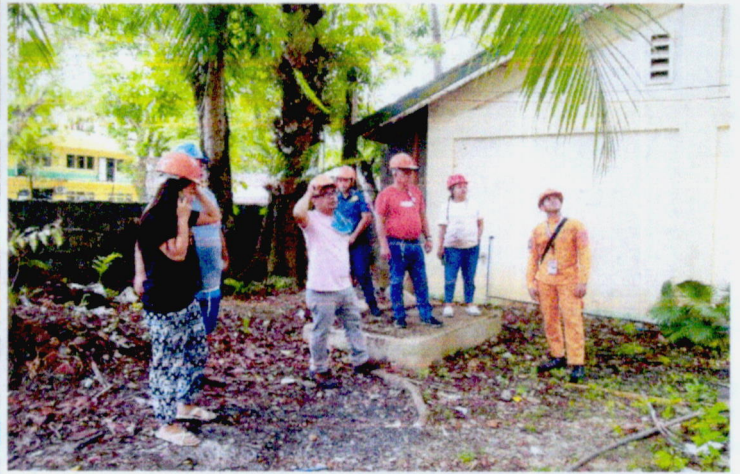
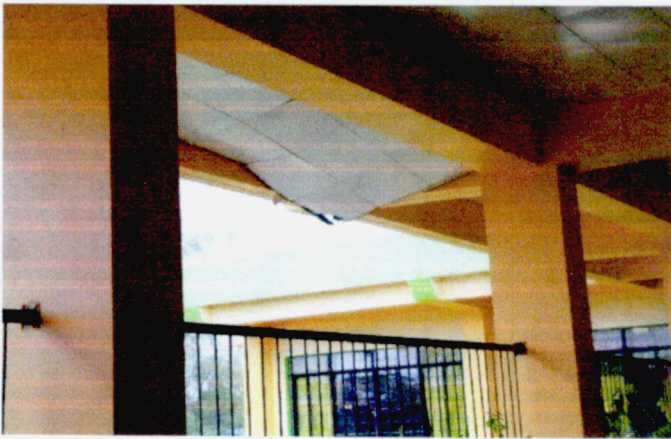
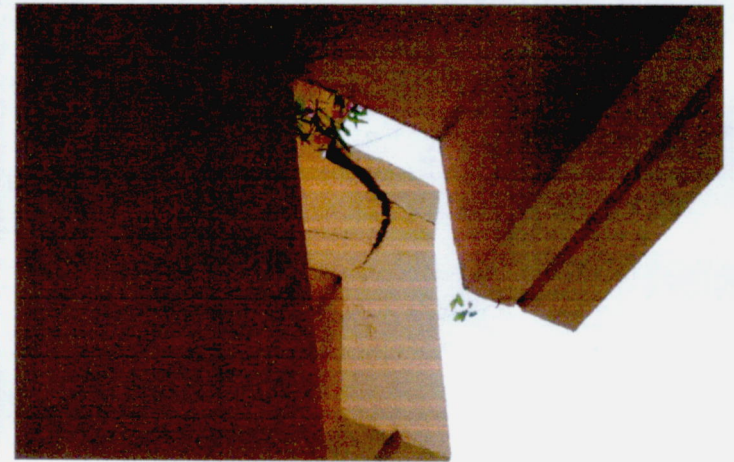
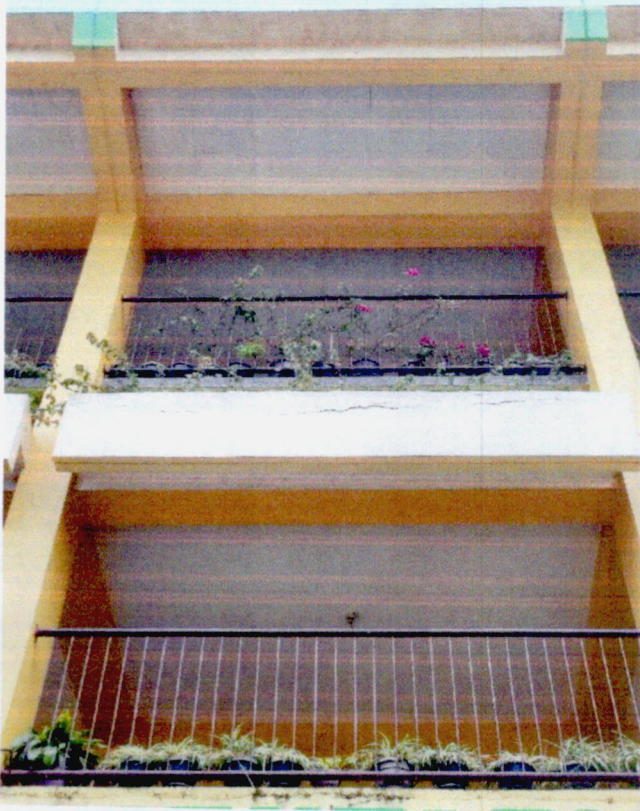
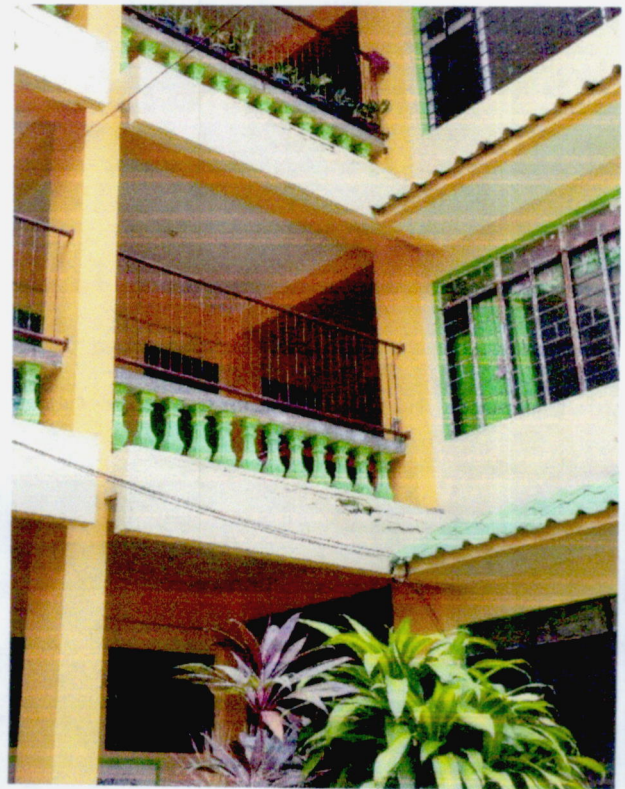
ODIONGAN SOUTH CENTRAL ELEMENTARY SCHOOL

- Concrete canopy/flower box cracks
- There are no substantial cracks in the beams or columns (the primary structural elements).

- Concrete canopy demolition
- Removal of a damaged ceiling on the third floor

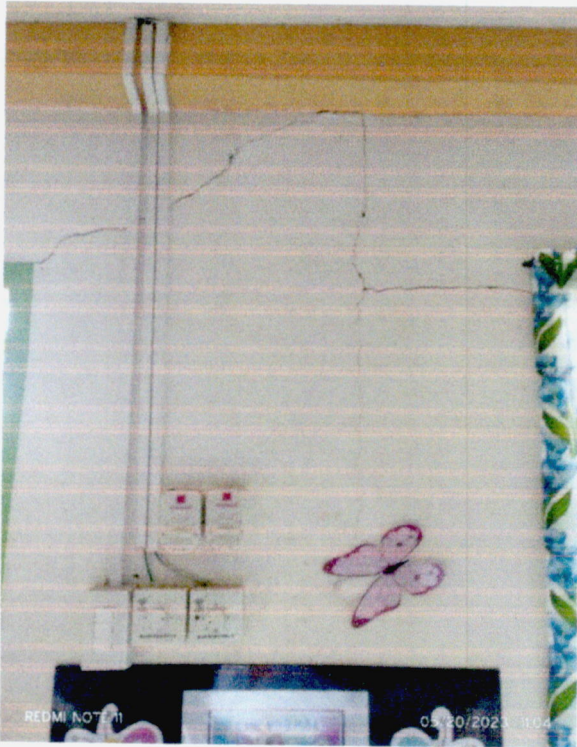
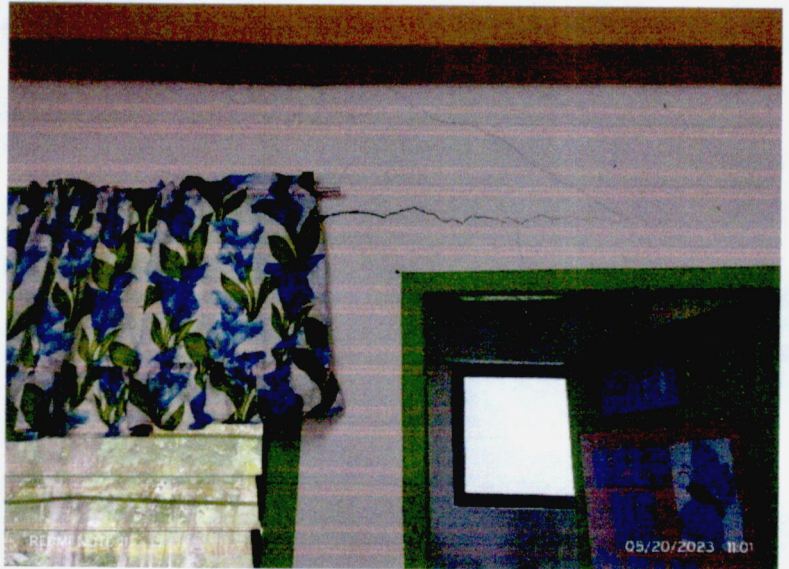
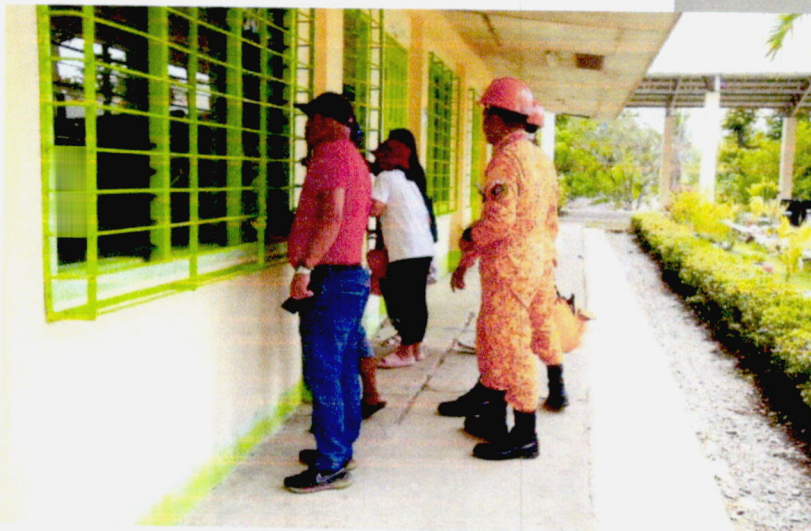
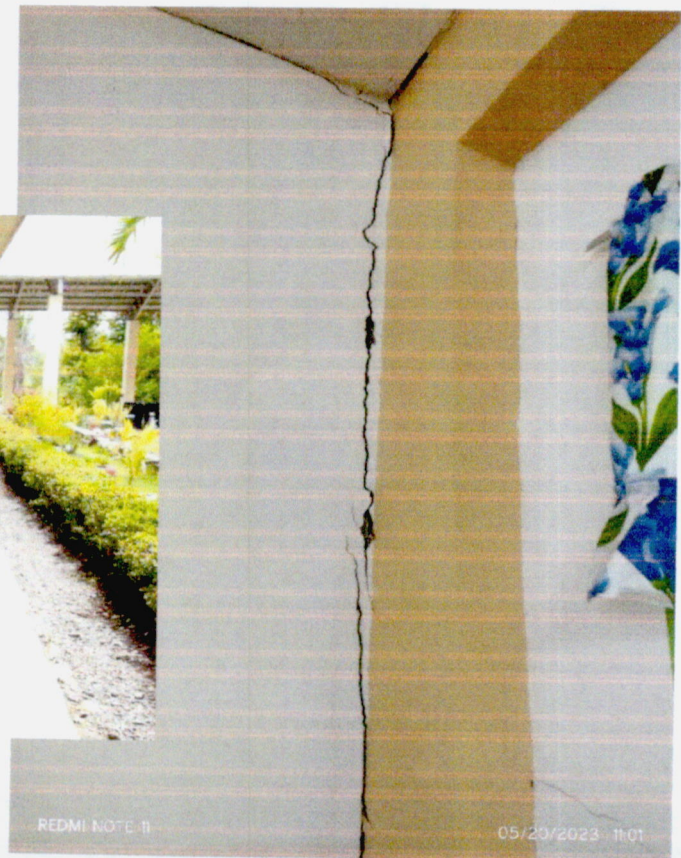
MALILICO ELEMENTARY SCHOOL

- Between the connection of the chb wall and column, cracks were seen.
- The main structural components of the classroom (the beam and column) did not show any significant cracks.

- Verify Malilico Elementary School's overall building's structural soundness.

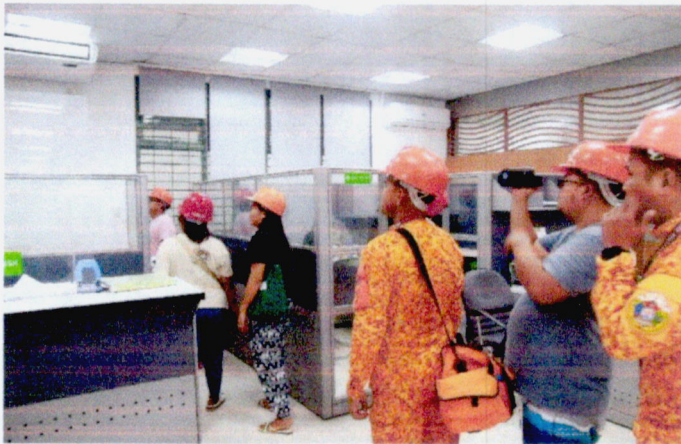
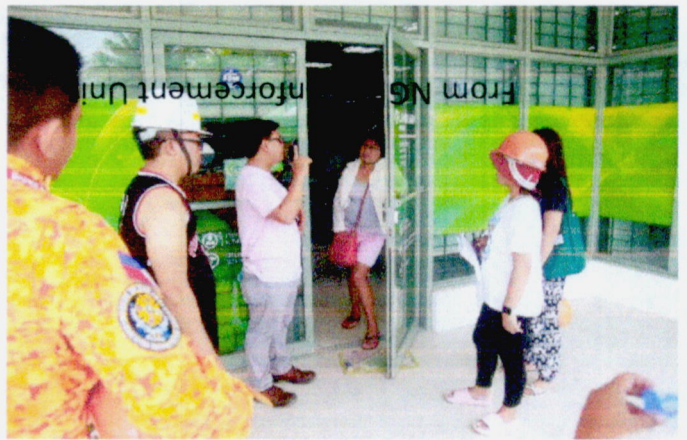
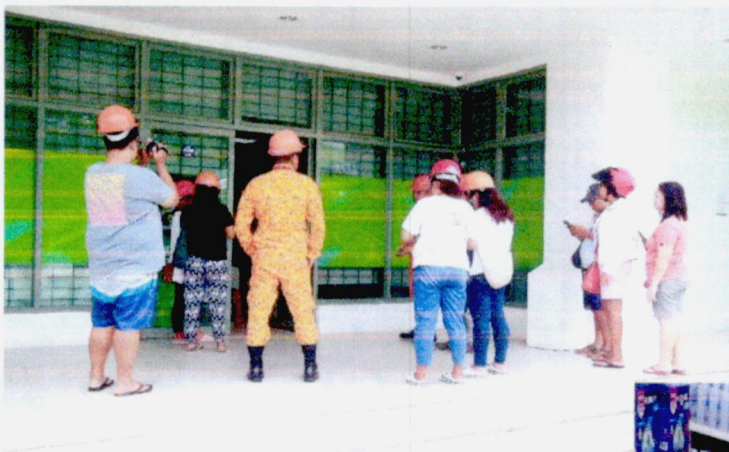
LANDBANK OF THE PHILIPPINES- ODIONGAN BRANCH

- Connections between structural parts (columns and beams) did not show any significant cracks.
- The main entrance's roof slab had cracks in it.

- Applying waterproofing will help prevent water leaks and seepage through the concrete slab, which could harm the main entrance's ceiling and cause the slab's reinforcements to corrode.
 - Landbank might work with the building contractor because the structure is still covered by warranty.
3. There were two (2) individuals brought at Romblon Provincial Hospital due to dizziness.
 4. For your information.

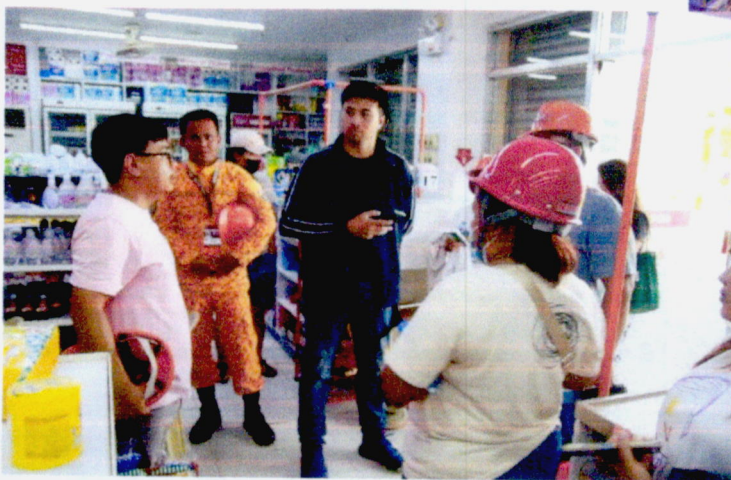
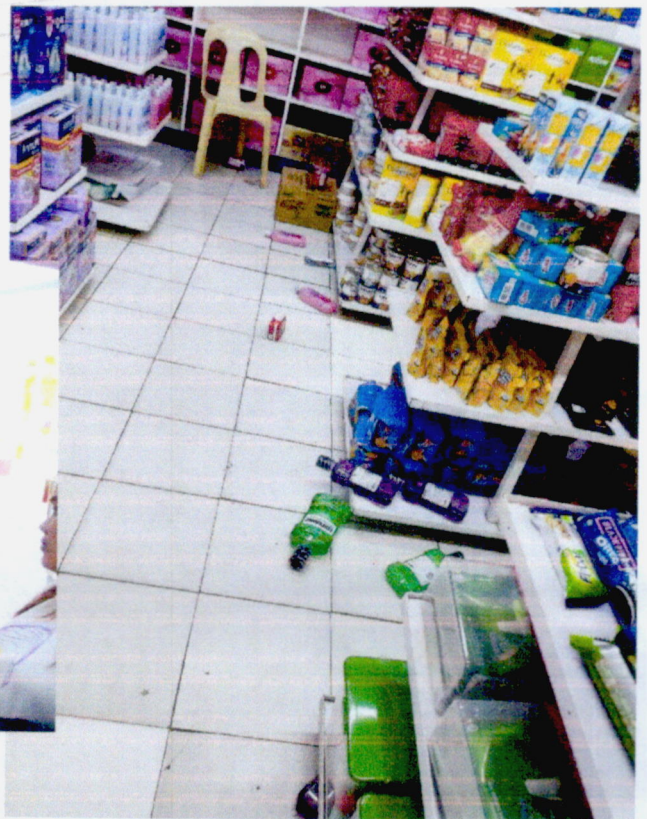
MERCURY DRUG STORE- ODIONGAN

- The store's interior was free of any new cracks.

- We strongly advise that the Mercury Store operate only as a window operation until Sunday, May 21, 2023, and to resume its full operation on Monday, May 22, 2023, assuming there will be no aftershocks to be recorded in the next 36 hours (actions may vary depending on the PHILVOLCS advisories). This is because the building where the Mercury Store is located was known to have poor structural integrity.

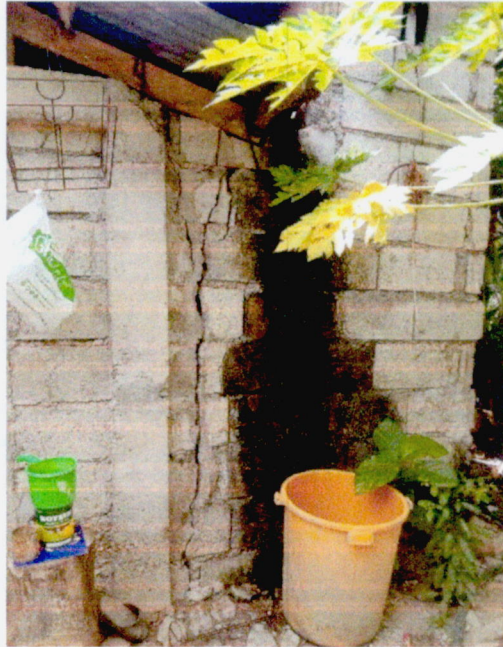
**JOCELYN BANTANG RESIDENCE AT BARANGAY MALILICO, ODIONGAN,
ROMBLON**

- Due to the movement of the earth as well as the kitchen's poor design and construction, a portion of it collapsed.

- renovation of the affected area
- The structural design should be discussed with an engineer.

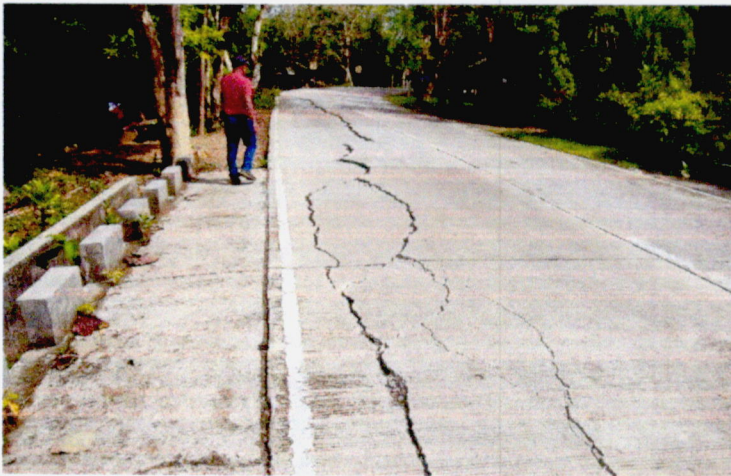
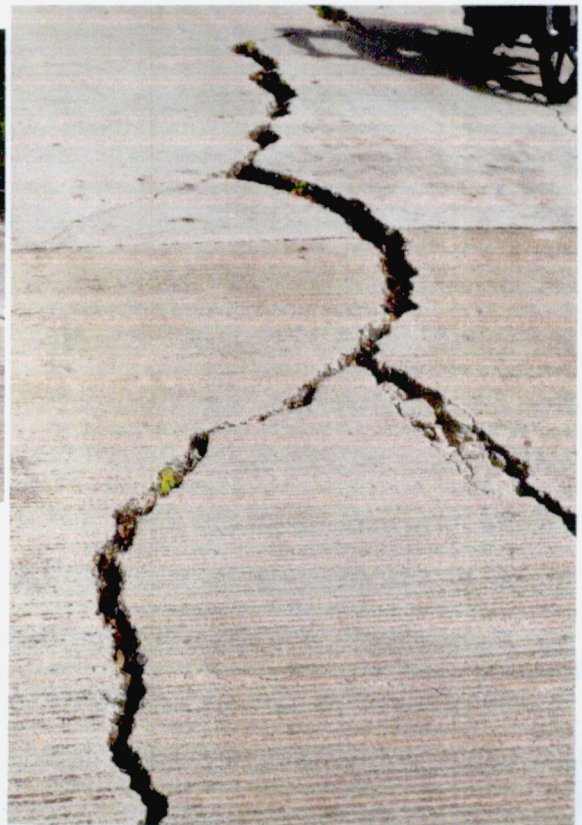
MALILICO- BALATUCAN ROAD

- Due to a weak foundation, significant longitudinal cracks were seen.

- PCCP should be replaced after being adequately compacted.
- findings and suggestions should be forwarded to the Provincial Engineering Office

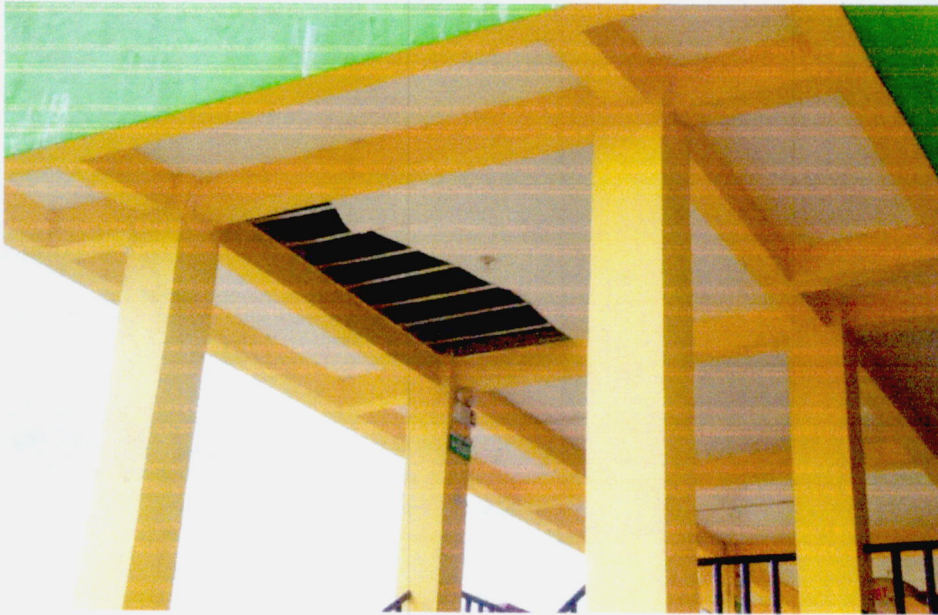
ROMBLON STATE UNIVERSITY- ENGINEERING BUILDING

- Due to vibration or movement, a portion of the ceiling board collapsed.

- removal of the collapsed ceiling section
- Verify all of the connections on the remaining ceiling.
