**SUBJECT** : **INSPECTION REPORT ON THE COMMERCIAL SAND  
AND GRAVEL (CSAG) EXTRACTION AT GAYAMAT  
RIVER, BARANGAY HARRISON, MUNICIPALITY OF  
PALUAN, OCCIDENTAL MINDORO**

10 May 2023

SUBJECT : **INSPECTION REPORT ON THE COMMERCIAL SAND AND GRAVEL (CSAG) EXTRACTION AT GAYAMAT RIVER, BARANGAY HARRISON, MUNICIPALITY OF PALUAN, OCCIDENTAL MINDORO**

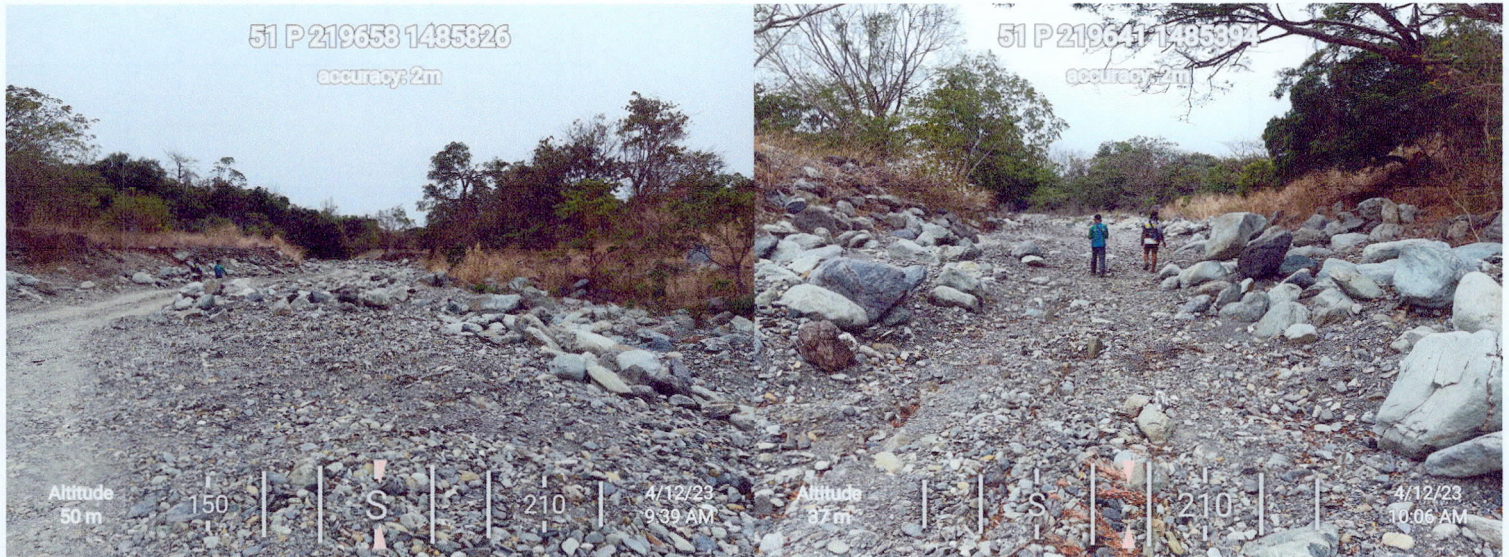
4. The following were noted during the site inspection:
  - a. Riverbed within the main channel of Gayamat River was dry, heavily silted with cobble to boulder-sized deposits (*Figure A-1*), including *armor rocks* located at the upstream section of the river. It is an intermittent stream with a relatively narrow main channel that is often dry throughout the year and which water only flows during incessant heavy rainfall events.

**Figure A-1.** Dry riverbed within the main channel of Gayamat, heavily silted with cobble to boulder-sized deposits

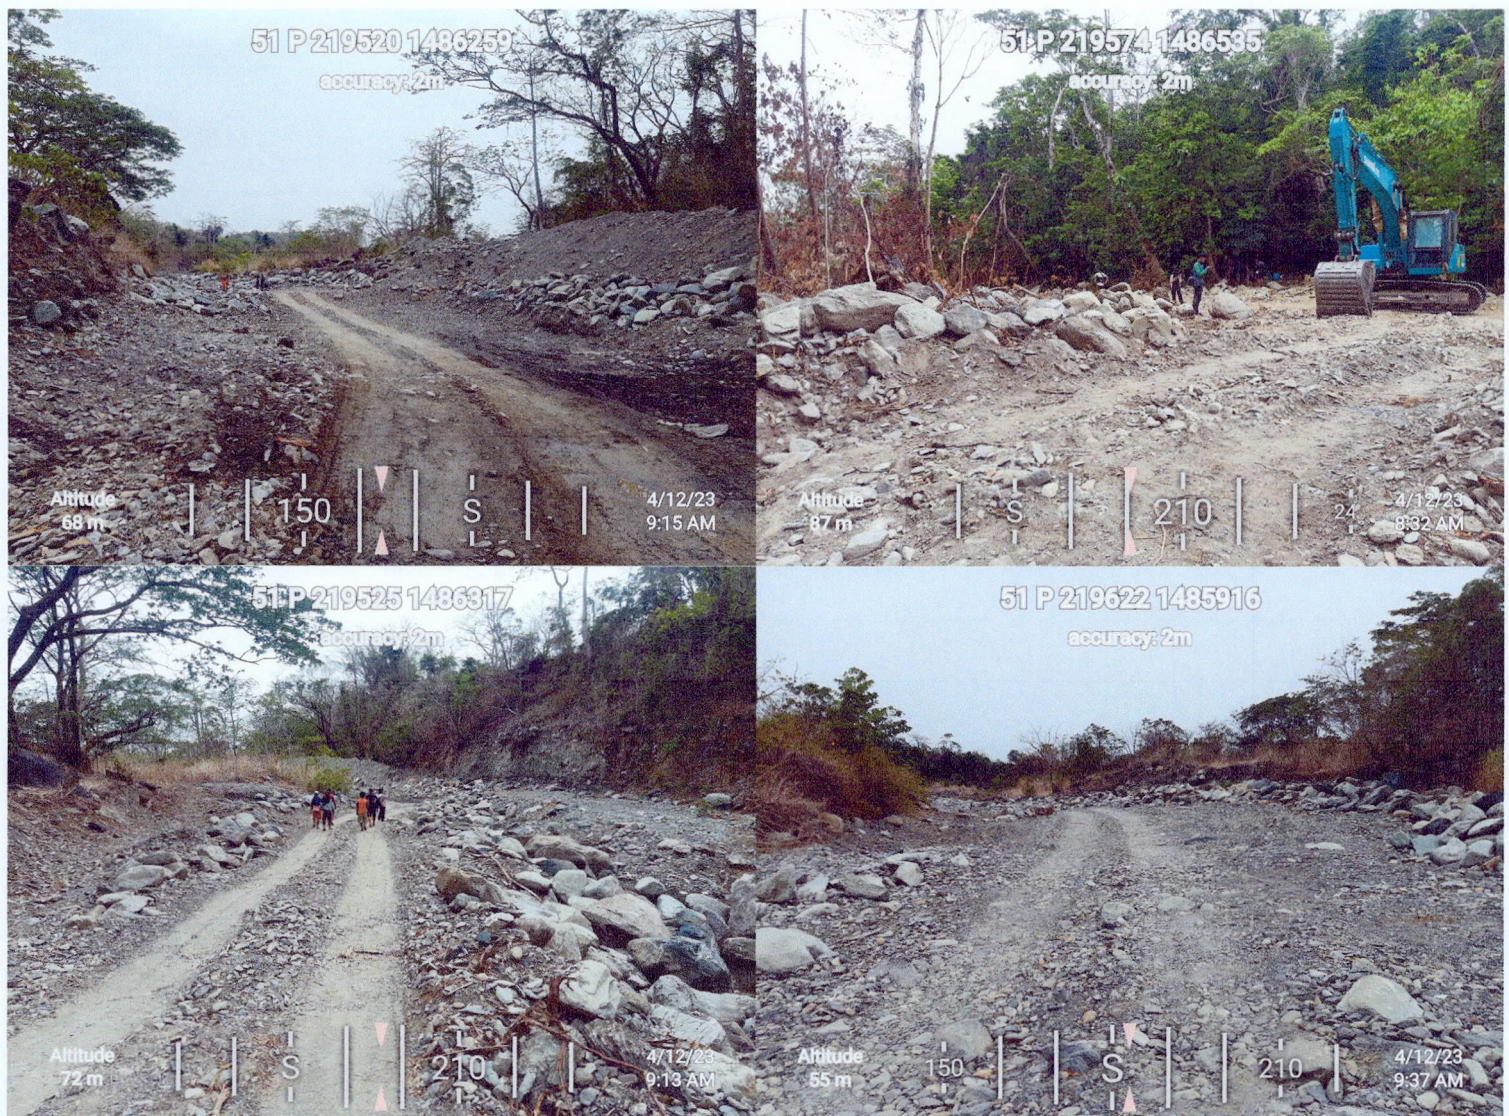
- b. Actual quarrying operations were not observed at the time of the inspection. However, there are discerned indications of sand and gravel extraction along the inspected river channel, within and *outside* the delineated and approved CSAG Permit boundary of Mr.

Raci. Some of the aggregates were notably placed/dumped along the edges of the riverbed, near its banks. (*Refer to Figure A-2*)

**Figure A-2.** Indications of sand and gravel extraction within the river. Some aggregates were dumped/piled-up along the edges of the riverbed

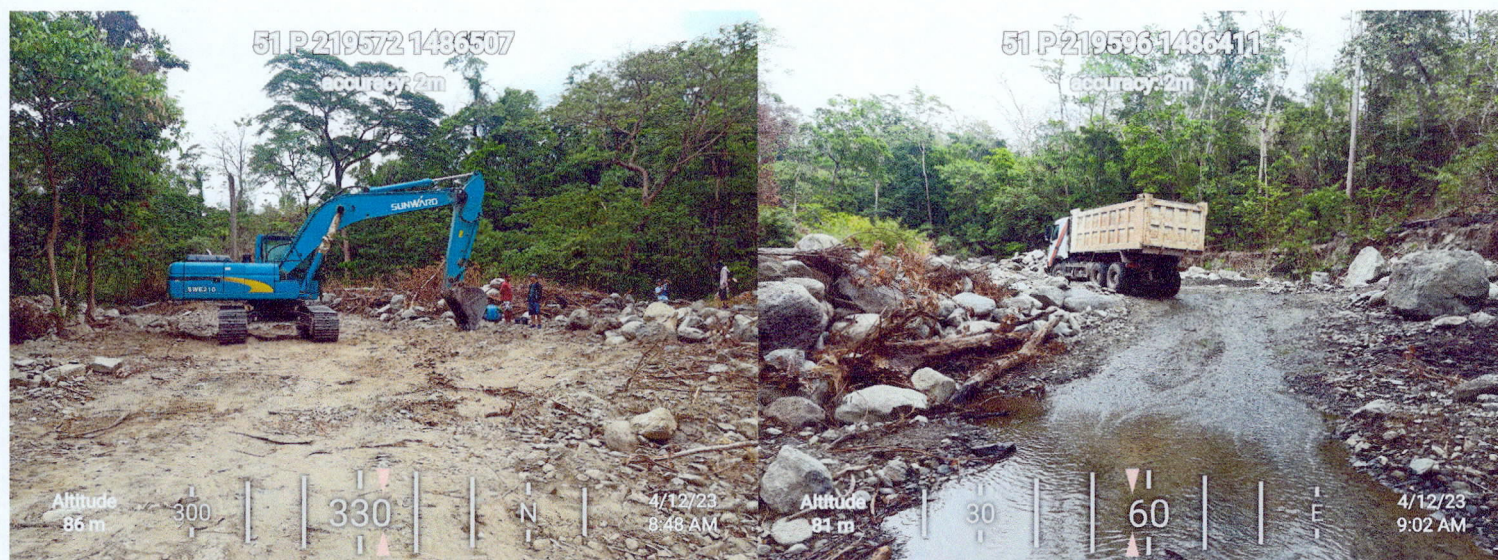
- c. Presence of heavy equipment and conveyances at the site i.e., Sunward SWE210 crawler excavator and dump trucks owned by the operator of the extraction activity (*Refer to Figures A-3 and A-6*), with the excavator being spotted at a ground distance of approximately 540 meters from the northern boundary of Mr. Raci's approved CSAG extraction site. (*Refer to Figure B-1*)

**Figure A-3.** Crawler excavator and dump truck observed upstream of the river, about 540 meters outside the permit area of Mr. Raci.

As such, Mr. Raci is hereby ordered to immediately **Cease and Desist** from further conducting the illegal extraction activities.

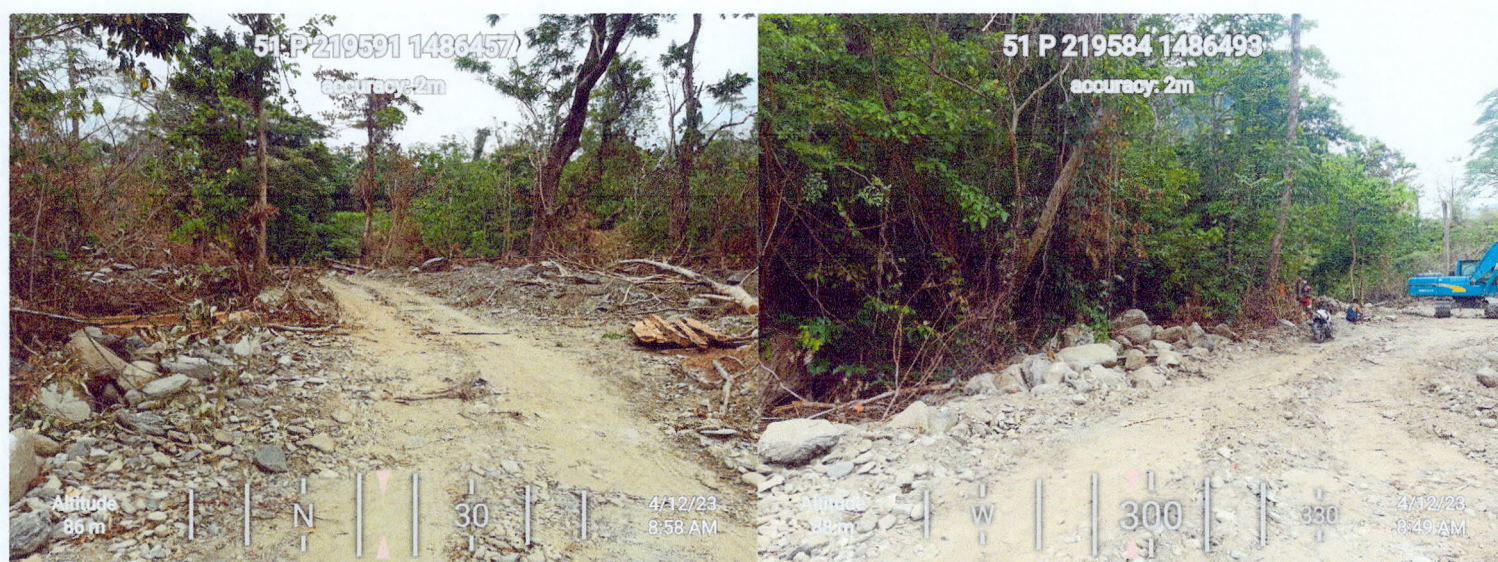
- d. Visible tracks of equipment and conveyances used in the presumed extraction activity were observed on the ground surface (*Figure A-4*). These particularly lead towards the upstream segment of the river which contains significant volume of boulder-sized materials (*Figure A-6*).

**Figure A-4.** Visible tracks of equipment and conveyances leading towards the upstream segment of Gayamat River.

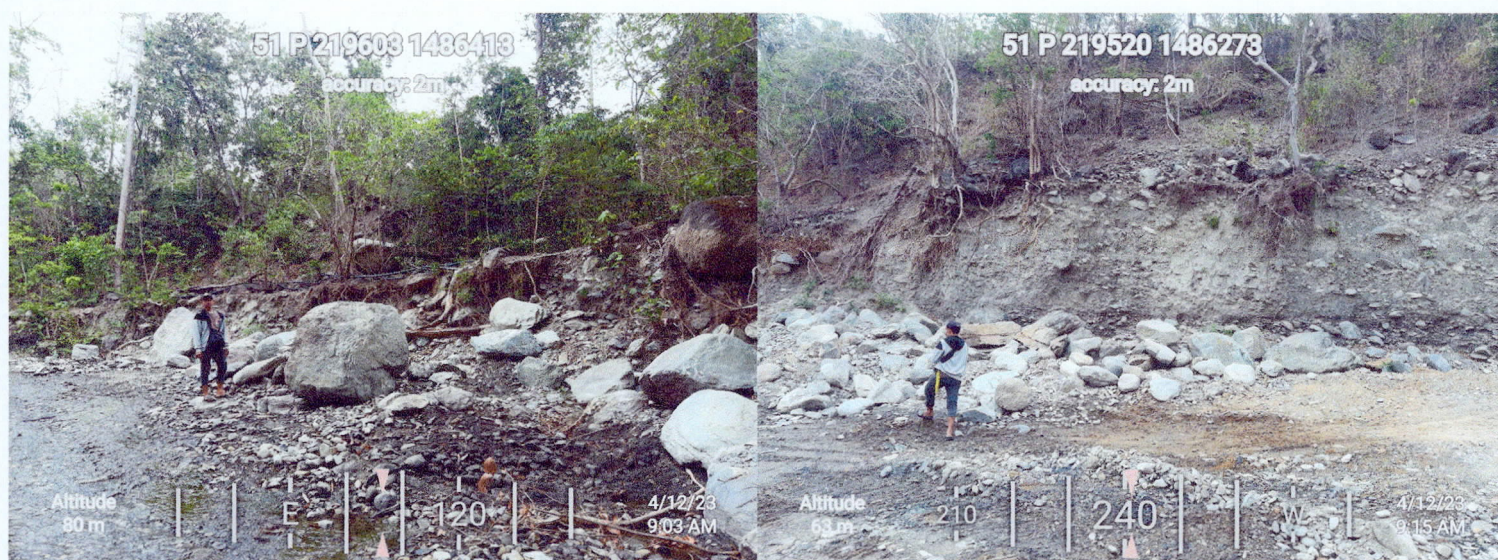
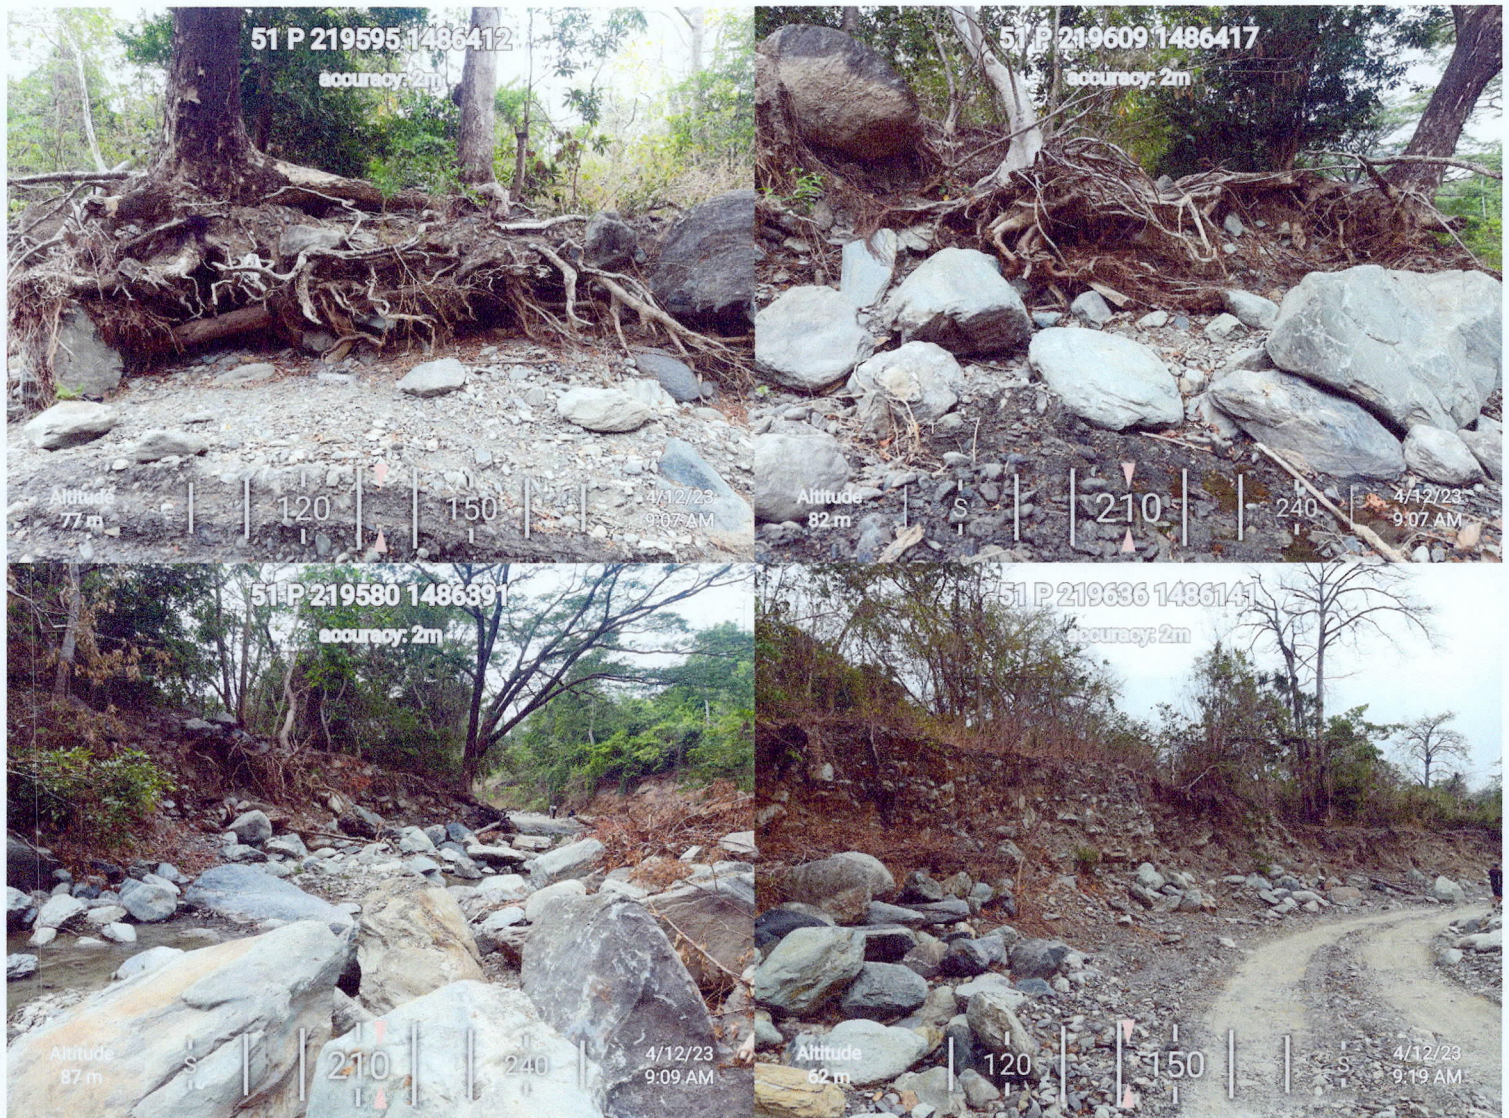
- e. Signs of ongoing riverbank erosion along some sections of the river channel (*Figure A-5*) evident by scoured, vertical, moderate to steeply sloping banks with already exposed roots, sediments, and rocks, as well as collapsed/uprooted/toppled vegetation and trees. These are particularly common along outer banks of the channel or cut banks which are areas constantly eroded by impact from high energy river flows.

3. To emphasize, Gayamat River's relatively narrow channel makes it a crucial site for bank erosion, which can be further accelerated by extracting too close to the banks, intentional removal of aggregates along said banks, and clearing of vegetation. It is important to note that vegetation in critical bank slopes plays a crucial role in stabilizing the river banks and preventing erosion as it anchors soil and rocks in place and reduces impacts of flooding.

**Figure A-5.** Indications of ongoing riverbank erosion along some sections of Gayamat River. Its relatively narrow channel makes it a crucial site for bank erosion.

4. It is advised to closely monitor illegal extraction activities in Gayamat River and its vicinity, as well as any other activities that may have negative impacts and cause significant changes to the river's morphology. This is to

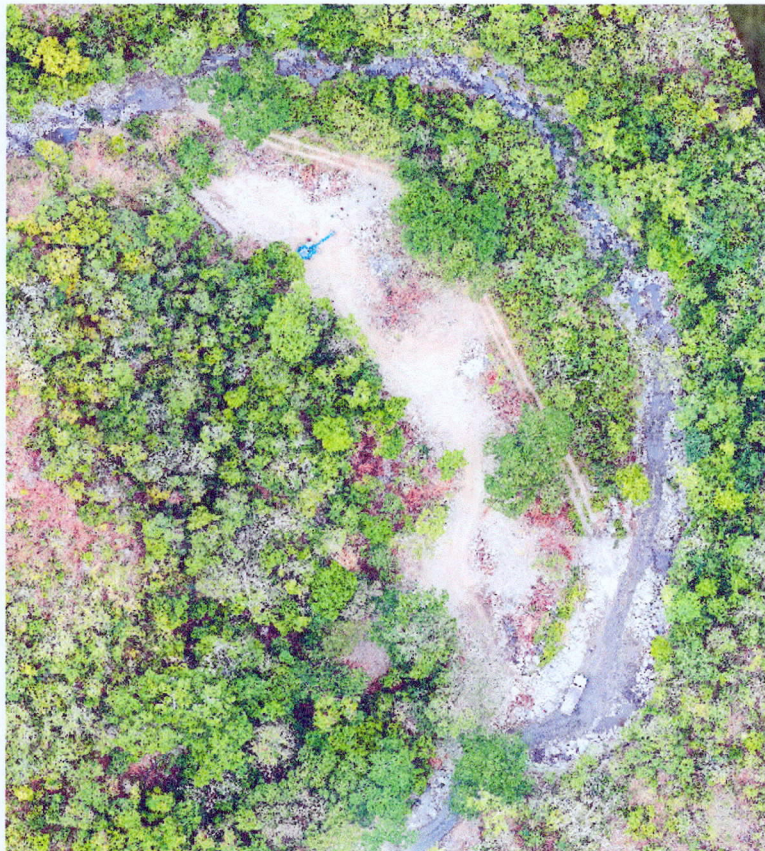
5. Comparison of processed drone images and Google Earth satellite image (December 2018) revealed the following:
- a. An excavated area located approximately 30 meters west of the upstream main channel of Gayamat River, centered at WGS 1984 geographic coordinates 13° 25' 58.87" N and 120° 24' 37.16" E (*Refer to Figures B-2 and B-3-A-A<sub>1</sub>*). The drone footage depicts that the terrain of the area has been significantly altered with excavation and levelling of up to 30 meters in width, and vegetation/trees within it have been cleared and removed. On-site, uprooted trees and those with exposed roots have been observed. It should also be noted that the excavator and conveyance used for the extraction activities of Mr. Raci were found in the same area (*See Figure A-6*).

**Figure A-6.** Drone image showing conspicuous tracks left by equipment and vehicle on the ground surface, which lead towards the upstream section of Gayamat River.

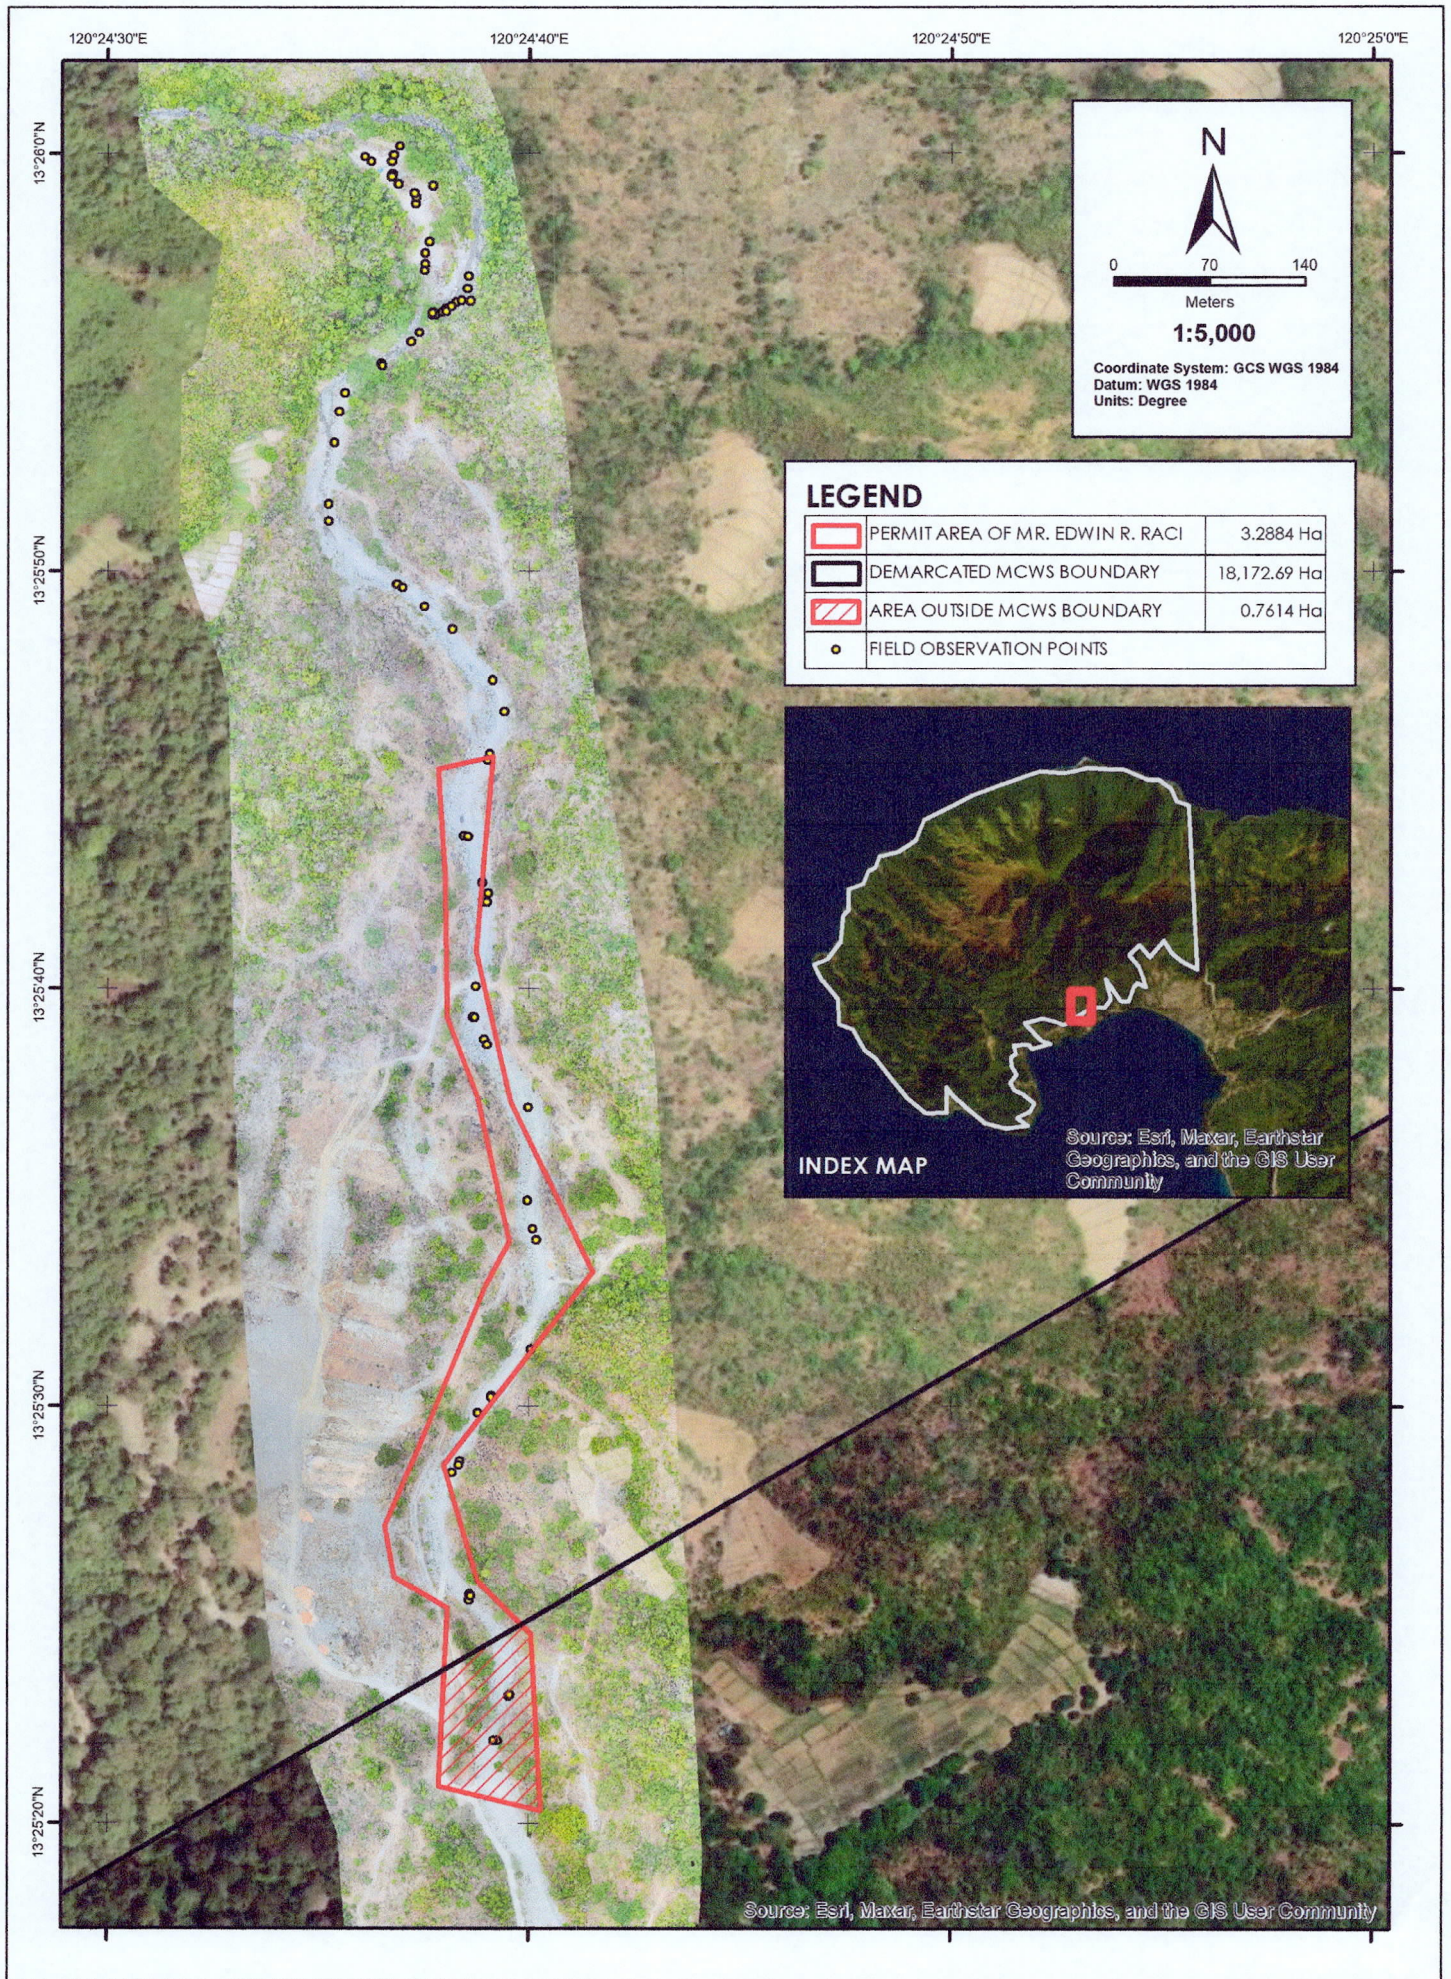
**Figure B-1.** Map showing the permitted area of Mr. Raci along Gayamat River, situated within the demarcated MCWS protected area boundary.

2. Considering that the CSAG permit site falls within the MCWS protected area boundary, it is recommended that review and reevaluation of the quarry application and necessary documents be conducted, as Section 15.a.2 of DAO 2010-21 states that:

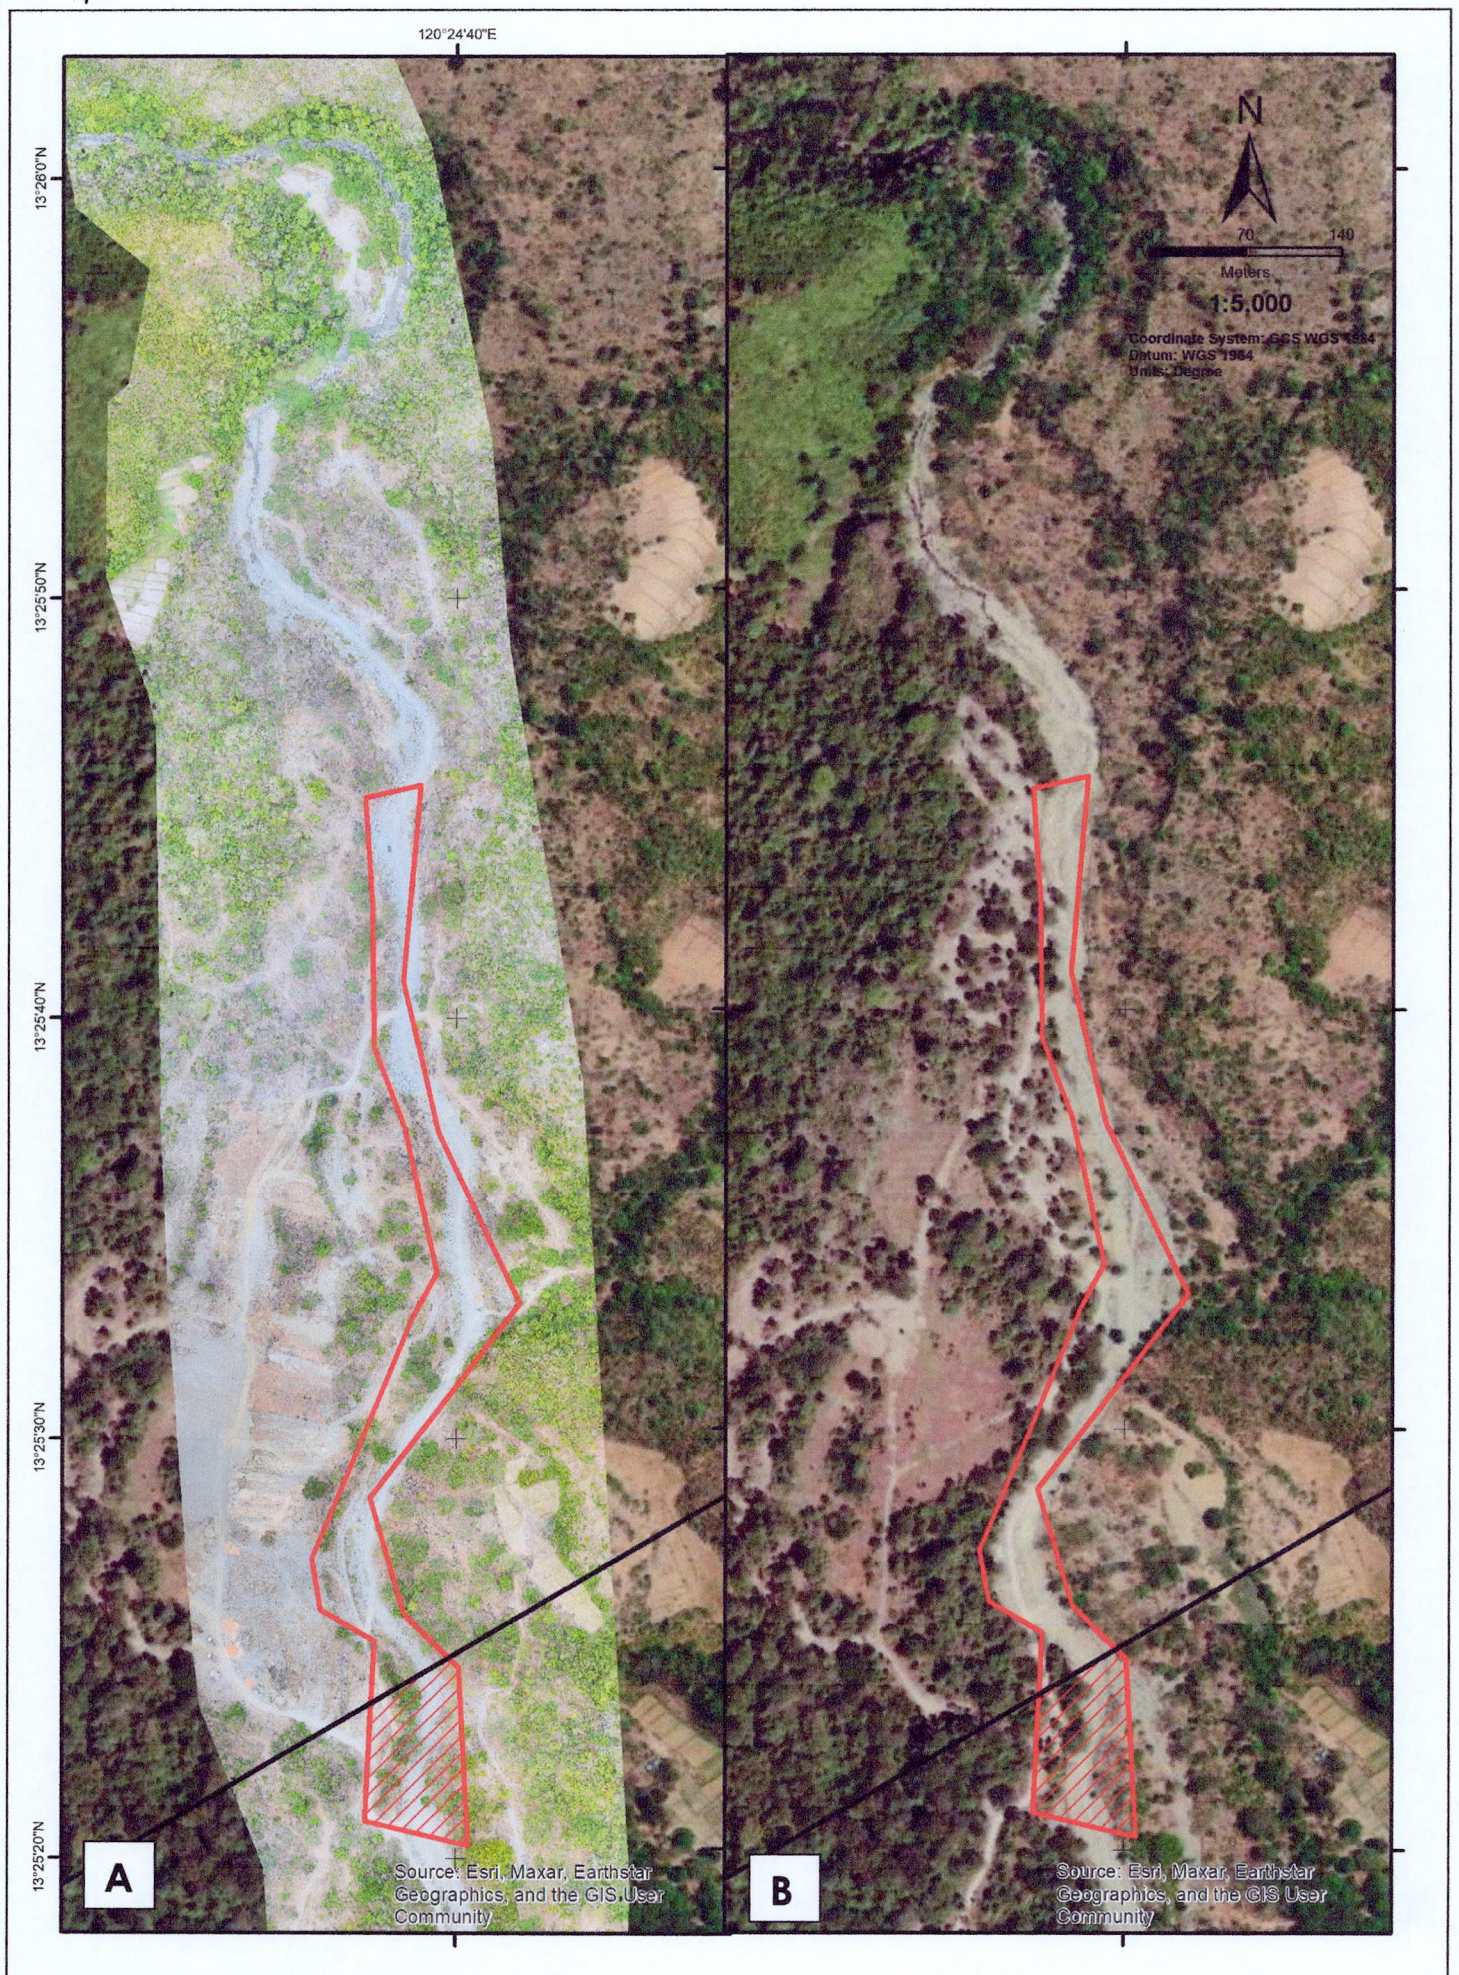
- b. The removal/clearing of vegetation and trees is also prominent on the banks adjacent to the southern portion of Mr. Raci's permitted area, located to the west, at WGS 1984 geographic coordinates 13° 25' 25.86" N and 120° 24' 35.73" E (*Refer to Figures B-2 and B-3-B-B<sub>1</sub>*).

**Figure B-2.** Comparison between the (A) processed drone image and (B) satellite image from Google Earth (2018)

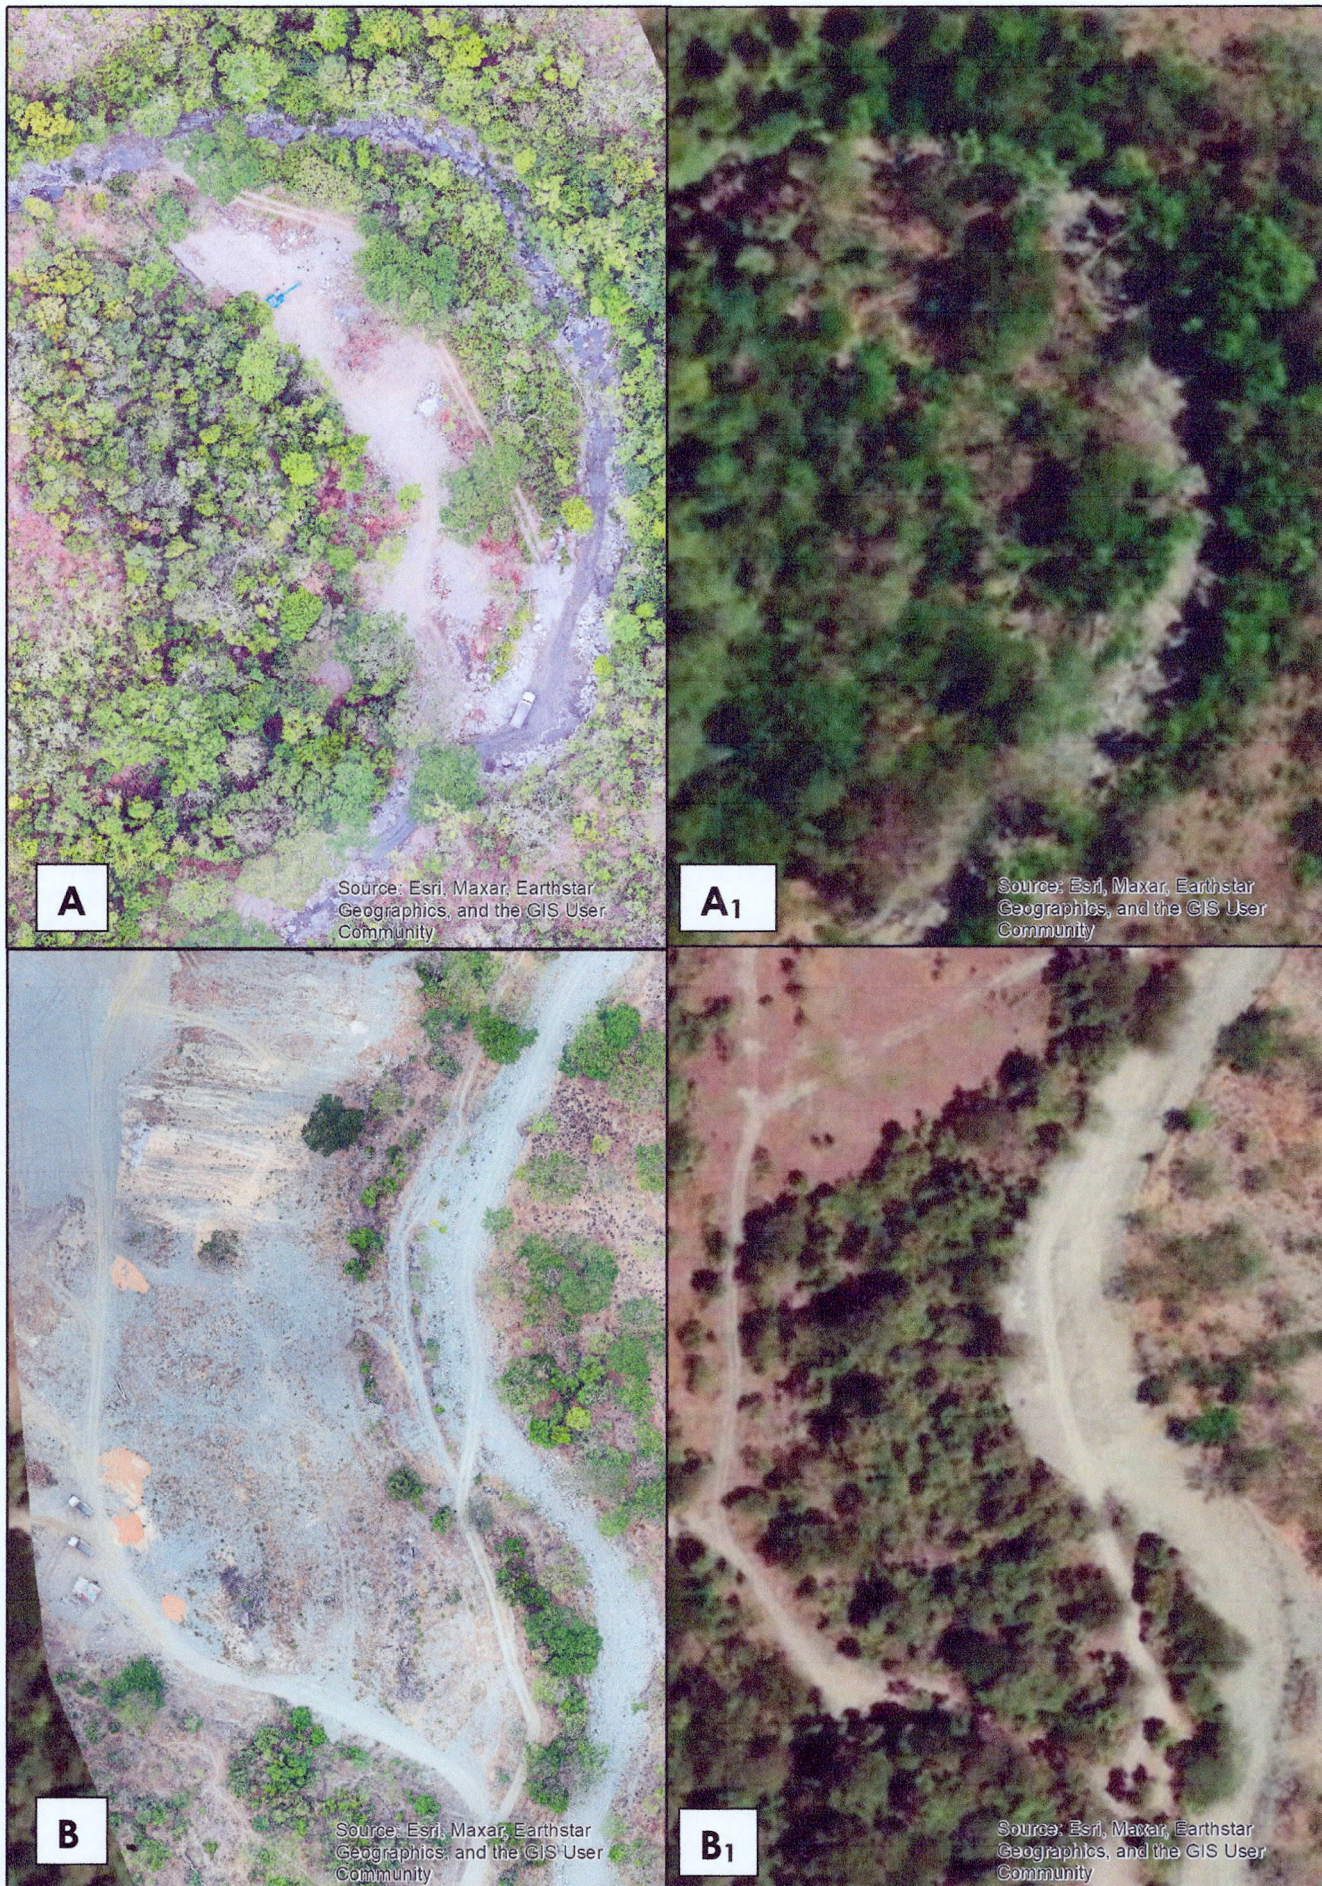
**Figure B-3.** Comparison between (A-B) processed drone images and (A<sub>1</sub>-B<sub>1</sub>) satellite images from Google Earth (2018)
