MEMORANDUM

FROM : The OIC, PENR Officer
Oriental Mindoro

SUBJECT : **SUBMISSION OF MONTHLY MONITORING REPORT OF
SCIENCE-BASED REAL-TIME WATERSHED MONITORING
INSTRUMENTS FOR THE MONTH OF APRIL 2023**

This refers to the five (5) watershed monitoring instruments installed within the two major watersheds of Oriental Mindoro, the Mag-Asawang Tubig River Watershed and the Bongabong River Watershed.

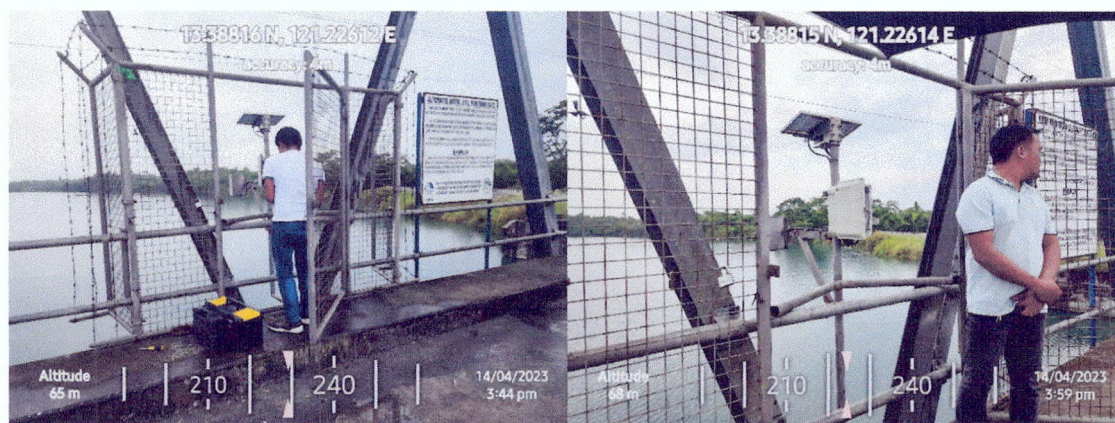
The Abaton Automated Water Level Station (AWLS) was already recommissioned after the installation of the solar panel and the solar charge controller. The Hydrosphere cloud already reflected the Abaton-AWLS data since 4:00 am of April 16, 2023. The station is closely monitored for any problem may arise.

Figure 2. Installation of new solar panel and solar charge controller in Abaton AWLS station

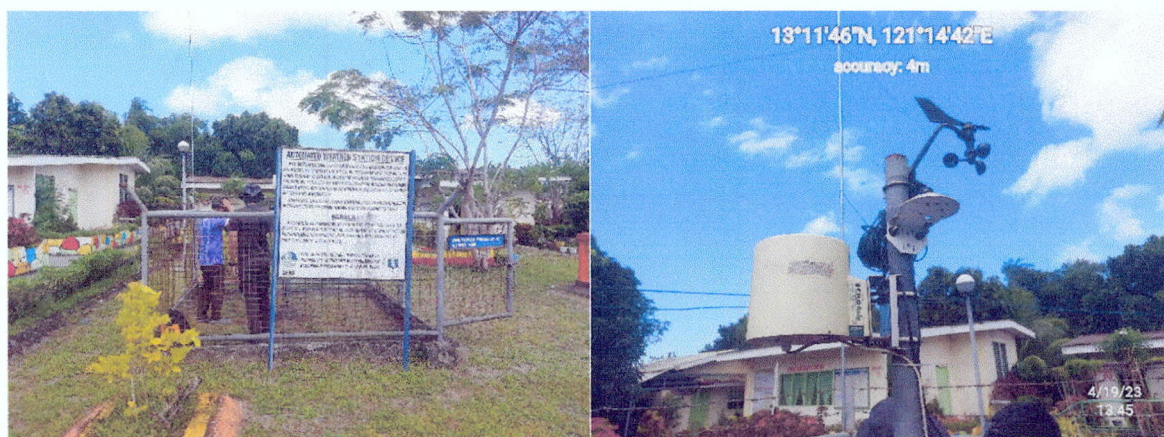
The Macatoc Automated Weather Station (AWS) is in good condition except for the soil moisture data and the relative humidity still exceeding 100%. The soil moisture sensors need replacement while technical expert is necessary to analyze the relative humidity data.

Figure 3. The Macatoc-AWS station with CDD personnel

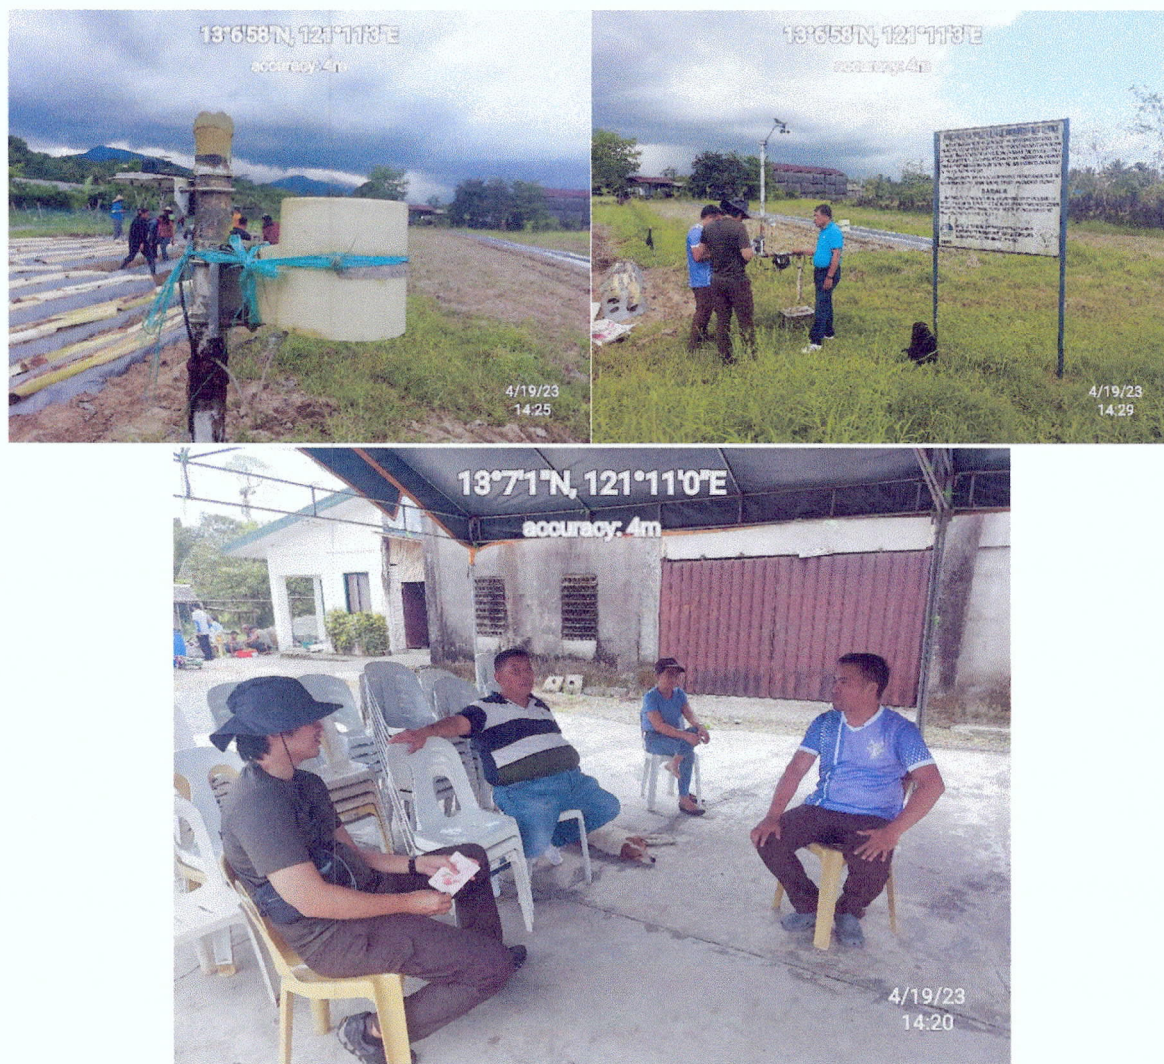
The DA Automated Weather Station (DA-AWS) has lacking data such as soil moisture, wind speed and direction. Additional observation in this station are as follows:

1. broken leveling bubble of the pyranometer;
2. ZL6 data logger cannot connect with the Zentra Utility App;
3. ZL6 battery voltage is declining even with high intensity of solar radiation and newly replaced battery; and
4. the relative humidity still exceeds 100%.

The DA-AWS station in Alcate, Victoria, Oriental Mindoro is in need of immediate attention for several instruments/sensor is in bad condition. It is suggested that the location of the station be transferred to a well-drained location and away from farm area and fencing shall be installed.

Figure 4. The DA-AWS station visit with RIARC chief and CDD personnel

It is recommended that the DA-AWS station will be relocated away from farm area and have fence.

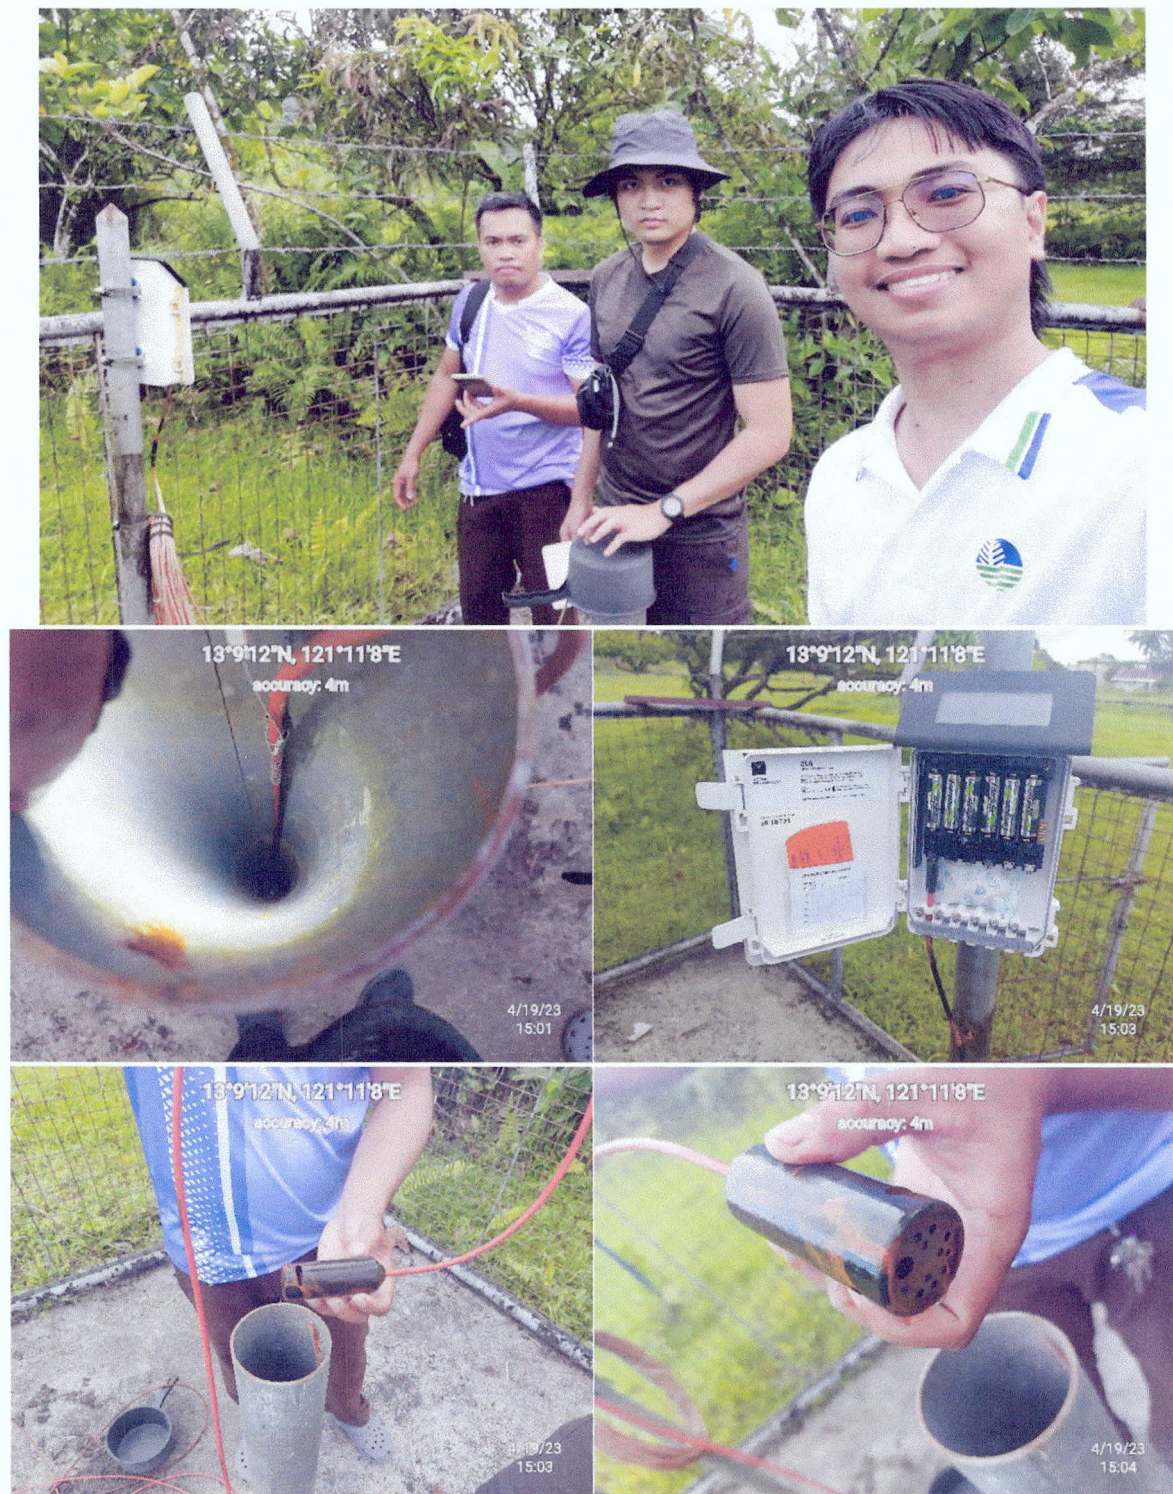
The MinSU Groundwater Monitoring Station (GWMS) is in good condition. CTD sensor cleaning is scheduled in the next site monitoring.

Figure 5. The MinSU-CTD (GWMS) station

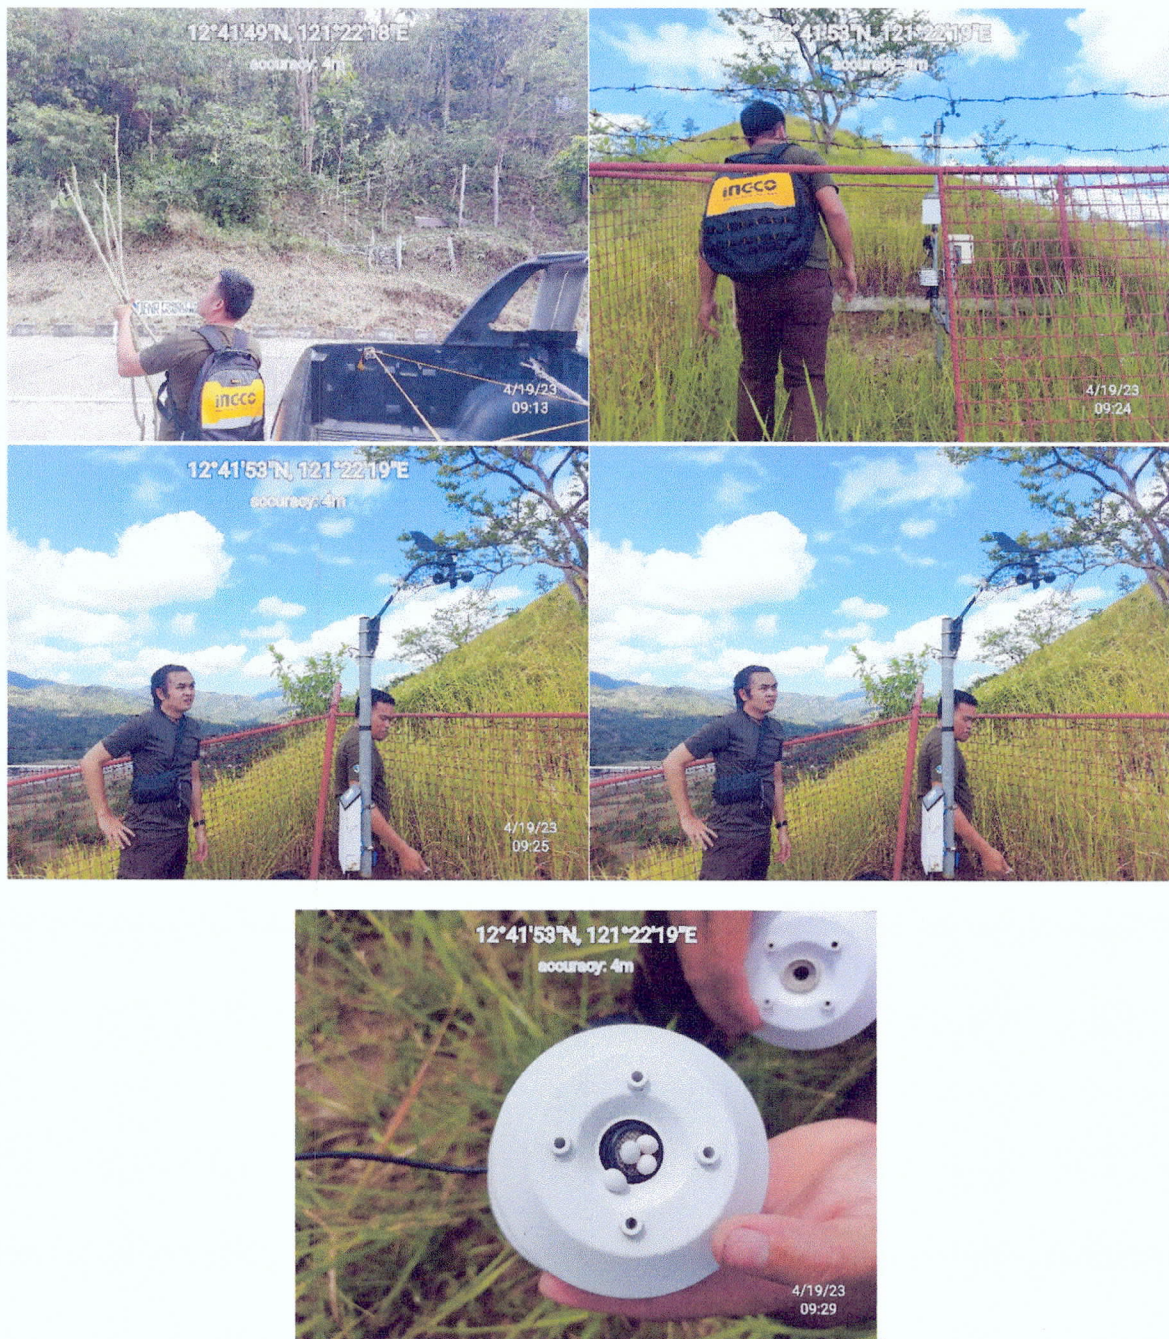
The Bongabong Automated Weather Station (AWS) is also in good condition except for the soil moisture data, presence of weeds in the vicinity and presence of lizard eggs in VP-4 sensor. The soil condition of the station is very compact and with presence of several stones causing the recommended insertion of sensor cannot be followed. Lizard eggs are still present in the VP-4

sensor despite of regular cleaning maintenance. Weeding of the vicinity is scheduled in the next monitoring activity.

Figure 6. The Bongabong AWS station with CDD personnel.
