Republic of the Philippines
Department of Environment and Natural Resources
MINES AND GEOSCIENCES BUREAU
MIMAROPA Region

January 11, 2022

MEMORANDUM

SUBJECT : **GEOLOGICAL SITE SCOPING REPORT FOR THE PROPOSED RECLAMATION SITE OF THE CORON BAY DEVELOPMENT PROJECT LOCATED IN THE MUNICIPALITY OF CORON, PROVINCE OF PALAWAN**

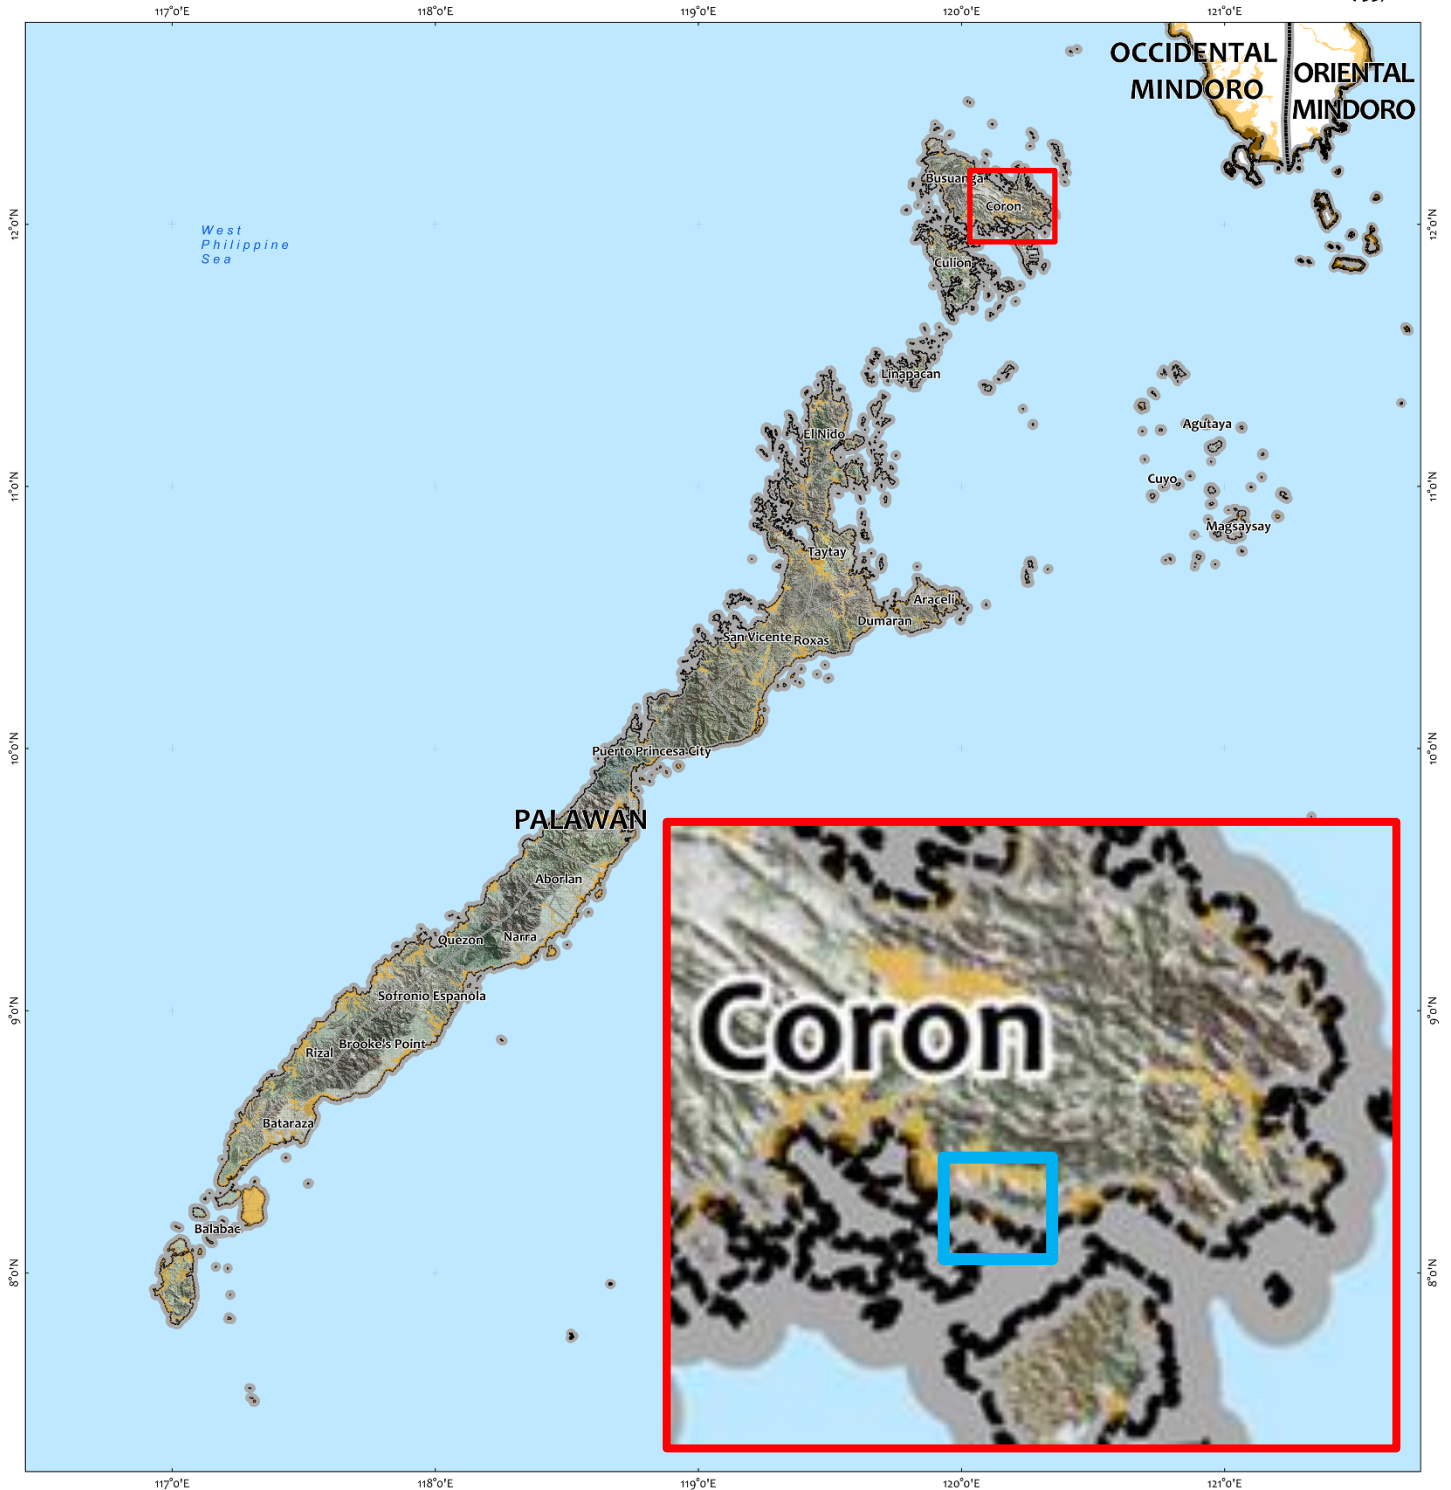
FIGURE 12. LIQUEFACTION HAZARD MAP

Depending on the energy released, and on the distance and depth of the source, ground shaking may affect the project site and its immediate vicinity. Associated with ground shaking are liquefaction (Figure 12) and consolidation settlement hazards. Reclamation projects are highly prone to these hazards because of the unconsolidated nature of the fill materials.

Meanwhile, even though the occurrence of earthquakes around Busuanga Island is relatively infrequent, the project site may still experience seismic-related hazards such as ground shaking, liquefaction, and consolidation settlement. In addition, a high-magnitude earthquake originating from Manila or Negros Trench may cause a tsunami that may inundate the project site and adjacent areas. With these, a comprehensive discussion on earthquake generators, and on the degree of susceptibility to seismic-related hazards should be provided in the report.

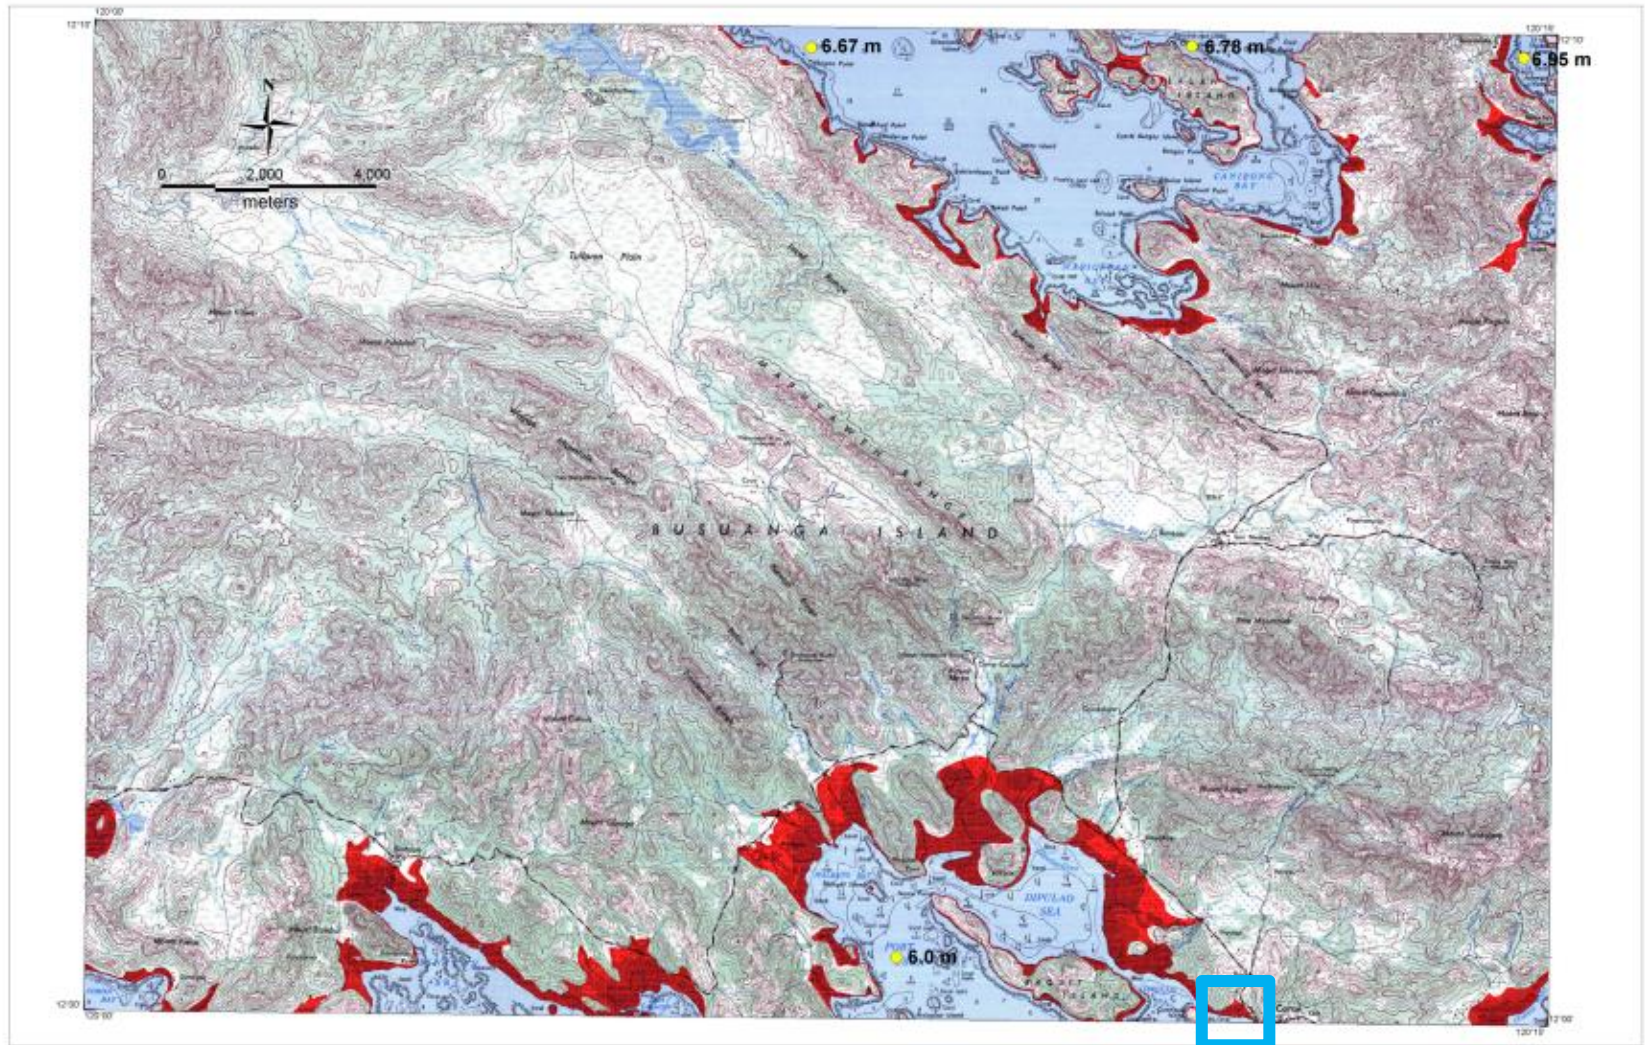
FIGURE 13. TSUNAMI HAZARD MAP

Moreover, the area may still be vulnerable to tsunamis. Based on the 2007 tsunami hazard map of PHIVOLCS, the occurrence of a 7.9-magnitude earthquake along Manila Trench or an 8.2-magnitude earthquake along Negros Trench may cause a tsunami that will inundate the coastal areas of Coron, with an inferred tsunami wave height of 6.0 meters at the coastline (Figure 13).

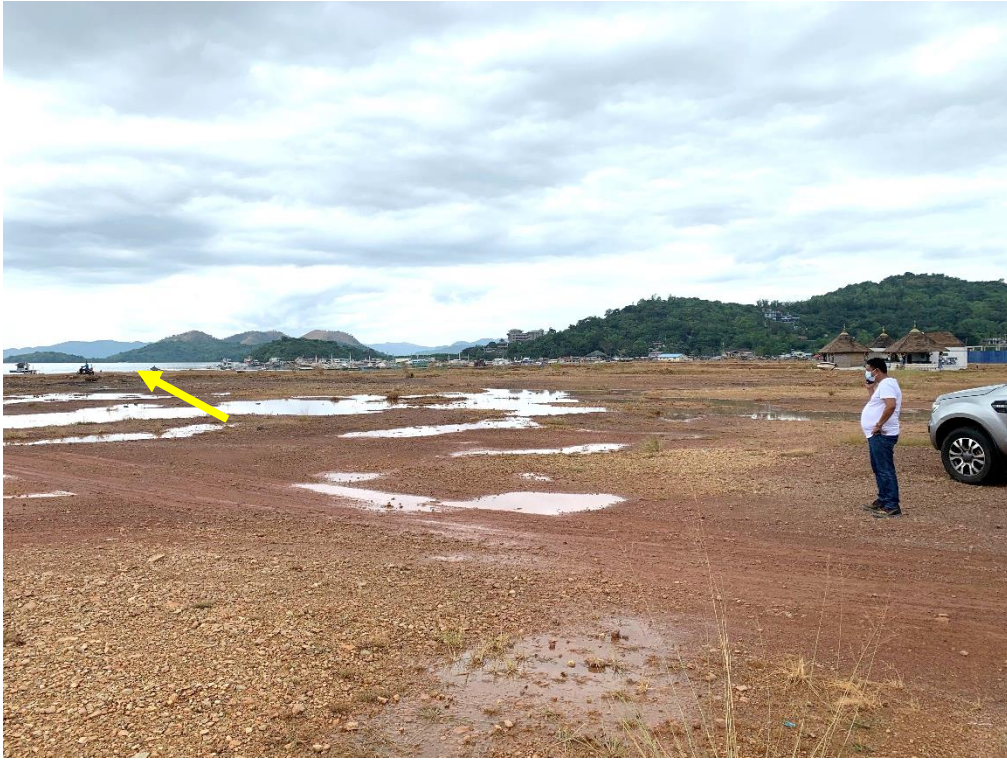
The project is estimated to cost P2,656 million – P2,256 million for the raw land reclamation, and P400 million for the horizontal development. The reclamation will have a total length of 2.8 kilometers with an average width of 200 meters. As part of the initial phase, 10 hectares was reclaimed and developed. Recently, another 20 hectares of raw land reclamation has been completed from the proposed 40 hectares reclamation area (Photo 1).

Photo 1. Twenty (20) hectares of the remaining 40 hectares has already been reclaimed. Yellow arrow points to the new coast at the edge of the reclaimed area.

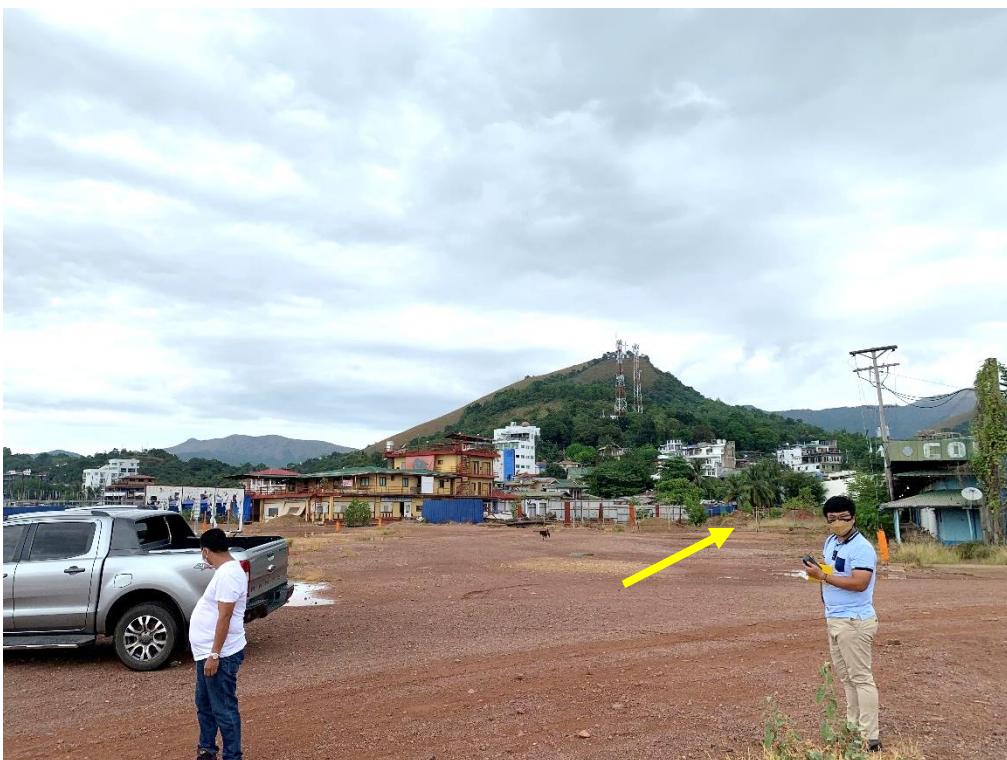
The project site of Coron Bay Development Project is surrounded by rolling hills to mountainous terrain, with elevation averaging 150 meters above mean sea level (amsl). The highest point visible from the site is the peak of Mt. Tapyas with estimated elevation of 210 meters amsl (Photo 2). It is located about 800 meters north of the site.

The project site is situated along the coast and is bounded on its north by a combination of narrow coastal plains, and rolling to mountainous terrain (Photo 2). The average elevation of the coastal plain in the vicinity of the site is around 3 meters above mean sea level (amsl), with a mean slope of roughly 5 degrees. Meanwhile, the highest elevation on the mountainous terrain nearest the site is approximately 195 meters amsl, with maximum slope of about 50 degrees. Based on the results of the 1:10,000-scale geohazard mapping activities conducted by MGB MIMAROPA in 2014, the coastal plain has low to nil susceptibility to landslide and other forms of mass movement while the mountainous terrain has moderate to high susceptibility to the same (Figure 4).

Photo 2. Mt. Tapyas on the immediate north of the project site. Yellow arrow points to the original coast.

Furthermore, the proximity of the site to rolling and mountainous terrain poses a concern for the possible occurrence of mass movements. The low-lying areas, including the project site, will be the receiver of potential landslide debris. In addition, the unconsolidated fill materials are vulnerable to subsidence and differential settlement. Therefore, a detailed study on mass wasting hazards must be conducted.

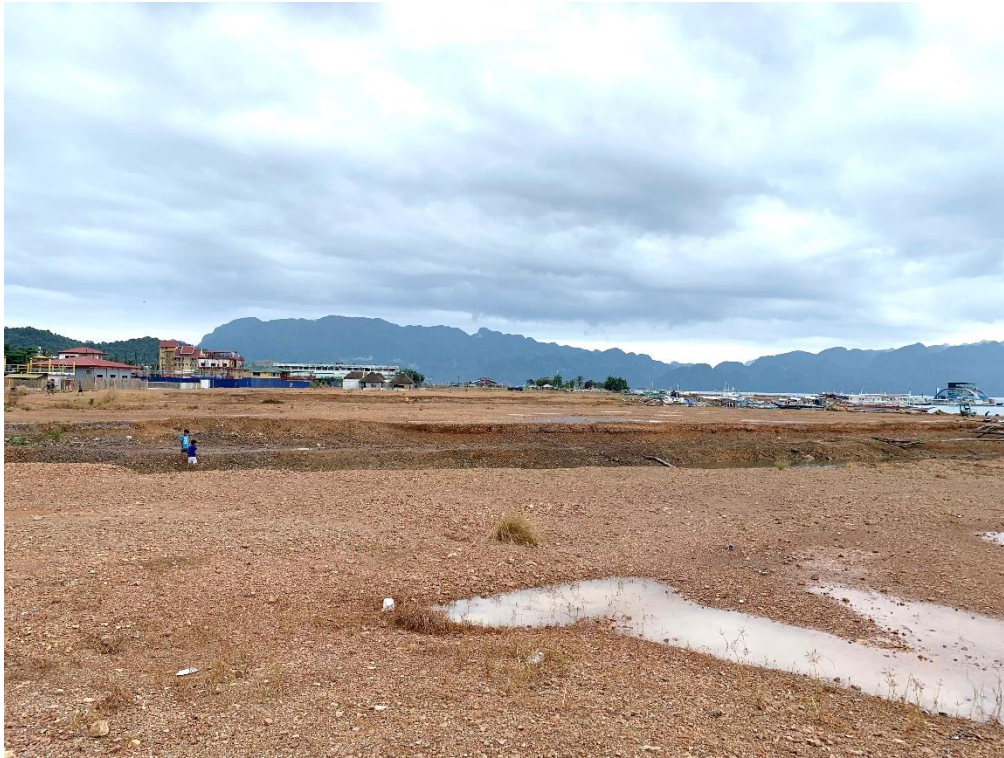
Photo 3. Narrow strips of unfilled areas serve as temporary drainage
