: SUBMISSION OF THE REPORT ON THE RESULTS OF THE

ASSESSMENT OF THE SUITABILITY OF BEACH FOREST REHABILITATION ON THE REMOTE ISLAND OF PAG-ASA

ISLAND, IN KALAYAAN, PALAWAN

ASSESSMENT OF THE SUITABILITY OF BEACH FOREST REHABILITATION ON THE REMOTE ISLAND OF PAG-ASA ISLAND IN KALAYAAN, PALAWAN

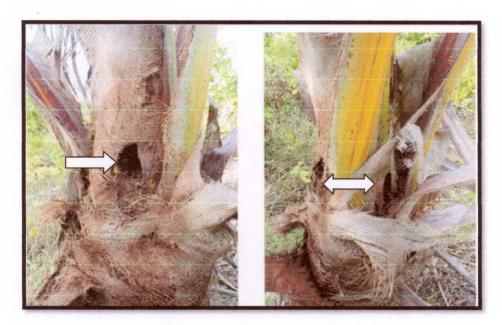
Another part of the rehabilitation efforts involved the planting of coconut, but unfortunately, this attempt was met with failure as well. The seedlings used for coconut planting were already stressed and wilted due to evapotranspiration suffered during the hauling process. The coconut seedlings were

prone to the rhinoceros beetle (Sinodendron cylindricum) infestation present on the island, which significantly hindered their growth and survival. The adult rhinoceros beetle feeds on the sap, fruits, shoots, leaves, and nectar of coconuts for its survival (Figure 2&3). This setback underscores the importance of not only selecting the right species but also ensuring the health and vitality of the seedlings chosen for reforestation projects.

Figure 2. The arrows show the hole made by rhinoceros beetle on the thrunk of young planted coconut

- Collaborate with relevant agencies such as DENR, DA-BFAR, PCA, PCSD, and DOT to develop and implement a comprehensive plan for the rehabilitation and protection of Pag-Asa Island's natural resources, particularly its beach forest ecosystem.
- Cease the planting of coconut seedlings until the rhinoceros beetle infestation on the island has been completely eradicated.
- Initiate salvage cutting of standing dead trees to eliminate host plants and ensure the destruction of rhinoceros beetle eggs and larvae.
- Regularly clean and remove debris on the island to minimize the spread of the rhinoceros beetle infestation.

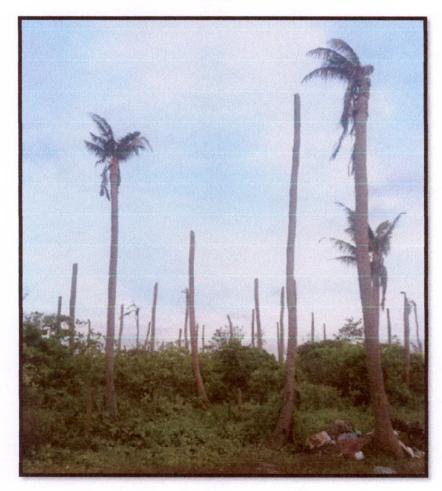
Figure 3. Dead and top pruned coconut devasted by Super Typhoon Odette in 2021

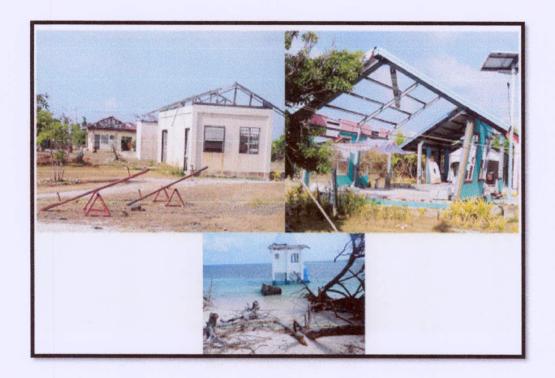
Other factors that may indirectly lead to the failure of past rehabilitation efforts were extreme weather conditions, coastal development, poor waste management and limited transportation. The passing of Typhoon Odette uprooted several beach vegetation and trees (Figure 4&5). Constructed structures for nursery were toppled down. Hence, seedlings were difficult to produce for propagation and rehabilitation purposes.

Figure 4. Devastated Infrastructure in Pag-asa Island made by super typhoon Odette.

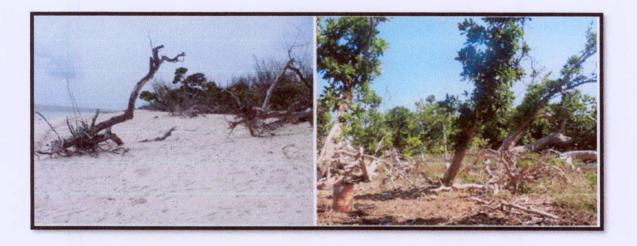
Figure 5. Uprooted trees in Pag-asa Island due to Super typhoon Odette.

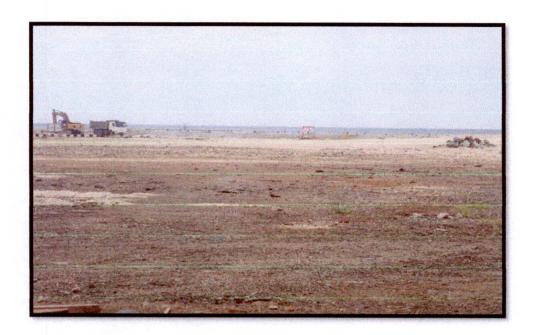
Coastal development had led to obliteration portions of the beach forests especially during the establishment of the air strip, sea port (Figure 6&7) and circumferential road. The on-going construction for the expansion the sea port area brought construction materials and equipment that trampledbeach vegetation. Thus, the construction did not just introduce foreign aggregates but also created barriers for beach forests.

Figure 6. Pier rehabilitation

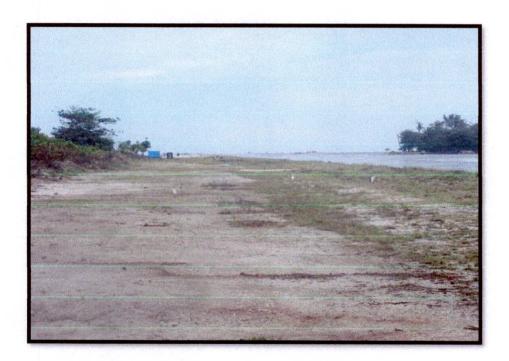
Figure 7. Airport in Pag-asa Island
