SUBJECT : REPORT OF PMRB ON THE FIELD VERIFICATION OF THE
APPLIED QUARRY AREAS OF EDNA BALMES, FERNANDO
TORRES, AND NESTOR SALES

**REPORT ON THE FIELD
VERIFICATION OF THE APPLIED
QUARRY AREAS OF BALMES,
TORRES, AND SALES**

3rd QUARTER (2022)

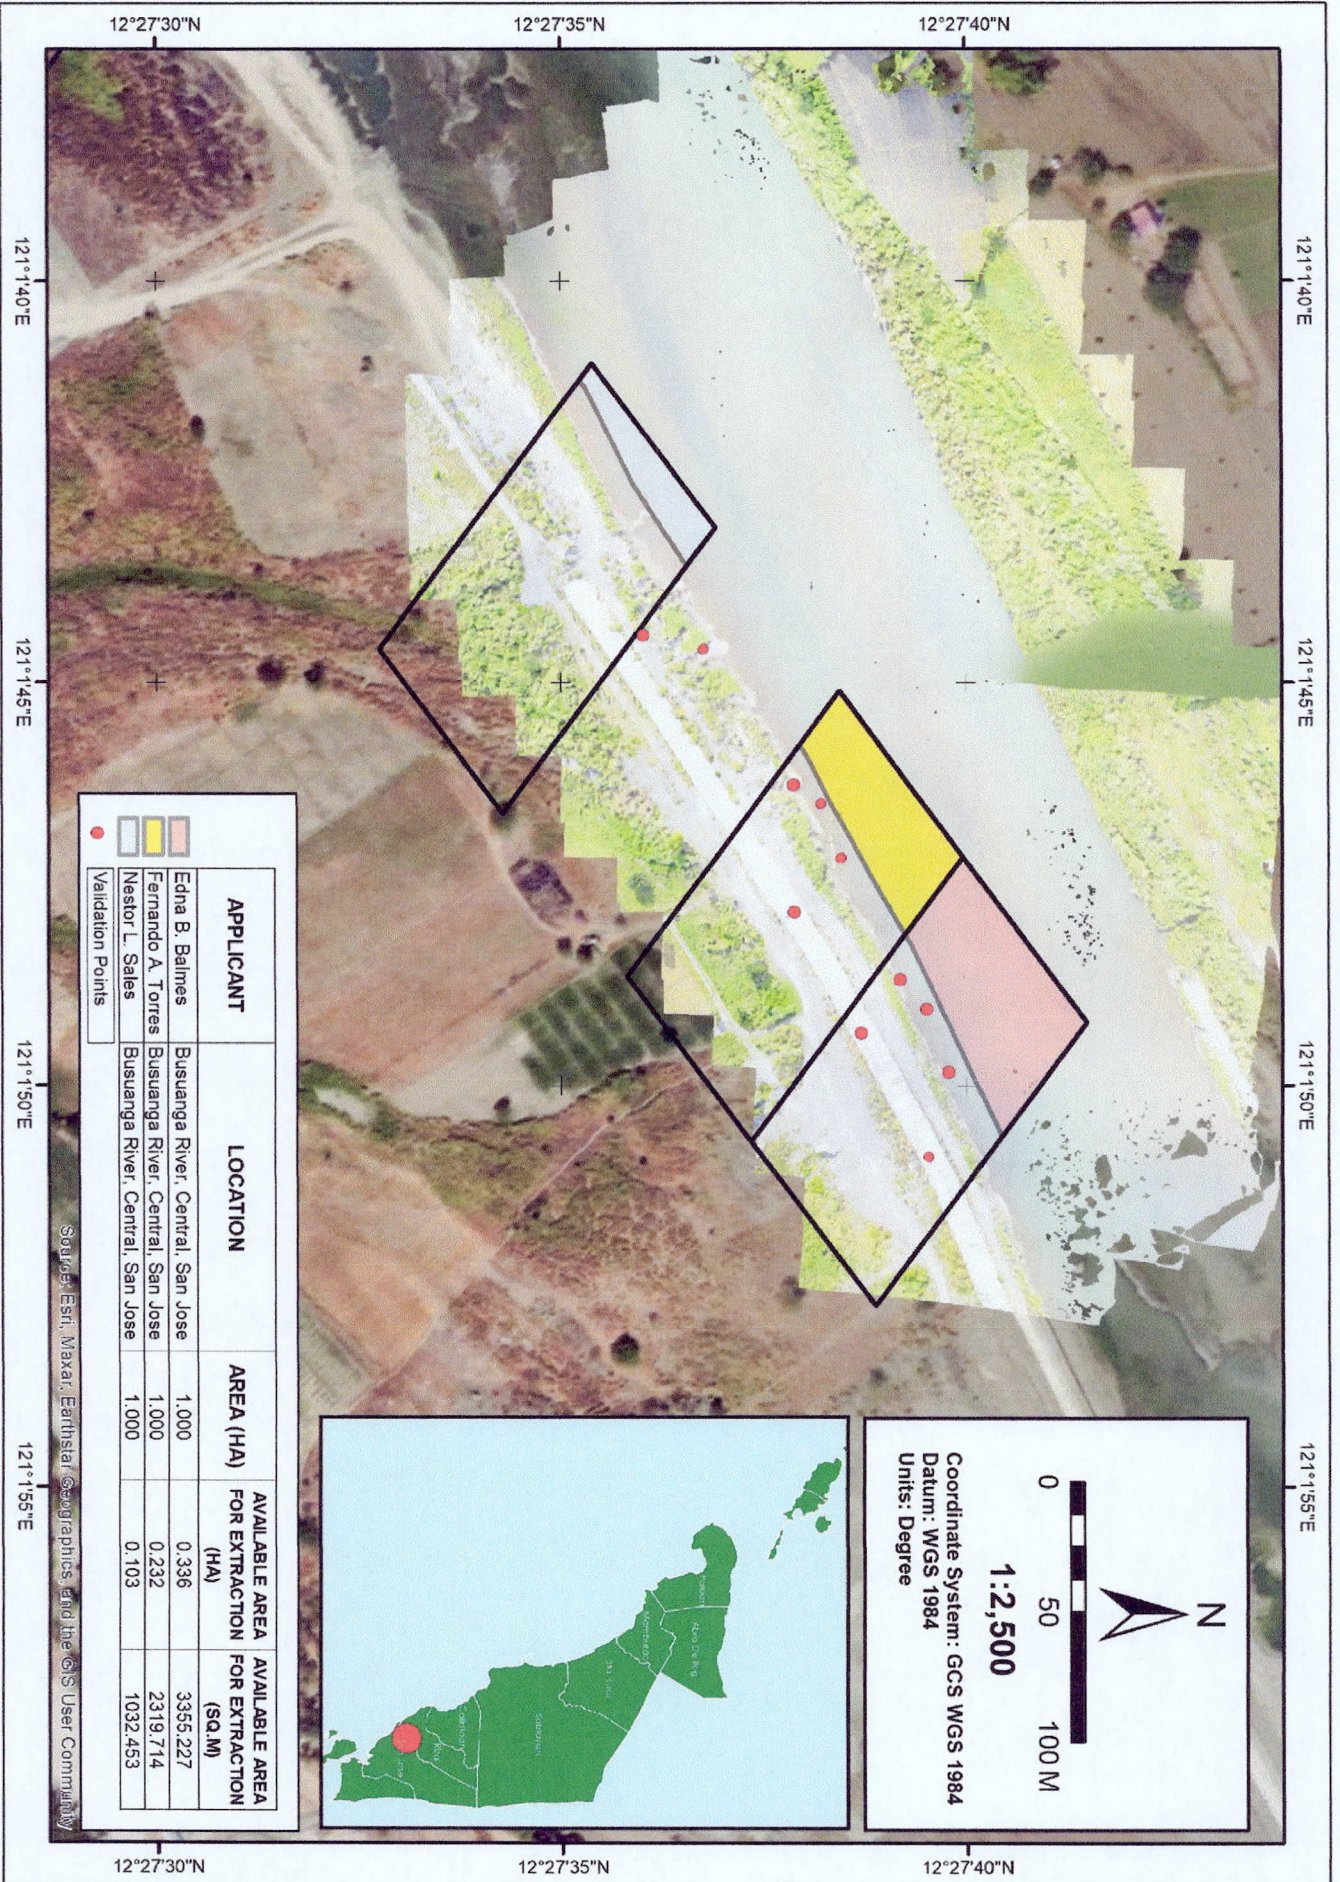
LOCATION MAP

- a. Delineation of the site based on on-site field assessment and desktop analysis using Geographic Information System (GIS) software and Google EarthTM reveals that only **0.336 ha (3,355.227 m²)** of the initial one (1) ha applied quarry site remains within the active river channel and may be potentially available for extraction. (*See Location Map*)

- a. Delineation of the site based on on-site field assessment and desktop analysis using Geographic Information System (GIS) software and Google Earth™ reveals that only **0.232 ha (2,319.714 m²)** of the initial one (1) ha applied quarry site remains within the active river channel and may be potentially available for extraction. (*See Location Map*)

only **0.103 ha (1,032.453 m²)** of the initial one (1) ha applied quarry site remains within the active river channel. *(See Location Map)*

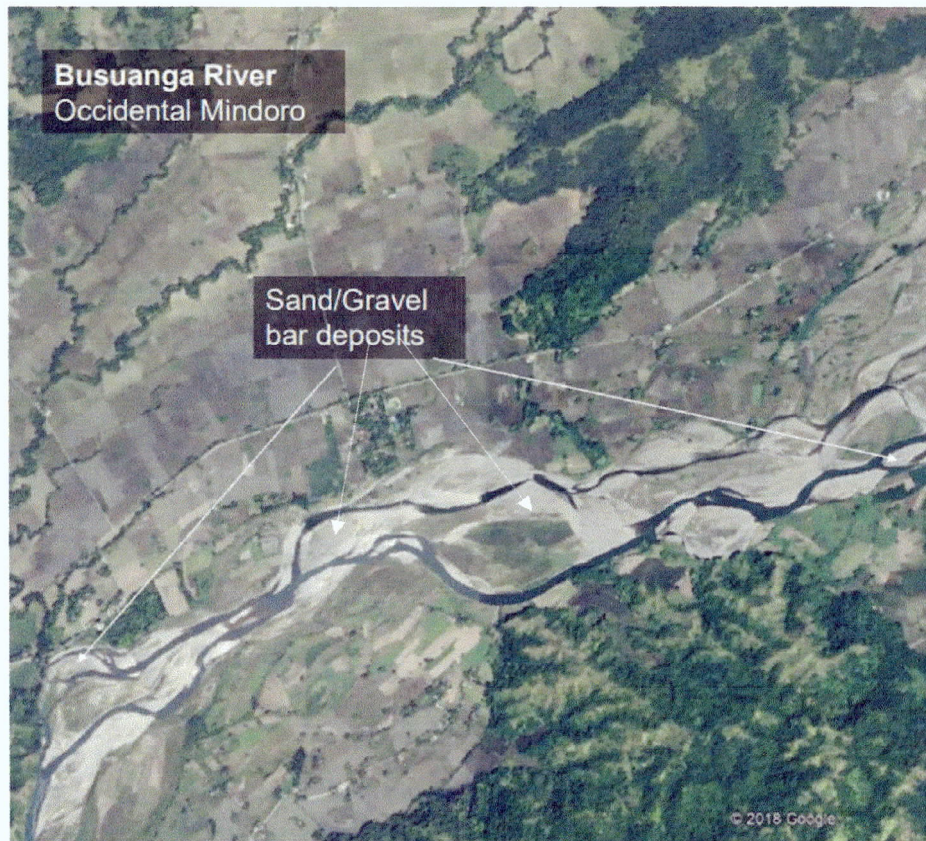
- c. During the assessment of the river segment near the proposed site, it was noted that water levels ranged from approximately 0.70m (*red validation points within the river channel shown on the attached map*) to more or less 1m towards the northwestern boundary of the applied area, in the central portion of the active channel. This particular segment is devoid of any **sand/gravel bar deposits** that are suitable and recommended for extraction/quarrying activities. (*Please see the*

attached satellite image – Photo 1 – of recommended quarrying sites). Riverbed deposits observed below the water table are consist mostly of cobble-sized sediments.

Photo 1. Satellite image showing suitable and recommended sites for sand and gravel extraction/quarrying activities

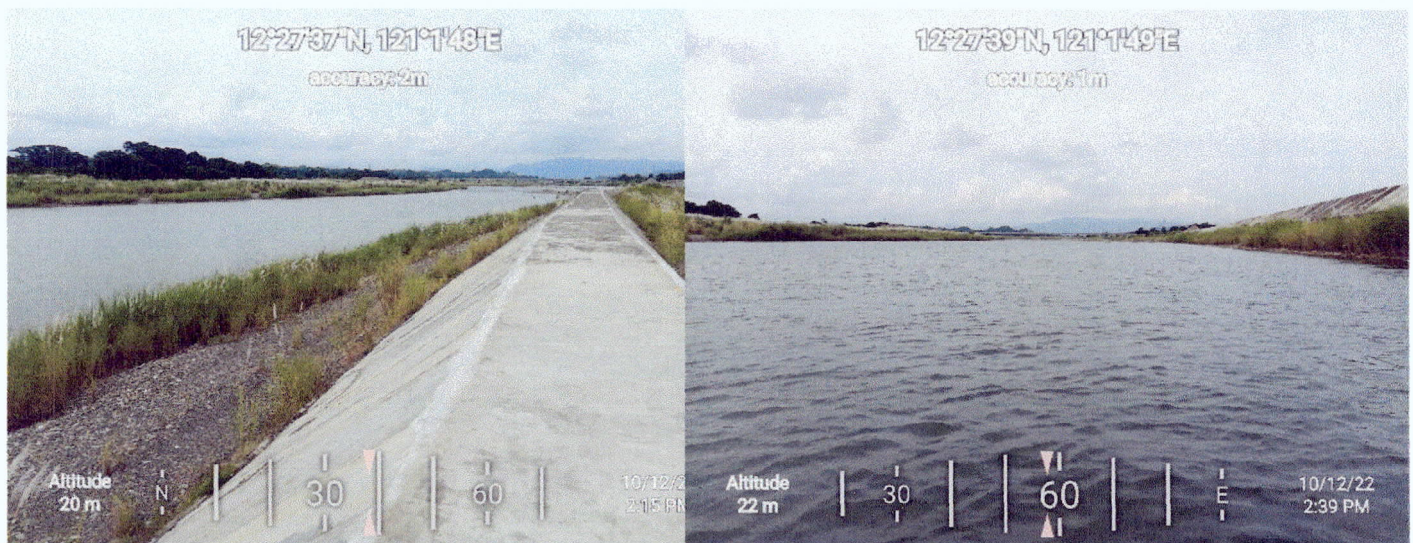
Photos 2-3. Portion of the applied area of Ms. Edna Balmes at Busuanga River, San Jose.

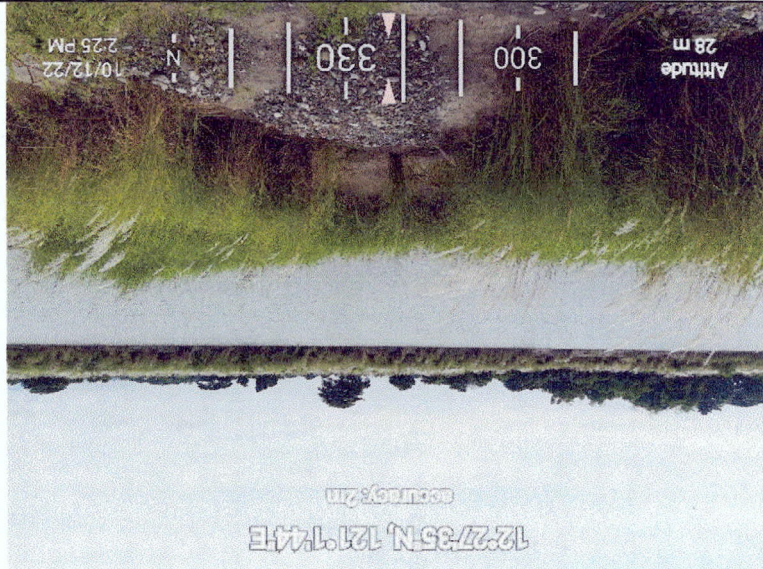
Photos 4-5. Portion of the applied area of Mr. Fernando Torres at Busuanga River, San Jose.

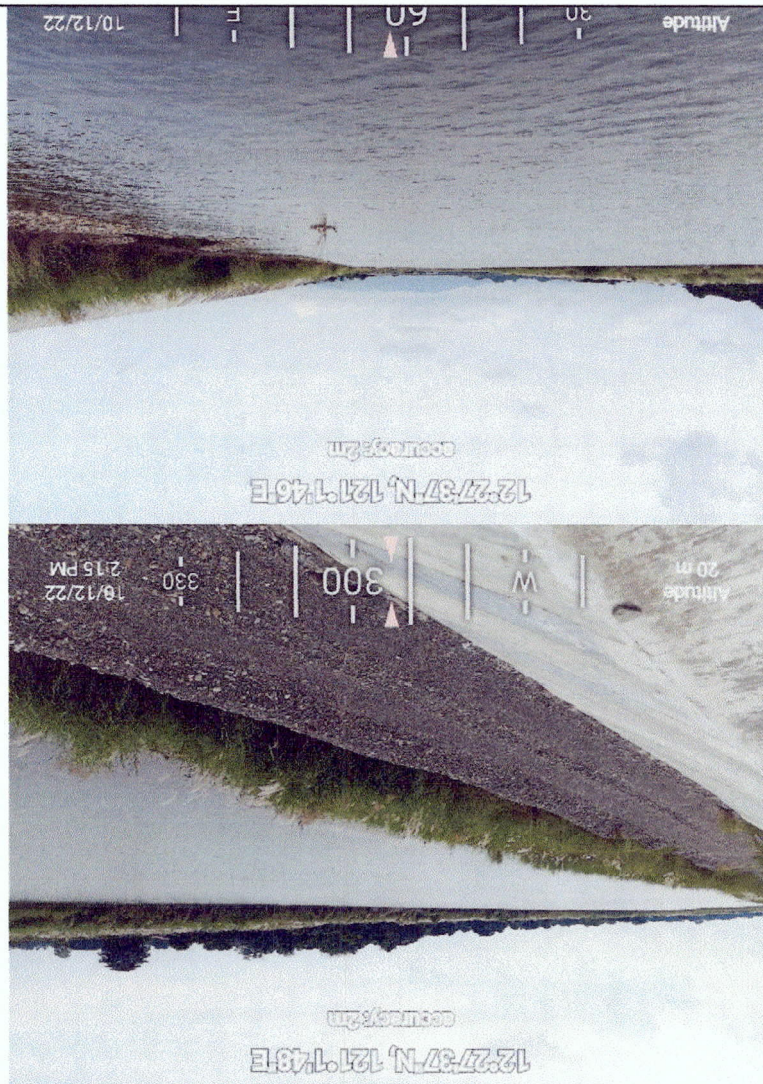
Photo 6. Portion of the applied area of Mr. Nestor Sales at Busuanga River, San Jose.
