**COMPLIANCE INSPECTION REPORT FOR WATER QUALITY MANAGEMENT**

Name of Establishment:	BACKYARD PIGGERY FARM	
Address:	Barangay Kilo-Kilo, Sta. Cruz, Marinduque	Geo Coordinates:
Nature of Business:	Livestock	13°26'14"N, 121°59'34"E
PSIC Code: 014	Product: Fattening and disposal of live hog/pig	Year Established: May 2021
Operating hours/day:	Operating days/week:	Operating days/year:

PICTURES/DOCUMENTATION TAKEN ON AUGUST 17, 2021  
RE: INSPECTION/INVESTIGATION ON THE COMPLAINT OF MR. FLORANTE ROSALES (PIGGERY IN MARINDUQUE)

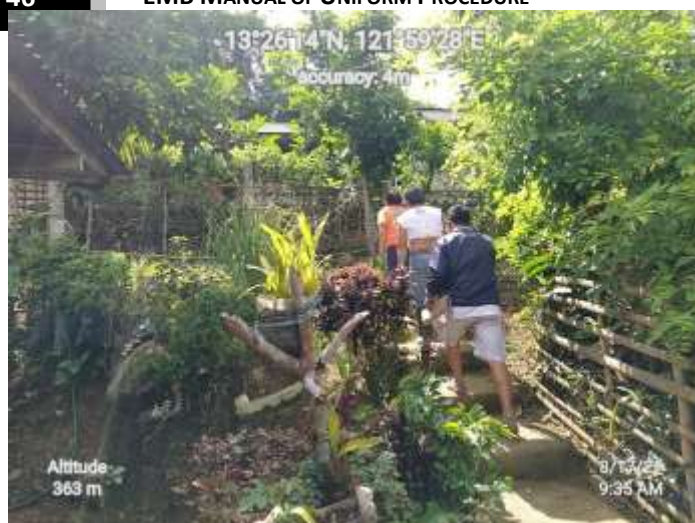
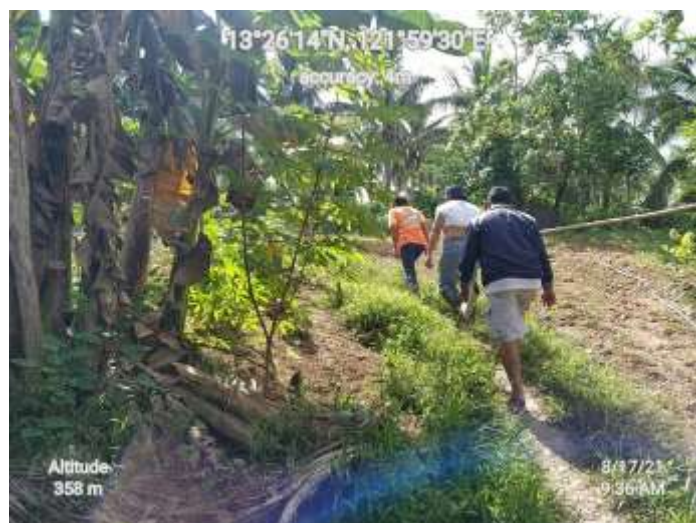
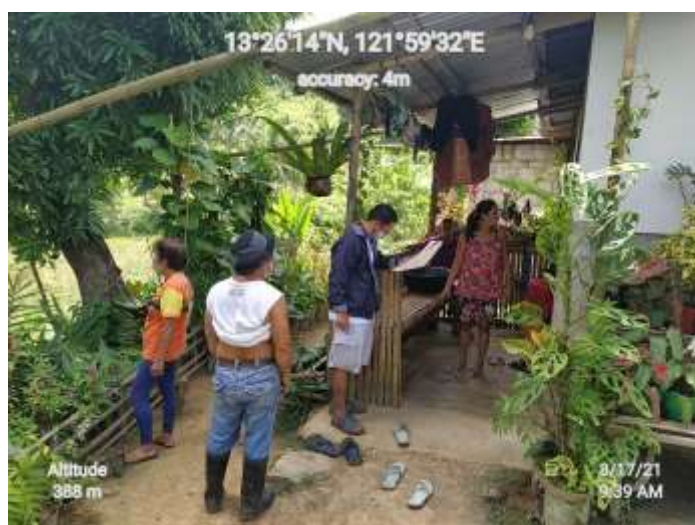
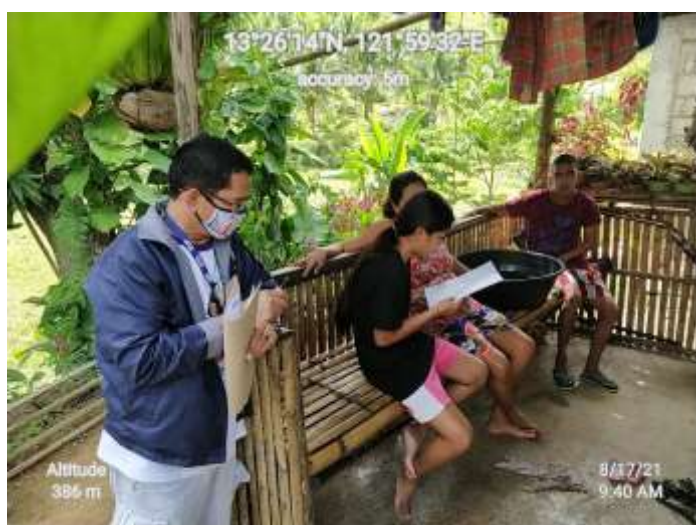
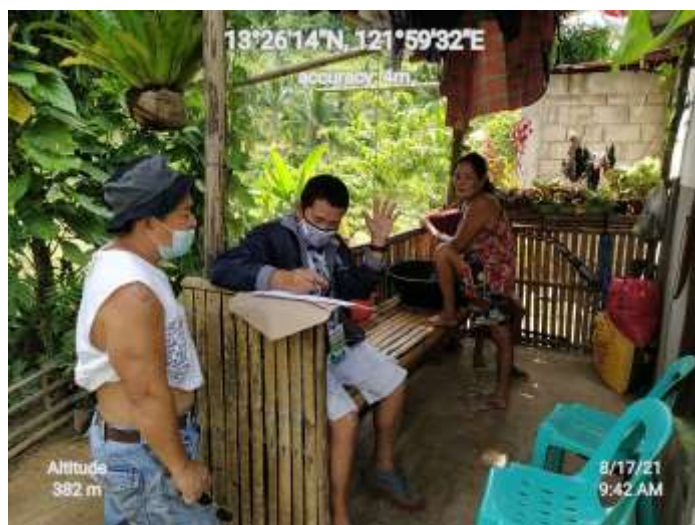
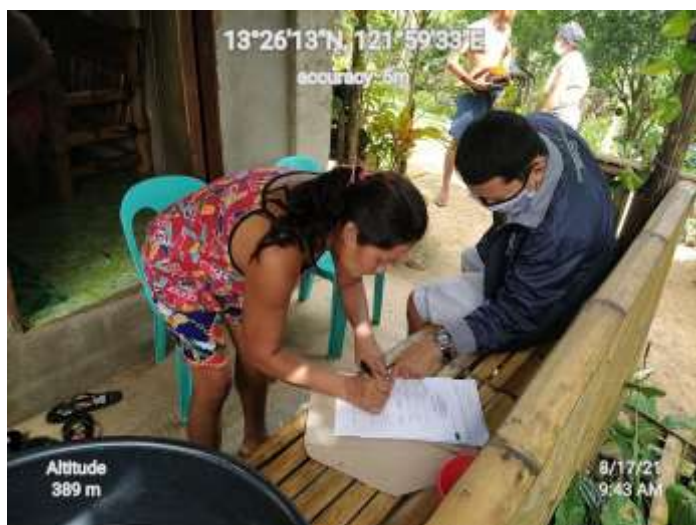
At the course of the inspection/investigation, the owner, Ms. Rosela Rodas (wearing red shirt), welcomed us and very much cooperative by giving all the details.

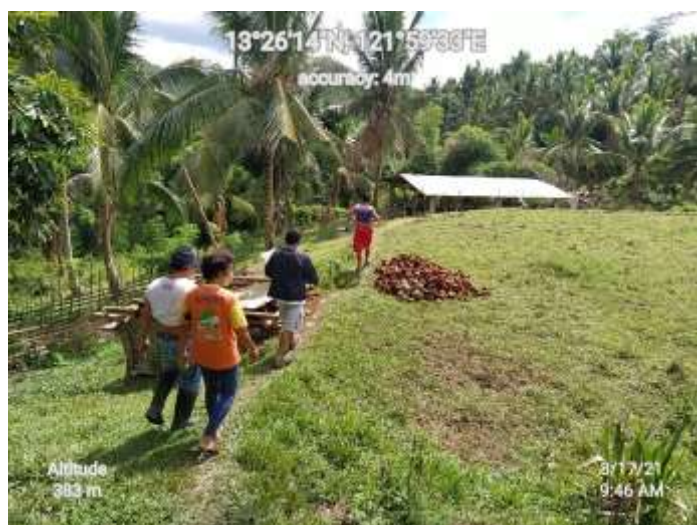
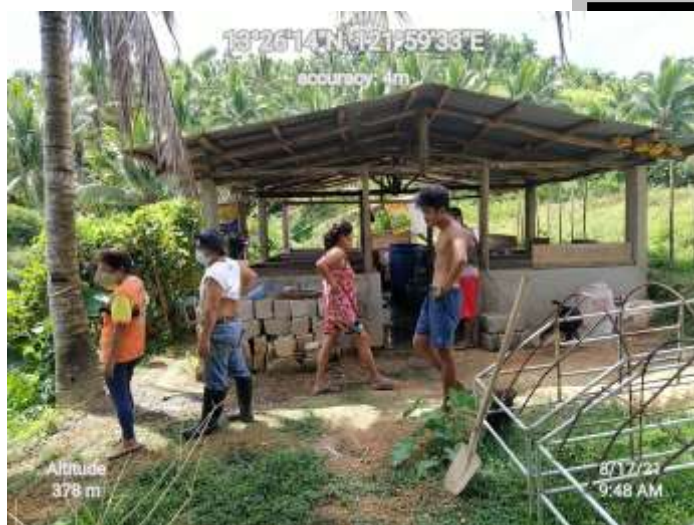
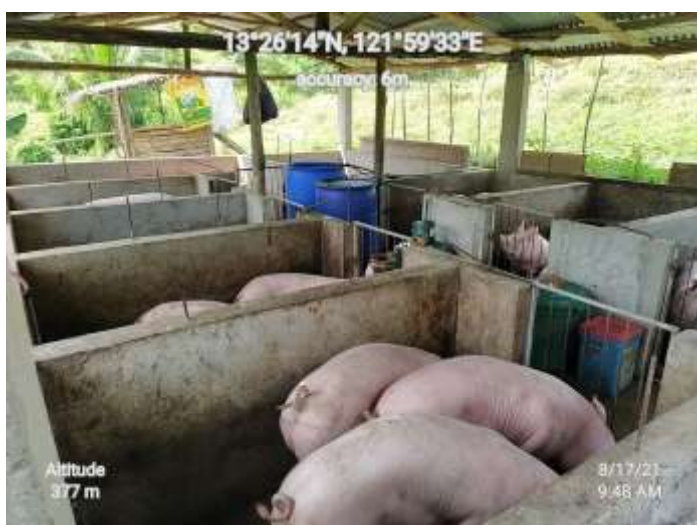
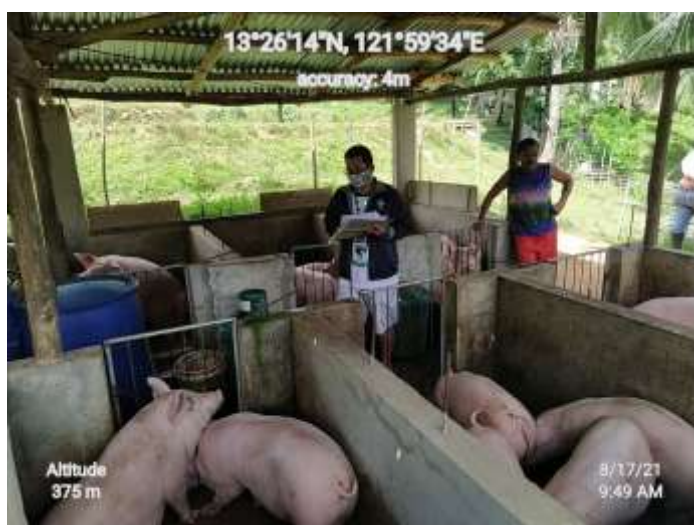
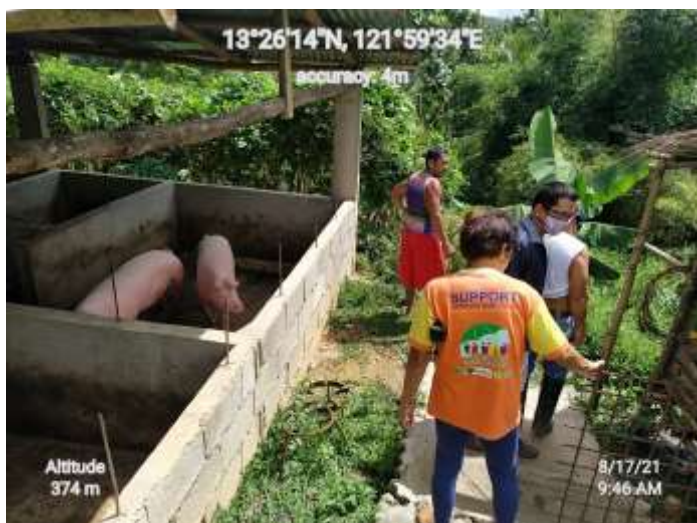
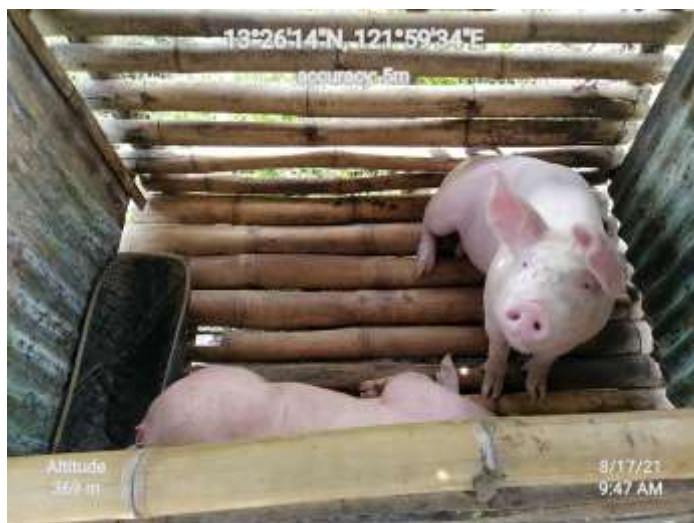
As of inspection date, the farm has one (1) piggery building with an estimated area of 50 sq.m. wherein a total of 28 heads of live hogs/pigs are being kept. According to the owner, 19 of them are over-grown and due for disposal.

3. As of inspection date, the farm has one (1) piggery building with an estimated area of 50 sq.m. wherein a total of 28 heads of live hogs/pigs are being kept. According to the owner, 19 of them are over-grown and due for disposal. However, disposal of the livestock is very much challenging considering that there has no market or interested buyer to be able to contact due to the effect of COVID-19 disease pandemic and IATF guidelines/restrictions since that the province is under GCQ.

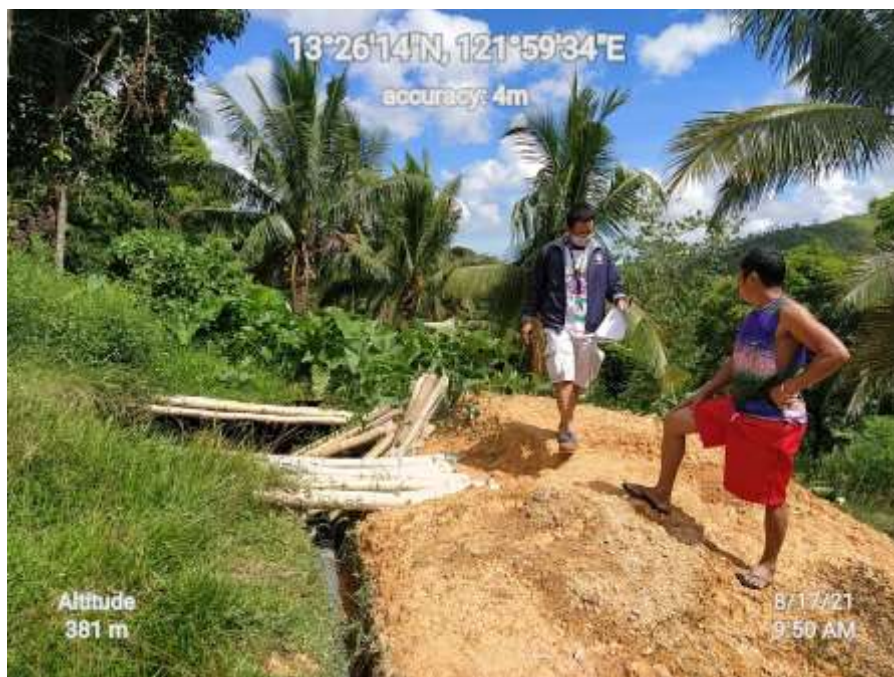
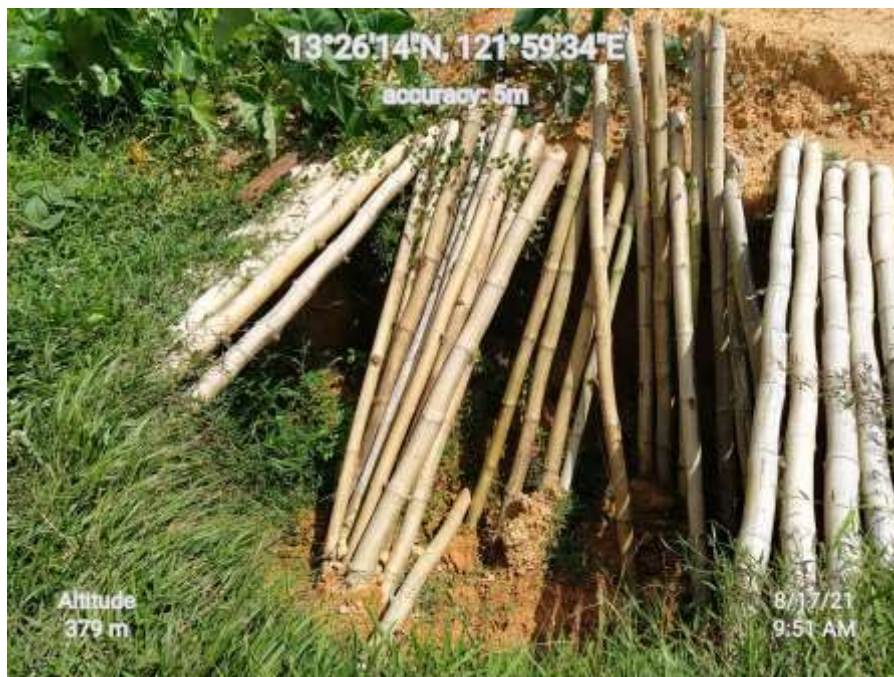
It also was observed that there has a pit, wherein the location of the proposed septic tank is to be built according to the owner.

4. Further, it was observed that there has a pit, wherein the location of the proposed septic tank is to be built according to the owner.
5. It was also noticed that an impounding or containment pond for the wastewater/effluent of the piggery was presence. According to the owner, it was their former small fishpond for "tilapia" with an estimated area of 30 sq.m. However, the pond has an opening which caused the draining of the wastewater/effluent of the piggery being complaint by Mr. Rosales.

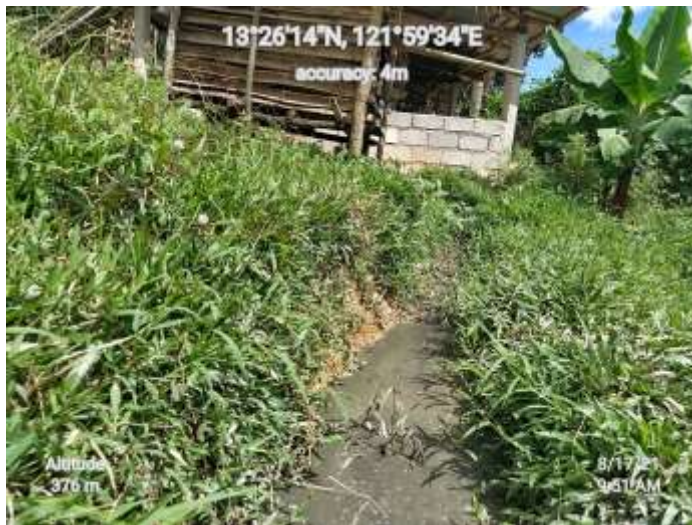
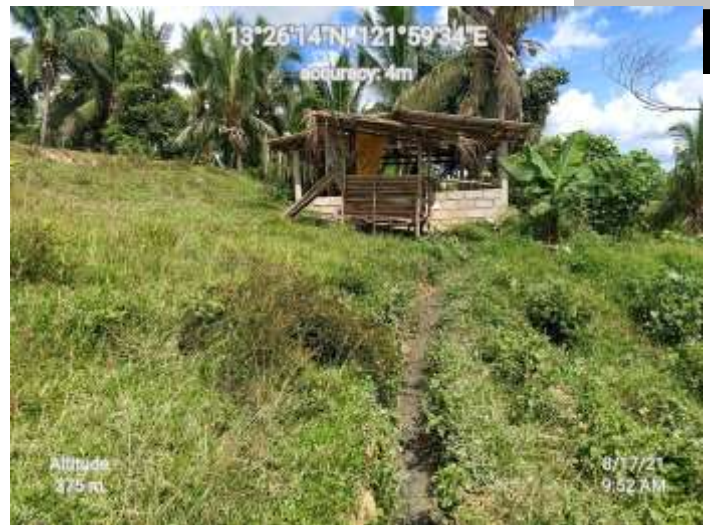
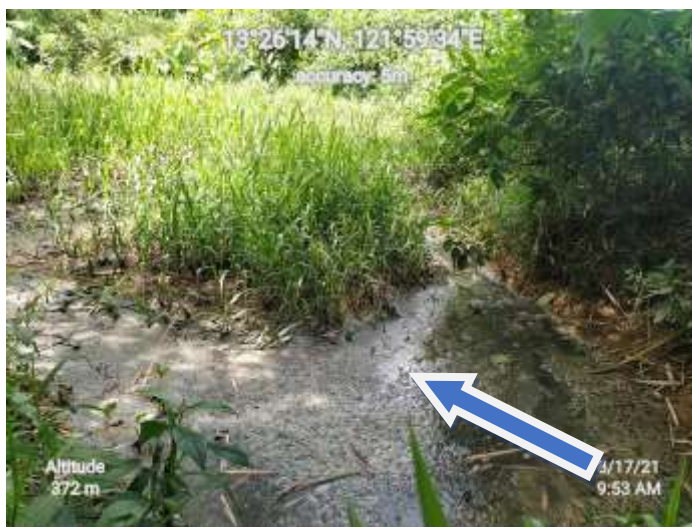
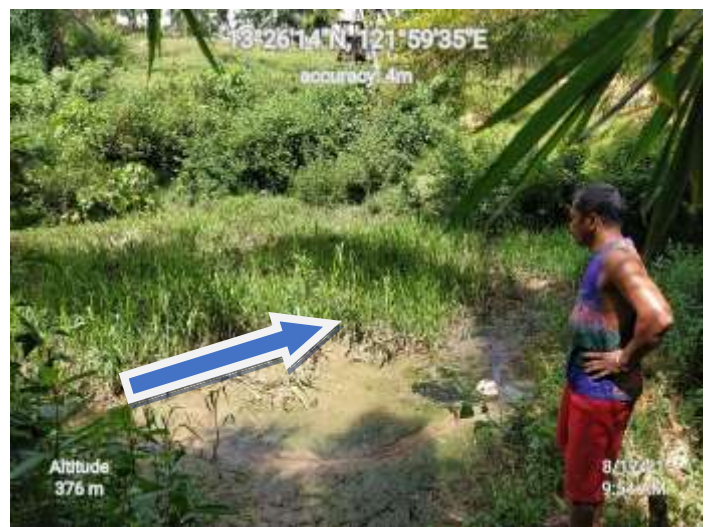
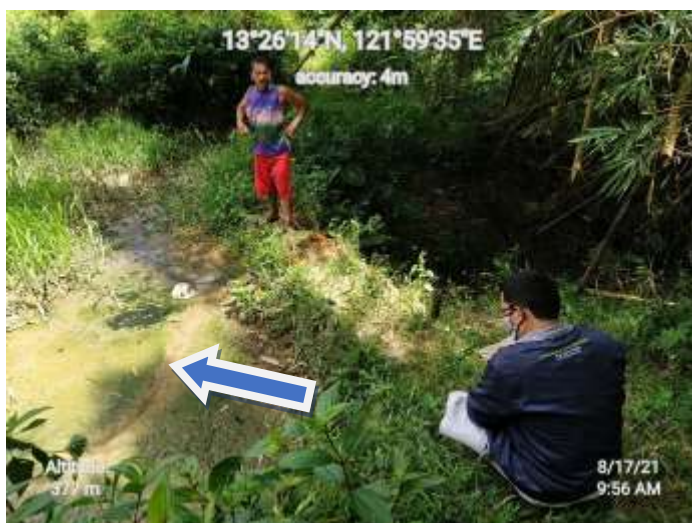
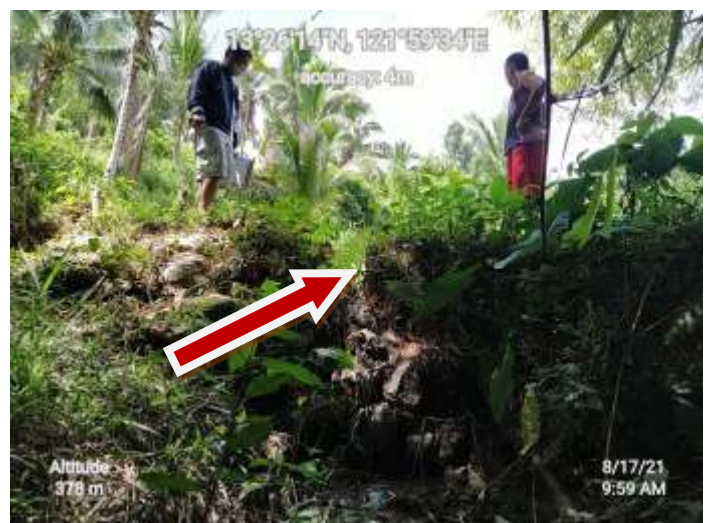
It was also noticed that an impounding or containment pond (blue arrow) for the wastewater/effluent of the piggery was present. According to the owner, it was their former small fishpond for "tilapia" with an estimated area of 30 sq.m. However, the pond has an opening (red arrow) which caused the draining of the wastewater/effluent of the piggery being complained by Mr. Rosales.
