MMT COMPLAINT MONITORING AND VALIDATION REPORT (CMVR) FORM FOR MINING INDUSTRIES

GRAYMONT (PHILIPPINES) INC. (FORMERLY UNICHAMP MINERAL PHILIPPINES, INC.)
Rio Tuba Export Processing Zone, Brgy. Rio Tuba, Bataraza, Palawan

DATE OF COMPLIANCE MONITORING AND VALIDATION: July 19-24, 2021

MONITORING PERIOD COVERED: January to June 2021 **Quarter/Semester Year:** 1st Semester 2021

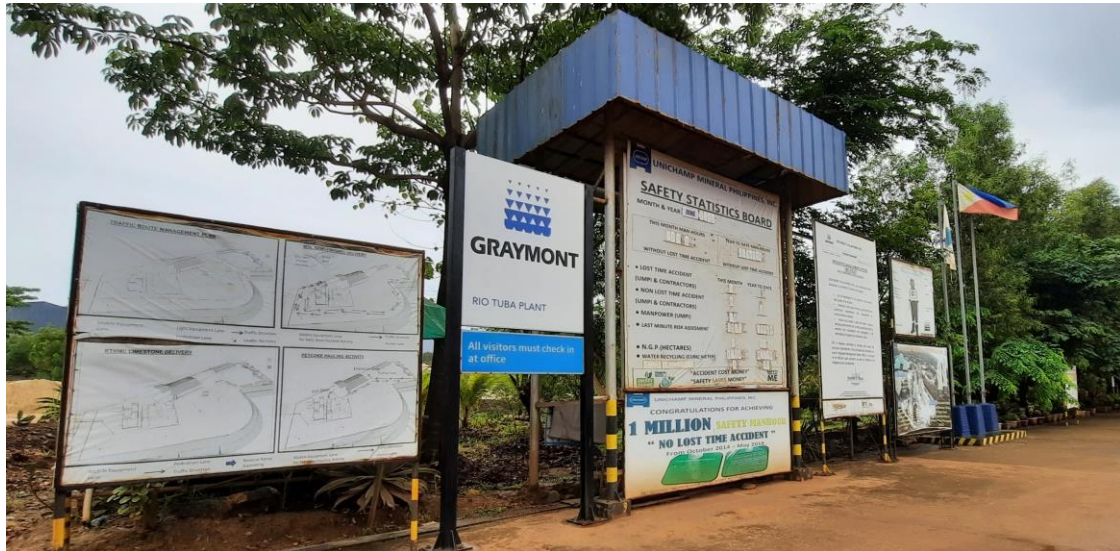
Figure 1. Updated Safety Statistic Board in front of the main building.

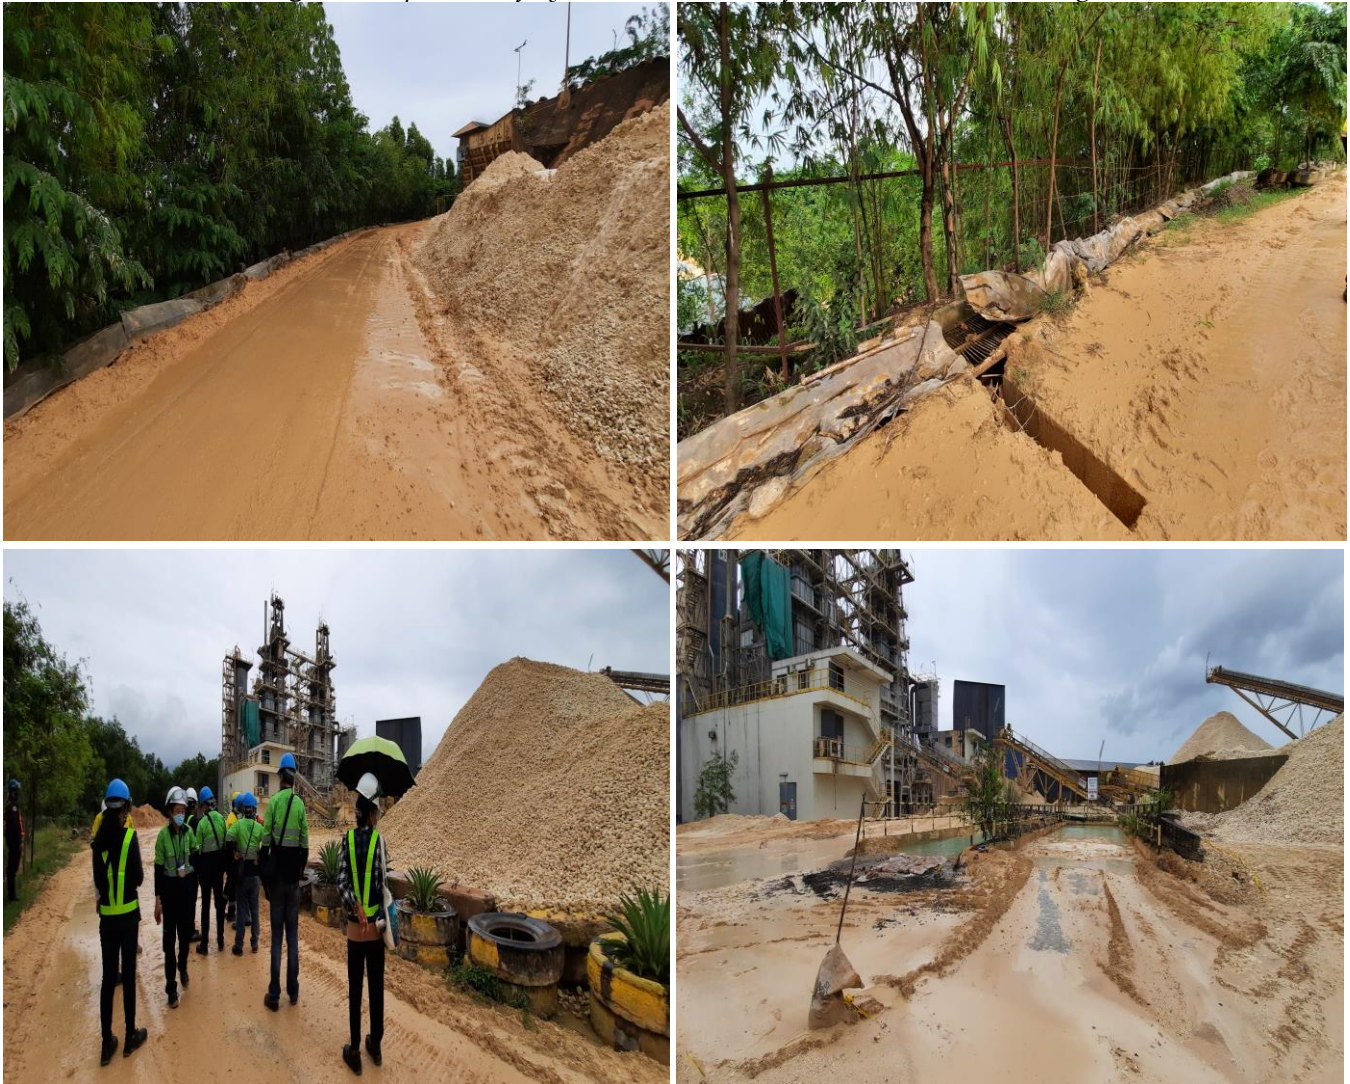
8. OTHER FINDINGS, OBSERVATION AND RECOMMENDATIONS					
<ul style="list-style-type: none">Accumulation of silt was noted on the concrete road near the limestone feed stockpile.

Figure 2 to 5. Road condition during the conduct of monitoring; already covered with accumulated silt along the path walk near the limestone feed stockpile and with the MMT validation team; condition of Limestone Washing pond and Silt pond during monitoring.

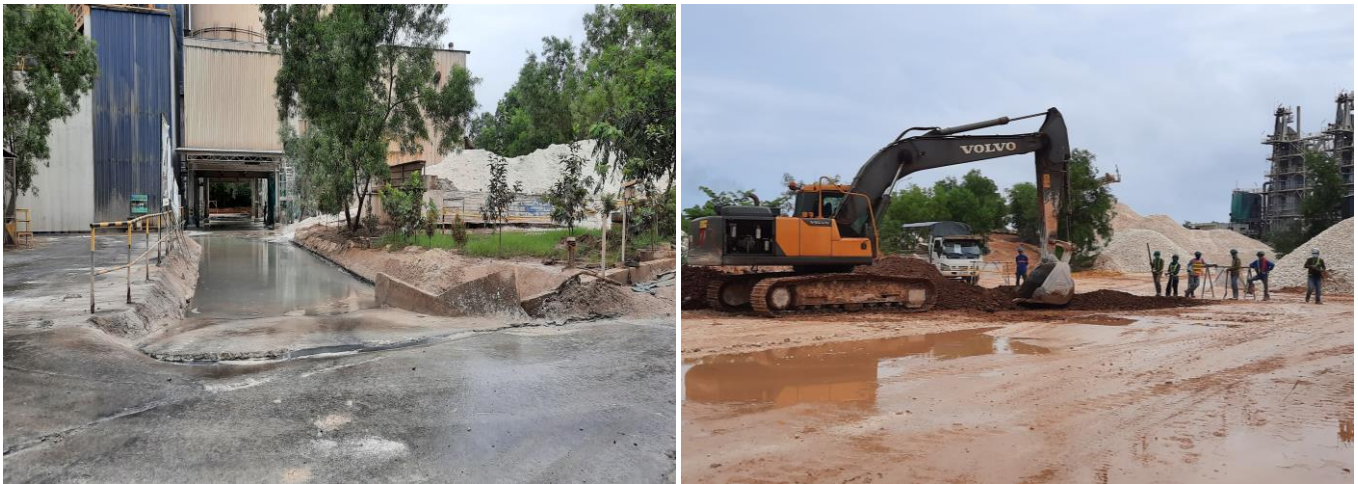
Figure 6 to 7. Condition near at Petcoke ; Ongoing road concreting in observed during the monitoring.

4.5 Road Concreting	GPI only concreted 1,337.0 square meters of the road with a reported cost of PHP6,095,830.16		X	Accelerate the concreting of the road to catch up with the plan for CY 2021.
	To concrete 18,666.5 square meters of the road with an annual budget of PHP 16,000,000.00.

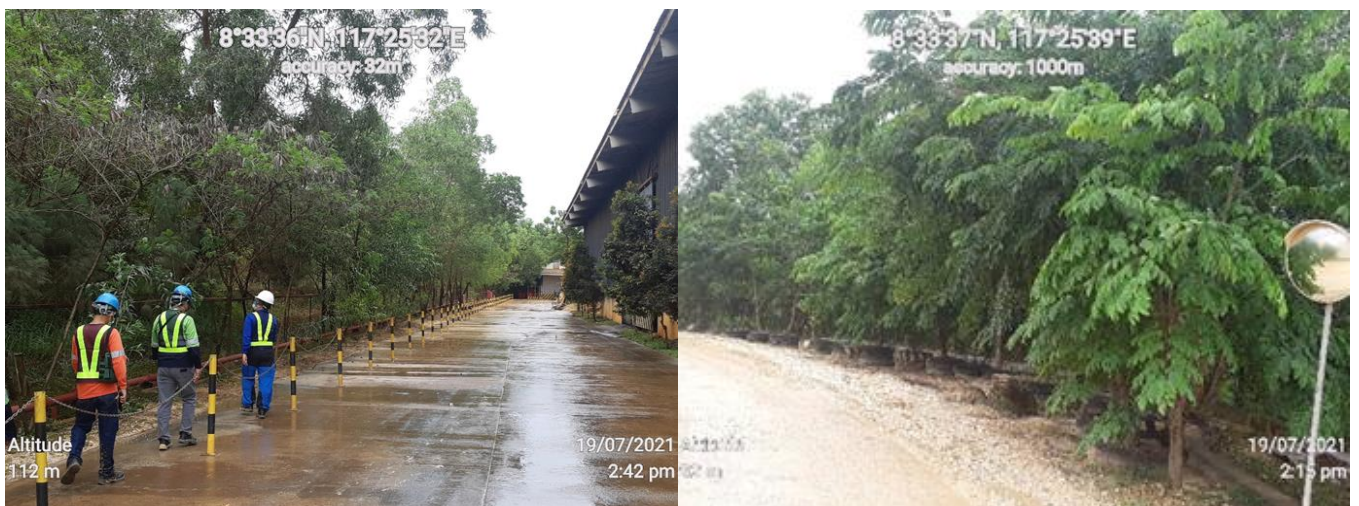
Figure 8 to 9. Planted trees within the vicinity of the company and buffer zone.

3. Establish appropriate measures and buffer zones along the entire periphery of the project site with appropriate species/vegetation cover to enhance the condition of the ecosystem and to serve as noise, vibration and dust buffers;	✓		<p>Buffer Zones along the entire periphery of the project site is fully planted with appropriate species/vegetation cover to enhance the condition of the ecosystem.</p> <p>Continuous protection and maintenance are fully implemented.</p>

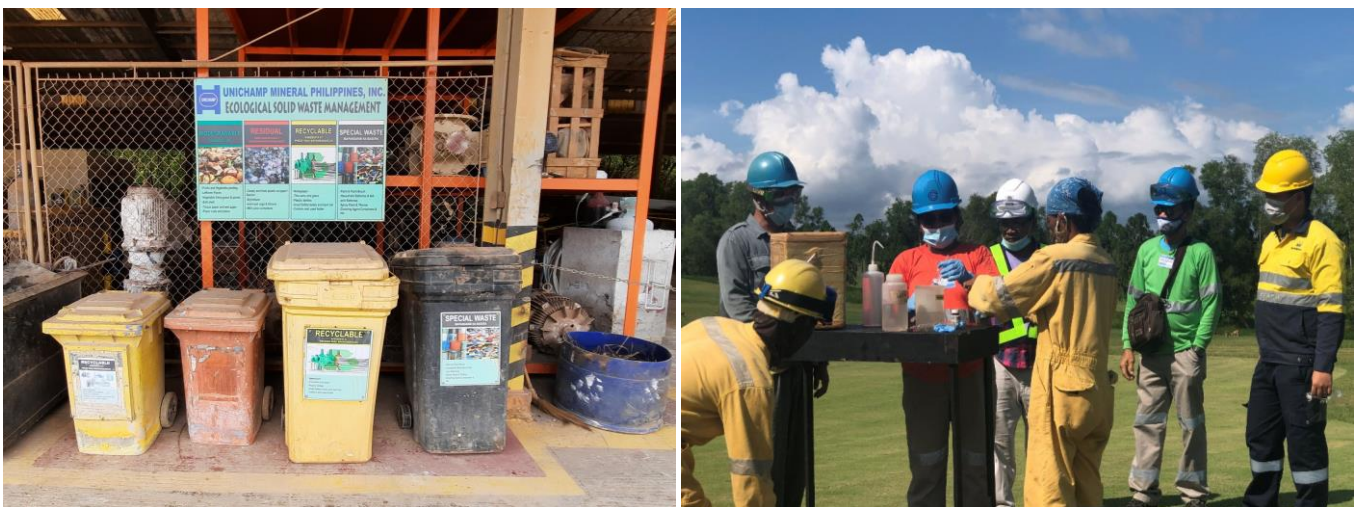
Figures 10 to 11. Solid waste trash bins provided at various working areas within the plant site; NO_x & Sox Sampling was conducted at Bulanjao Golf Course on March 3, 2021.
