MEMORANDUM

SUBJECT : REPORT ON THE CONDUCT OF GROUND

VALIDATION SURVEY AND LAND CLASSIFICATION STATUS OF LOT NO. 9540, PLS 726-D COVERED BY TCT NO. T-1339 IDENTICAL TO LOT 8, APPROVED PLAN NO. PSU 106364 LOCATED IN BARANGAY SAN

ANTONIO, STA CRUZ, MARINDUQUE.

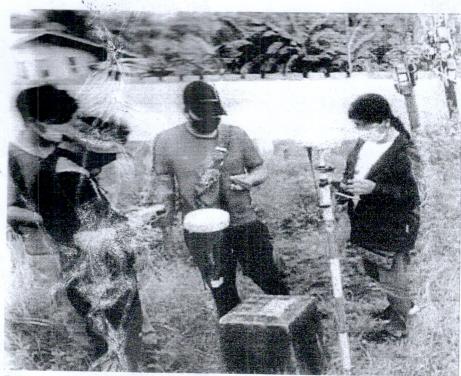
Recovered control points within Sta. Cruz, Marinduque used for calibration of Precision Instrument

3. The team recovered four (4) existing control points within the Municipality of Sta. Cruz which was used for calibration of precision instrument used, base station is located on south-western most part of existing golf course;

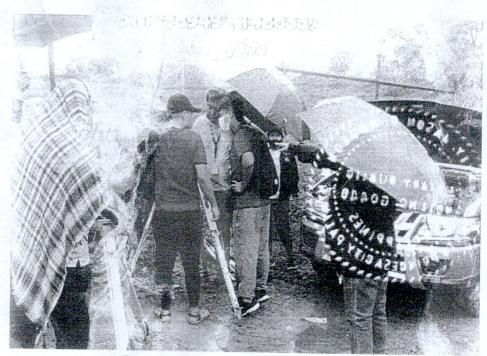
Base Station located near the subject lot

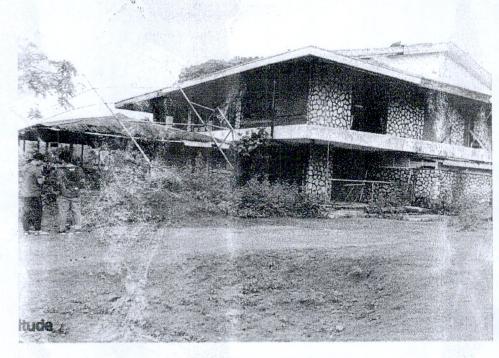
Abandoned Marcopper Club House

- The actual position of Lot No. 9540, Pls. 726-D was located on the ground using the approved technical description found in the lot data computation declaring as school sites, the subject lot falls within and identically with Lot 8 of approved Plan No. PSU 1063664 as surveyed for the Municipal Government of Sta. Cruz which was covered by Transfer Certificate of Title (TCT) No. T-1339 owned under the name of Marcopper Mining Corporation located within Barangay San Antonio, Municipality of Sta. Cruz, Province of Marinduque; (Annex "B")
- 2. Abandoned buildings and Marcopper Golf Club house was seen and documented within the suggest lot;

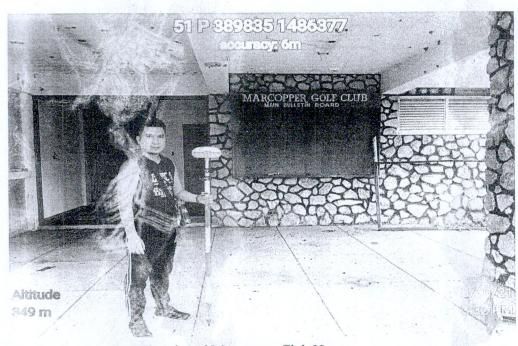
Abandoned Marcopper Club House

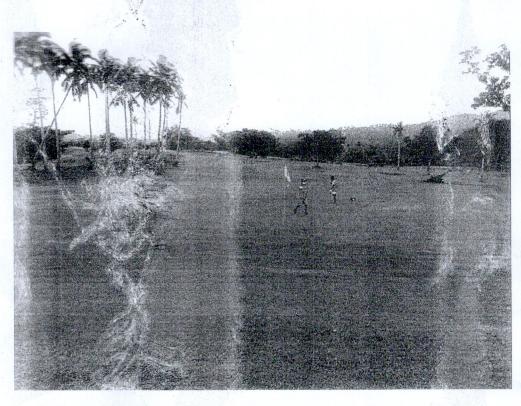
Marcopper Golf Course

- b. Using replotted/digitized LC Map, corner number 45 and 46 falls the same as the western boundary of Tapian Pit;
- c. When using the approved LC Map No. 789, the alleged Timberland block falls within flat terrain and used as existing Marcopper Golf course;
