**MEMORANDUM**

**SUBJECT :** **Provincial Resolution No. 5607-2021 of the Sangguniang Panlalawigan of Oriental Mindoro**

**SUBJECT** : **INVESTIGATION REPORT RE: MONITORING OF SAND AND GRAVEL OPERATIONS IN THE VICINITY OF PULA AND BANSUD RIVER IRRIGATION SYSTEM (RIS) DAMS IN THE MUNICIPALITIES OF PINAMALAYAN AND BANSUD, ORIENTAL MINDORO**

#### **Pula RIS Dam**

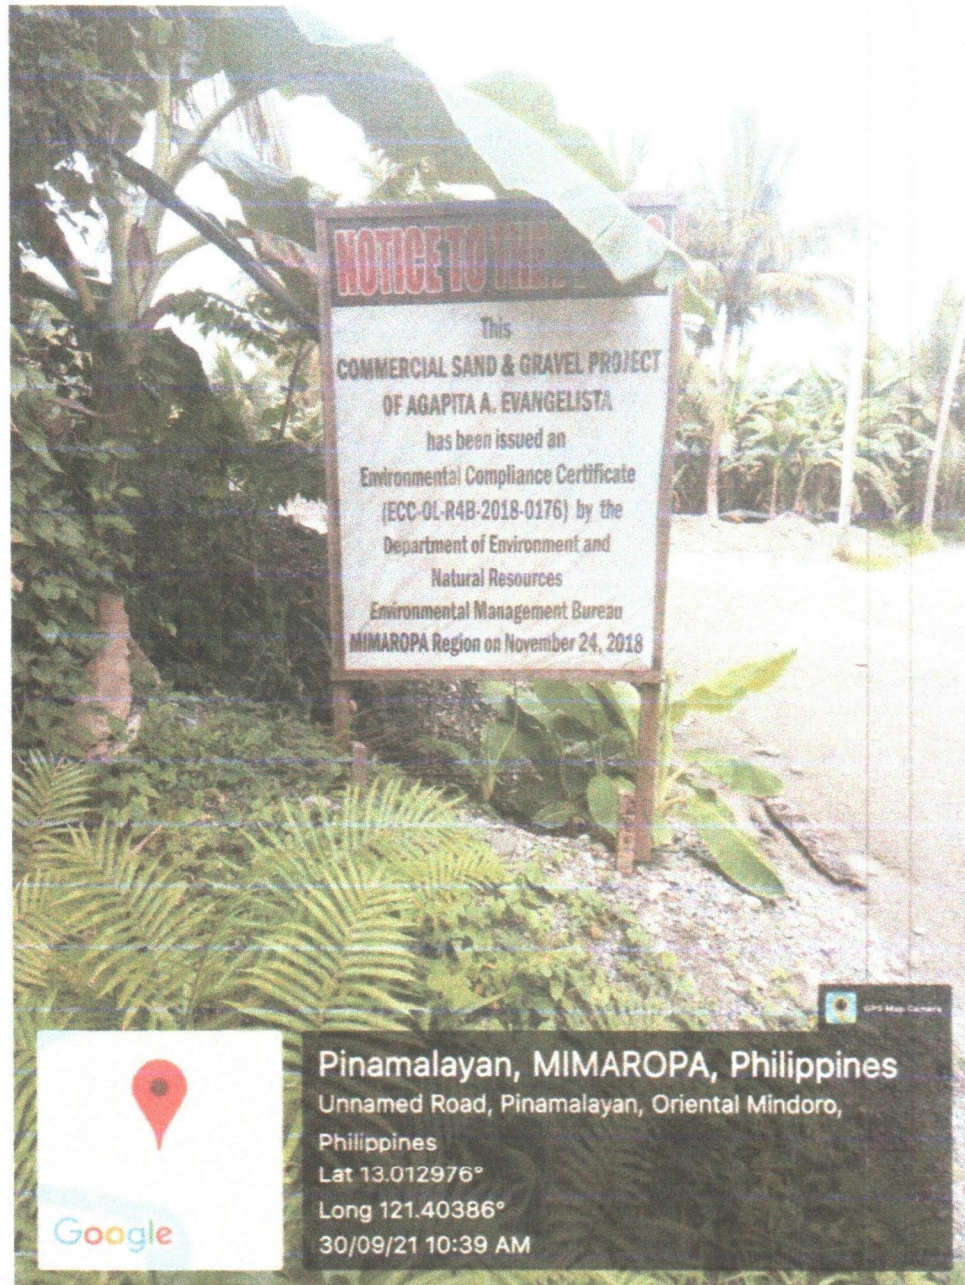
- Compliant in providing notice to the public thru a bulletin board declaring that the project was issued an ECC
  - As per site inspection the extraction activity followed the 1-meter maximum depth rule of extraction stipulated in the ECC

Photo 2. ECC Notice Board of Ms. Agapita A. Evangelista

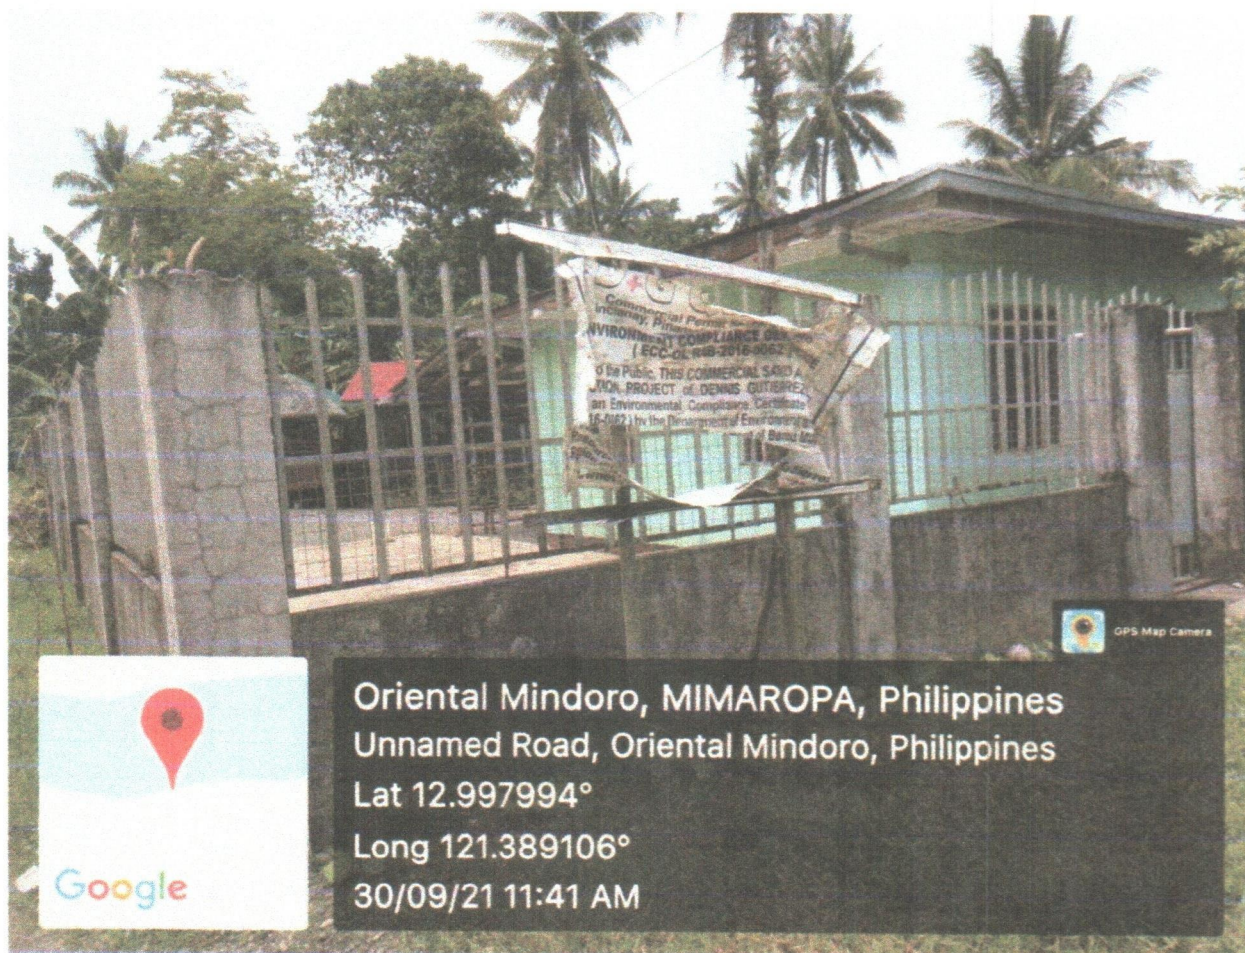
- Compliant in providing notice to the public thru a bulletin board declaring that the project was issued an ECC
  - As per site inspection the extraction activity followed the 1-meter maximum depth rule of extraction stipulated in the ECC

Photo 4. ECC Notice Board of Mr. Dennis P. Gutierrez

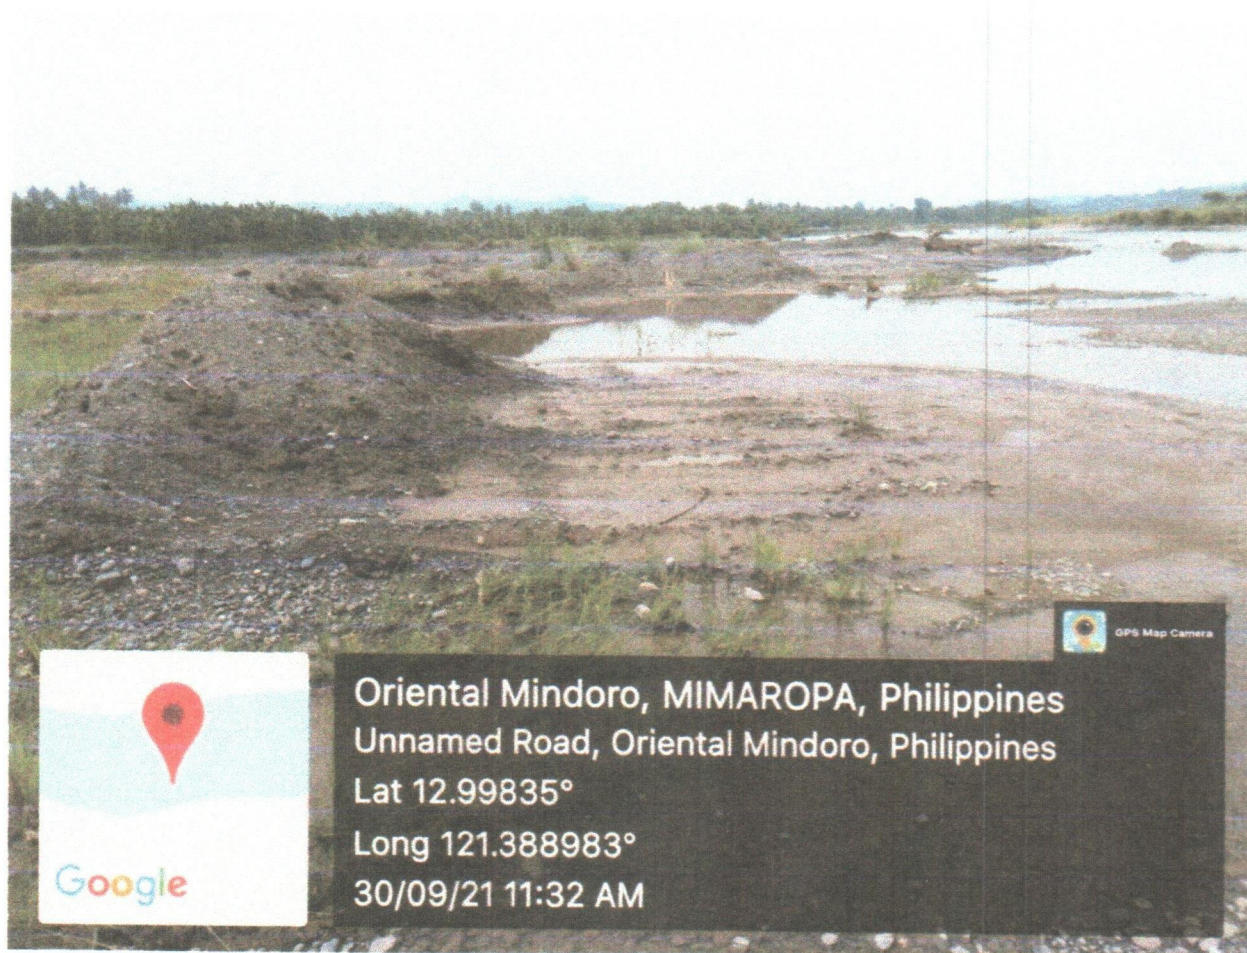
- The extraction site is 1,140 meters away from the dam but is outside the permitted area of the quarry as shown in figure 2.
- c. Permit area of Mr. Ferrmiyl C. Talagtag (CSAG Permit No. CP-ORM-213.)

Photo 5. Extraction Site of Mr. Dennis P. Guitterez

3. The following CSAG permittees extracted outside of their permit areas: (1) Dennis P. Guitterez and (2) Ferrimyl C. Talagtag. With this in regard, the aforementioned permittees violated the terms and conditions stipulated in their issued Environmental Compliance Certificate (ECC) and CSAG permit mentioned hereunder.

Hence, you are hereby ordered to immediately **CEASE AND DESIST** from conducting sand and gravel activities outside your permit area. This is without prejudice to the filing of appropriate charges against you with the proper court for violation of the applicable provisions of RA No. 4942.

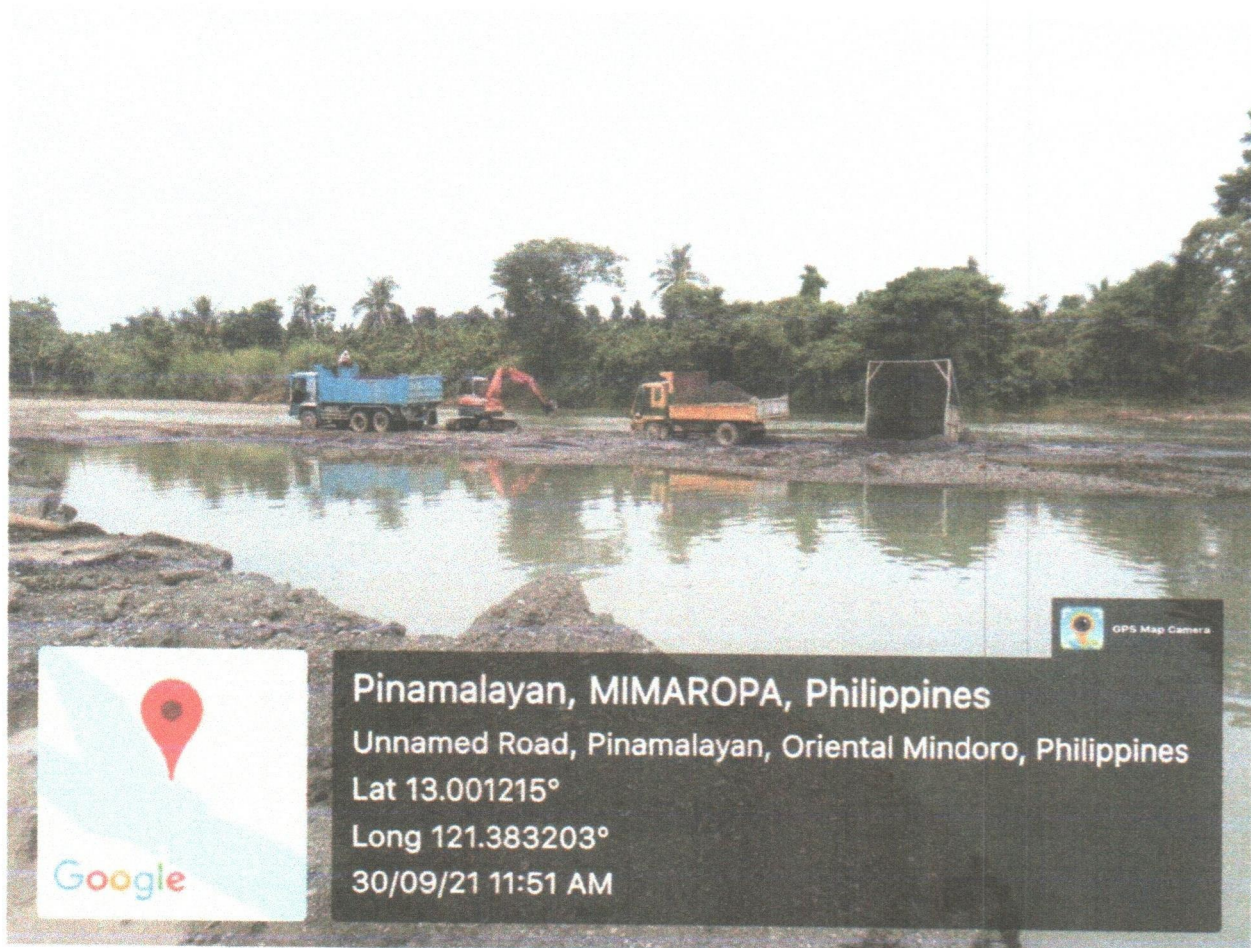
Photo 7. Extraction site of Mr. Ferrimyl C. Talagtag

Hence, you are hereby ordered to immediately **CEASE AND DESIST** from conducting sand and gravel activities outside your permit area. This is without prejudice to the filing of appropriate charges against you with the proper court for violation of the applicable provisions of RA No. 4942.

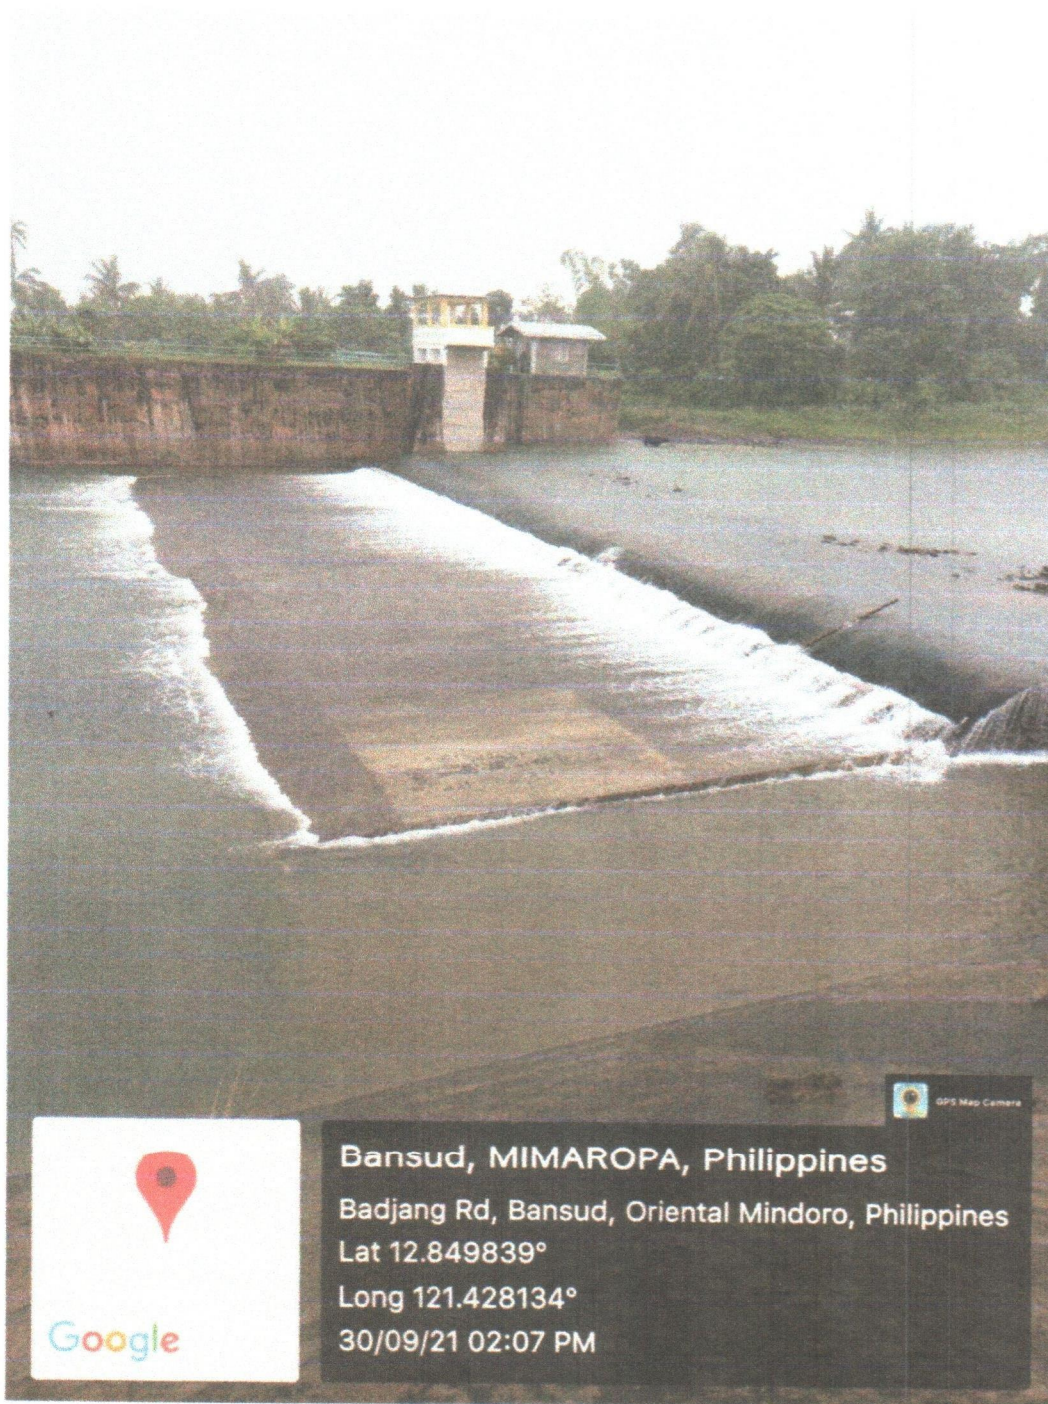
Photo 9. Bansud RIS Dam
