SUBJECT : **URGENT REQUEST FOR CAPITAL OUTLAY FOR THE REPLACEMENT OF ZL6 DATA LOGGER OF GROUNDWATER MONITORING STATION (GWMS) INSTALLED AT MINSU, VICTORIA, ORIENTAL MINDORO**

SUBJECT : **REPORT ON THE REGULAR MONITORING AND MANUAL UPDATING OF FIRMWARE OF THE DATA LOGGER OF THE INSTALLED WATERSHED INSTRUMENTS WITHIN THE PROVINCE OF ORIENTAL MINDORO**

PHOTODOCUMENTATION OF THE DAMAGED ZL6 DATALOGGER OF GROUNDWATER MONITORING STATION (GWMS) INSTALLED AT MINDORO STATE UNIVERSITY (MinSU) DURING THE FIELD VISIT OF THE REGIONAL OFFICE ON DECEMBER 7-8, 2021

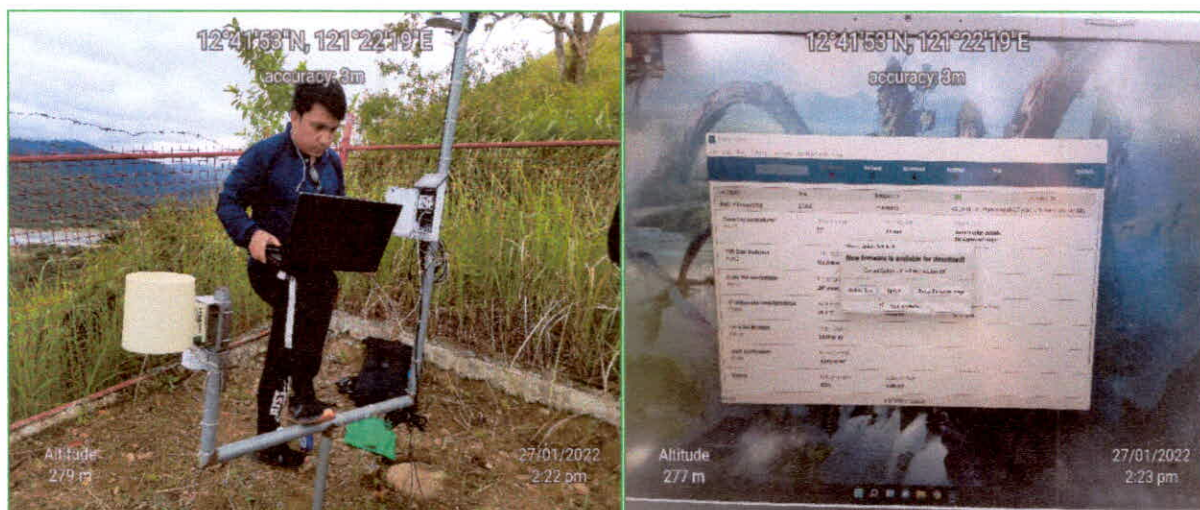
The data logger of the AWS was manually updated thru the use of a laptop with updated Zentra Utility application connecting to the data logger (*see Figures 2*) and the Cellular Upload Test was conducted to ensure that the data logger transmits data smoothly after the update (*see Figures 3*). Also, the rechargeable batteries were replaced with new ones to properly charge the previously used batteries.

Figures 2: Photos showing the manual updating of the firmware of data logger thru the use of a laptop with updated Zentra Utility app.

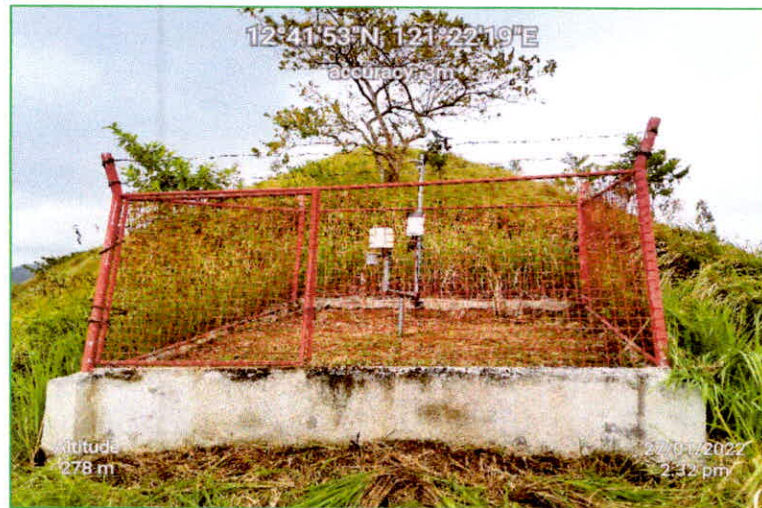
Further, the location site of the AWS was cleared of the grasses that infested the area. Multi-purpose grease was applied to the cables connected to the data logger to prevent any insects from crawling inside the data logger.

Figure 4: Photo showing the maintained site of the installed AWS after the monitoring activity

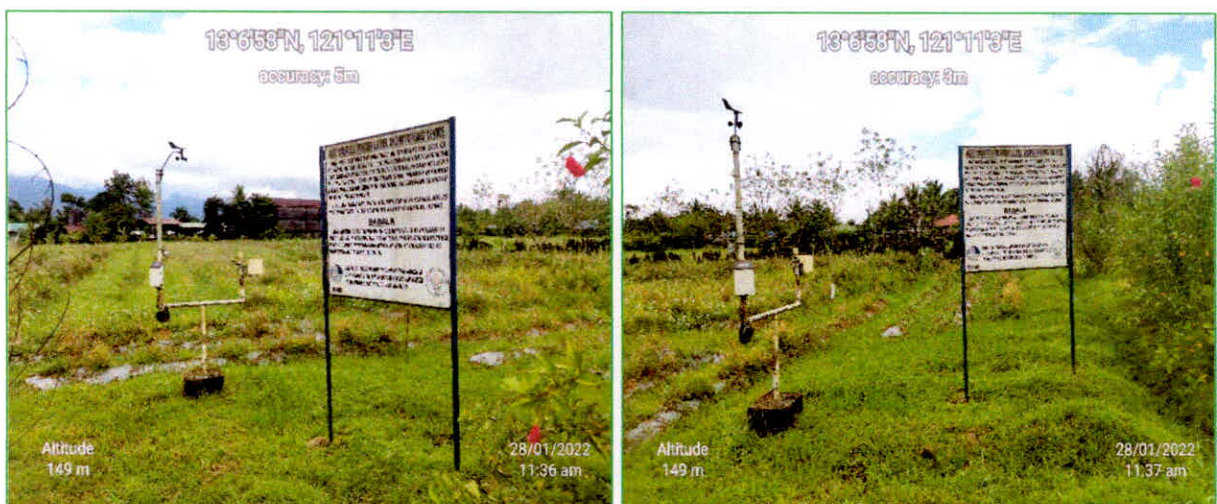
In DA-Regional Integrated Agricultural Research Center, the installed AWS is within the compound of the center and being maintained by DA staff assigned within the area. During the monitoring, the firmware of the data logger was manually updated thru the use of a laptop with installed Zentra Utility app and the Cellular Upload Test was conducted to ensure that the data logger transmits data smoothly. Also, the rechargeable batteries were replaced with new ones to properly charge the previously used batteries. The device was functioning properly after the successful updating of the firmware and other activities conducted.

Figures 5: Pictures showing the installed AWS within the vicinity of DA MIMAROPA Regional Integrated Agricultural Research Center

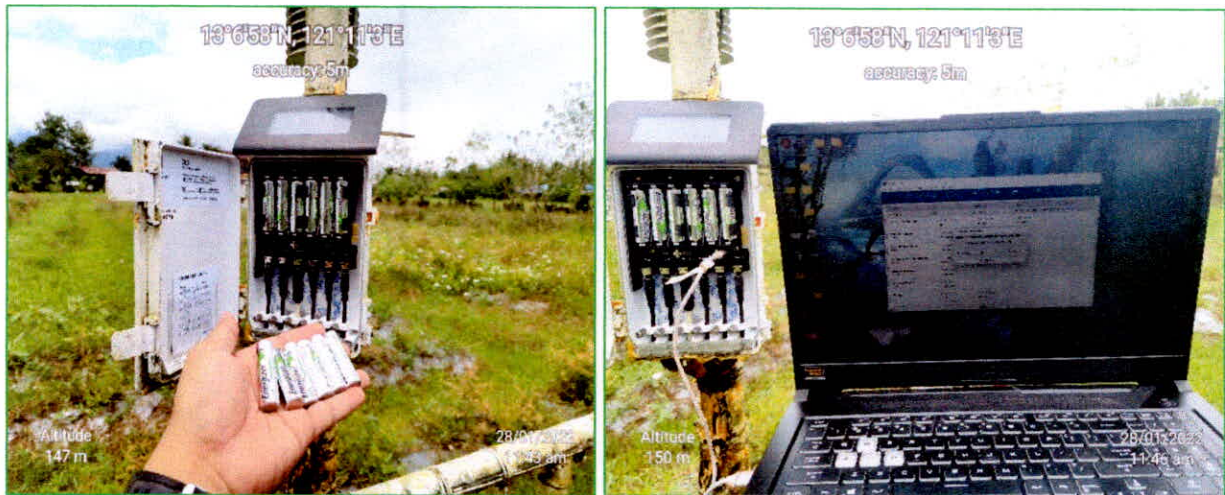
Figures 6: Pictures showing the rechargeable batteries for replacement to the old ones and the manual updating of the firmware of the data logger of the AWS

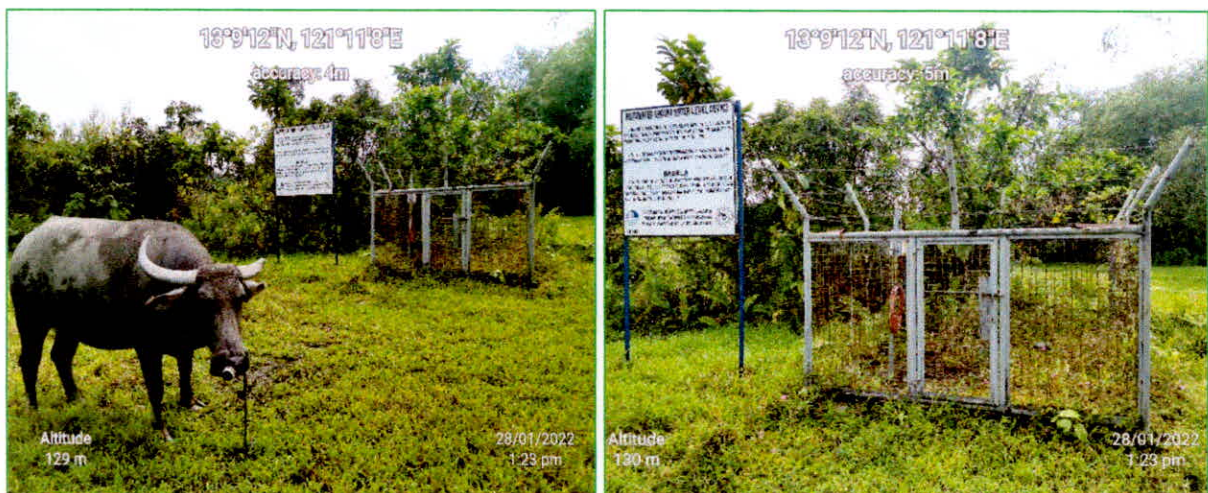
Meanwhile, in Mindoro State University, the installed groundwater monitoring instrument - CTD within the campus's vicinity was being maintained by Engr. Jackson, the focal person of the university. Upon opening of the data logger, it was observed that moisture penetrated the device as evident by the presence of rusts starting to infect the battery compartment and the moist in the batteries (*see Figures no. 8*).

Figures 7: Pictures showing the location site of the installed CTD (groundwater monitoring) within the vicinity of Mindoro State University (formerly Mindoro State College of Agriculture and Technology)

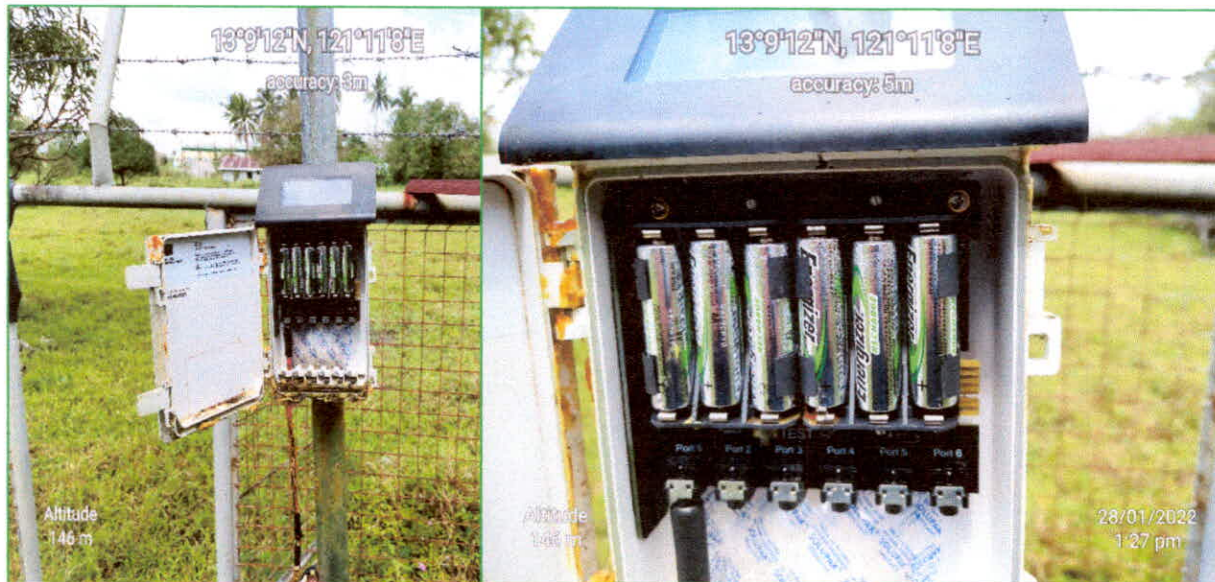
Unfortunately, the manual updating of the firmware of the data logger was unsuccessful because the logger does not respond when connected to the laptop and it's possible that the circuit board of the logger was damaged by the moisture that penetrated inside. Also, the rechargeable batteries were not replaced due to the presence of rusts within the battery compartment as it will damage the new batteries. Replacement of data logger will be requested to the Regional Office.

Figures 8: Pictures showing the inside of the data logger of the CTD with the battery compartment showing signs of rust due to the moisture that penetrated the device.

Groundwater Monitoring Station - CTD (within Mag-asawang Tubig Watershed – MinSCAT Main Campus, Brgy. Alcate, Victoria, Oriental Mindoro)	<ul style="list-style-type: none"> The circuit board was damaged due to the moisture that leaked inside the data logger that resulted to the inability of the logger to send the data collected by the CTD sensors to the cloud server 	<ul style="list-style-type: none"> For replacement of the data logger since its circuit board was damaged by the moisture as a result of the previously infesting of ants 	<ul style="list-style-type: none"> Manual updating was not done as the data logger is not responding even after being connected to the laptop Data logger must be replaced and fund will be requested to the Regional Office

Particulars	Amount
One (1) unit ZL6 Data Logger with 1 year subscription and installation	110,000.00
One (1) unit Sealed Lead Acid 12V 5AH Battery	1,500.00
10 packs Desiccant Silica Gel 100g	3,000.00
5 packs Moth Balls (175 grams)	1,500.00
Repair of the gate of AWLS	30,000.00
TOTAL	146,000.00

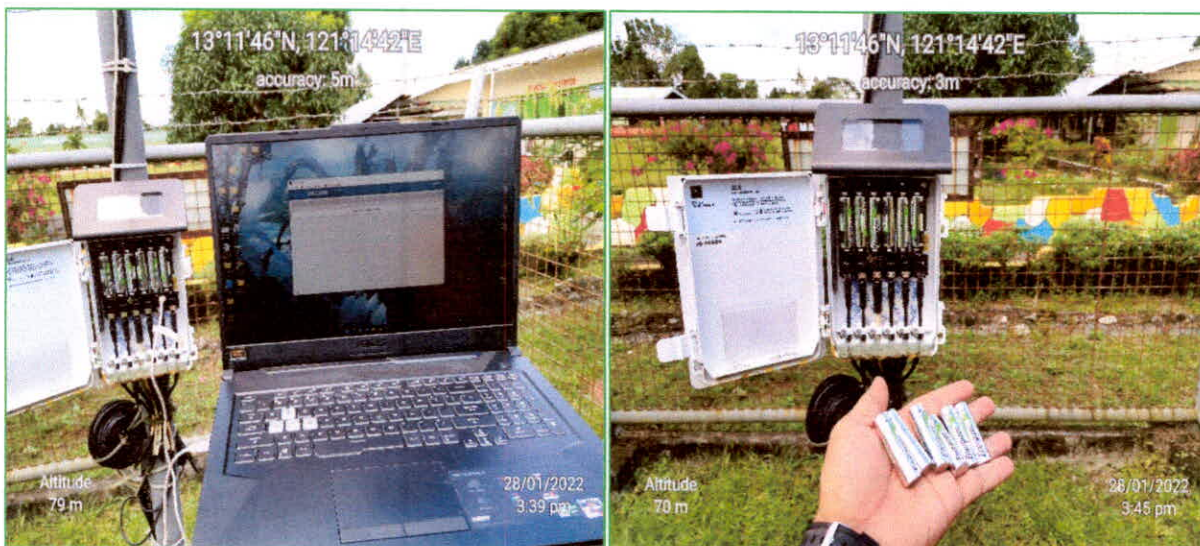
Figures 10: Pictures showing the rechargeable batteries for replacement to the old ones and the manual updating of the firmware of the data logger of the AWS

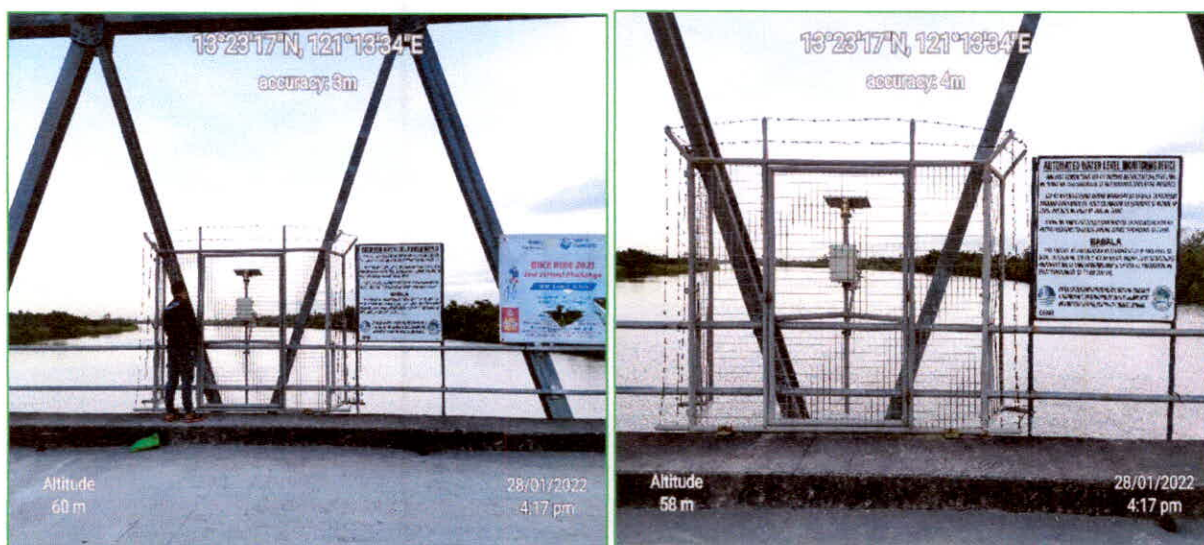
For the installed Automated Water Level Station located in Abaton bridge, Brgy. Parang, Calapan City, the device was functioning properly during the time of monitoring. Unfortunately, upon opening the gate of the AWLS, the welding of the middle hinge of the gate got broken due to the rusts that infecting it (see *Figures no. 13*). WD40 was sprayed to the other hinges of the gate to loosen the rusts. Manual updating of firmware was not done with the AWLS since it is from a different manufacturer as compare to the AWS.

Figures 11: Pictures showing the installed Automate Water Level Station in Abaton bridge, Brgy. Parang, Calapan City, Oriental Mindoro.

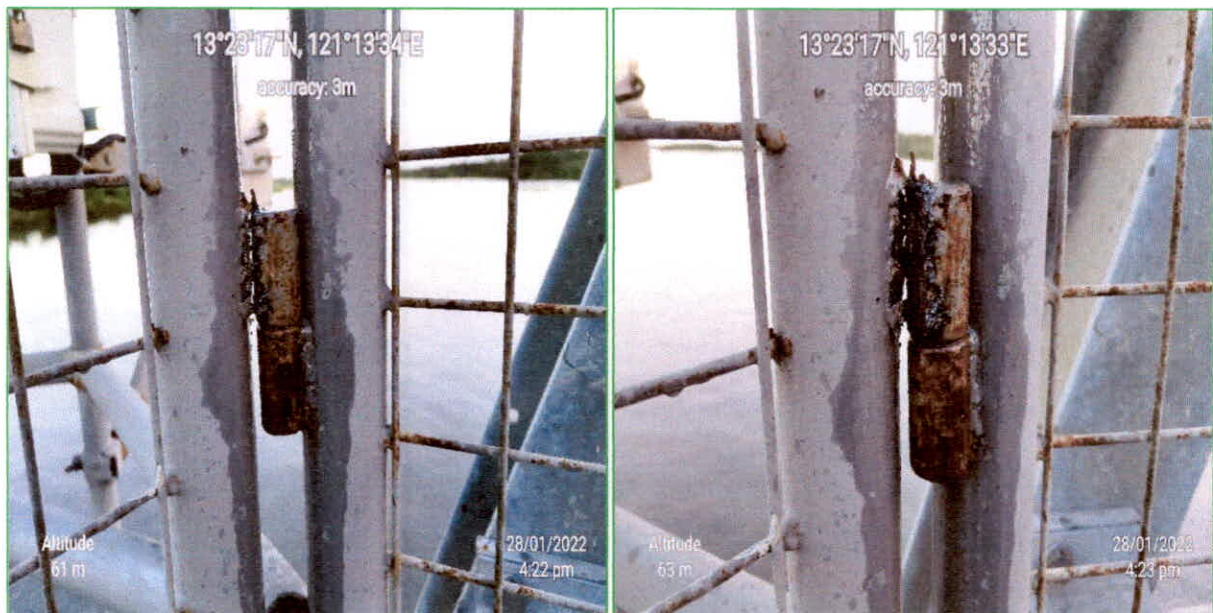
Figures 13: Pictures showing the broken welding of the middle hinge of the gate of the AWLS

Automated Weather Station (within Mag-asawang Tubig Watershed – DA-RIARC, Brgy. Alcate, Victoria, Oriental Mindoro)	<ul style="list-style-type: none">• The area of the site was maintained by the center's personnel	<ul style="list-style-type: none">• The re-application of grease will be part of the regular monitoring of the PENRO-CDS personnel	<ul style="list-style-type: none">• Manual updating of the firmware and cellular upload test was successfully conducted including the replacement of the batteries.• The AWS is functioning properly during the time of monitoring
Automated Water Level Station (within Mag-asawang Tubig Watershed – Abaton Bridge, Brgy. Parang, Calapan City, Oriental Mindoro)	<ul style="list-style-type: none">• The hinges of the fence were rusted that resulted to difficulty of opening the gate• The welding of the middle hinge got broken after opening the gate	<ul style="list-style-type: none">• The re-application of grease to the cables and re-spraying of WD40 lubricant will be part of the regular monitoring of the PENRO-CDS personnel	<ul style="list-style-type: none">• The data logger's firmware is still up-to-date.• Request fund to the Regional Office for the repair of the gate of the AWLS and replacement of its battery

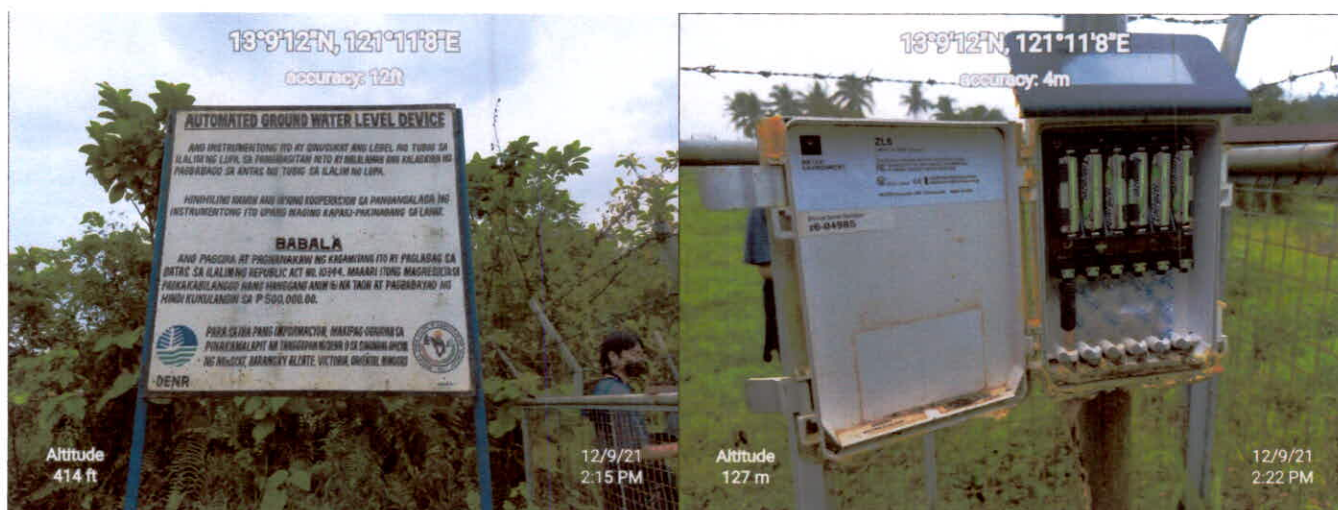
Figure 1. Datalogger of GWMS installed at MinSU, Oriental Mindoro.

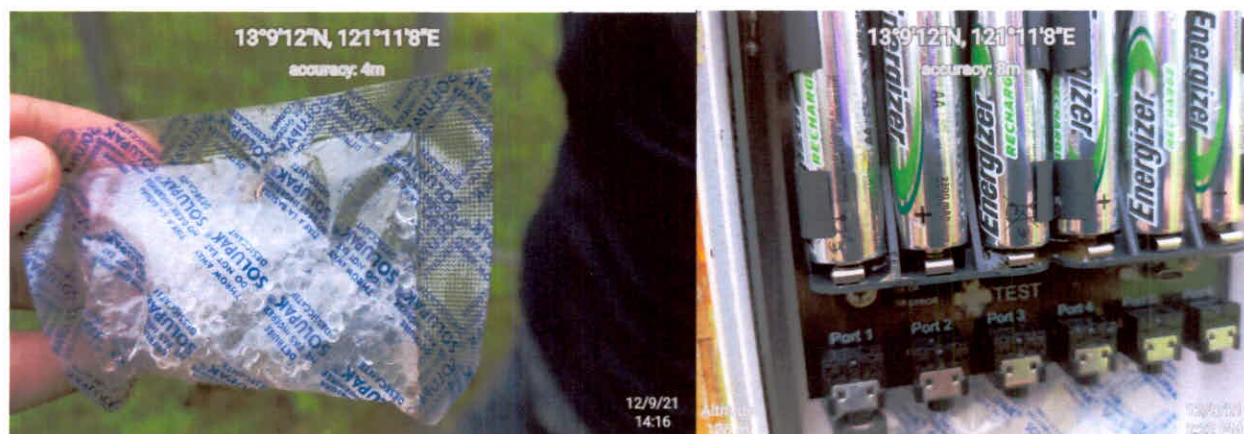
The report indicated that all five (5) watershed monitoring instruments are functioning, except for the Groundwater Monitoring Station (GWMS) installed at Mindoro State University (MinSU), Victoria, Oriental Mindoro. It was found out that the ZL6 data logger (z6-04985) was dysfunctional due to ant infestation and water leakage in the batteries.

Fig. 2. Rainwater-soaked dessiccant (right) and batteries (left) inside the datalogger of GWMS.

Relative thereto, we are respectfully requesting your Office for capital outlay amounting to **Php 110,000.00** for the replacement/procurement of the ZL6 data logger of the GWMS. The data logger is a vital component of the instrument as it records the real-time data (15-minute interval) collected by the GWMS which includes groundwater conductivity, temperature and depth (CTD).

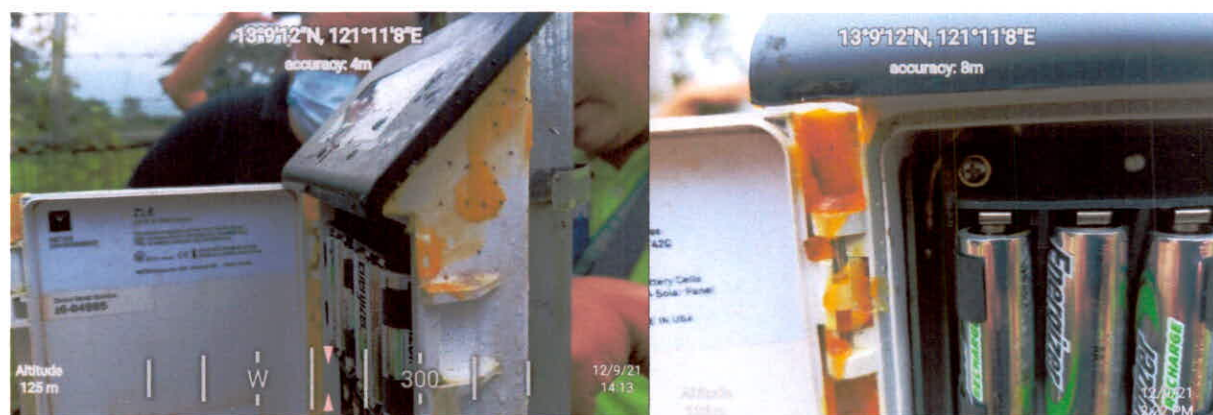
Fig. 3. Ant infestation in the datalogger of GWMS.
