REQUEST FOR UPDATE RE: PPC SLF PAB CASE

DENR PAB CASE NO. 4B-00948-19

This Office is respectfully asking for information on the status or any update relative to the case of Puerto Princesa Sanitary Landfill located at Brgy. Sta. Lourdes, Puerto Princesa, Palawan. The Water Pollution case was docketed as 4B-00948-19. The said case is among the agenda discussed during the 3rd DENR One MIMAROPA Regional Management Conference.

SUBJECT : "DIRECTIVE TO IMMEDIATELY CONDUCT AND

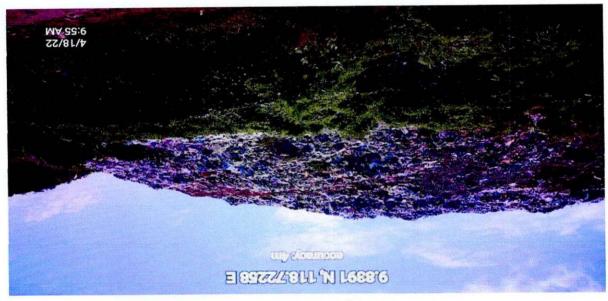
In the landfill itself, it is high time that the phase 1 parcel of the disposal site be now subjected to Safe and Closure Rehabilitation following the prescribed outline for its implementation. The effort of the Operation Officer Mr. Barte in trying to reduce erodability of the mountainous -like garbage as in benching approach is no longer ideal and effective due to the present landfill elevation. If pursued, it may lead eventually to the collapse of the landfill.

The mountain-like scenario of the PPC Sanitary Landfill

Recommending immediate implementation of Safe and Closure Rehabilitation Plan for the phase I cell and expedition of the construction of the phase II cell. For the condition of the two LTPs which remain un-functional up to this time for the same reasons as cited in the previous reports, it is strongly recommended that said pressing issue among others be discussed or reiterated by the top management.

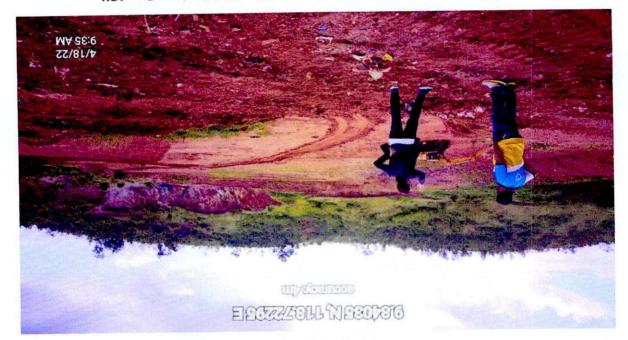
There is an on-going construction of phase II cell which needs to be expedite so that the utilization of the phase 1 cell be immediately terminated and rehabilitated instead.

The under construction Phase II cell of the PPC Sanitary Landfill

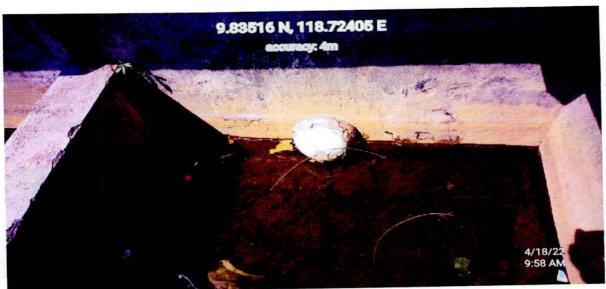
From the time the CDO was served by the Regional Office staff, who executed the CDO via insertion of a ball on the on the Leachate Treatment Plant's (LTP) outlet and sealed it as a manifestation of disallowing effluent discharge, this visit confirmed its same position.

The symbol of the executed Cease and Desist Order

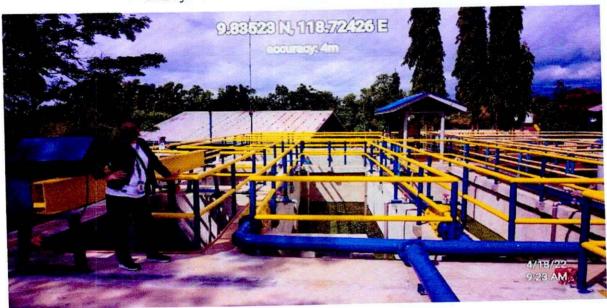
This inspection reveals another LTP constructed just adjacent to the first LTP of the same design and capacity. The first LTP was still not functional as reported in the previous reports. Since the LTP is not yet effectively functional the reason why parameters for landfill management cannot pass the effluent standards, the approach to manage wastewater is still via pumping it back and fort to the landfill. Inquiry related to the effect of storm Odette on the operation of landfill, Mr. Barte cited that they were opted to temporarily open the outlet on that specific period due to heavy pour of rainstorm to prevent overflow which can be a force majeure incident.

The newly constructed Leachate Treatment Plant

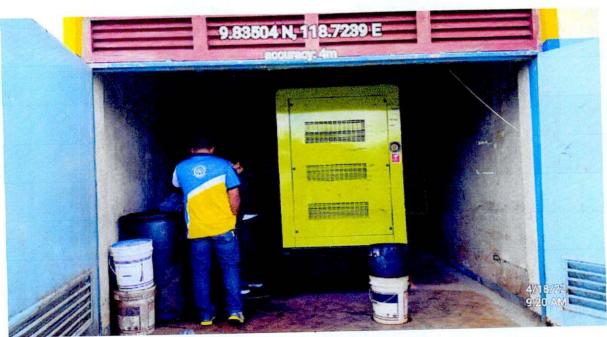
The newly purchased back-up generator set

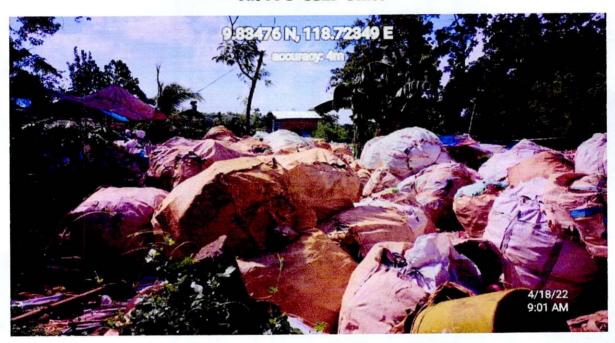
The Recyclables filtered from Collections from Households
