SUBJECT : **INVESTIGATION REPORT ON THE ALLEDGED QUARRY
ACTIVITY IN SITIO QUINCE DIAZ, BRGY. GUADALUPE,
CORON, PALAWAN**

SUBJECT : INVESTIGATION REPORT ON THE ALLEGED QUARRY
ACTIVITY IN SITIO QUINCEDIAZ, BRGY. GUADALUPE,
CORON, PALAWAN

Background Information

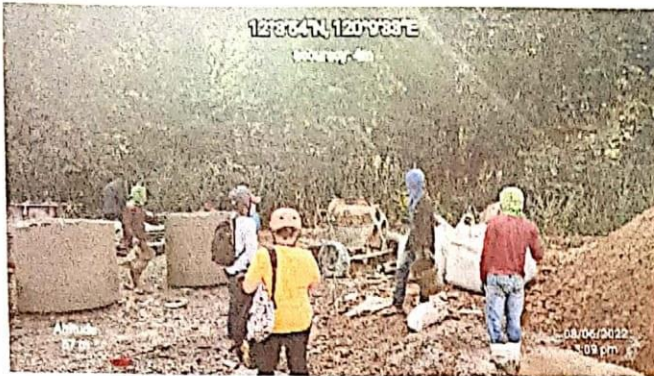
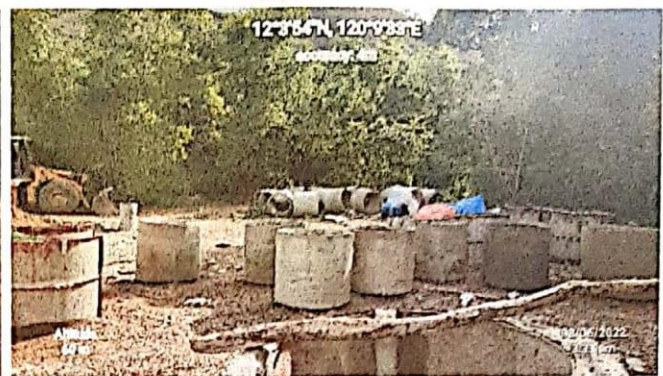
3. Interview with the foreman, Mr. Reynold "Black" Petalbero, mentioned that they were only utilizing the remaining stockpiles in the area in making reinforced concrete pipe culvert (RCPC) (*see Photo Documentation*). He added that these RCPCs are for the concreting projects of the government, mainly the DPWH. He further added that they have complied with the newly released CDO of the MGB.

Workers within the quarry site observed making reinforced concrete pipe culverts (RCPC).

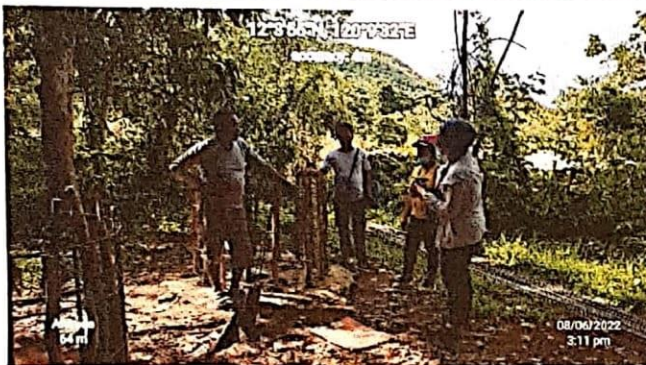
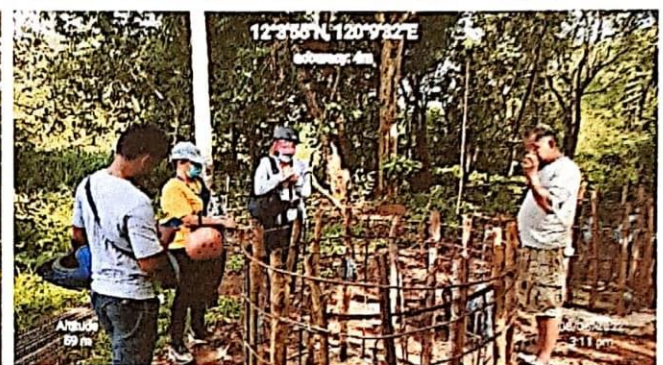
Interview with Mr. Petalbero (Foreman Black). The circular wood are used to shape the steel reinforcements of the RCPCs.

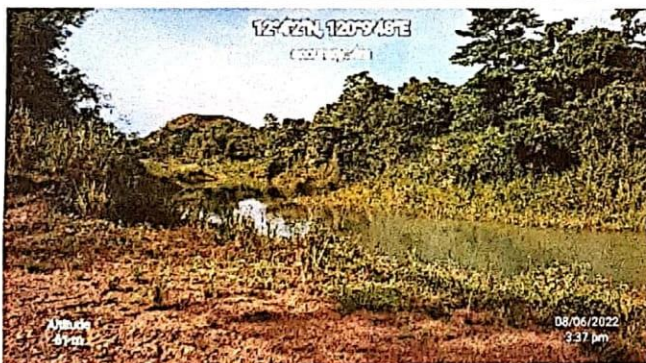
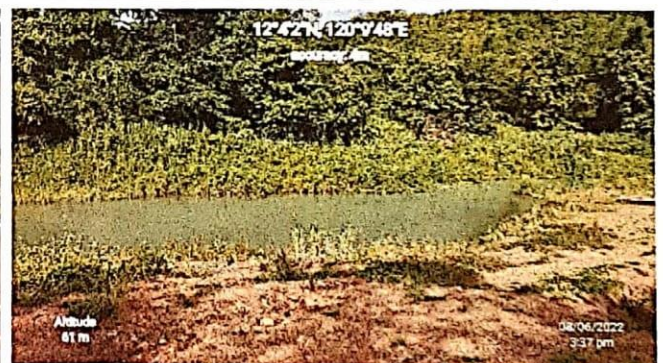
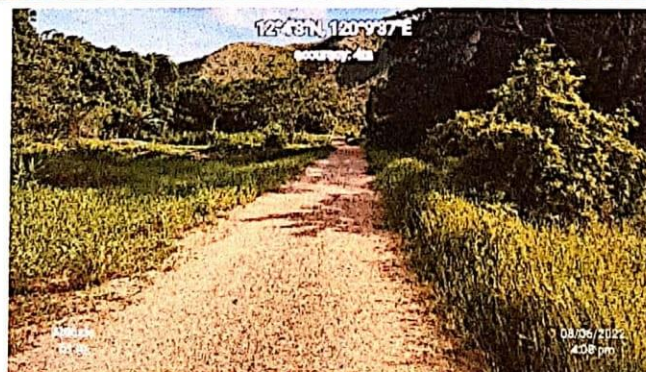
5. On-site observations suggest that there were no recent quarry activity in the area. Evidences such as the undisturbed river channel and rough roads with no track marks were noted. To add, vines are already growing in the area and no quarry equipment was noticed (*see Photo Documentation*).

Current state of the river in quarry site and the road leading to it.

1. The company is recommended to continue the compliance with the released CDO. Should they plan to continue their operations, the acquisition of the necessary documents is required.
