Investigation on the Alleged Environmental Damage

Caused by Sand and Gravel Quarry in Isaub River in

Barangay Isaub, Aborlan, Palawan

SUBJECT: INVESTIGATION ON THE ALLEGED

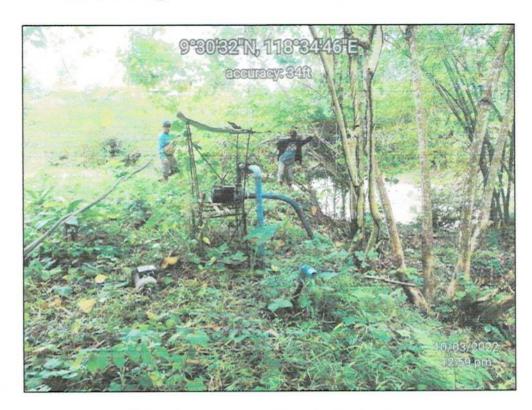
- 2. There are seventy-five (75) signatories thru Ms. Gladys Villarosa that are against for the renewal of the commercial sand and gravel permit of Ms. Violeta Lumis. According to Ms. Villarosa their water source for doing household chores and farming has been affected when the operation of Ms. Lumis started in 2020. Alarmingly, they were forced to buy bottles of mineral water for drinking during the operation of Ms. Lumis. The water pump is located approximately at 9°30'32" N, 118°34'46" E, five to seven meters away from the river (See Photo 1 and 2). Additionally, they claimed that the location of the pump before the quarry, was more than seven meters away from the river;

Photo 2. Water pump along the Isaub River

It is recommended that this matter is further evaluated by the LGU in coordination with the permittee and the residents affected before granting any endorsement for the renewal of the SAG permit;

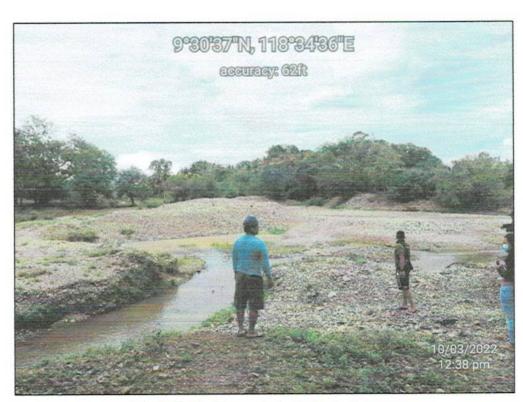
- 4. The stockpile located at approximately 9°30'37" N, 118°34'36" E is situated in the active channel of the river. Smaller particles are carried through the downstream segment of the channel and this will affect the quality of the water. Also, there were no markers nor indication that the stockpile is for disposition. It is recommended that stockpiling should have substantial distance from the river and beyond the recommended buffer zone. It is recommended to be checked by the Provincial Mining Regulatory Board (PMRB) the identification of the undisposed stockpile in the area;

Photo 5. Undisposed stockpile in the area.
