SUBJECT : **CLARIFICATION OF THE INVESTIGATION REPORT**
REGARDING SAND AND GRAVEL EXTRACTION IN CORON,
PALAWAN

SUBJECT : CLARIFICATION OF THE INVESTIGATION REPORT
REGARDING SAND AND GRAVEL EXTRACTION IN CORON,
PALAWAN

Background Information

Brgy. San Nicolas

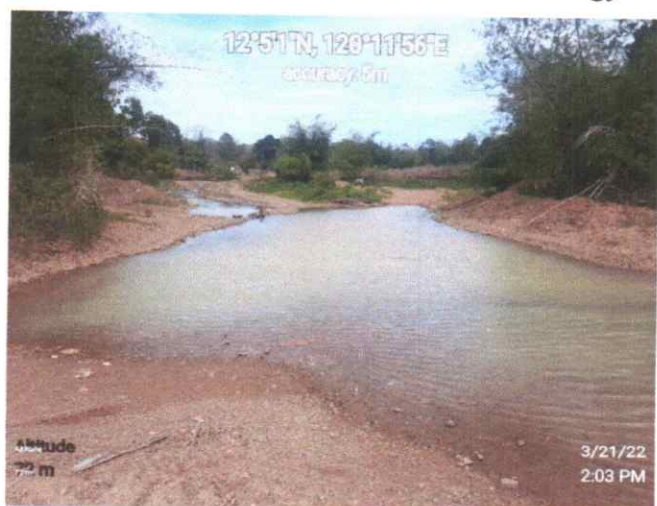
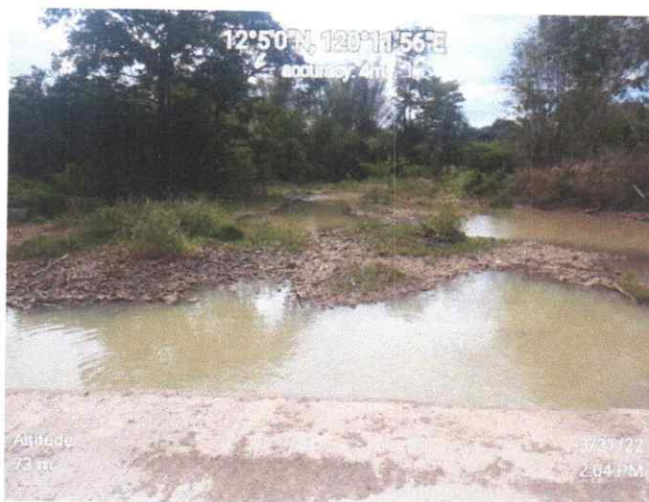
5. This was confirmed during the investigation as no quarry equipment nor sacks of sand and gravel are observed in the area. Plants can also be observed on the piles of sediments implying no recent extraction was made.
6. The area, however, needs rehabilitation as the flow of the river is blocked by sediments. As the river is shallow, flooding in the area may heighten (*see Photo Documentation*).

SAG excavation in Brgy. San Nicolas. Piles of sand and gravel were left in the river channel, blocking its natural flow, upon ceasing of quarry operations.

1. Based on the investigation, the former operator is suggested to rehabilitate the area to lessen the effect of flooding.
