SUBJECT : **INVESTIGATION REPORT ON THE QUARRY OPERATION
ALONG MALABNAO RIVER IN BRGY. SAN RAFAEL,
BUSUANGA, PALAWAN**

SUBJECT : INVESTIGATION REPORT ON THE QUARRY OPERATION
ALONG MALABNAO RIVER IN BRGY. SAN RAFAEL,
BUSUANGA, PALAWAN

Background Information

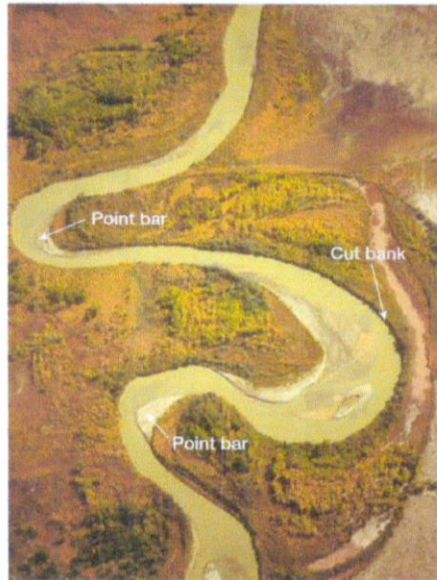
7. Mrs. Alexis Libertad-Tolarba was also interviewed by the undersigned (*see Photo Documentation*). It was mentioned that Mr. Sariego was conducting extraction further upstream of the inspected area. Given the undersigned's limited time during inspection, the mentioned area will be inspected the following week. She added that on this site, a lot of bamboos have already fallen due to the removal of earth materials beneath its roots. She also mentioned that the erosion along cutbank (Figure 2) has also been hastened due to the quarry activity in the area.

Figure 2. Parts of a river. *Excerpted from Essentials of Geology by Lutgens, Tarbuck, & Tasa (2011).*

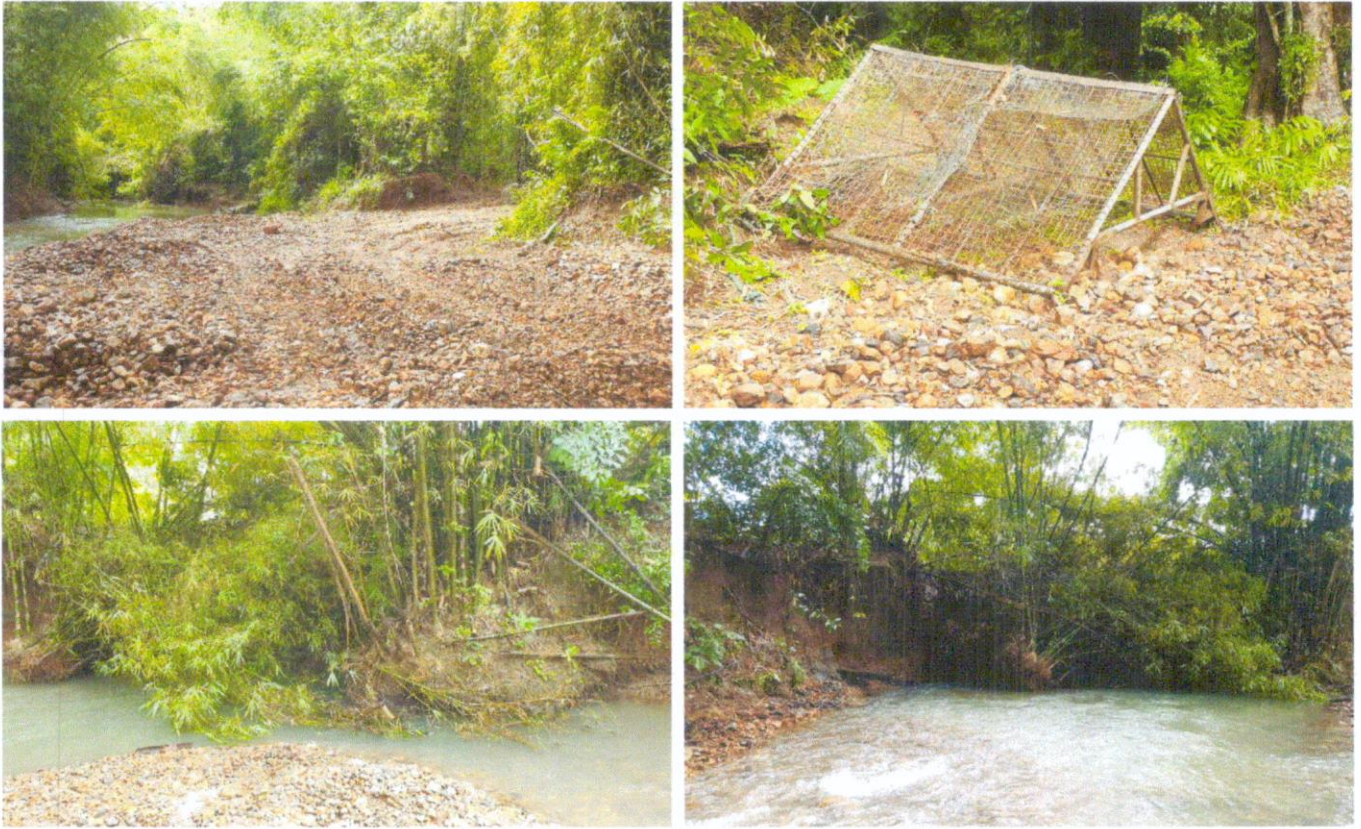
Annex-1

Last 30 September 2022, a verbal complaint was received by the undersigned regarding sand and gravel extraction in Brgy. San Rafael, Busuanga, Palawan. It was mentioned that the quarry activity was operated by Mr. Frederick Sariego. Based on the sent photographs (*see Annex-1*) of the complainant, Mrs. Alexis Libertad-Tolarba, erosion along riverbanks was aggravated by the quarry operation.

Photographs sent by the complainant, Mrs. Alexis Libertad-Tolarba. As mentioned by her, these were taken last 02 October 2022. No ongoing excavation was seen however, evidence of recent movement may be observed.

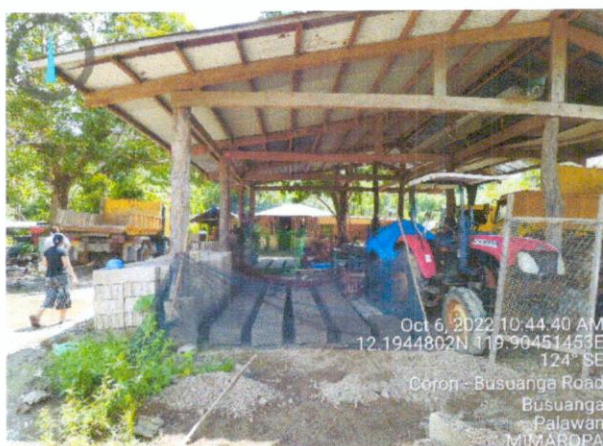
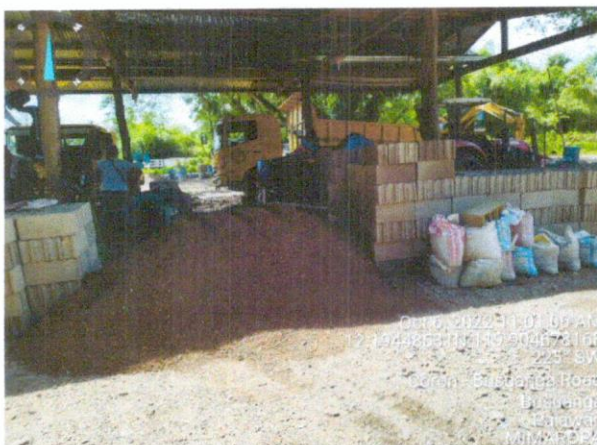
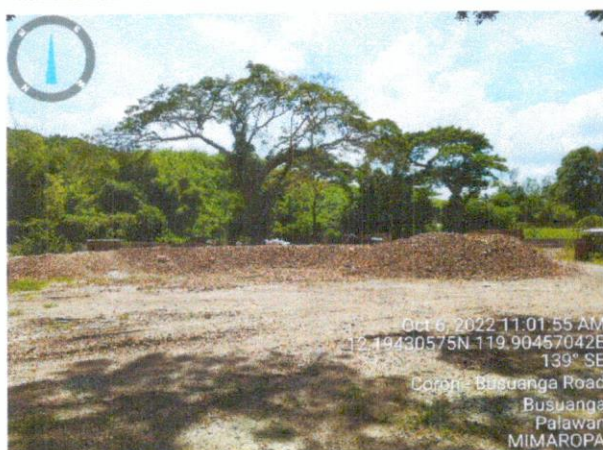
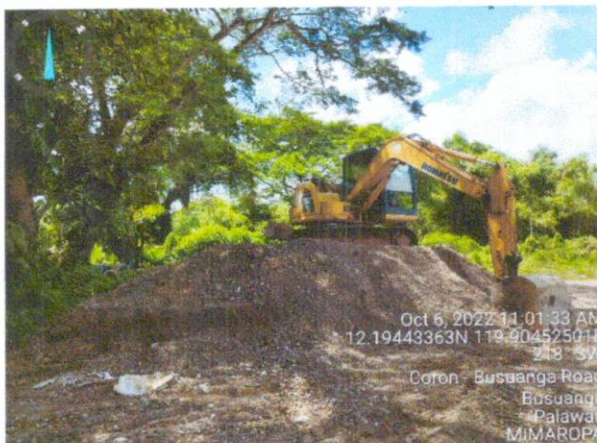
4. Upon arrival in the area, stacks of hollow blocks and stockpiles were observed. Parked heavy equipment was also noted. As mentioned by the councilors, these trucks are owned by the province of Palawan and were only parked in the area. Moreover, an ongoing sand and gravel operation was observed along the bank of the river (*see Photo Documentation*). As per the statements of the councilors, the proponent supplies to different government projects such as Rural Health Unit, slaughterhouse, and others within the municipality of Busuanga. The undersigned asked Kgw. Sariego if her husband has the necessary permits for the activity but unfortunately, she was not certain about the papers of the business.

The observed hollow blocks and stockpiles near the quarry site of Mr. Sariego. It was explained by the barangay councilors that the yellow heavy equipment in the area is owned by the province of Palawan and was only parked in the site.

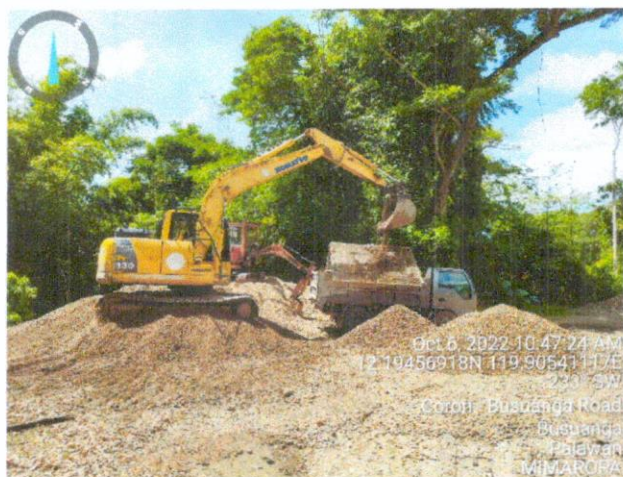
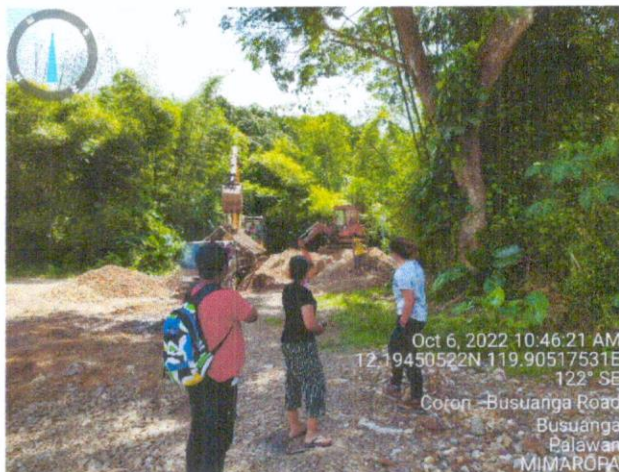
Ongoing extraction on the stockpiles of the proponent. The necessary permits/clearances were asked to Kgw. Sariego however, all the documents were kept by Mr. Sariego.

1. It is recommended to Mr. Sariego that extracting without a valid permit is considered to be illegal, hence, should cease from conducting extraction in the area. It is advised to first secure the necessary permits prior to the extraction of sand and gravel.
2. Provided that the proponent conducted extraction without a permit, this constitutes to violation of Section 103 of Republic Act 7942, otherwise known as the Philippine Mining Act of 1995.

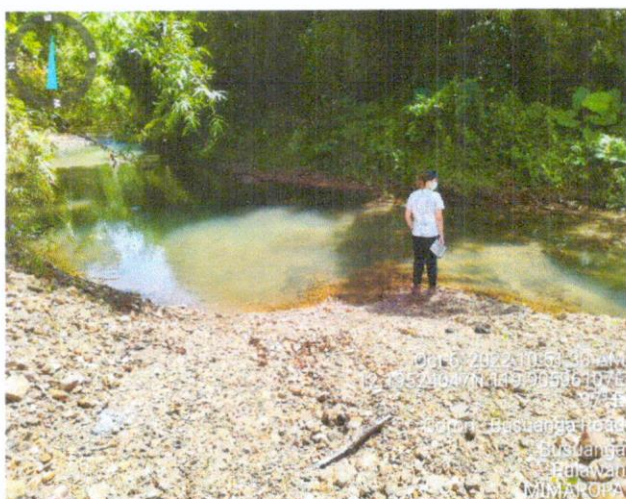
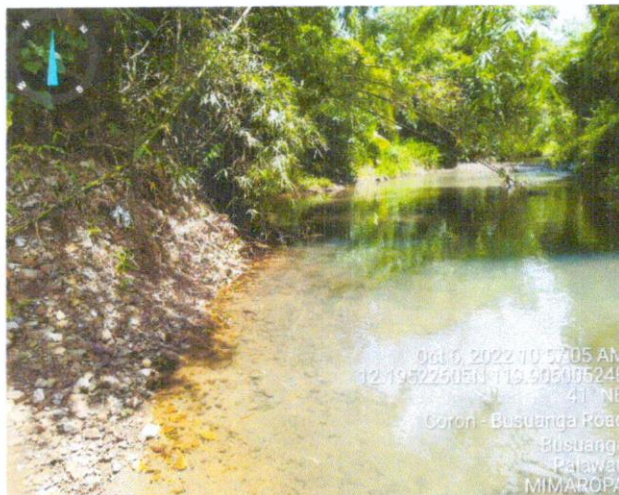
6. It was noted along Malabnao River that some portion of it was blocked by a makeshift road (*see Photo Documentation*). Some bamboos have also been destabilized and have fallen into the river without the soil to anchor and support it.

Current state of Malabnao River. The makeshift road slightly blocks the flow of the river. Few fallen bamboos were also noted.

3. Mr. Sariego is also recommended to rehabilitate the area to limit the effects of erosion. Removing the blockage of sand and gravel along the river channel is suggested.
4. Endorse this to PMRB to clarify why they have issued an order of payment for the penalty. Moreover, the PMRB Coron is also requested to further explain for allowing the proponent to conduct extraction without a permit.

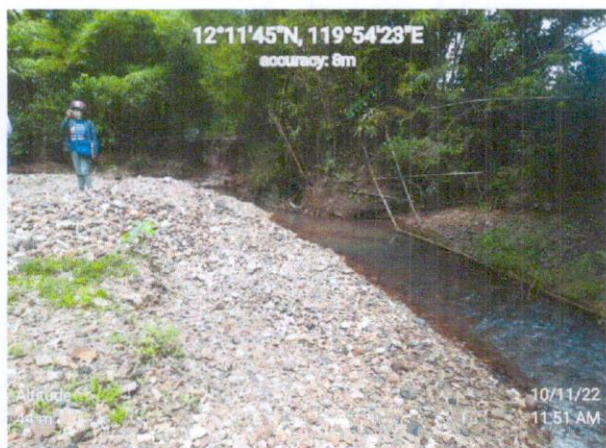
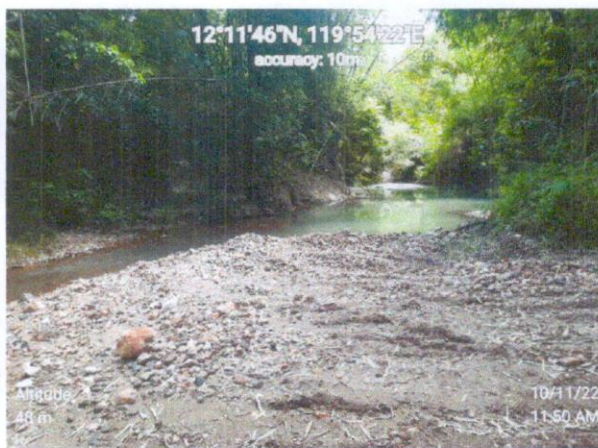
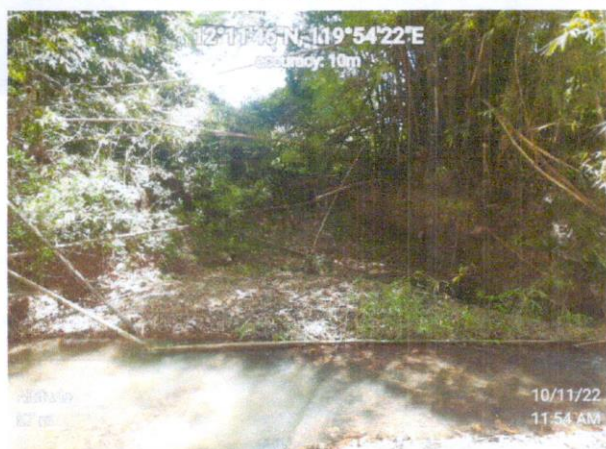
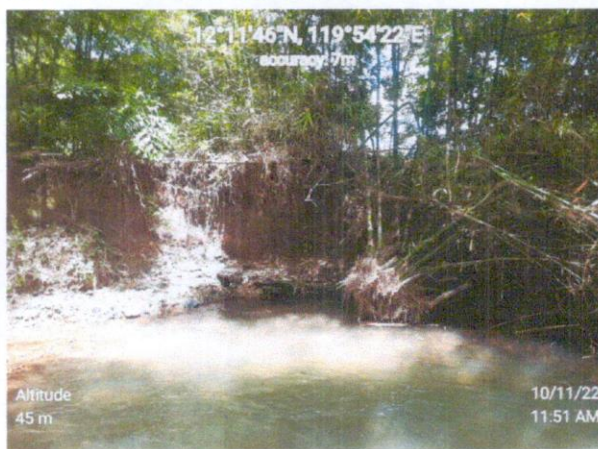
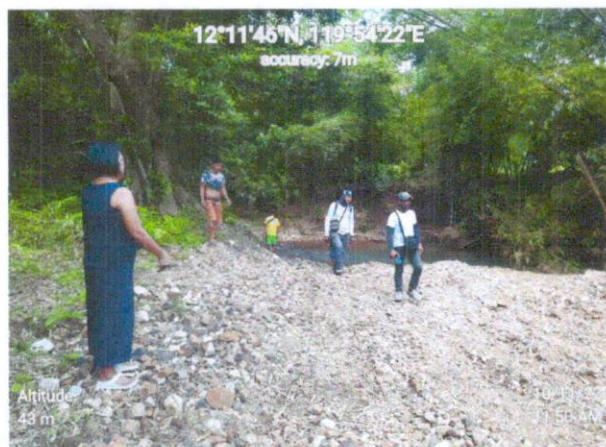
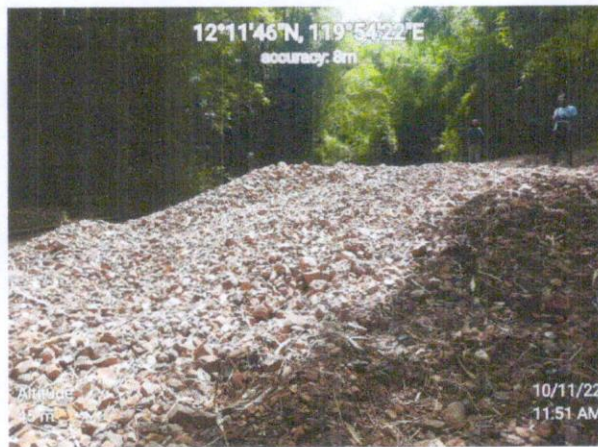
9. A follow-up monitoring was conducted on 11 October 2022 on the mentioned site of Mrs. Tolarba. Numerous fallen bamboos were indeed confirmed in the area, a likely result of very rapid erosion of the cut bank as the bamboos are still alive without it being properly attached to a soil substrate. To add, a large pile of sand and gravel obstructs the flow of the river and narrowed the channel width (*see photo documentation*). As river system is dynamic in nature, it compensated for the blocked inner bank by moving laterally outward towards the cutbank. As a result, the cutbank became more prone to erosion. The locals were also asked regarding the occurrence of flooding during the investigation to verify other possible causes of the rapid erosion in the site. According to them, the last flood has occurred two years ago.

The current state of the quarry site mentioned by Mrs. Tolarba. It was observed that earth materials obstruct the flow of Malabnao River. Further, bamboos were seen detached and some that have fallen to ground.
