SUBJECT : **REPORT ON THE ILLEGAL EXTRACTION OF SAND AND GRAVEL IN BRGY. TININTINAN AND BRGY. POBLACION IN THE MUNICIPALITY OF ARACELI, PALAWAN**

SUBJECT : **REPORT ON THE ILLEGAL EXTRACTION OF SAND
AND GRAVEL IN BRGY. TININTINAN AND BRGY.
POBLACION IN THE MUNICIPALITY OF ARACELI,
PALAWAN**

Background Information

PHOTO DOCUMENTATION

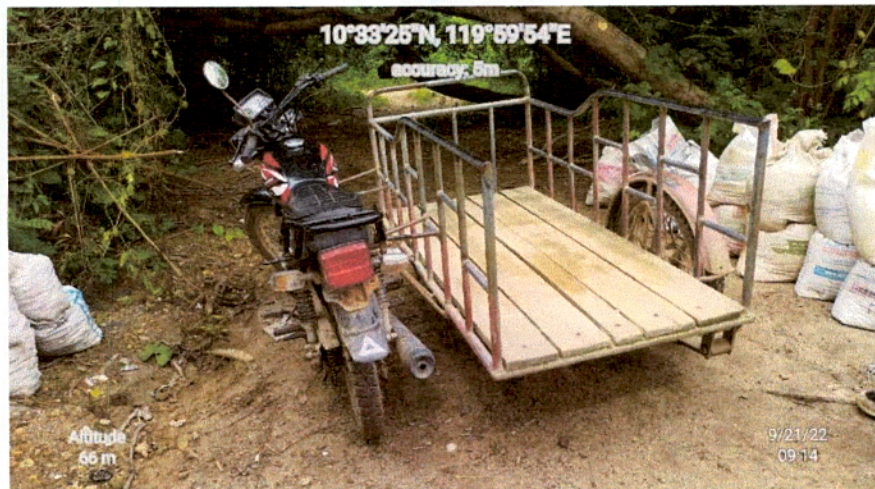
1. EnMO Mr. Gregas and the Undersigned first conducted inspection in Brgy. Poblacion. The undersigned then noted sacked sand and gravel along the coast (photo 2). Mr. Teddy Ballidor and his topdown (photo 1) were also noted in the vicinity.
2. The undersigned then interviewed Mr. Ballidor if he has any information on who utilizes then sacked SAG observed.
3. Mr. Ballidor insisted that he has no idea on who owns the SAG material and claims that he is checking at the coastal area when the undersigned saw him. The undersigned then elucidated to Mr. Ballidor the penal sanctions of such

Photo 1. Topdown belonging to Mr. Teddy Ballidor

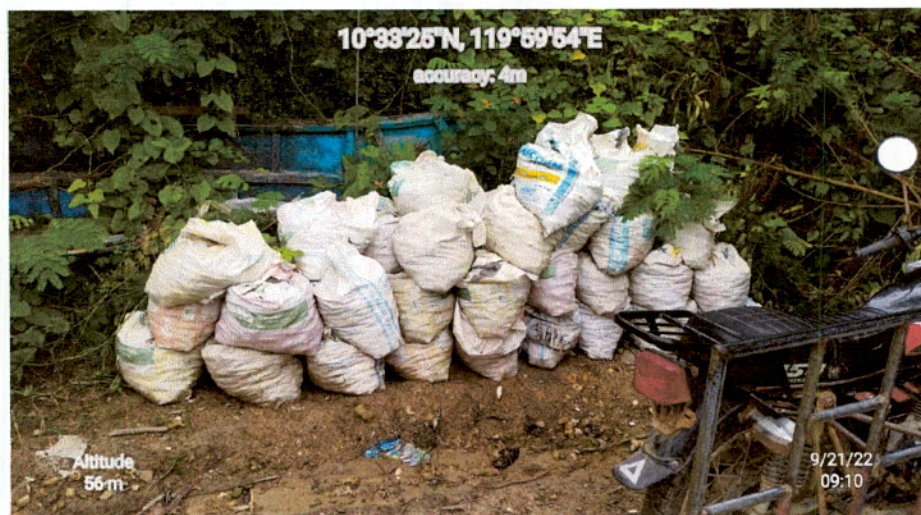
4. There are 100 sacked SAG which are of notably different color / composition compared to the materials within the coastal area of Brgy. Poblacion.
5. The undersigned then interviewed two fisherfolks within the area. They stated that such materials were sourced from Kutad Island. However, they did not know who transported the SAG.

Photo 2. Sacked SAG materials observed in Brgy. Poblacion, Araceli, Palawan

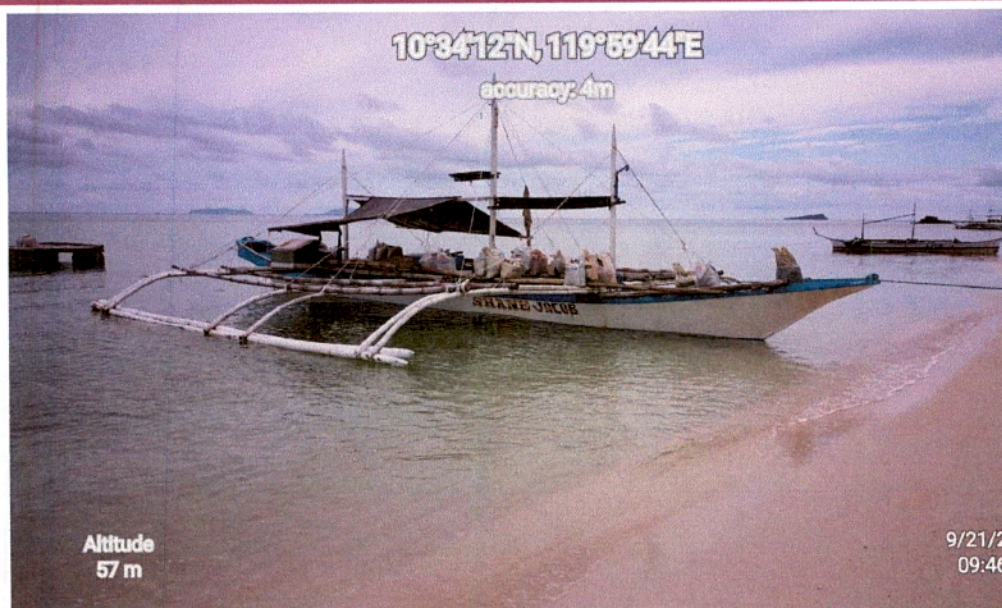
6. The undersigned and Mr. Gregas then went to the beach of Brgy. Tinintinan and saw sacked SAG materials with a different provenance loaded in *Shane Jacob* Boat and along the coast (photo 3). There are 22 sacks of SAG materials observed (photo 4 and 5)

Photo 3. Shane Jacob boat loaded with SAG materials

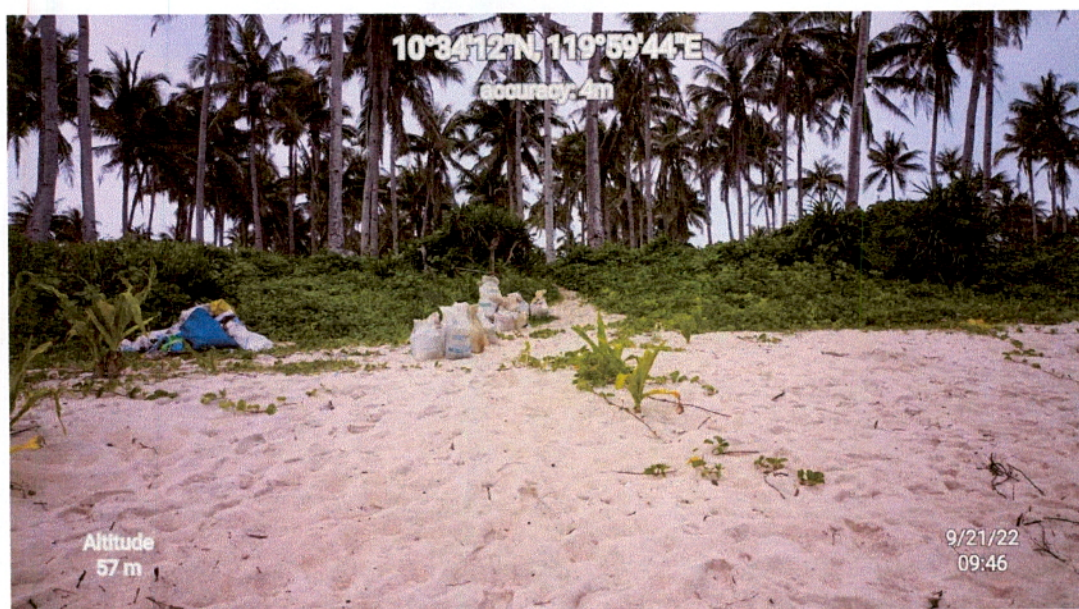
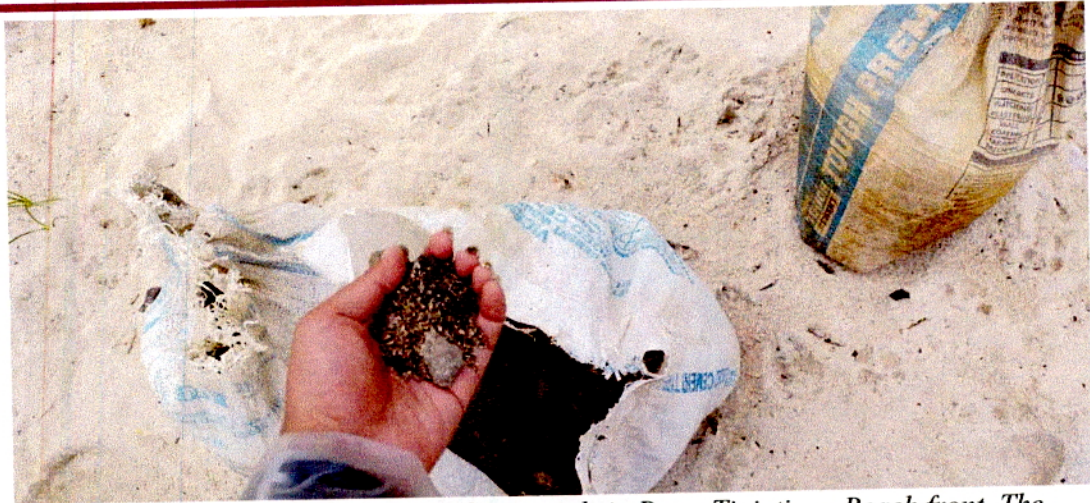
Photo 4 and 5. Observed Sacked SAG materials in Brgy. Tinintinan Beach front. The sacked SAG has a different material than the beach sand, indicating different source.

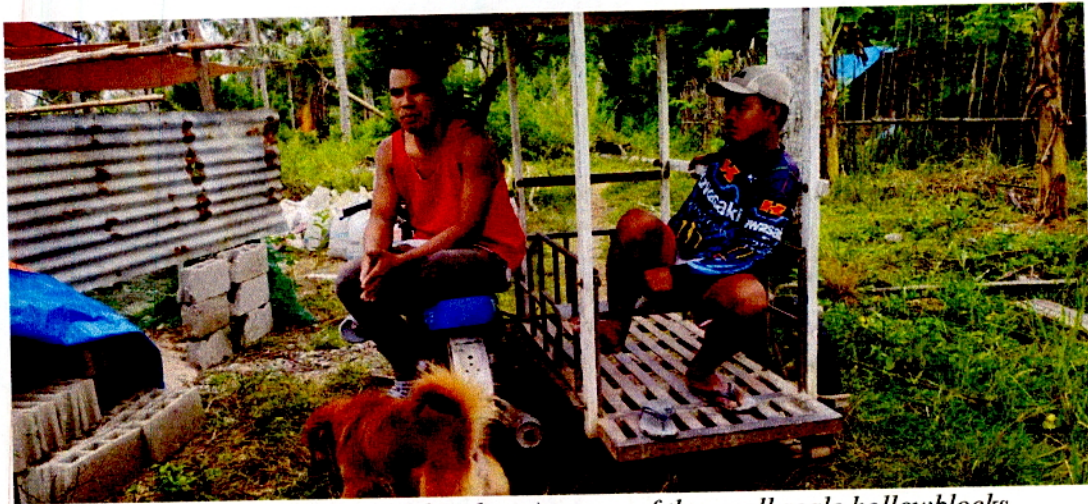
8. Upon further investigation, the undersigned found the small scale hollow block production of Mr. Joey Escubin. Fortunately, Mr. Escubin is present at the time of inspection (photo 6).

Photo 6. Mr Joey Escubin (red tank top) owner of the small scale hollowblocks

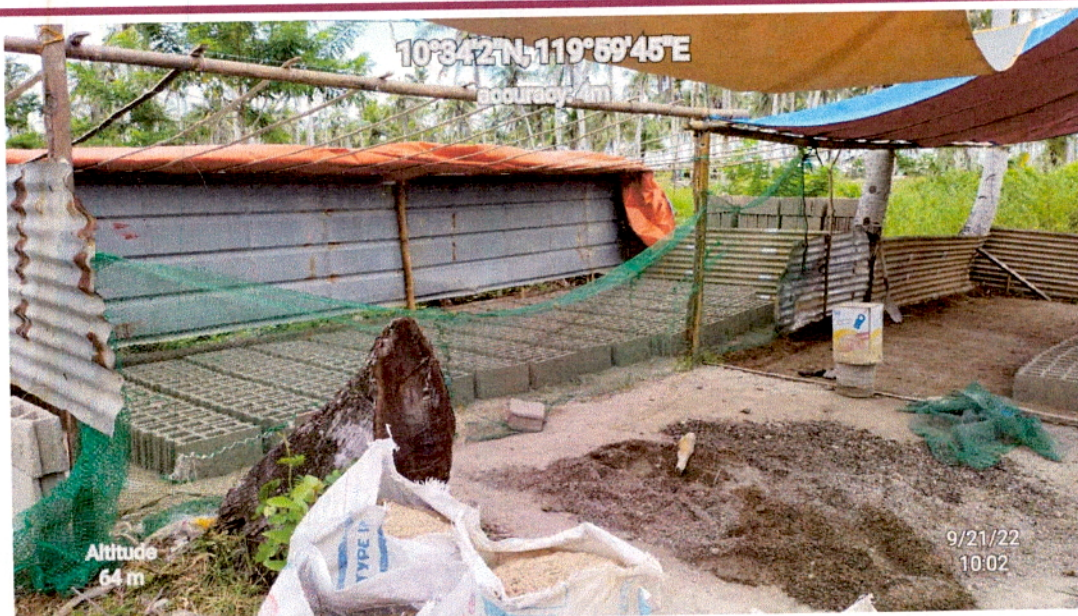
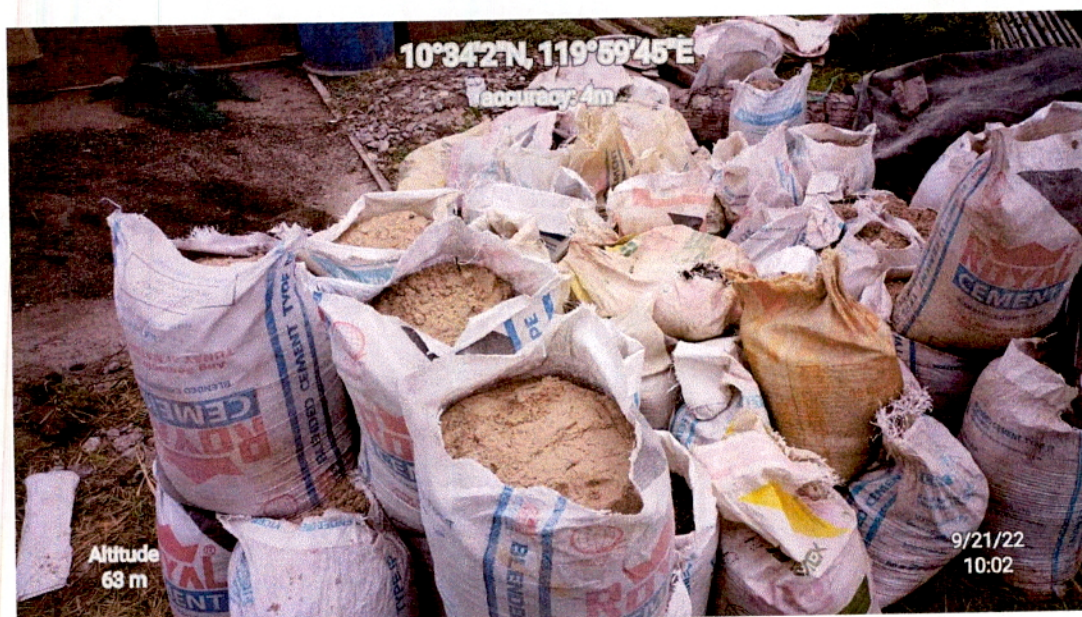
Photo 7 and 8. SAG materials utilized for the production of hollow blocks owned by Mr. Joey Escubin.

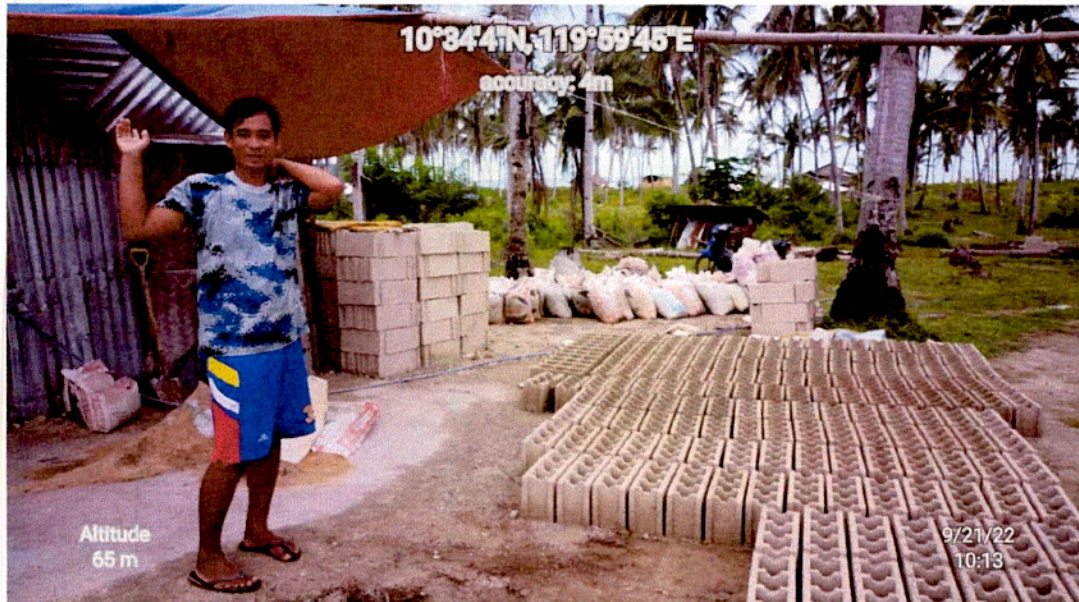
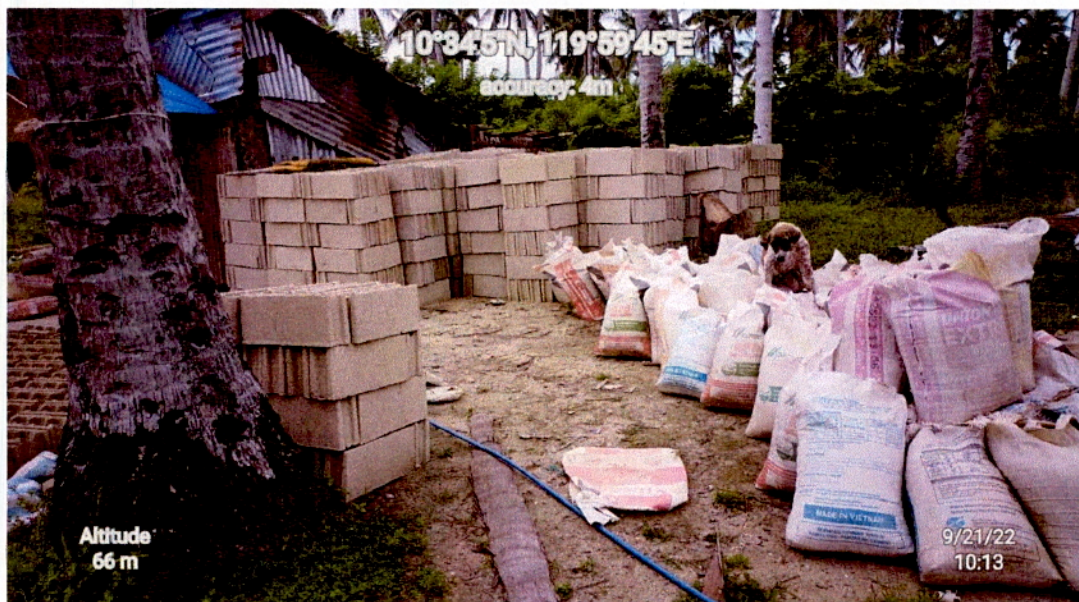
11. Upon interview, caretaker Jeremy said the hollowblocks production (photo 9 and 10) were owned by Mr. Jerry Lledo who works in the Government Municipality of Araceli.

Photo 9 and 10. Hollowblocks production owned by Mr. Jerry Lledo.

4. Strict implementation of environmental laws must be incessantly observed by the LGU particularly Mr. Jerry Lledo who allegedly works in the Municipal Government of Araceli, Palawan.
5. Further investigation of the reported extraction in Kutad Island,
6. Such direct extraction from the ground should be discouraged as it cannot be replenished and can pose fall accident when left unchecked and uncovered.

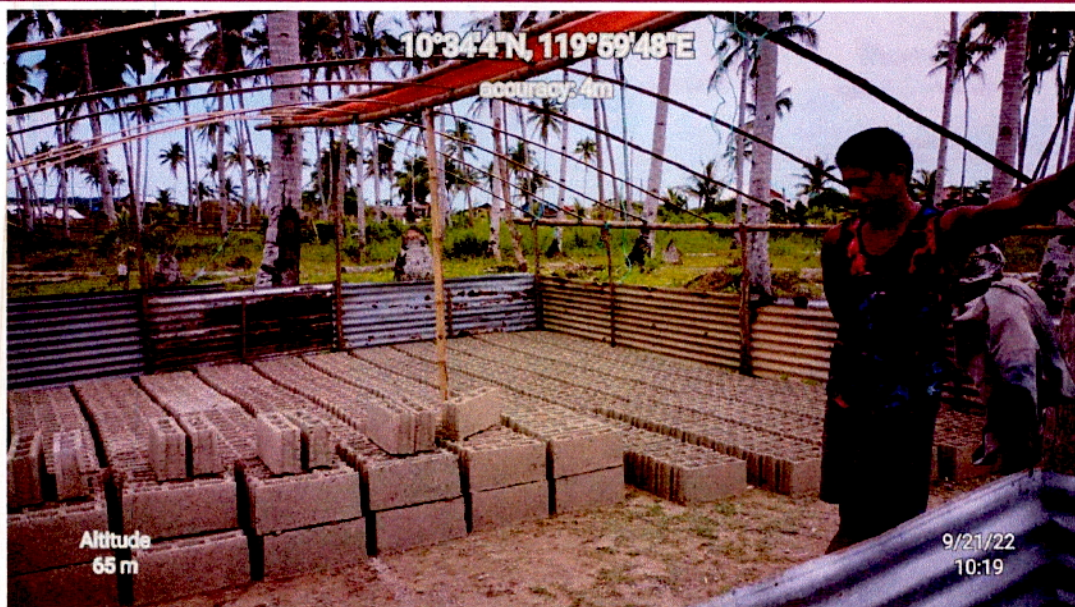
12. Another production is owned by the interviewed Mr. Norjun Ezuleo (photo 11).
13. Some of the materials were sourced by extracting directly on the ground (photo 12).

Photo 11. Hollowblocks production owned by Mr. Norjun Ezuleo.

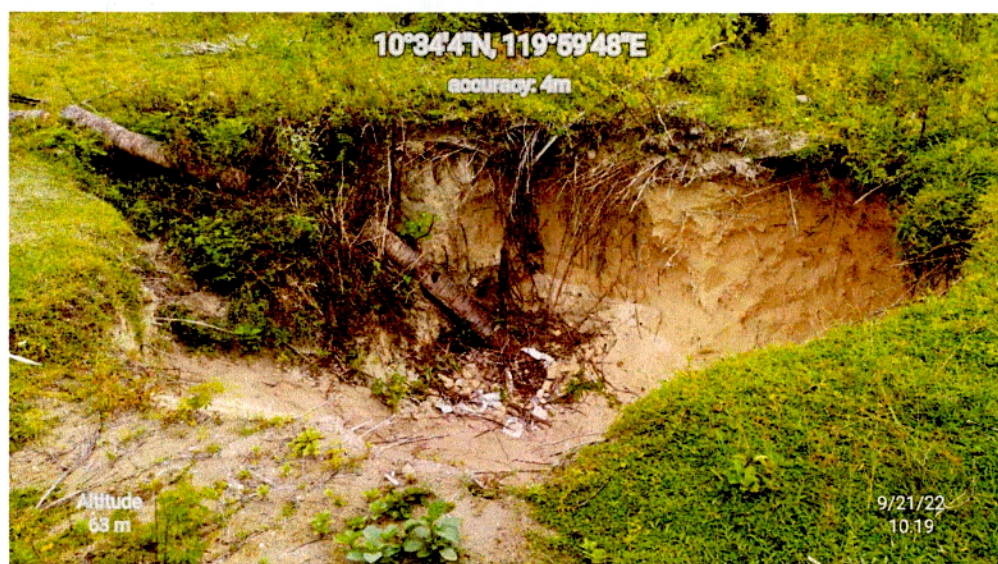
Photo 12. Source of Sand Materials of Mr. Ezuleo. This pit poses a safety hazard.
