**SUBJECT: REPORT ON THE COASTAL ASSESSMENT
CONDUCTED AT CORON BAY RECLAMATION
PROJECT**

SUBJECT : **Back-to-Office-Report: Official Travel to Brgy. 5, Coron, Palawan on July 10 – 15, 2022 to conduct a coastal assessment on possible impacts of the reclamation done by 428 construction.**

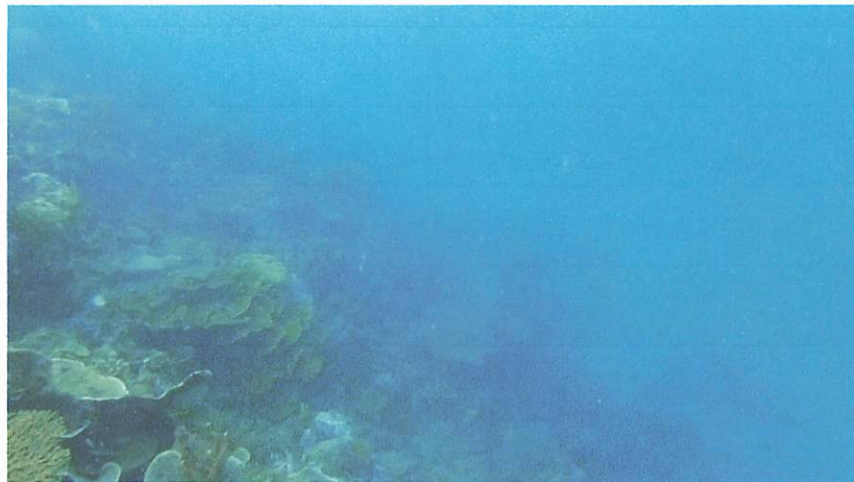
Figure 3. Cloudy and low visibility reef in Siete pecados.

The second site surveyed for siltation is Discovery Island at approximately 350 meters on the right side of the reclamation area when facing the sea. The site had very poor visibility due to siltation (Figure 3). Coral patches in the area were seen covered with silt and will most likely die in the coming days due to smothering (Figure 4).

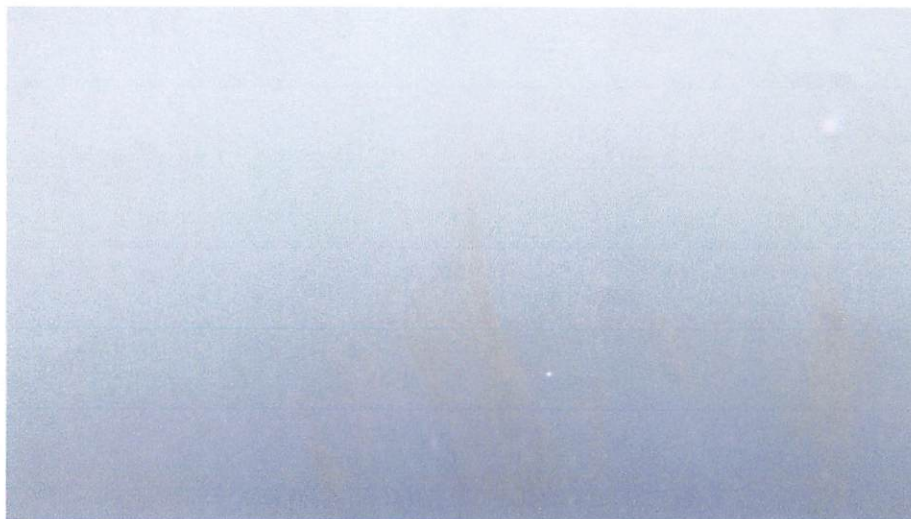
Figure 4. Very low visibility in a mixed habitat of seagrass and coral colonies

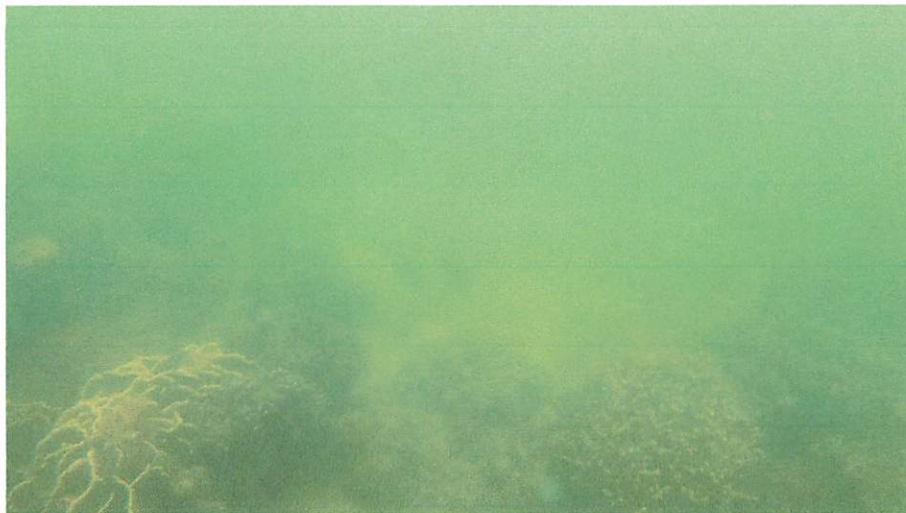
Figure 5. Heavily silted coral patch in front of Discovery island

Two separate areas in front of the reclamation area was surveyed to determine the impacts of siltation on the coastal environment. Heavy siltation was observed in both stations, 2-3 meters away from the reclamation area (Figure 5 & 6).

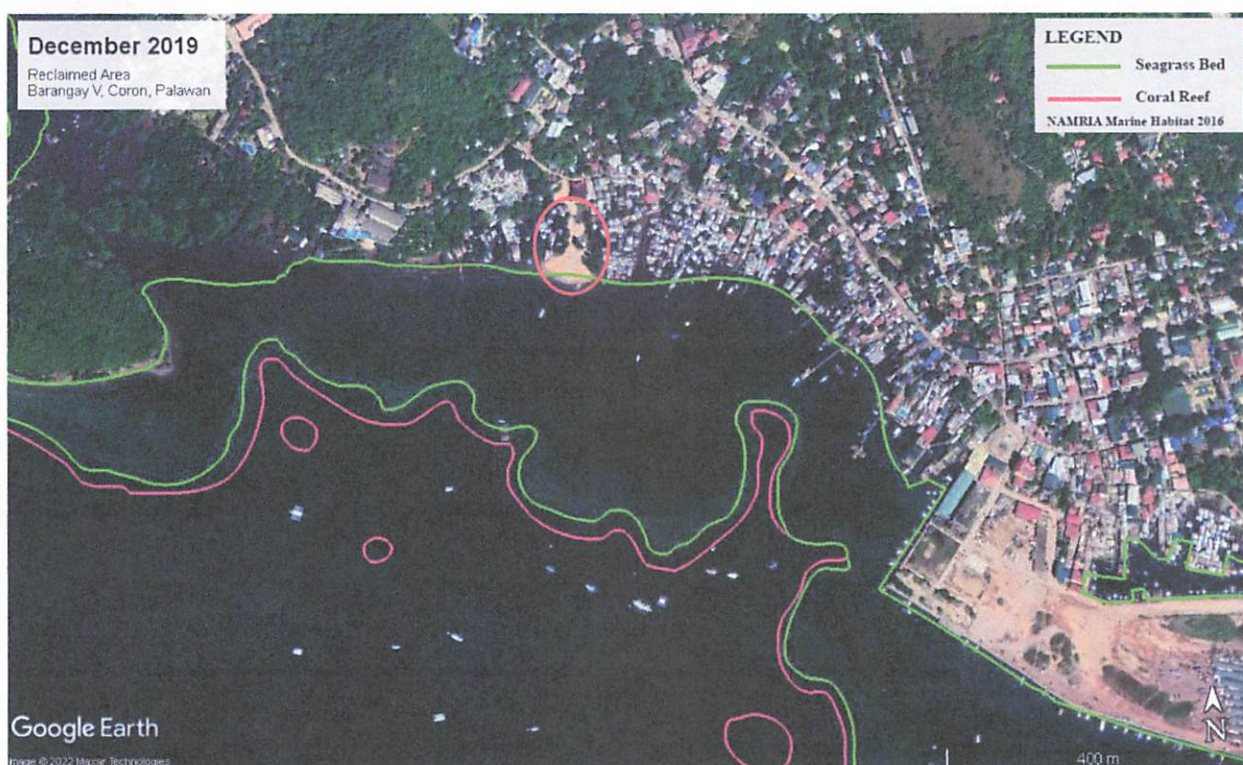
Figure 8. Google satellite image captured in December 2019;

A small area has been reclaimed in 2019 (Red Circle). Based on the NAMRIA Marine Habitat 2016, a large area of seagrass bed (green outline) and coral reef (pink outline) on the edge are present in the reclamation site. Based on the interview with several locals, the reclamation site used to be a good fishing ground where you can buy fresh fish from fishers. The information gathered from the interview confirms that the coastal area was originally a healthy seagrass ecosystem with patches of coral colonies which is now the reclamation site.

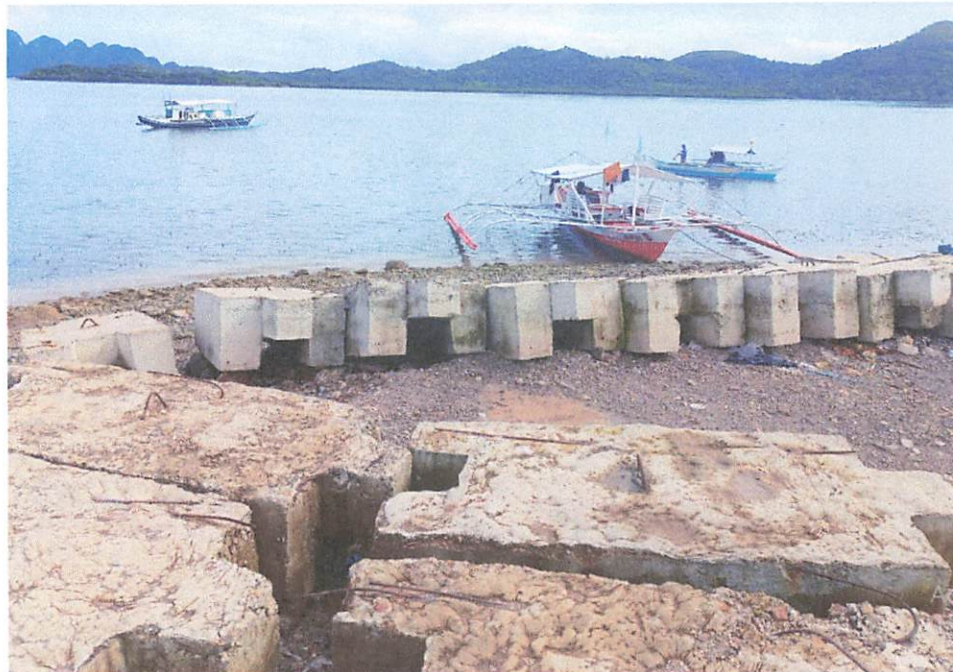
Figure 11. Cement post left unused for the construction of the seawall

The photo above shows the cement post that will be used for the construction of the seawall surrounding the reclamation site.

1. Immediate construction of the seawall surrounding the reclamation area to prevent further damage brought about by increased turbidity and siltation.
2. Issuance of a Notice of Violation (NOV) and imposition of appropriate penalties.
