SUBJECT : **MONITORING REPORT ON STATUS OF RISK REDUCTION
EFFORTS ON OIL SLICK FROM FROM MT PRINCESS EMPRESS
WITH THE CONSOLIDATED RESULTS ON RAPID RISK
ASSESSMENT**

SUBJECT : **MONITORING REPORT ON THE STATUS OF RISK REDUCTION EFFORTS ON OIL SLICK FROM MT PRINCESS EMPRESS WITH CONSOLIDATED RESULTS ON RAPID RISK ASSESSMENT**

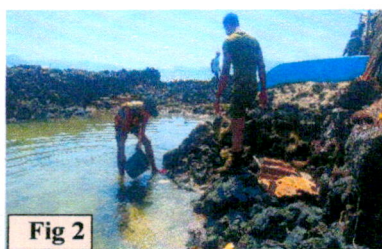
- Joined the Marine Battalion Landing Team -3 in responding to the report of oil slick/sheen in Calumpang, Calawag, Taytay, Palawan (Fig 2)
- Volunteers, residents and BLGUs started improvising oil spill boom using coconut husks, among others (Fig 3 and 4)

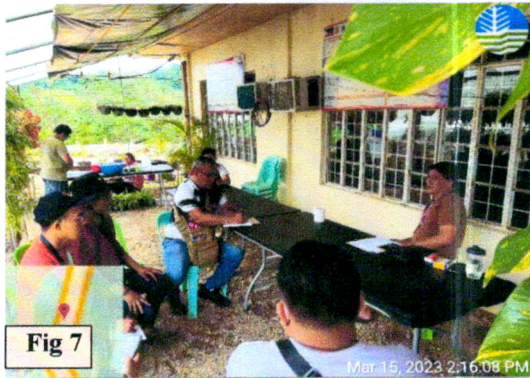
Fig 7

- Coordination to the Municipal Disaster Risk Reduction Management Officer (MDRRMO) with regards the progress LGU monitoring and the deployment of personnel for water

sampling in designated areas reported of oil presence sightings (Fig 7). The coordination was spearheaded by delos Angeles.

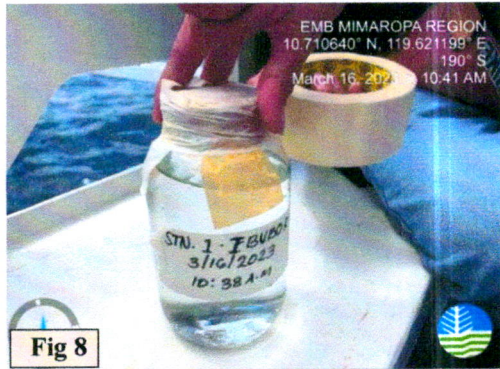
Fig 8

- Water samples taken in three areas suspected to have been contaminated (Fig 8). The results turned out to have all passed the standard of oil and grease contamination (Fig 9).
- Information Officer Rodel M. Dorado (Dorado) along with delos Angeles, and MGB embedded staff Francis Jade Cometa, among others, were in non-stop coordination with the various sectors, and the Barangay Local Government Units in the coastal area. They actually participated in the production of improvised spill boom.
- The PCG has spill booms, absorbent pads and protective gears available anytime needed.

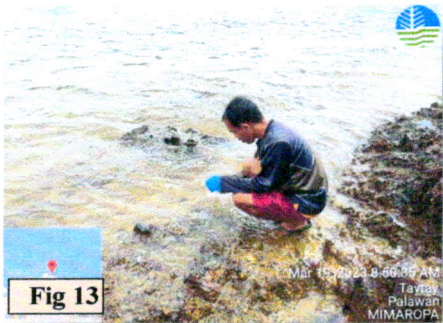
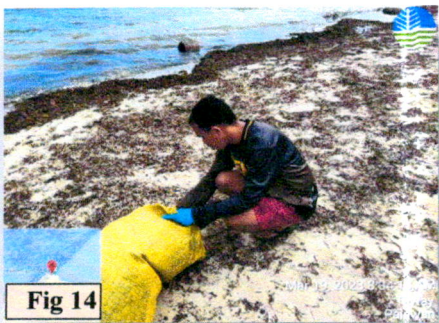
- Dorado constantly monitored the coastal area of nearby Taytay Bay and did not find traces of oil slick. (Fig 13 & 14)

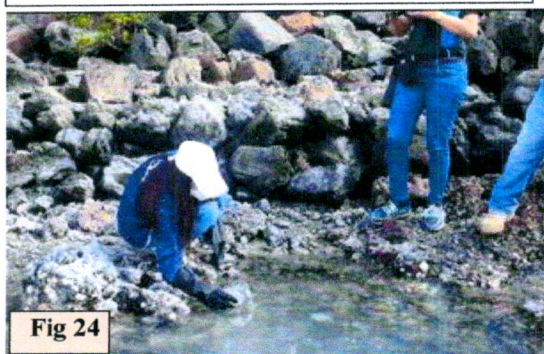
Photo documentation: Shown above (Fig 23) is the vicinity of Amogues. Fig 24 shows the EMB representative taking water sample. Fig 23 is a BFAR representative on interview with Pastor Oscar Escala, a seaweeds farmer. Fig 26 is delos Angeles catching the drone, and Fig 27 shows the actual immersion of Team 1 in the community making the interview.

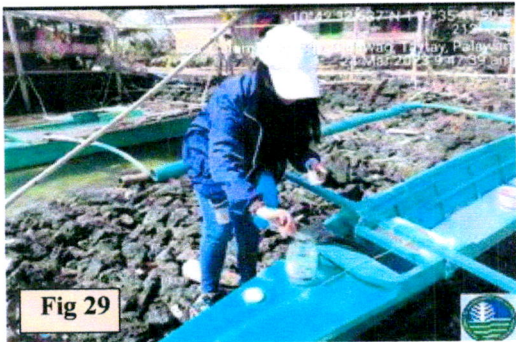
Photo documentation: Fig 28 above shows the vicinity of Calumpang. Fig 2 again shows the the same EMB representative taking water sample in Calumpang. Fig 30 shows that houses in the area are in the easement zone. Fig 31 shows newly harvested seaweeds of good and pricy species called “Giant. The drums in Figure 32 contain debris contaminated with oil tarts but not really of large amount.

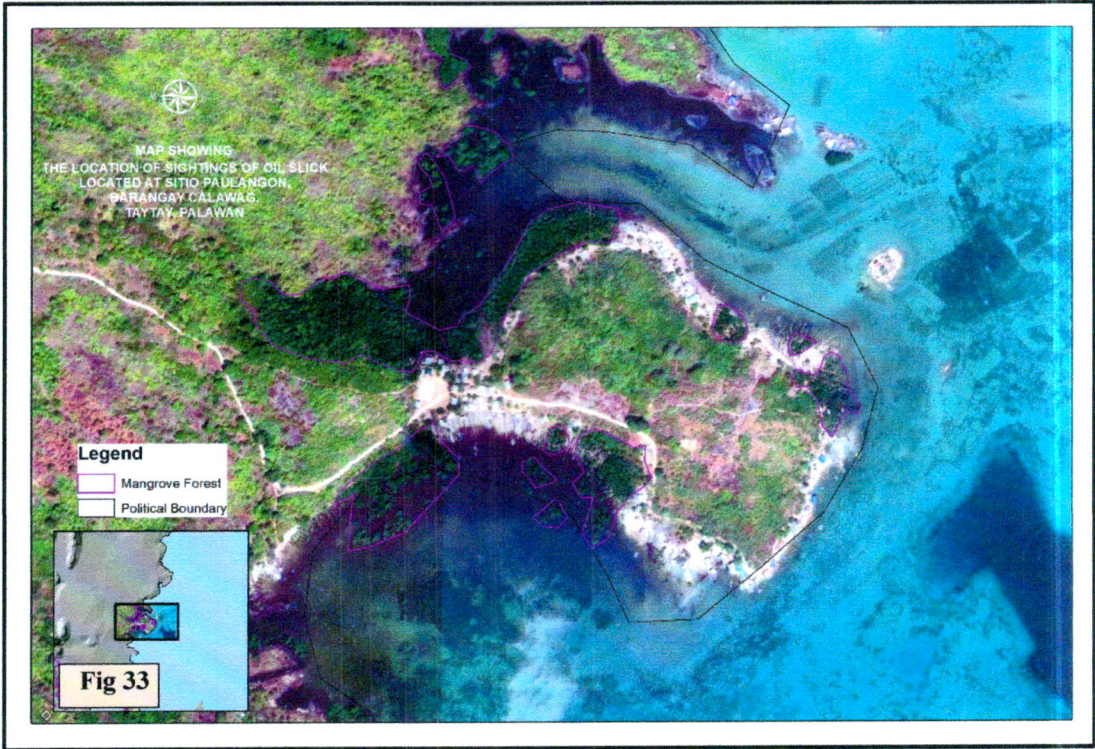
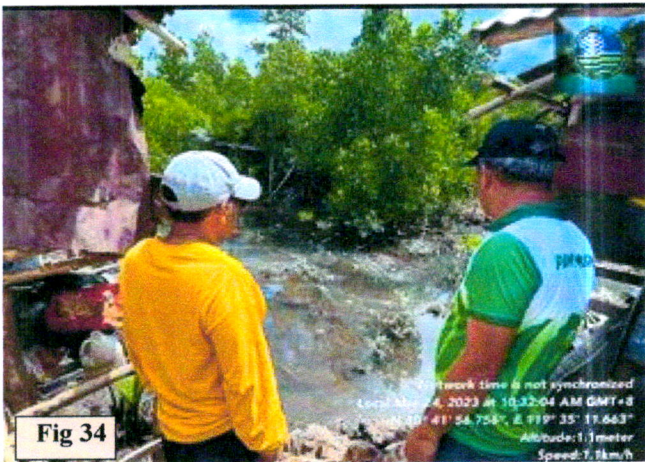
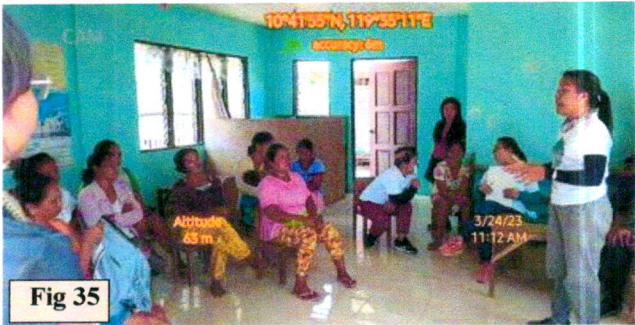
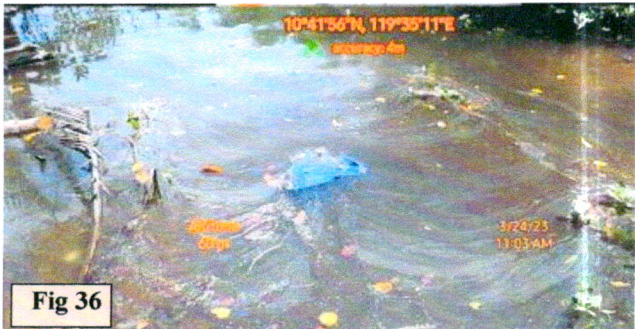
Photo documentation: The vicinities of Paulangon is shown in Fig 33. Figure 34 shows the CENRO and Palawan Council for Sustainable Development Staff sighting oil sheen on the water in immediate mangroves habitat. Fig 35 shows a CENR Office staff taking the chance on doing Information, Education, and Communication (IEC). Fig 36 shows the water clear having oil sheen. The place is nearly an islet and some houses are already reached by the tide.

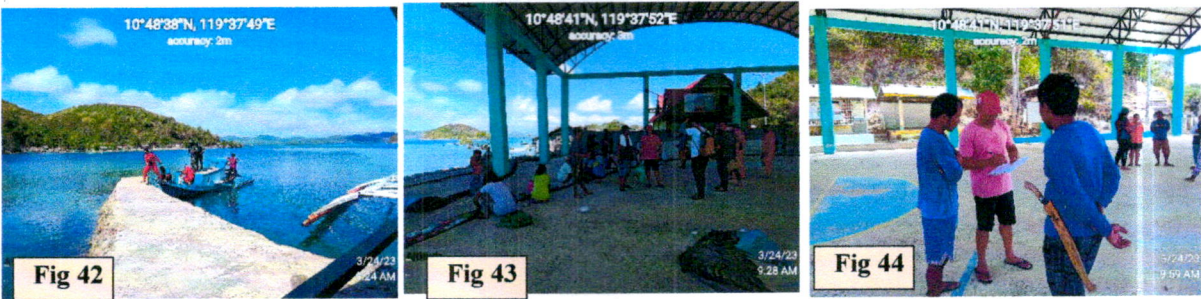
Photo documentation: Fig 41 shows Barangay Biton including its immediate bay around. Dinamayan Island is also shown southeast of the mainland barangay. Fig 42 shows the wharf where the team anchored. Fig 43 shows some residents making readying oil spill boom, and Fig 44 shows the team member doing the actual interview.

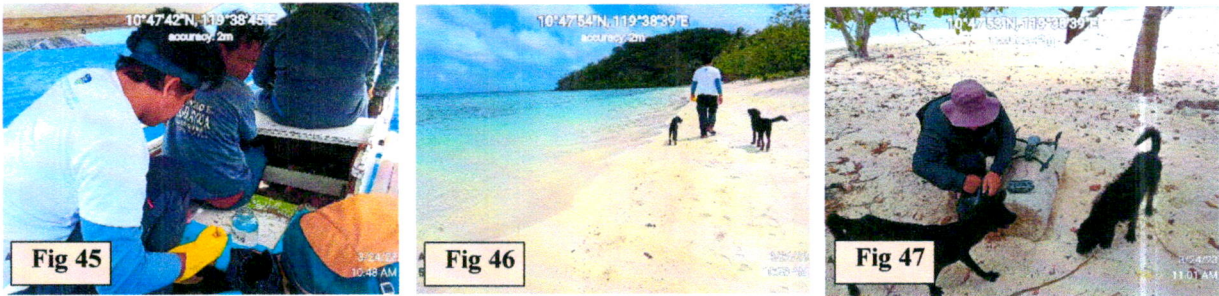
Photo documentation: Above Fig 45 shows MGB embedded personnel assisting water sampling. Fig 45 shows the same MGB embedded personnel doing coastal checking, and Fig 47 shows PCSD representative setting up drone to be flown.

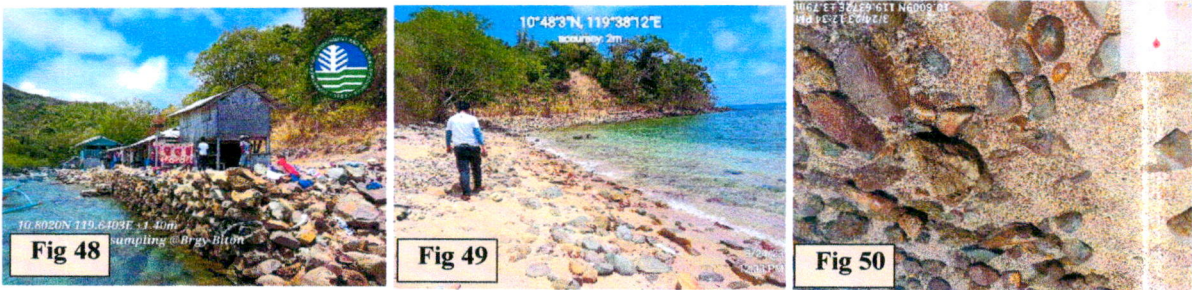
Tagpao (Figures 48, 49, 50)	
Location	10° 48' 02" N 119° 38' 11" E
Assessed	12:26 Noon onwards of March 24
Respondent	Included in the 12 for the whole Biton
BIODIVERSITY	– see Table 13
DEGREE OF OIL	- see Table 14

Photo documentation: Above Figs 48 and 49 shows the same MGB embedded personnel doing a round of coastal checking. Fig 50 is a close-up shot of the foreshore which, accordingly is clean or free of oil contamination.

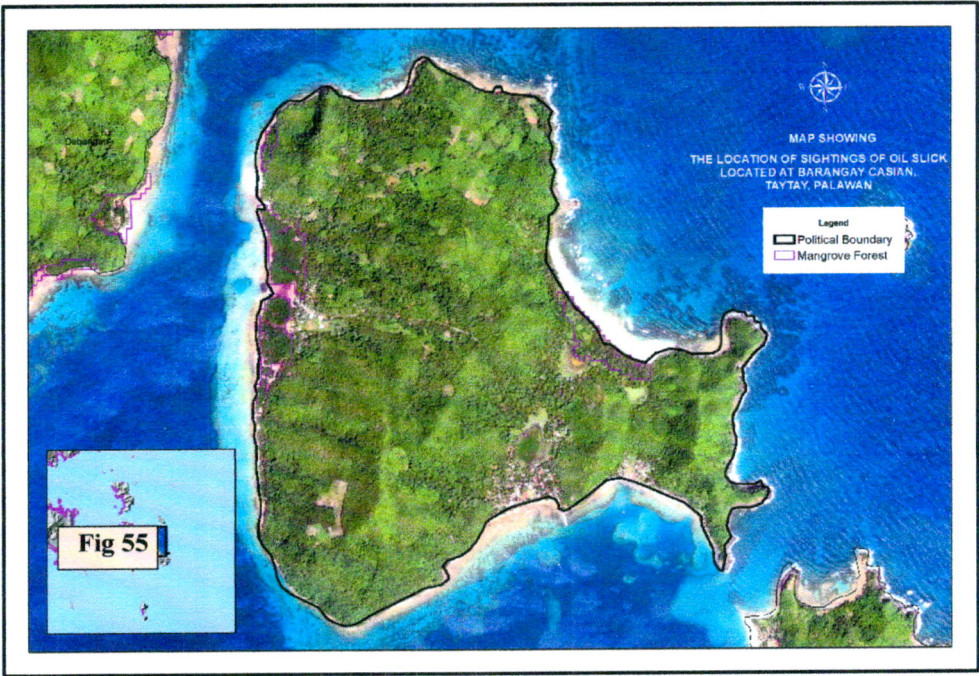
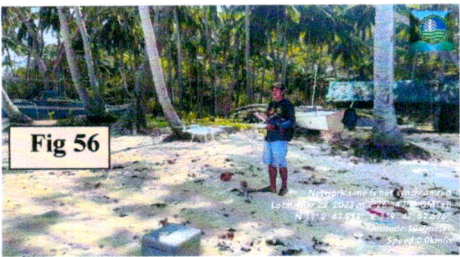
Photo documentation: Casian Island is shown in Fig 55. The Rapid Assessment was pushed through last March 28 and Fig 56 shows the CENRO Staff flying drone over Amianan coastline. The area is in continued monitoring as shown in Fig 57 where on March 30, men of the Coast Guard, among others, collected the drums earlier provided to contain debris contaminated by tarts, including sands. The waters samples previously taken in the area failed in the test. Fig 58 shows the CENRO Staff taking interview on March 28. Assessment in Debangan was aborted as advised by the Philippine Coast Guard that it was risky to proceed in the area since the previous days.
