COMPLIANCE MONITORING AND VALIDATION REPORT (CMVR) FORM FOR MINING INDUSTRIES

IPILAN NICKEL CORPORATION
Maasin, Mambalot, Ipilan and Calasaguen, Brooke’s Point, Palawan

Date of Compliance Monitoring and Validation: 15-17 February 2023
Monitoring Period Covered: July to December 2022 Quarter/Semester/Year 4th Quarter

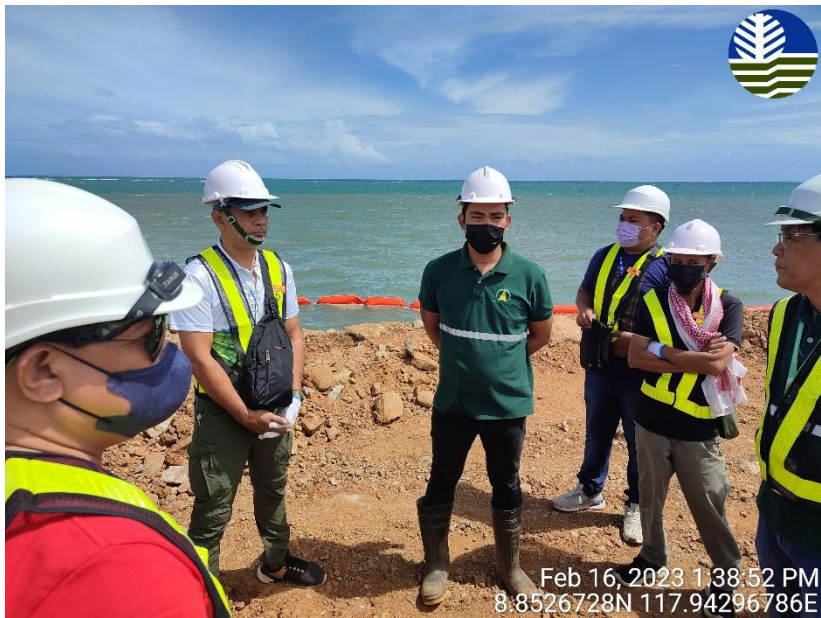
Site visit in the pier site

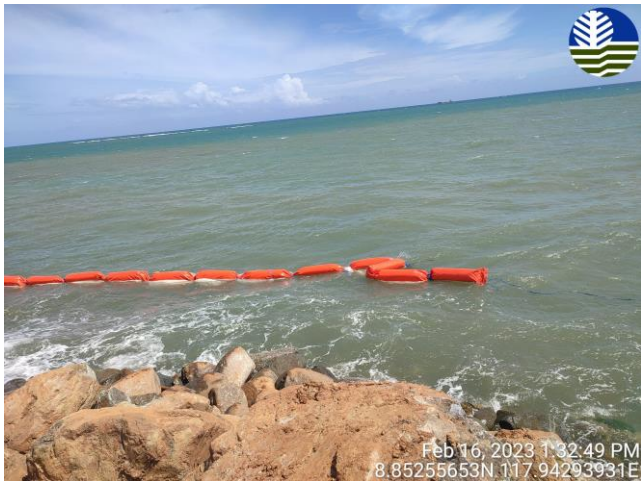
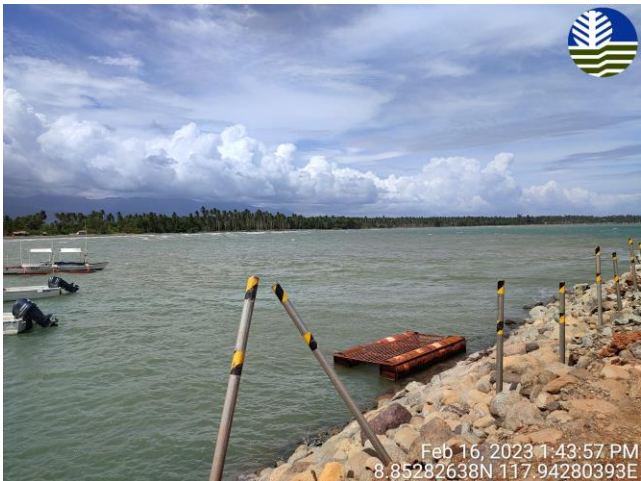
6. Discoloration around the causeway/pier area was observed (February 16, 2023) and it was also observed during sampling activity (February 17, 2023). However, gradient was also observed at sampling station Marine Water (MW) 1,2, and 3 located at Brgy. Mambalot which are located afar from the pier.

Discoloration was observed around the pier site.

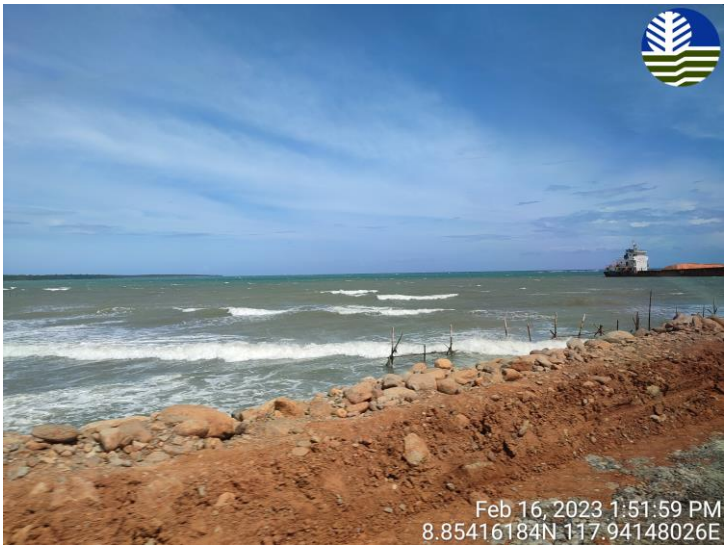
7. Installed silt fence along pier was wrecked during the heavy rainfall that occurred last December 2022 and January 2023.
8. Fisherfolks (lobster farmer) has been relocated to other area provided with financial assistance and other livelihood program.

Installed Silt fence that needs maintenance and repair.

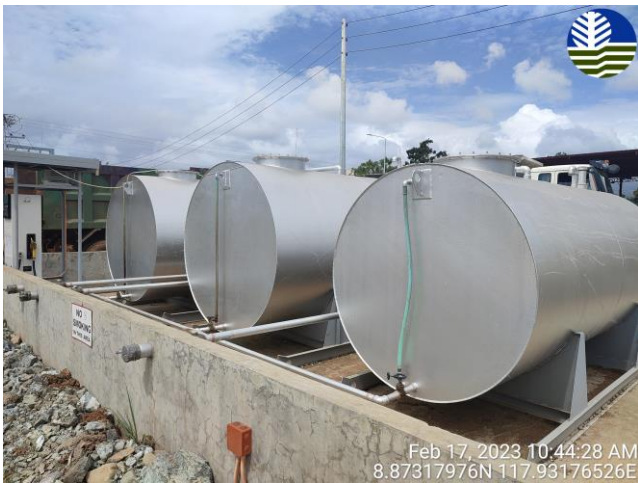
13. All standby generators set, and fuel tanks have a valid Permit to Operate until CY 2027 and submits SMR in compliance to issued post-condition.
14. Registered as HW Generator. Summary inventory of HW generated was observed within the HW facility. Improvement on HW Facility including storage management, proper labeling is still on-going.

Fuel tanks with a total of 94 KL located at mine camp.

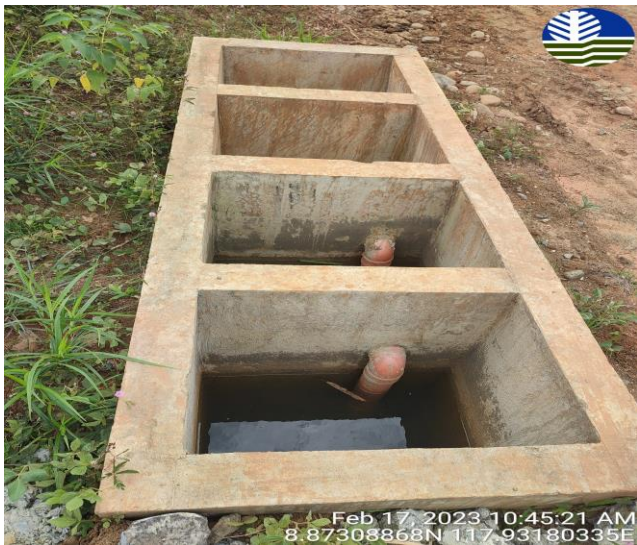
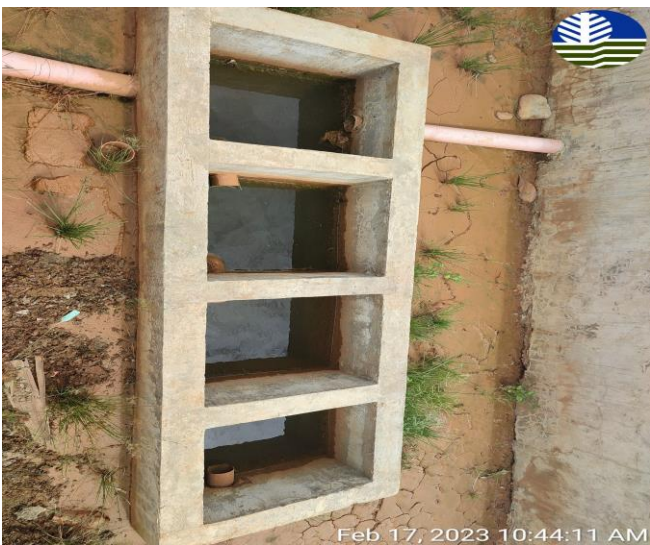
5 units of Oil and Water Separator.

2. Erosional Control & Reforestation	Planted trees along the periphery of the project was observed	✓		Continuous seedling production.
	3. Checkdams, Oil-Water Separator and septic tanks	With 2 pending application for DP on SY 4-5-Overflow, no valid DP for septic tanks and OWS	✓		Installation of Oil-Water Separator (OWS) within the contractor's camp.

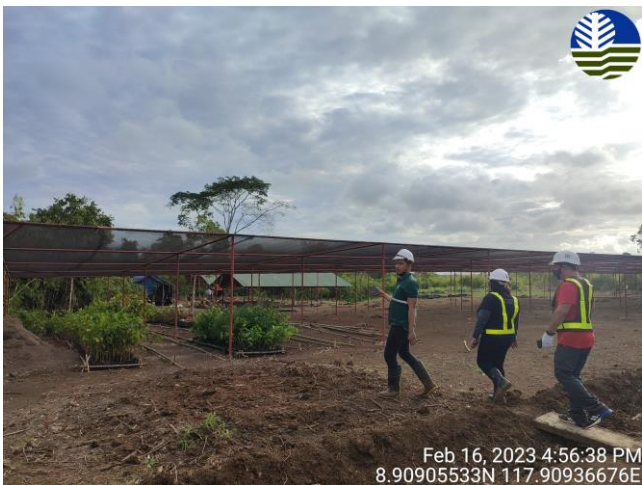
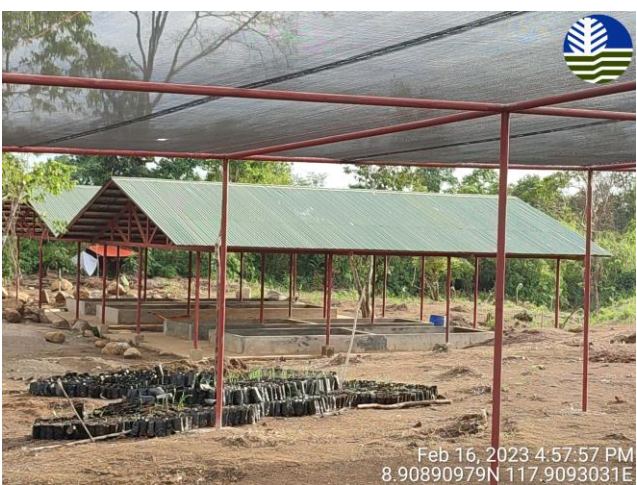
1. Establishment of a reforestation and carbon sink program using endemic species and other species identified during the rehabilitation research to mitigate greenhouse gas (GHG) emissions of the project in line with the DENR's thrust for GHG emission reduction programs. The program shall be submitted to EMB prior to the project implementation;	✓		With established nursery for seedling production at mine camp and at old camp including organic fertilizer production. Additional constructed nursery with 1,900,000 holding capacity and vermi-composting facility near at SY 5.

Newly constructed vermi-composting facility and nursery with a total holding capacity of 1,900,000.

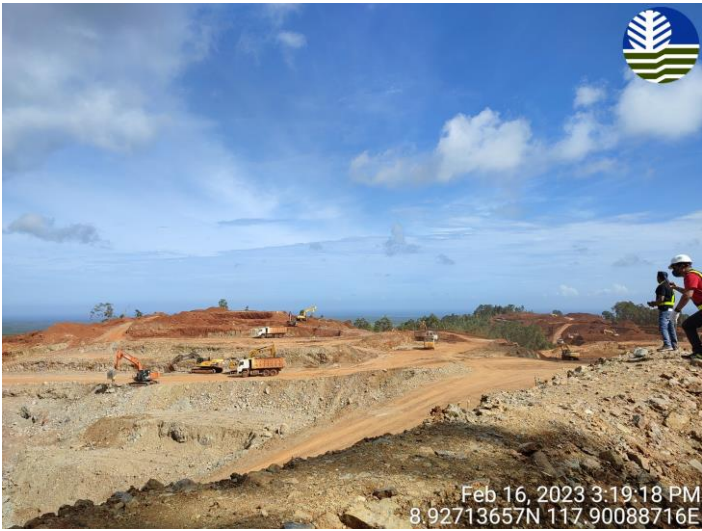
Active mine pit.

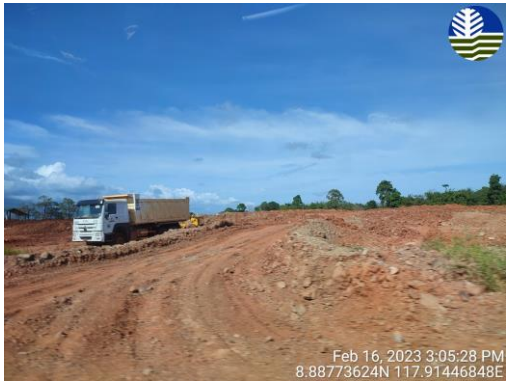
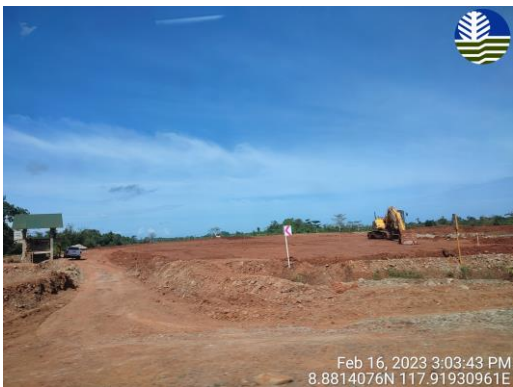
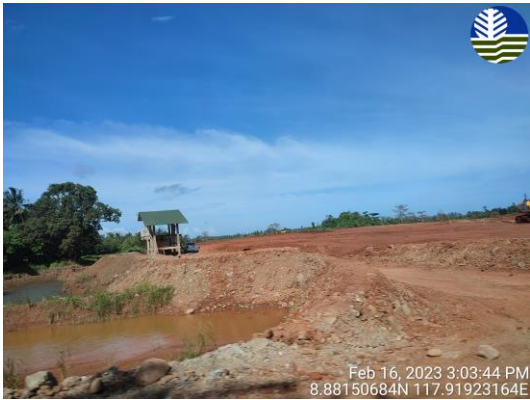
12. Stock Yard (SY) 4 and 5 is no longer operational and no stockpile was observed. These are previously known as the MY 1 and 2. Only SY 1, 2, and 3 are being used for stockpiling.

SY 4 and 5 (previously MY 1 and 2) are no longer operational, and no stockpile was observed.

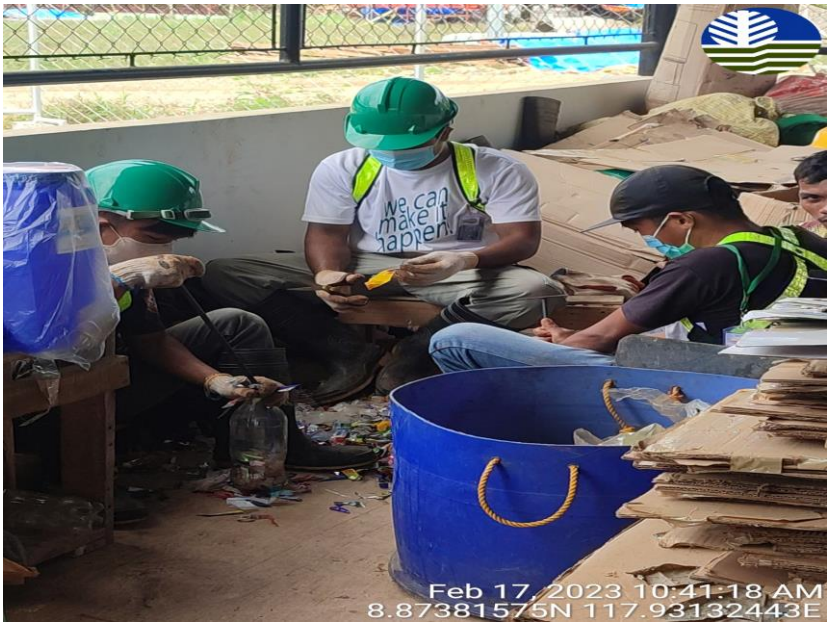
15. Conversion of generated residual waste into eco-bricks was observed.
16. With pending application for Discharge Permit SY 04-05-overflow.

Conversion of generated residual waste into eco-bricks

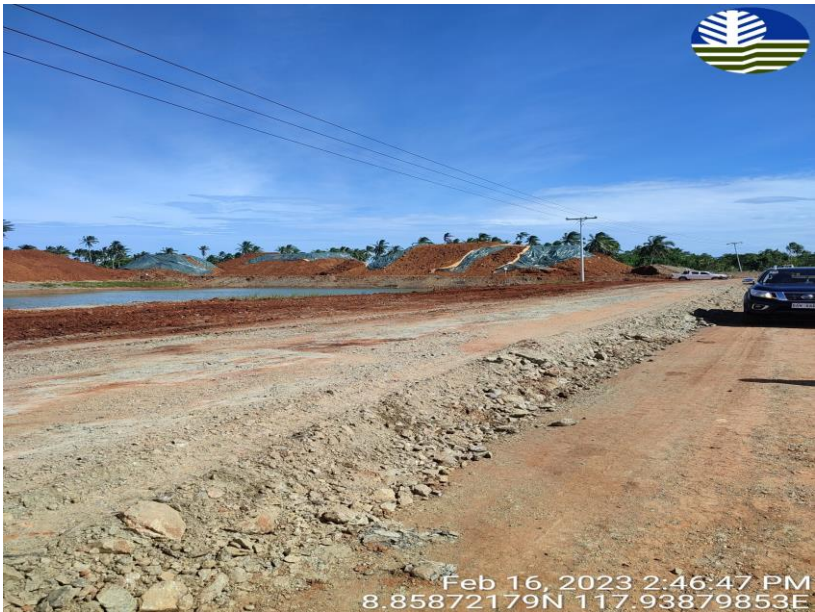
10. Road maintenance/road sprinkling was observed for dust minimization.
11. Sedimentation pond together with perimeter berm adjacent to the MYs was observed to prevent unfiltered wastewater to infiltrate/overflow into the adjacent water body.

Road improvement was observed.
