ENVIRONMENTAL IMPACT STATEMENT

Mompong River Restoration Project Sablayan, Occidental Mindoro

Environmental Impact Statement Report Mompong River Restoration Project

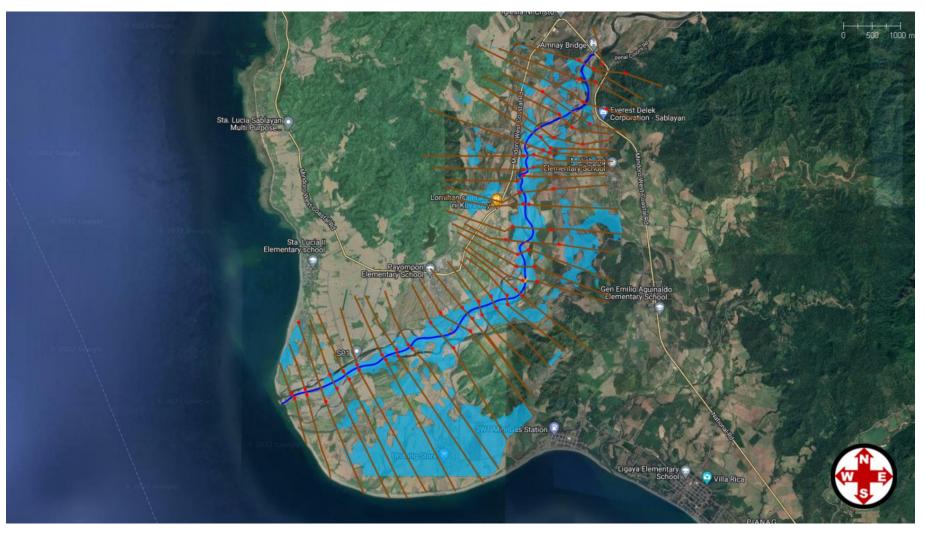
Figure 2-38. Flood Hazard Map at 2-Yrs RRP

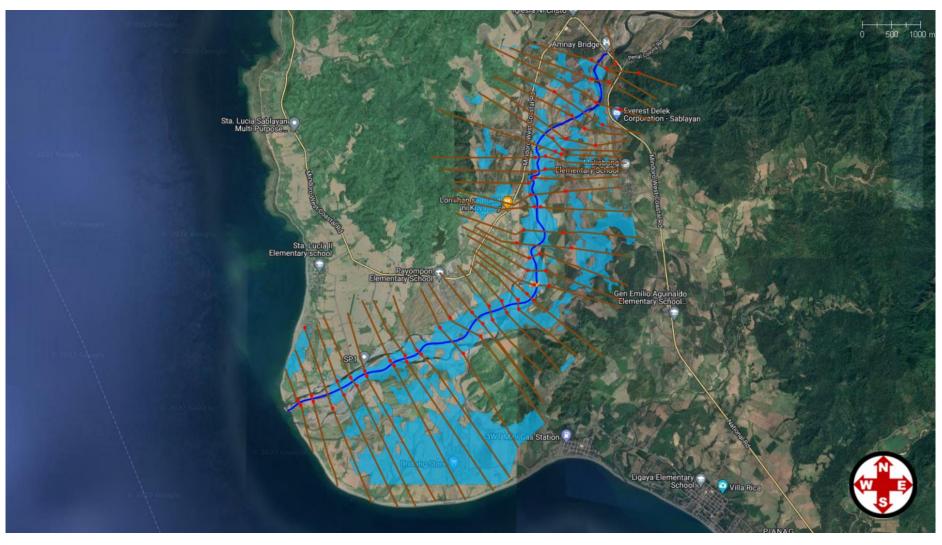
Figure 2-39. Flood Hazard Map at 5-Yrs RRP

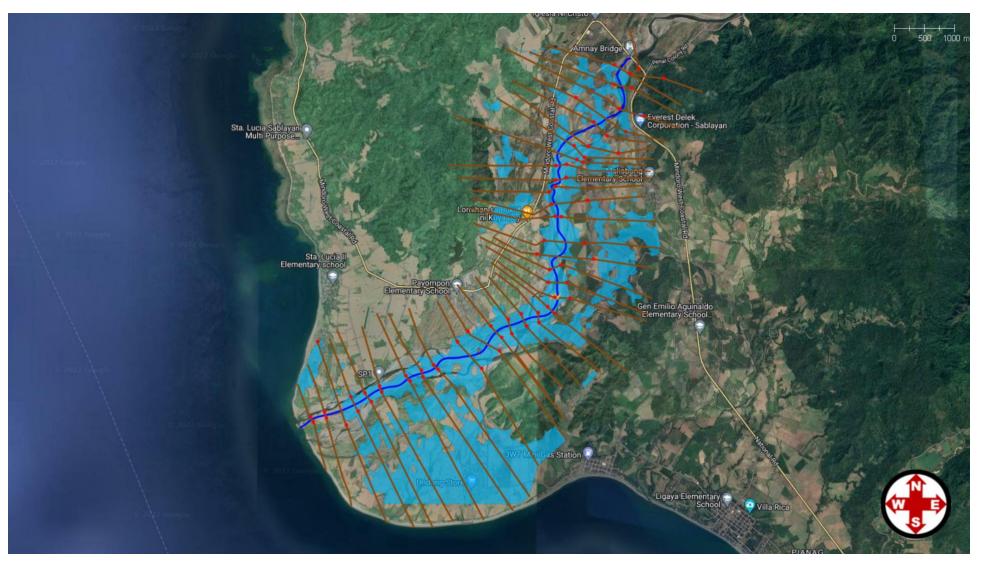
Figure 2-40. Flood Hazard Map at 10-Yrs RRP

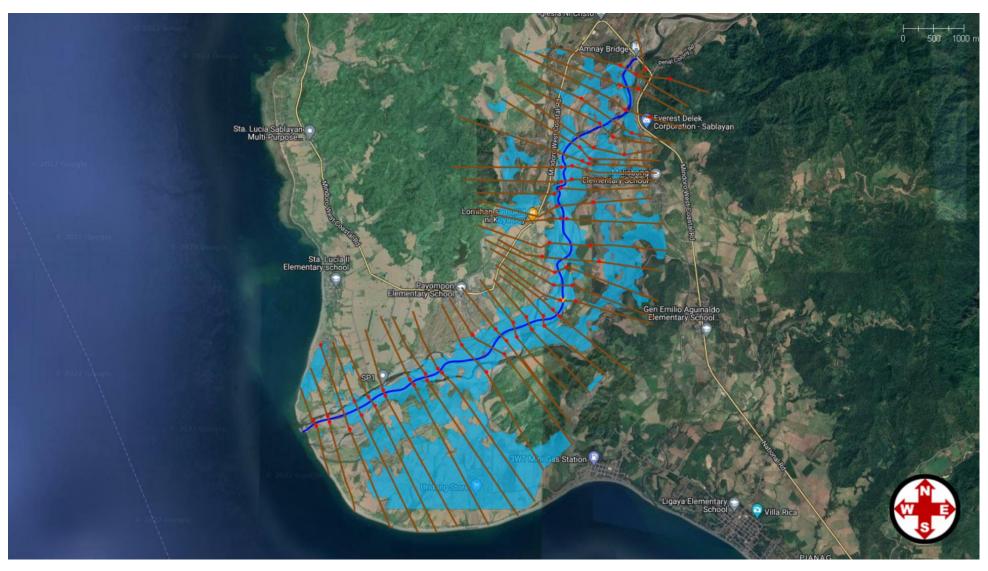
Figure 2-41. Flood Hazard Map at 25-Yrs RRP

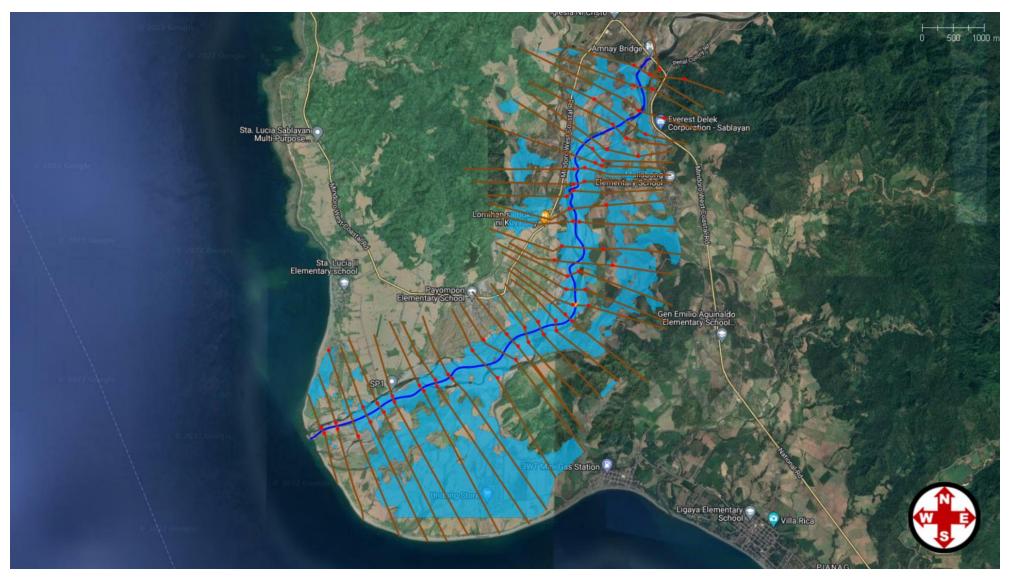
Figure 2-42. Flood Hazard Map at 50-Yrs RRP

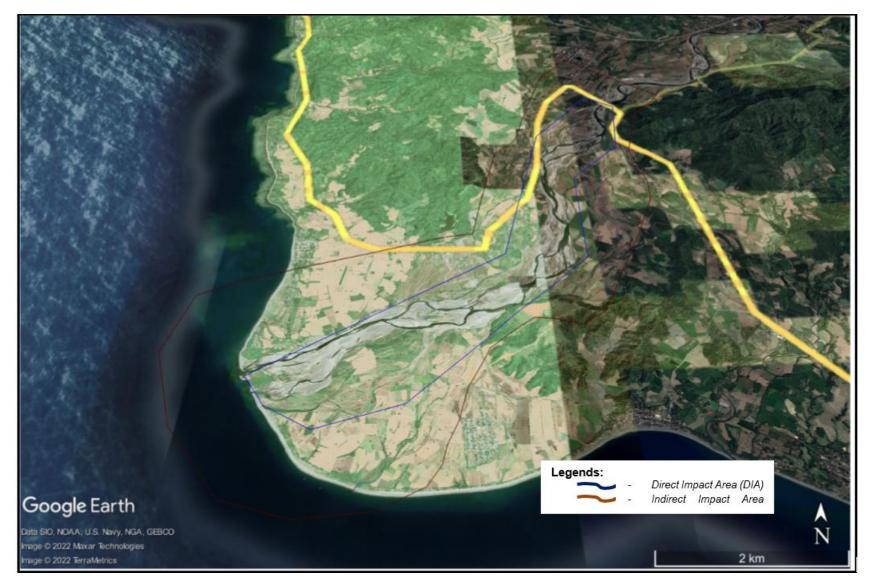
Figure 2-44. Potential Impact Area

²⁷³ The direct impact area (DIA) encompasses the project area due to the expected change in its hydrologic characteristics particularly the widening and deepening of the river channel. The Indirect Impact Area (IIA) consists of the floodplain, coastal outlet of the river and agricultural lands that are using the river as source of water for irrigation. The potential impact areas are shown in Figure 2-46.

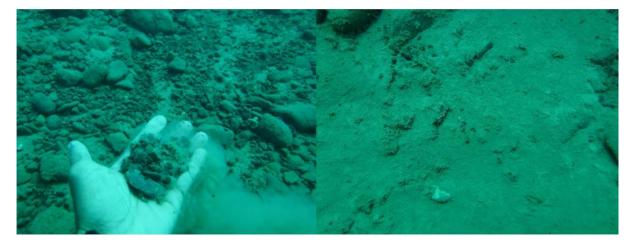
Figure 2-59. Fine sand and pebbles dominate the nearshore seabed in front of the Mompong River estuary as seen during 8 manta tows

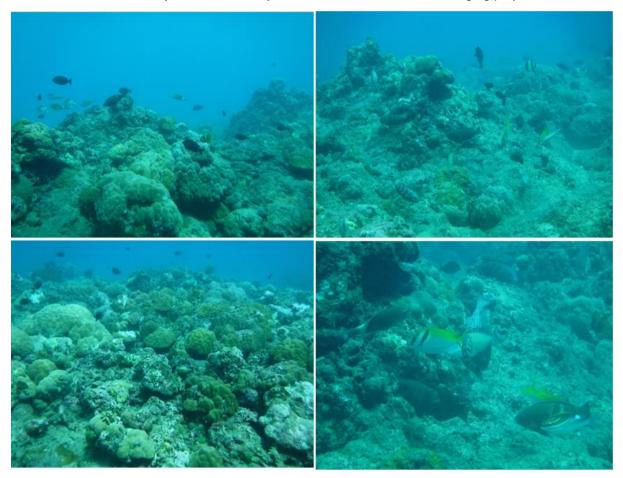
Figure 2-61. Live hard massive corals, dead corals, and sand in spot dive station 4 in the vicinity of the Sablayan MPA; observed during marine ecology baseline assessment in the coastal area of the proposed Mompong River Dredging and Construction of Crushing Plant Project; 26-27 October 2021

- ³²⁶ The lone spot dive station where corals were observed is in the Sablayan MPA where live hard corals in a degraded reef were observed to occur some 1.3 to 2 km away from the estuary. Corals in the area consist mostly of the massive varieties (*Porites* spp.) mixed with dead coral formations that have been caused by dynamite blasts and cyanide burns in the past (Figure 2-61, Figure 2-62). Live corals were cataloged at 50% with mostly massive scleractinian corals, dead corals at 30%, and sandy substrate at 20 % (Figure 2-63). Due to its distance from the estuary, the corals in this area are unlikely to be affected by sediment streams from the dredging project.
