**SUBJECT :** **ALLEGED ON-GOING MOUNTAIN QUARRYING AND  
SILTATION IN CORON, PALAWAN**

**SUBJECT :** INVESTIGATION OF THE ONGOING CORON BAY  
DEVELOPMENT PROJECT (48 HECTARES RECLAMATION  
PROJECT) OF THE PROVINCIAL GOVERNMENT OF  
PALAWAN AND MOUNTAIN QUARRY SOURCES

**SUBJECT :** INVESTIGATION REPORT ON THE LANDSLIDE IN THE  
MOUNTAIN QUARRY IN SITIO LAMUD, BRGY. POBLACION  
6, CORON, PALAWAN

SUBJECT : **REPORT ON THE CONDUCTED MONITORING AND  
PATROLLING IN THE RECLAMATION AREAS  
(BARANGAYS 2, 3 AND 5), CORON, PALAWAN**

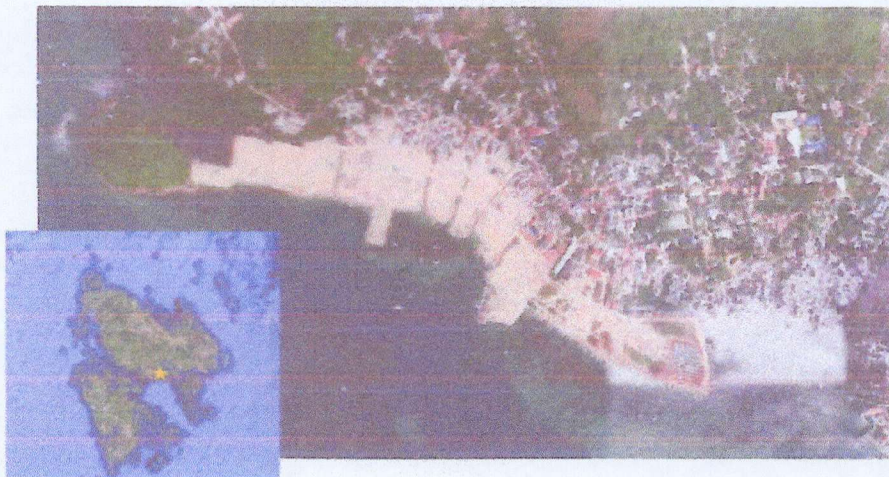
The Coron Bay Development Project (CBDP) is located along the coasts of Brgy. Poblacion 2, Poblacion 3 and Poblacion 5. The project is initiated by the Provincial Government of Palawan, under the administration of Hon. Jose Ch. Alvarez, to boost its tourism. The government aimed to make a world-class tourism estate where all amenities are clustered (Figure 1).

**Figure 1.** Location of the Coron Bay Development Project. Images adapted from Google Images.

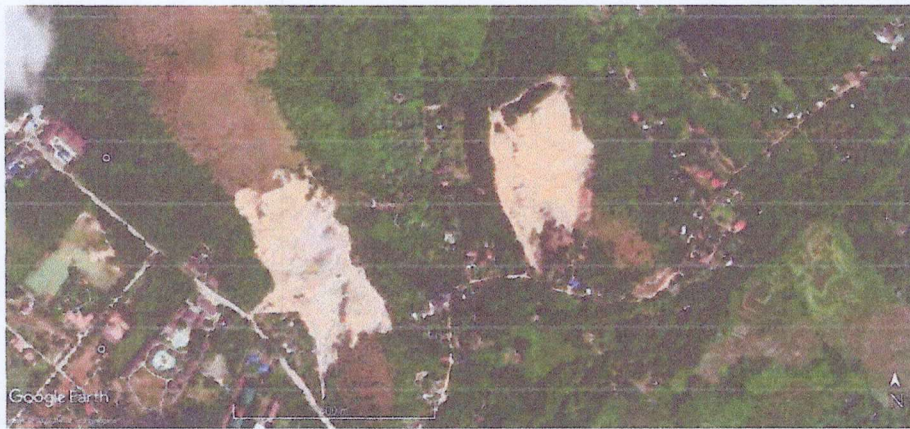
Based on the locals of Coron, the main source of the earth-filings for the reclamation is the mountains found in Brgy. Poblacion 6 – Bella C. Tiotangco Mountain Quarry and the mountain 500 m away northwest of Bella C. Tiotangco (Figure 2). The following contractors on these quarry sites are BCT Trading & Construction Inc. and 428 Hi-Tech Group Inc.

**Figure 2.** The mountain quarries in Brgy. Poblacion 6. On the right is owned by Ms. Bella C. Tiotangco whereas the quarry on the left is by the municipality of Coron. These mountain quarries are about three (3) km away from the reclamation project. Images are excerpted from Google Images.

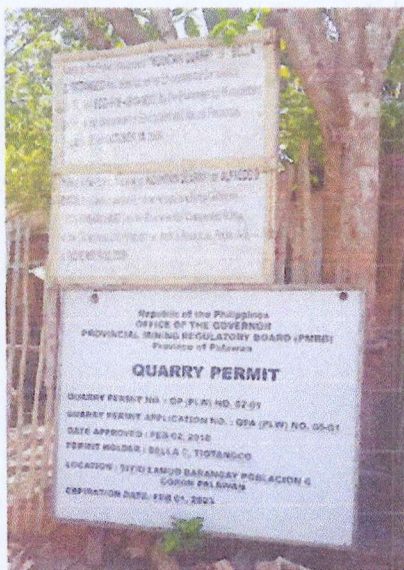
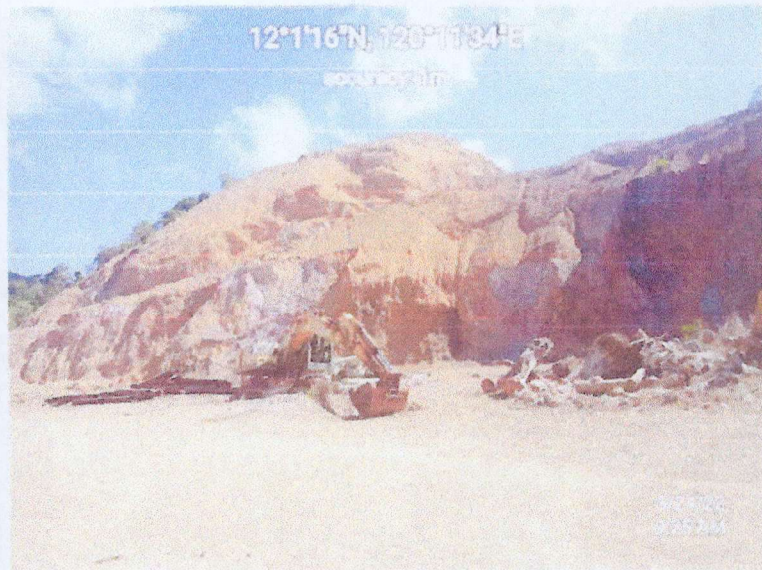
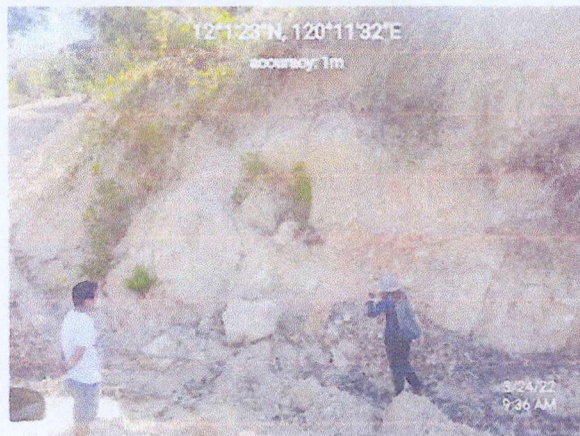
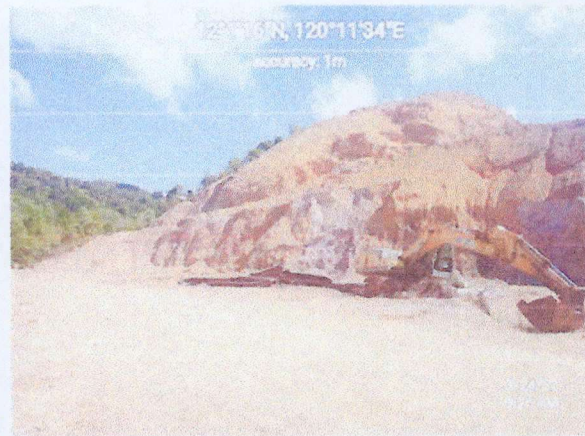
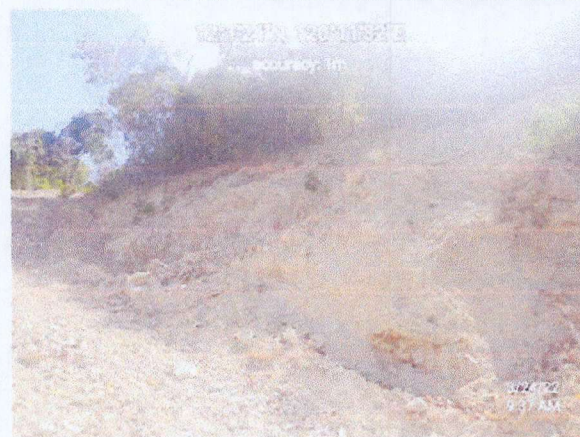
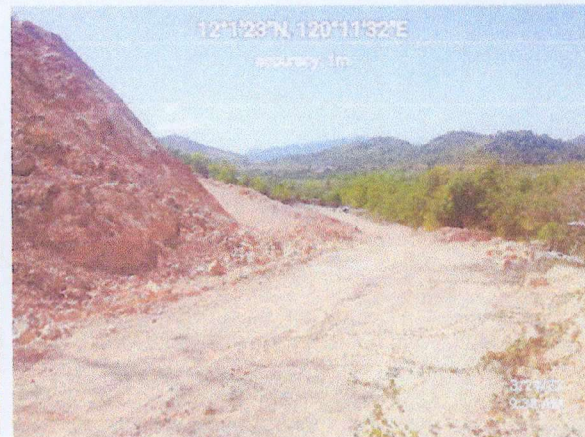
## Photo Documentation 1

4. At the gate, the ECC billboard of Ms. Bella Tiotangco and Mr. Alfred Batul was posted. The quarry permit issued to Bella Tiotangco was also posted (*see Photo Documentation 1*).

5. During the discussion of MGB embedded with Mr. Duaso, he confirmed that the BCT followed the CDO issued by MGB last December 2021. This was also confirmed on the ground, as no recent tracks were observed, and some plants are already growing on certain parts of the quarry wall.

10. Lastly, the site poses danger to nearby residents. The quarry wall was cut too steep (15 m high) and no benches were established. Since the stability of the mountain was disturbed due to excavation, events such as mass wasting or landslide may soon occur.

Photographs of the quarry site of Bella Tiotangco in Brgy. Poblacion 6. A signpost of the ECC and quarry permit can be found in the entrance.

3. It is also recommended that the company conduct a relocation survey to address their issue regarding the exact location of their permit area. Moreover, immediate rehabilitation should be done to stabilize the slope.
4. Ms. Bella Tiotangco should also be reminded that extraction outside her permit area is deemed illegal. In addition, should the proponent want to continue the mountain quarry, a new quarry permit should be acquired as their permit will expire in 2023.
5. As the provincial mining regulatory board, PMRB-Coron should monitor such activities to ensure that every company complies with the law.
6. Endorse this to PMRB-Palawan for the proper evaluation of the violations in the terms and conditions of the Quarry Permit.
7. Recommended to pay maximum penalties for extracting materials outside of its permit area and to trees affected by the project.

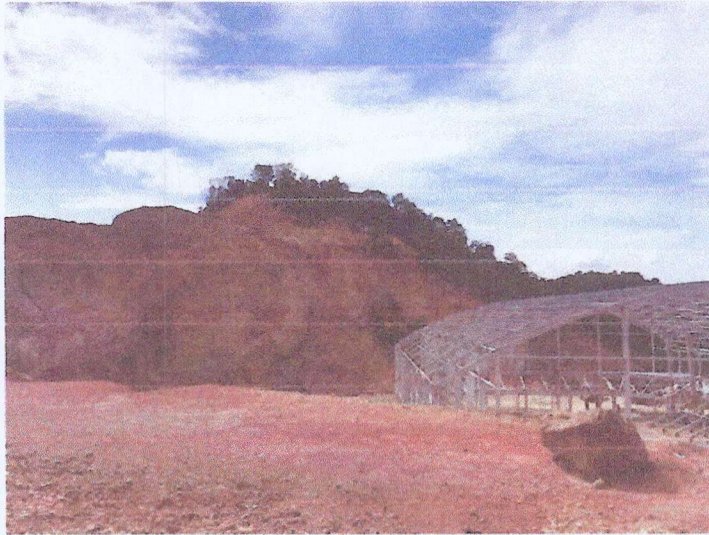
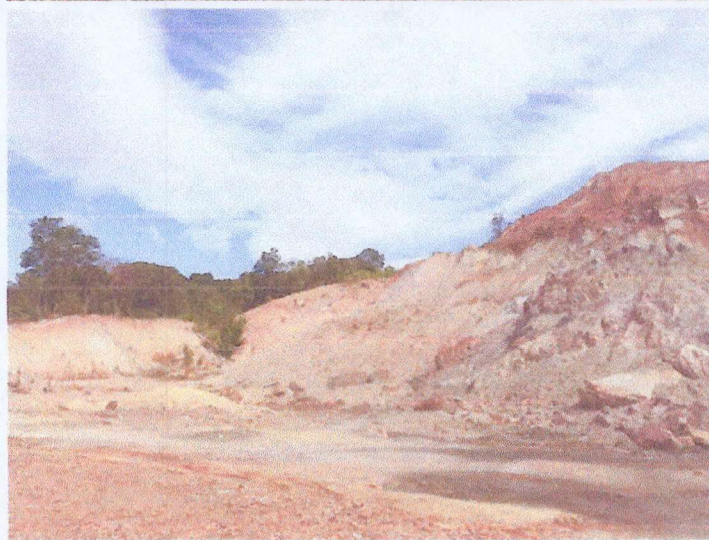
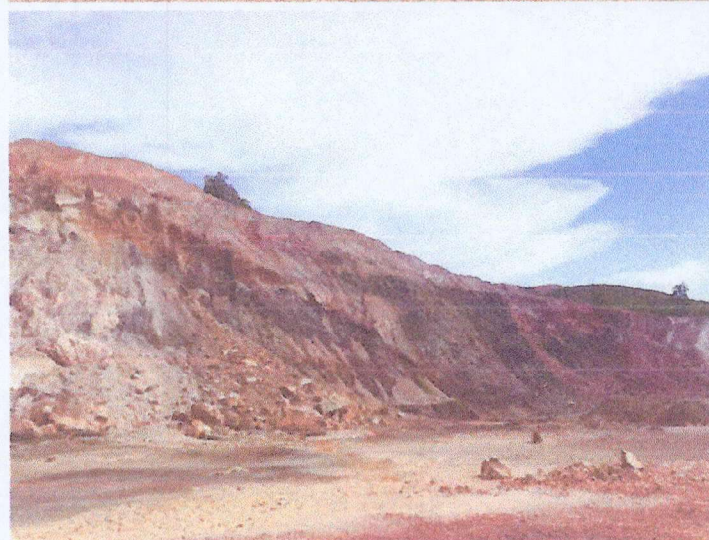
## Photo Documentation 2

5. Based on ground observation, the quarry wall was cut too steep. The presence of cracks was also noted in which a rock fall may possibly occur. This poses a hazard to the stadium being constructed as it is built near the wall (*see Photo Documentation 2*).

Site photographs for the excavation site for the construction of government facilities in Sitio Lamud, Poblacion 6.

1. As the subject area operates without permits it clearly violates Section 103 of RA 7942 and is regarded as an illegally sourced mineral as per Section 116 Chapter XII of DAO 2010-21.
2. It is recommended to the LGU and contractor to immediately rehabilitate the subject area as rockfall may soon occur.

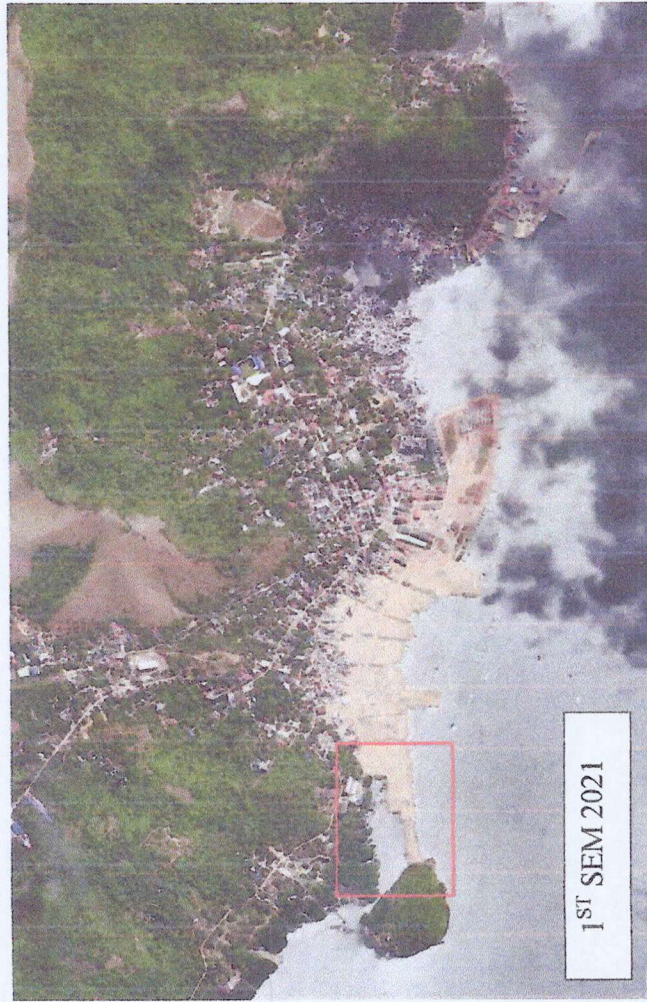
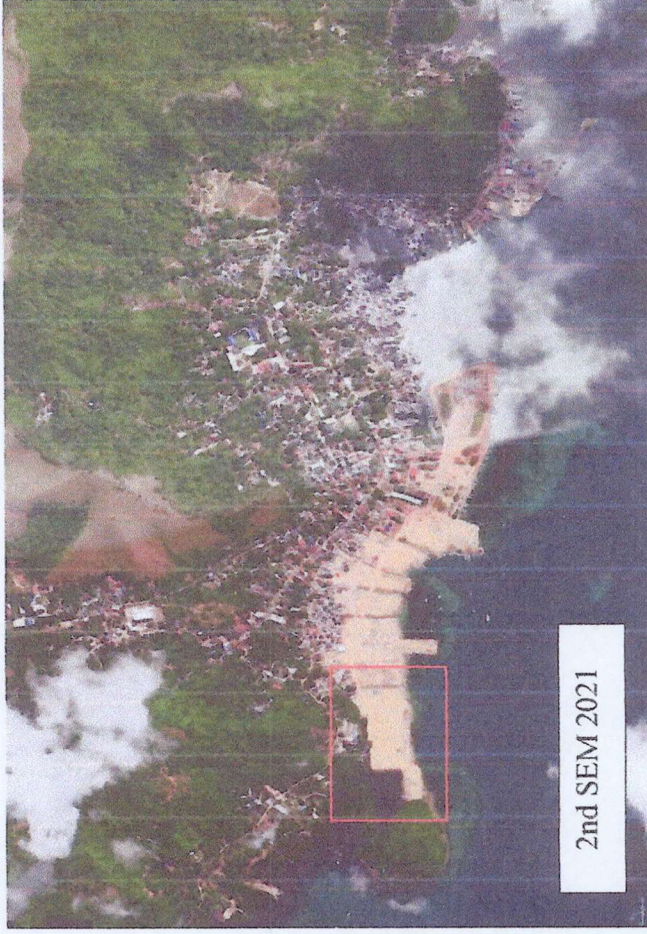
SATTELITE IMAGE OF  
RECLAMATION SINCE 1<sup>ST</sup> SEM

As per google generated maps of 2021, it was observed that during this year, the proponent, and the contractor continued to reclaim (*please see the red square box*) the area, even there's was a standing order and instruction from the CENRO dated 28 January 2021 to stop for doing any activities until such Area Clearance is secured.

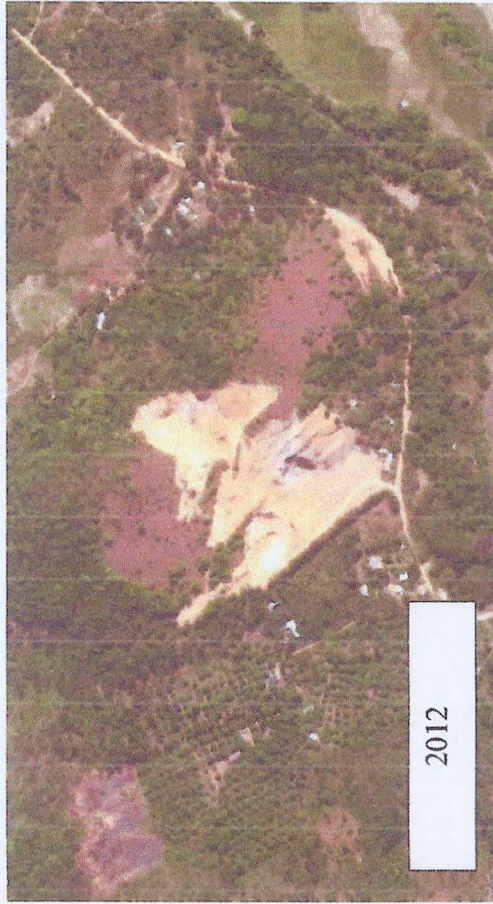
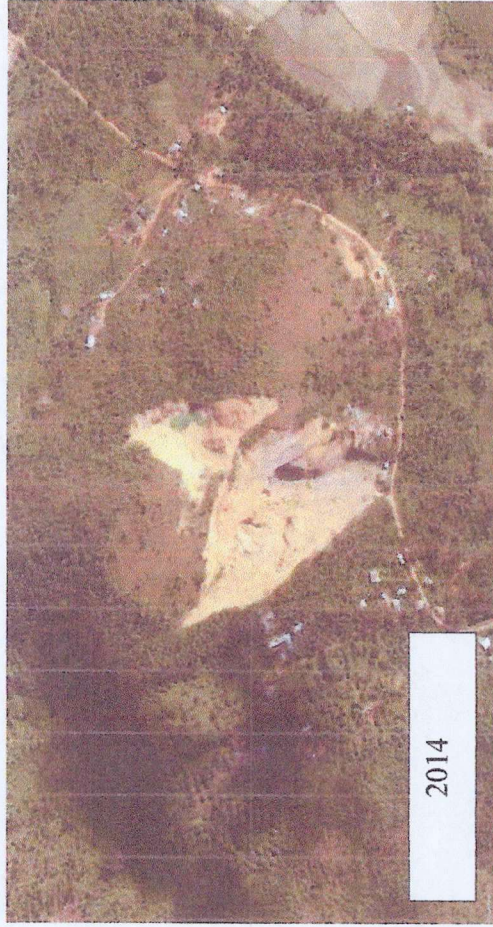
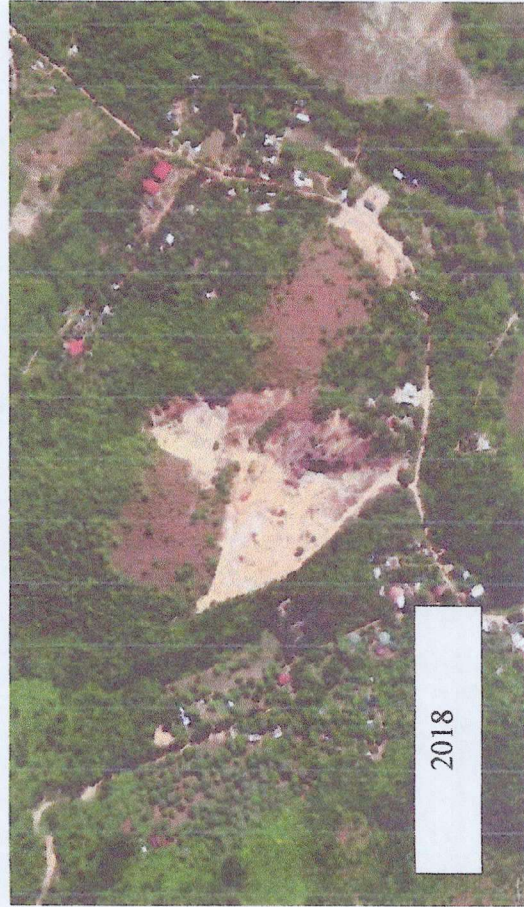
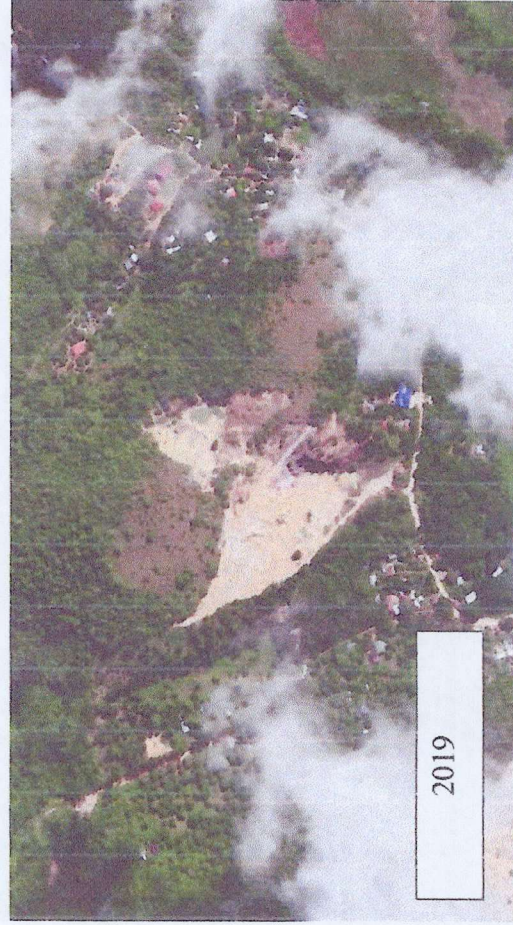
SATELLITE IMAGE OF BCT  
QUARRY FROM 2012-2019

6. As per ECC issued to Bella Tiotangco, they are allowed to extract a total of 40,000 m<sup>3</sup> per annum in their 4.99 hectares permit area.
7. Based on google satellite imagery, from 2019 to 2021, active excavation was observed in the Bella Tiotangco Mountain Quarry simultaneous with the quarry in the LGU compound.

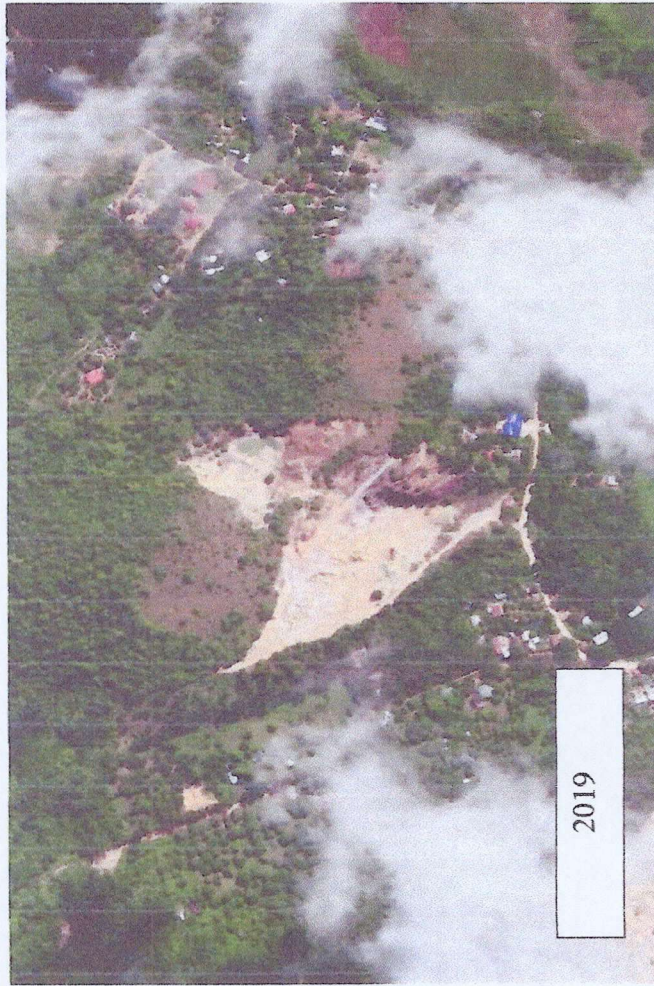
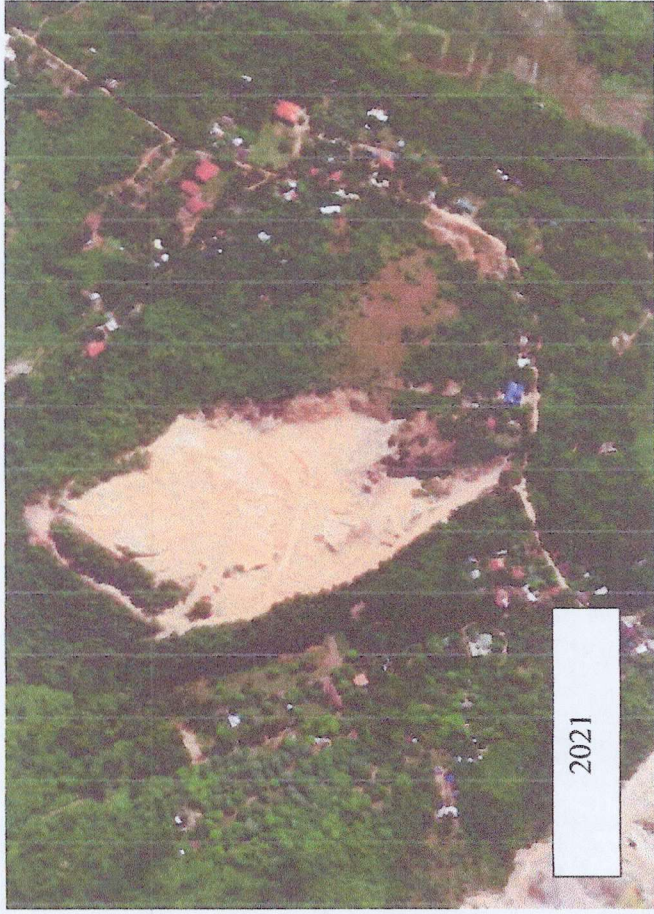
SATELLITE IMAGE FROM 2019-  
2021

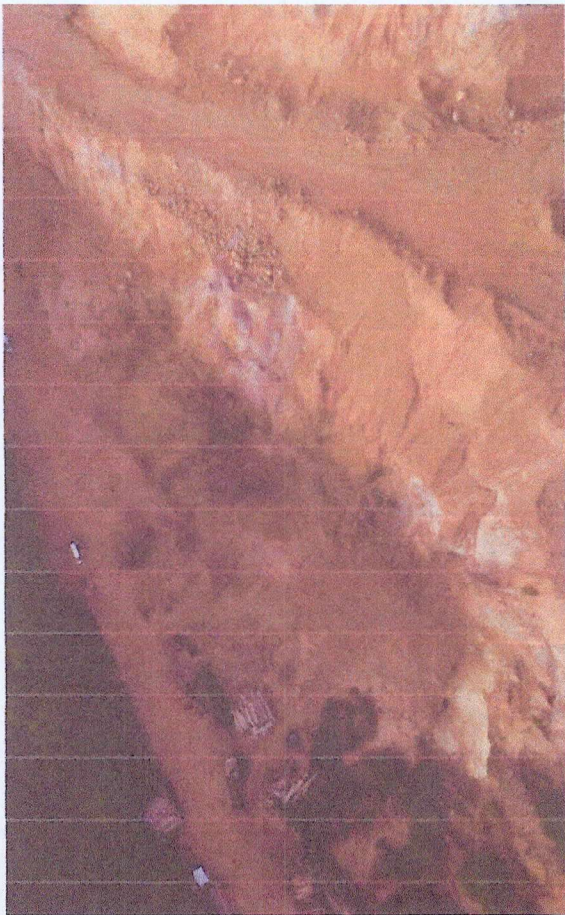
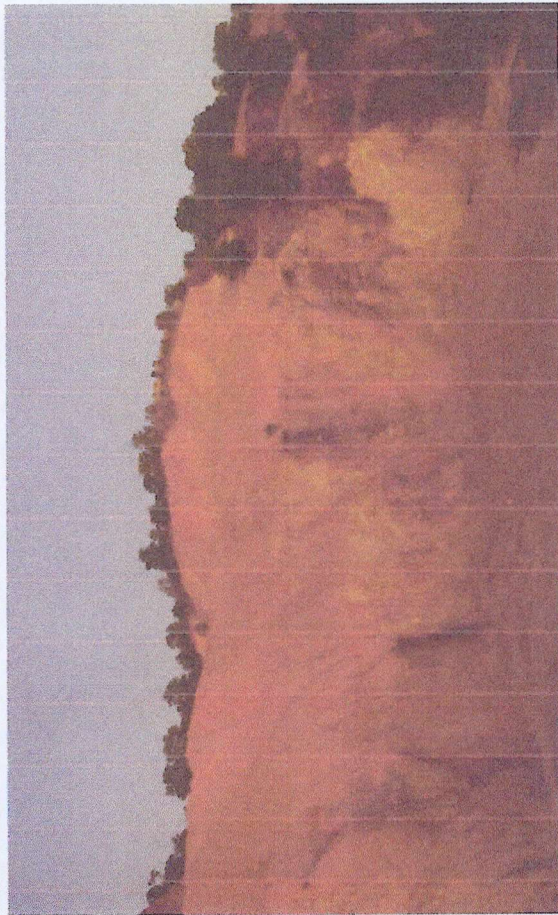
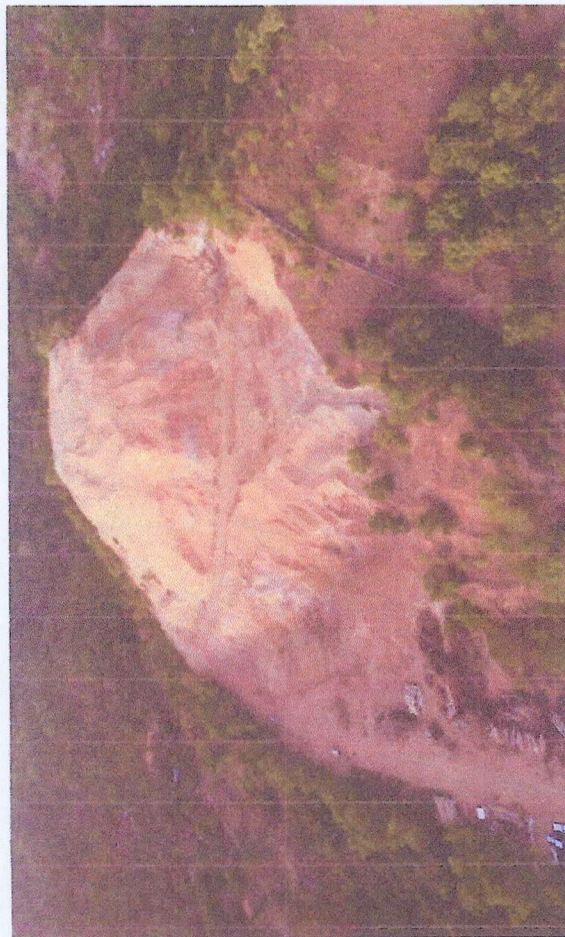
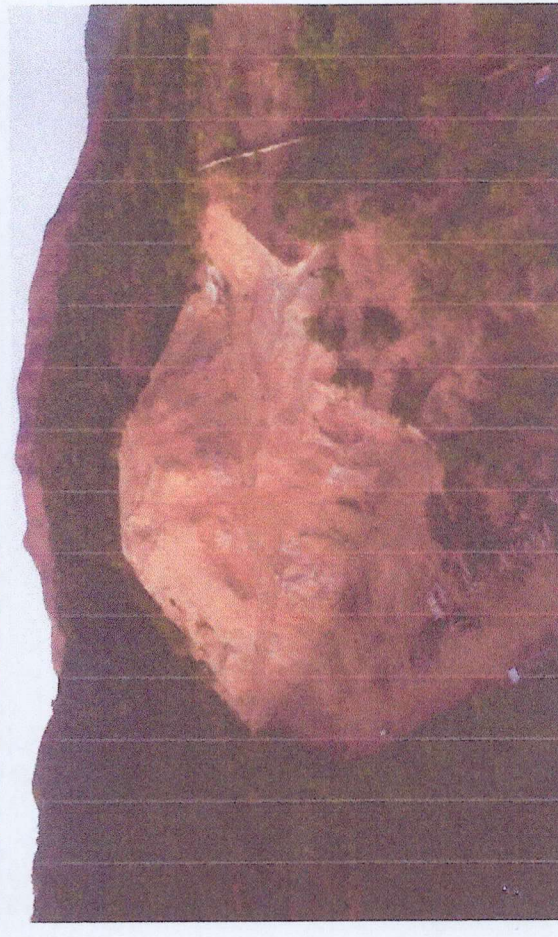
AERIAL PHOTOS OF BCT QUARRY  
AT SITIO LAMUD

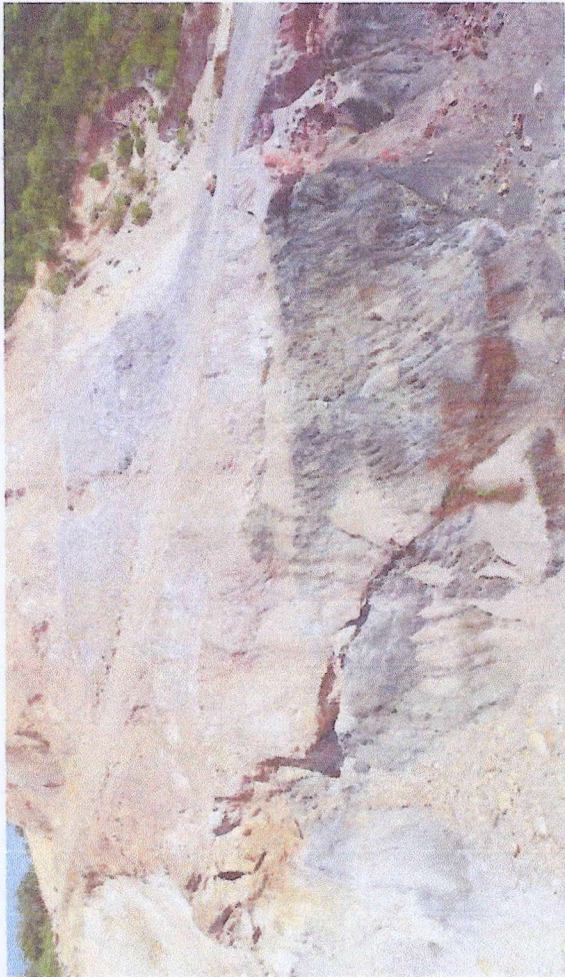
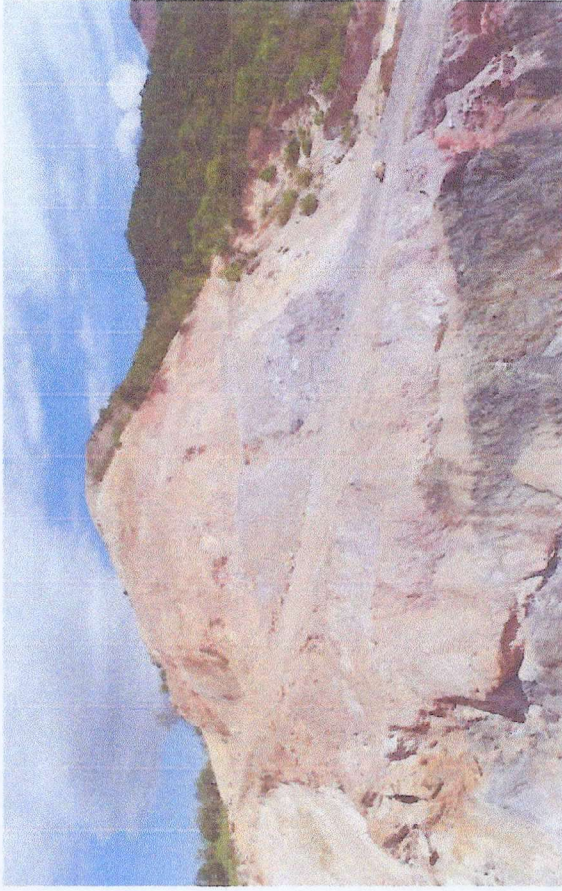
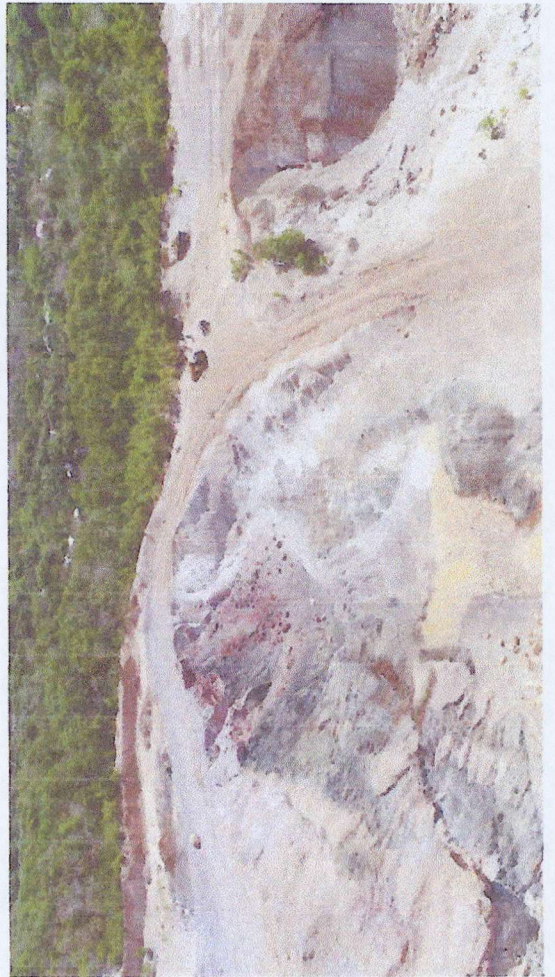
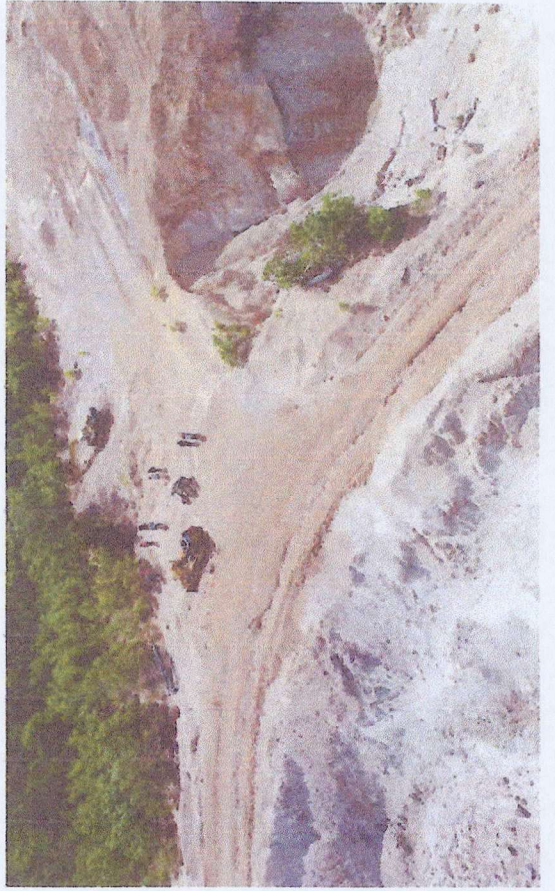
AERIAL PHOTOS OF EXCAVATION  
FOR PROPOSED STADIUM

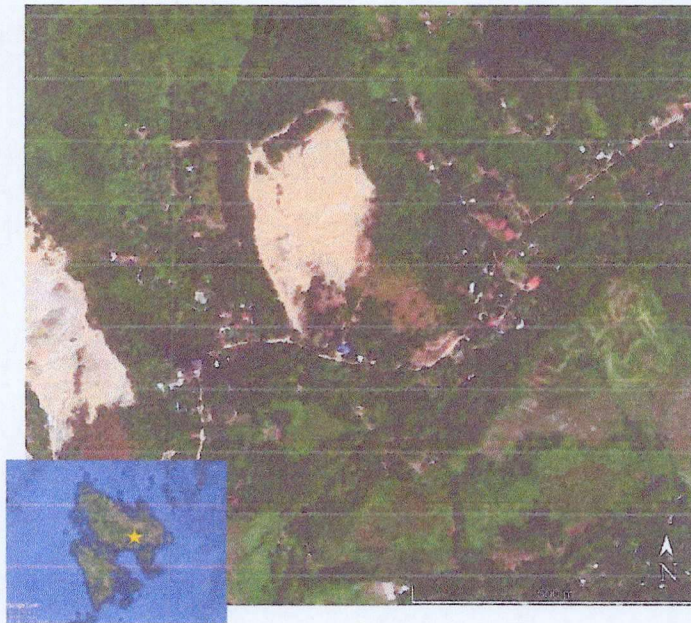
1. The subject area is geographically at 12° 01' 21" N, 120° 11' 39" E. It is within Sitio Lamud under the jurisdiction of Brgy. Poblacion 6. The area is approximately 3 km away from CENRO which can be reached by an approximately 5-minute motorcycle ride (Figure 1).
2. Upon arrival in the area, piles of eroded aggregates were observed along the access road and floor/base of the mountain quarry (*see Photo Documentation*). The sound of flowing water along the quarry wall was also heard.

**Figure 1.** Location map of the mountain quarry in Sitio Lamud, Brgy. Poblacion 6, Coron. The image is from Google Earth.

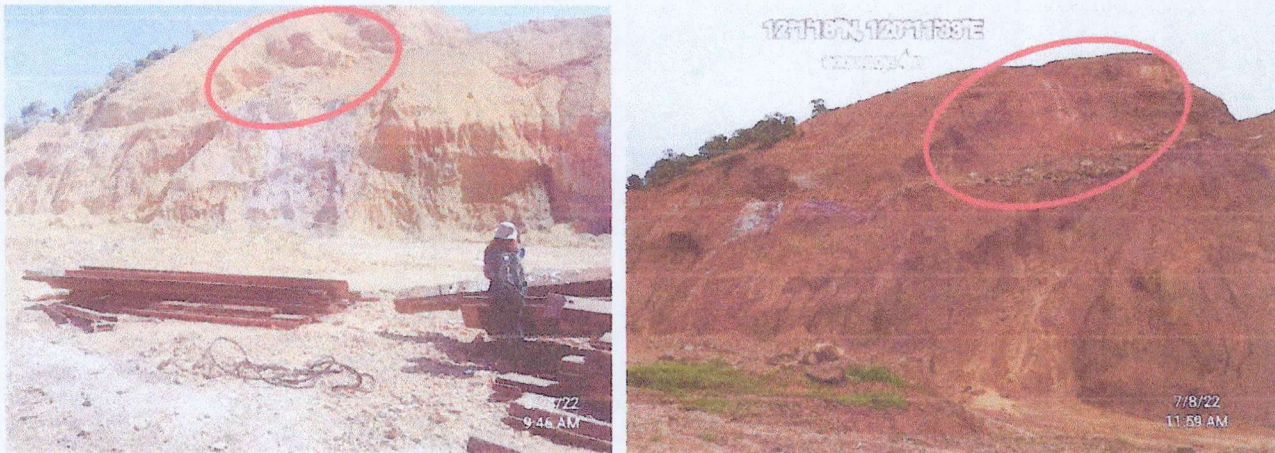
3. Looking at the slopes of the quarry, an area with a noticeable scarp can be seen. Below it, debris of rocks up to ~half a meter across and soil was also observed. Based on the lack of gullies on the scarp and the deposits lacking signs of compaction due to recent rains, it suggests that the movement happened quite recently (see *Photo Documentation*).
4. Comparing an image taken from 24 March 2022 to the recent image, it can be concluded that a portion of the quarry face is missing in the recent image. (Figure 2).

**Figure 2.** Comparison of the morphology of the area. The image on the left was taken in March whereas the image on the right was taken in July. Encircled is the area where evidence of mass movement was observed.

1. Although the slopes are made up mostly large of stable rock mass and there are no signs of a large-scale mass movement, the possible risks of mass movement cannot be understated. The company should hasten the rehabilitation of the area to minimize the possible hazards posed by the quarry site.
2. To CENRO, inform the company regarding this matter.

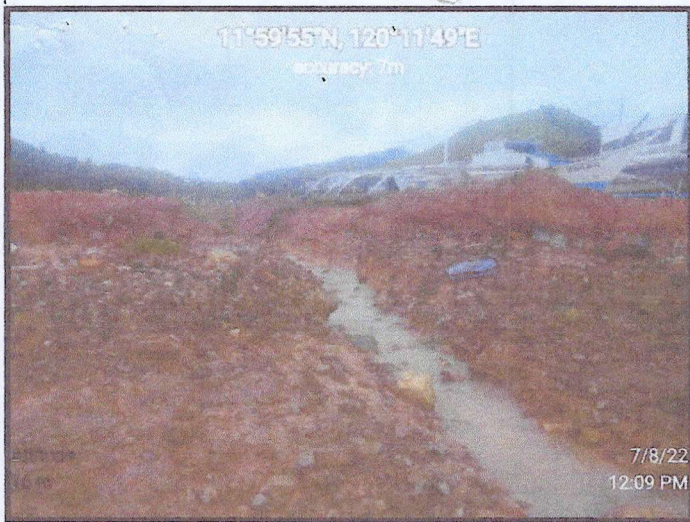
Please be informed that on July 8, 2022, the undersigned conducted monitoring and patrolling. No activities or developments observed except siltation due to heavy rains.

Reclamation area during monitoring on July 8, 2022

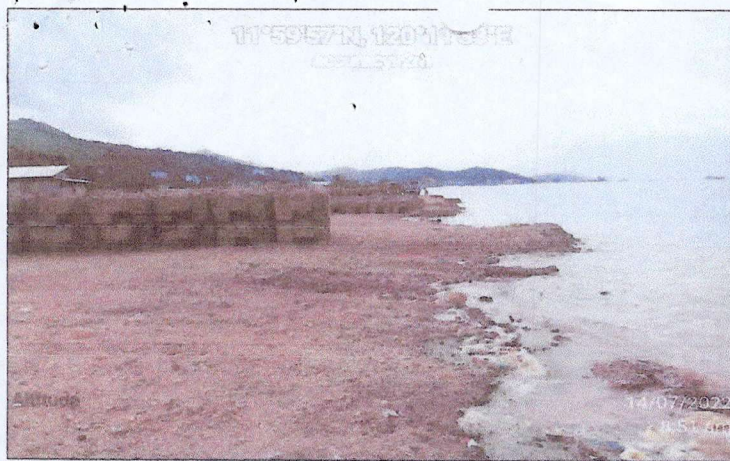
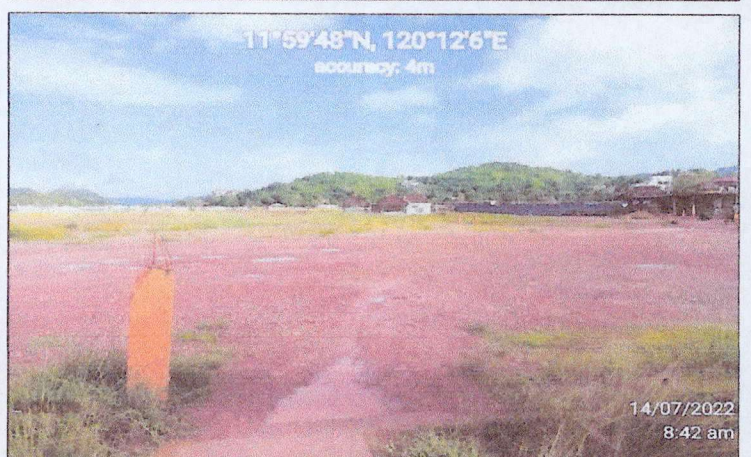
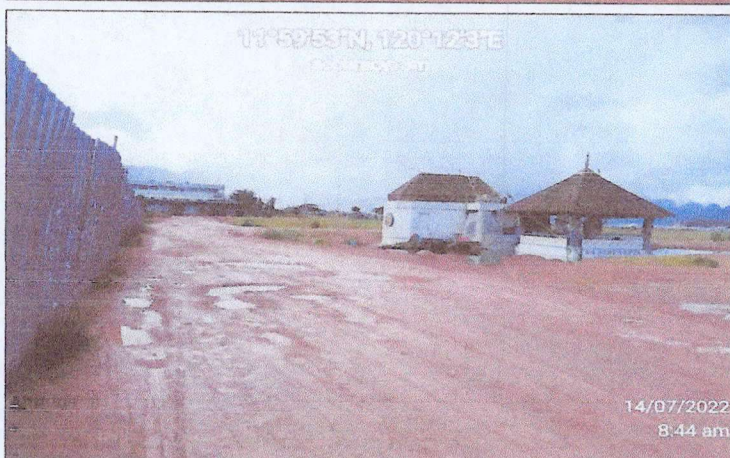
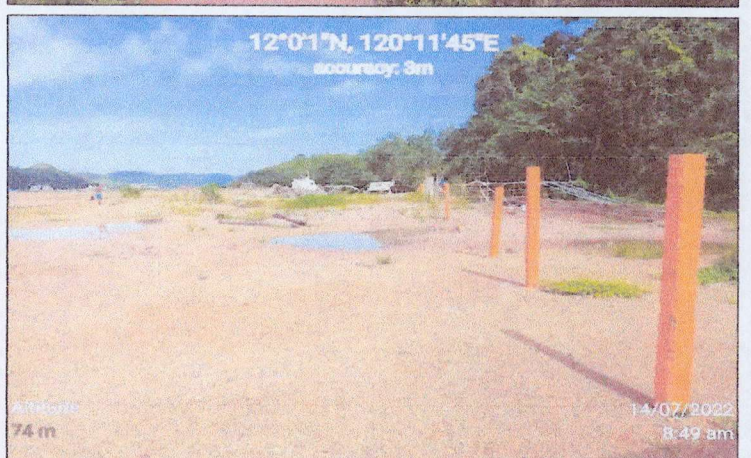
Please be informed that there is no activity/development observed during the conduct of monitoring and patrolling. However, flooding was observed due to the heavy rain on previous days and lack of proper drainage system in the area.

Geo-tagged photos taken in the reclamation area of  
Barangays 2,3 and 5, Coron, Palawan
