**SUBJECT :** 2<sup>ND</sup> QUARTER REPORT ON COASTAL AND MARINE  
ECOSYSTEMS MANAGEMENT PROGRAM (CMEMP) OF  
DENR PALAWAN

# **Coastal and Marine Ecosystems Management Program**

2<sup>nd</sup> Quarter FY 2022

### **Protected Area: Rasa Island Wildlife Sanctuary**

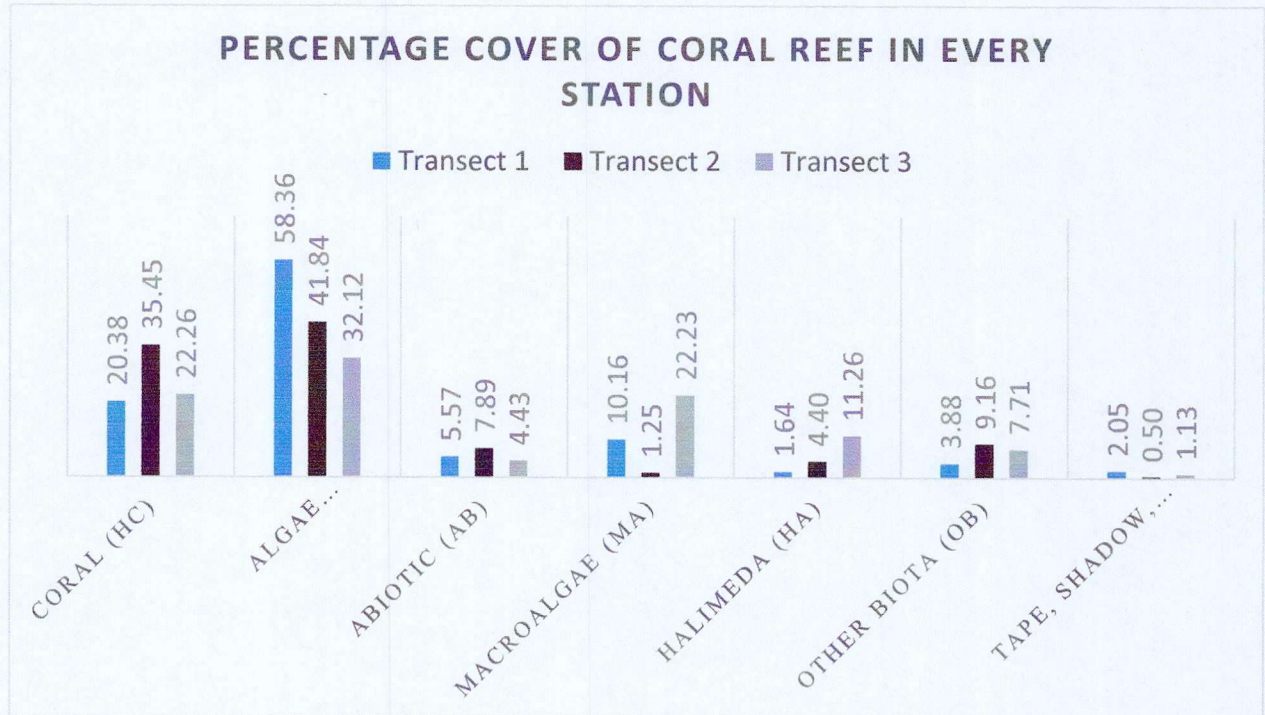
Figure 2. Percentage of corals in three stations

Out of three stations established, Station 3 has the highest cover of live corals with 35.45% which falls in Hard Coral Cover Category B. Likewise, this station got the highest number of TAUs present in the transect. (Fig. 2)

A total mean of 26.03% was computed for hard live corals. Meanwhile, corals with algal assemblage turns to have a higher mean percentage (44.11%). This implies that ecological factors deteriorating the community of coral reefs could be present. However, there is a presence of macroalgae with 11% mean cover in which contributes to the mortality of corals. In average Rasa Island Wildlife Sanctuary Coral cover falls in HCC Category B and generic coral diversity of Category B. (Table 3).

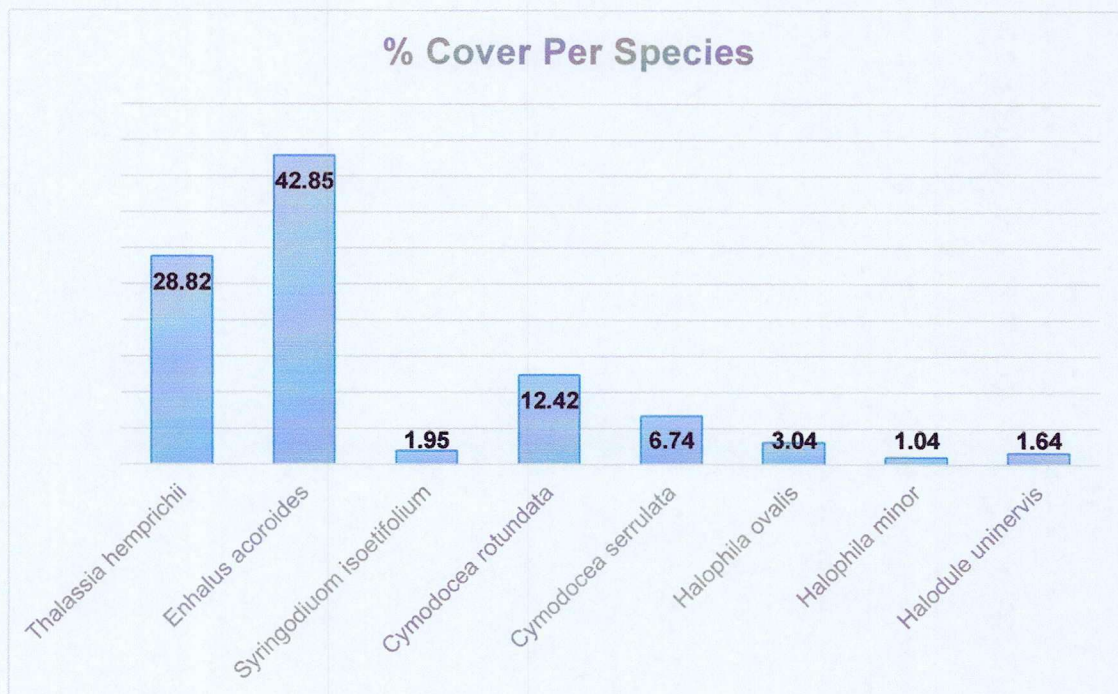
Figure 4. Percent Cover per species

Figure 4. shows the percentage cover of seagrass found in Rasa Island Wildlife Sanctuary. The highest percentage cover consist of *Enhalus acoroides* with a total percentage cover of 42.85% followed by *Thalassia hemprichii* with total percentage cover of 28.82 %, *Cymodocea rotundata* with total percentage cover of 12.42%, *Cymodocea serrulata* with total percentage cover of 6.74%, *Halophila ovalis* with total percentage cover of 3.04%, *Syringodium isoetifolium* with total percentage cover of 1.95%, *Halodule uninervis* with total percentage cover of 1.64% and *Halophila minor* with the lowest percentage cover of 1.04%.

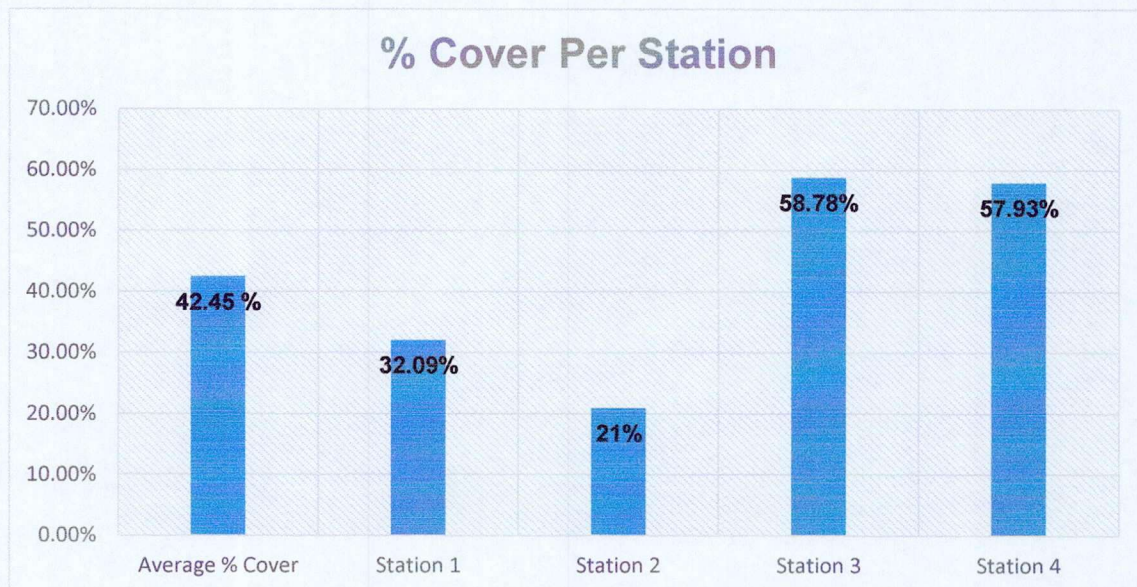
Figure 5. Category condition per station and average category condition

Figure 5. Shows the category condition of seagrass in Rasa Island Wildlife Sanctuary. It also shows that among the four stations that was assessed, Station 3 has the highest category condition which falls into good condition followed by station 4 which also falls into good condition, Station 1 which falls into fair condition and station 2 which falls into poor condition (Amran 2010). The total average category condition of seagrass in Rasa Island Wildlife Sanctuary is 42.45% which falls into Fair condition.

1. Continuous and intensive information education campaign (IEC) on the role of seagrass on the marine ecosystems;
2. Implementation of strict protection and monitoring in the coastal and marine habitats of Rasa Island Wildlife Sanctuary;
3. Incorporating adaptive mitigating measures on the effects of climate change and adverse anthropogenic activities on our coastal and marine ecosystems.

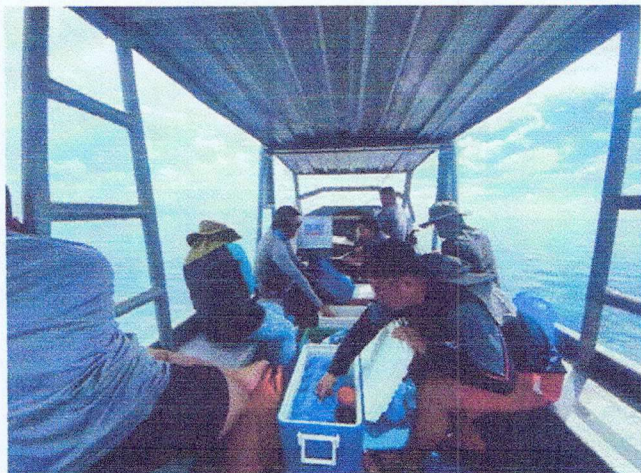
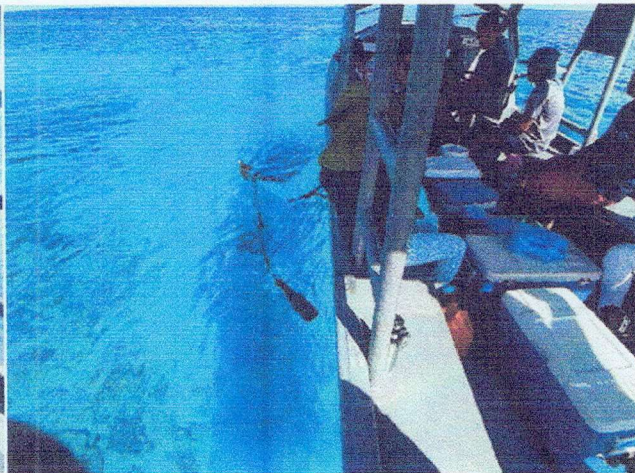
The water quality monitoring was conducted in TRNP on May 10-13, with the assistance of the Palawan Council for Sustainable Development Staff. Water samples and *in situ* water parameters were collected from the 20 monitoring sites on the reefs, inside the lagoon, and in the buffer zone of the park. *In situ* water parameters collected include temperature, dissolved oxygen, pH, total dissolved solids, conductivity, and salinity. Water samples were taken to the PCSD Environmental Laboratory for analysis of the following parameters: oil and grease, nitrates, phosphates, total suspended

Figure 2. (Left) The team collects water samples for laboratory analysis. (Right) Dr. Faith Perez (PCSDS) deploys a multiparameter water quality meter to obtain *in situ* data. Photo by TMO/Anthea Valenzuela
