SUBJECT : SUBMISSION OF THE WATER QUALITY MONITORING
PRELIMINARY REPORT OF APO REEF NATURAL
PARK FOR THE FIRST SEMESTER OF CY 2022

Water Quality Monitoring Report

1st Semester of 2022

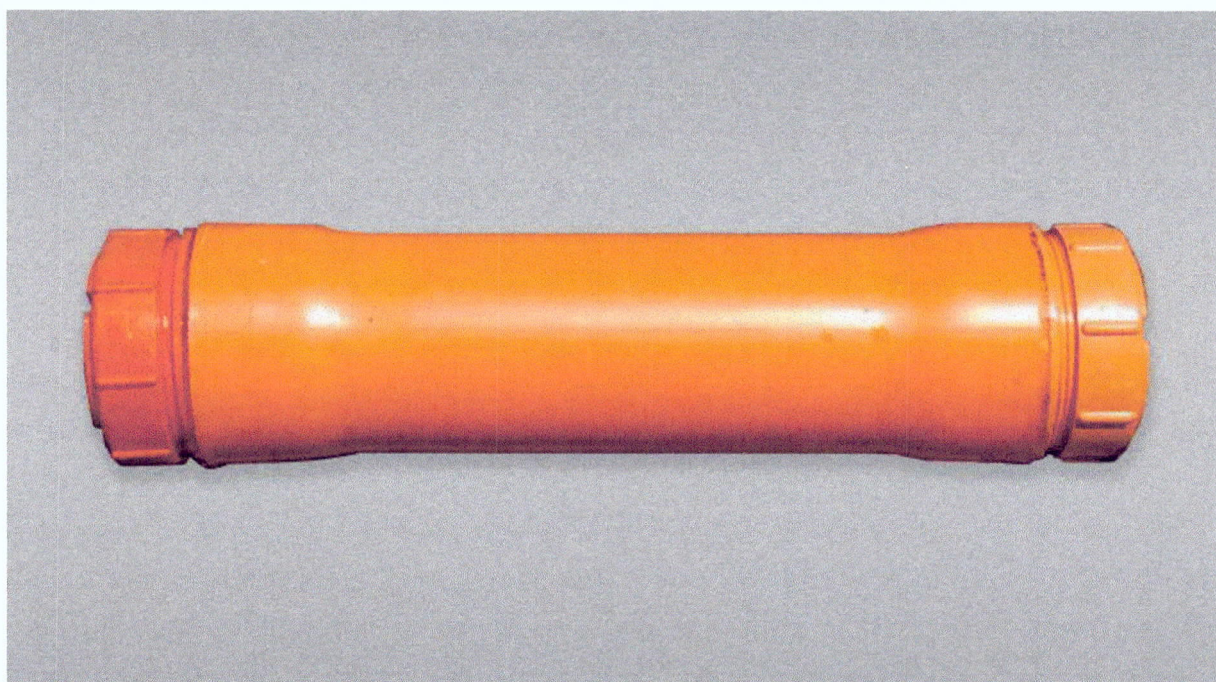
Figure 2. PVC sampling device used in collecting samples from different depths (surface, middle-layer, and near-bottom) at Ego Wall.

Discrete sampling was the method used in collecting water samples from the groundwater well and monitoring stations along the bathing beach. This was also used in collecting samples for oil and grease analysis in Ego Wall and the two stations in San Antonio. Depth-integrated sampling was the method used in collecting the other water samples in these deeper monitoring stations. For this sampling method, separate water samples were collected at the surface (0.10-0.50 m), middle layer (~5 m), and near-bottom depth (9.5-10 m) using an improvised PVC sampling device (Figure 2). The sampling device used was designed to work like a Van Dorn sampler. However, two divers manually close the stoppers unlike the Van Dorn which features a messenger. The water samples from the three different depths were then mixed before transferring to the sample containers.

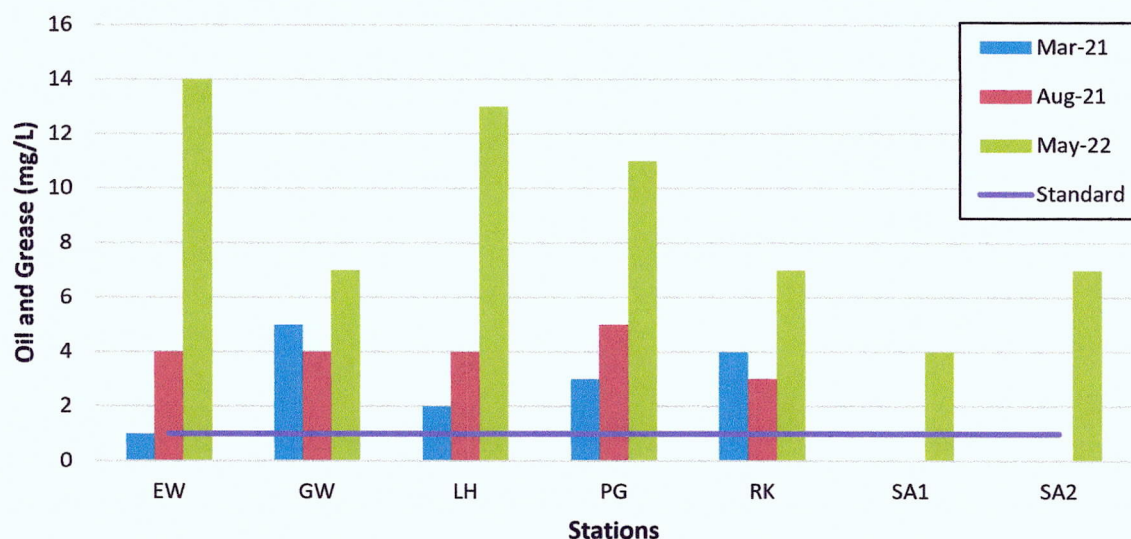
Figure 3. Oil and grease concentration across the monitoring stations from 2021 to 2022.

Oil and grease is the only chemical parameter measured wherein all stations failed the Class SA and Class B standards, with measurements ranging from 4 to 14 mg/L. The amount

oil and grease increased in the five initial water quality monitoring stations (Figure 3). A possible cause for this increase may be the corresponding increase in tourism operations within the Protected Area. In Ego Wall, the increase may be artificial, although unlikely, due to the change in sampling method from depth-integrated sampling to discrete sampling. Petroleum hydrocarbons, for instance, are more likely to be transported horizontally from its source than vertically or deeper into the water column (National Research Council, 2003) therefore, higher concentrations will be available on top of the water column where the samples were taken.

Marine transportation activities are suspected to be the main cause of the increased oil and grease in ARNP. This is because ARNP is proximal to domestic shipping routes, particularly long-distance primary routes which connect major ports in the country (MARINA, 2018). Ropax vessels (RoRo passenger-cargo vessels) and cargo vessels including container and tanker ships are serving mainly for these routes (JICA, 2005). These vessels are known to release oil, mainly petroleum oil, into the sea in their routine operations, and as a result of major accidents like collisions and groundings. Other vessels such as commercial and small-scale fishing boats and recreational boats may also be contributing to oil pollution in ARNP.

Generally, it is recommended that sampling stations within the Protected Area be increased to improve the generality of the findings. Should this pose challenges in complying with the advised holding time for the samples, replicate samples for each monitoring station may be collected instead as an initial effort to improve the reliability of inferences drawn from the data. Aside from these, the Maritime Industry Authority (MARINA) should be consulted for feasible actions addressing the increased oil and grease levels within the MPA, and response plans for major accidents which may lead to oil spills should be developed.

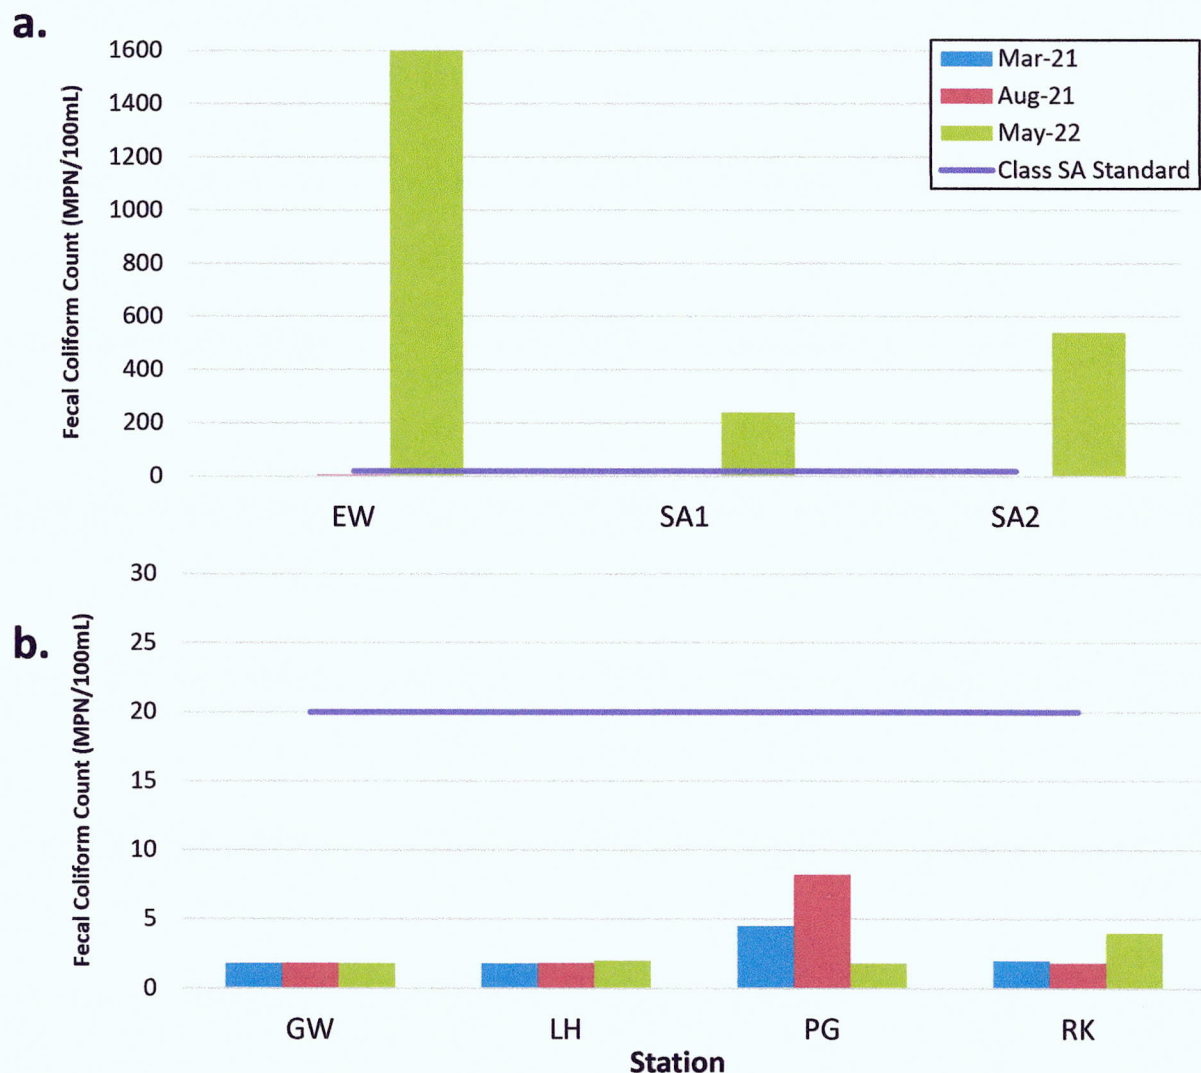
Figure 4. Fecal coliform count across the monitoring stations from 2021 to 2022. Monitoring stations with depth greater than 5 meters (a); monitoring stations proximal to the septic tank system (b).

Apart from oil and grease, fecal coliform count is another parameter which showed notable results (Table 4). The groundwater well and bathing beach stations (LH, RK, and PG) all passed the Class SA and Class B standards for fecal coliform count. This is despite being closer to the potential point source which is the septic tank system at the Ranger's Station. Fecal coliform count in these stations also remained fairly the same from 2021 to 2022 (Figure

4). In contrary, all water quality monitoring stations with depths greater than 5 meters failed the standards for Class SA water bodies. There was a significant increase in fecal contamination in Ego Wall from 2021 (1.8 and 4.5 MPN/100 mL) to 2022 (>1600 MPN/100 mL). Sewage from Apo Island is unlikely to be the source of this fecal contamination given the results in nearby monitoring stations. Other possible sources will be sewage discharge from shipping, recreational, and fishing vessels and stormwater runoff from mainland Sablayan.

For fecal coliform count, the sole bacteriological parameter measured, four of the seven monitoring stations passed the standard for Class SA and Class B water bodies. These include the groundwater well and the monitoring stations along the bathing beach indicating that the water from these areas is safe for human contact, particularly for bathing, and other domestic uses. On the other hand, measurements acquired in Ego Wall and San Antonio were high and well above the accepted levels. This is especially alarming for Ego Wall which is a popular dive site for tourists. A possible cause for the sudden increase of fecal contamination in this site is sewage discharge from vessels including recreational boats which increased their operation within the Protected Area this year. The fecal coliform count in this area should be closely monitored in the next sampling period and the necessary management actions shall be taken if it sustains high levels of fecal contamination.

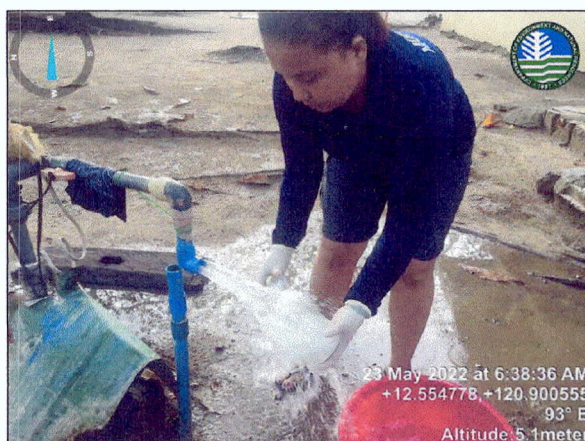
One station was sampled for groundwater: the groundwater well proximal to the Ranger's Station. Water from this groundwater well is accessed for domestic use using a galvanized iron hand pump and an electric water pump. This station was included in the assessment because it was adjacent to a septic tank system on the island which can impact groundwater quality.

In sampling the groundwater well, at least 68 gallons of water were purged from the well before sampling. This was done to eliminate the stagnant water in the well and acquire a water sample that is representative of the characteristics of the groundwater. After purging, sample containers were filled with water from a PVC pipe connected to the electrical pump and nearest to the well.

Collection of water samples from the groundwater well beside the Rangers' Station.
