SUBJECT : **REPORT ON THE FOLLOW-UP MONITORING FOR THE SAND AND GRAVEL ACTIVITIES OF MR. CORREA AT BRGY. SAN NICOLAS AND MR. MANTAP AT BRGY. GUADALUPE, AND QUARRY OPERATION OF 428 HI-TECH GROUP INC. AT BRGY. SAN NICOLAS, CORON, PALAWAN**

SUBJECT : **REPORT ON THE FOLLOW-UP MONITORING FOR THE
SAND AND GRAVEL ACTIVITIES OF MR. CORREA AT BRGY.
SAN NICOLAS AND MR. MANDAP AT BRGY. GUADALUPE;
AND QUARRY OPERATIONS OF 428 HI-TECH GROUP INC.
AT BRGY. SAN NICOLAS, CORON, PALAWAN**

**SUBJECT : REPORT ON THE FOLLOW-UP MONITORING FOR THE
SAND AND GRAVEL ACTIVITIES OF MR. CORREA AT BRGY.
SAN NICOLAS AND MR. MANDAP AT BRGY. GUADALUPE;
AND QUARRY OPERATION OF 428 HI-TECH GROUP INC. AT
BRGY. SAN NICOLAS, CORON, PALAWAN**

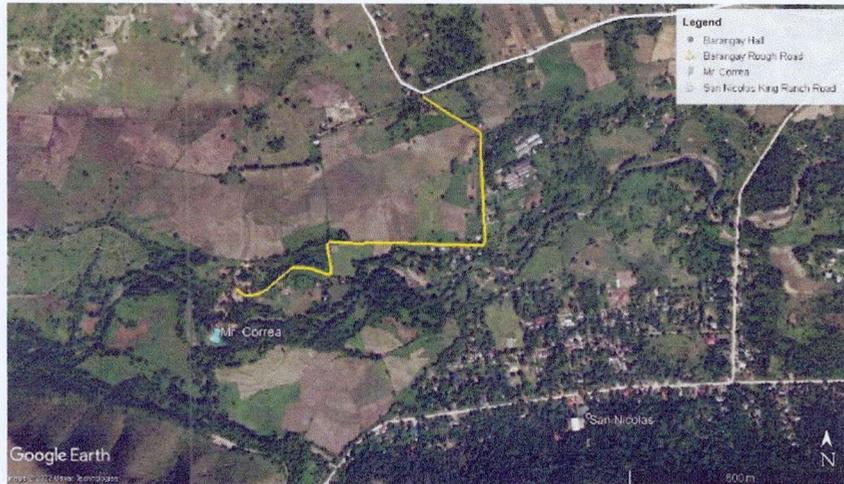
Figure 2. Road project of Mrs. Correa. The yellow line represents the total length of the 1.3 km rough road to be filled.

1. To all proponents, keep up their compliance with the cease-and-desist orders until the necessary permits are acquired.
2. For Mr. Correa's case, the activity supporting the barangay's plan to improve the situation of the community road may continue provided that the source is from their existing stockpiles, and there will be no further extraction of materials from the river. Furthermore, there should be no commercial disposition of the said aggregates until such permits are acquired.

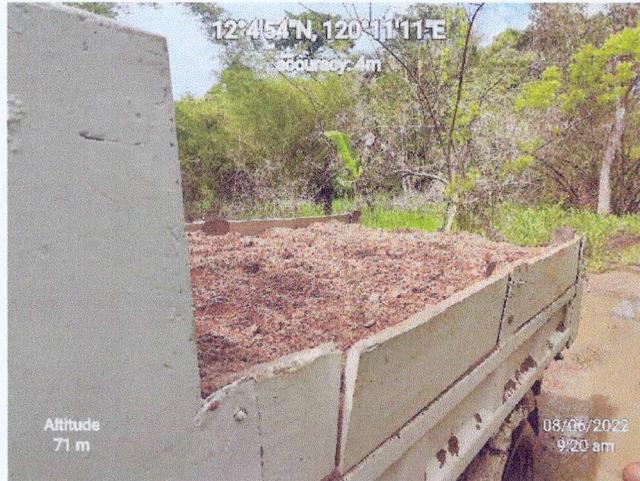
3. Prior to site arrival, a small white truck with a carrying capacity of 3 cu. m. was seen with a full load of sand and gravel (*see Photo Documentation*). Based on the driver, Mr. Jerome, the aggregates were to be used as a fill material for the depressions in the dirt road which accumulates standing water. This barangay road is utilized by the community residing in Sitio Tabok and other nearby sitios going to the barangay proper.

4. The caretaker, Mr. Roman Fabia, mentioned that the observed activity was a request from the barangay. Mrs. Correa, the wife of the owner, further confirmed this statement. She added that a total of 36 cu. m. will be used, and the material will be taken from the existing stockpiles and waste gravels from hollow block production (*see Photo Documentation*). Based on google earth measurements, a total of 1.3 km will be the scope of this activity (Figure 2). Mrs. Correa further mentioned that this is part of their social development program, and this is part of their yearly contribution to the barangay of San Nicolas.

White truck carrying aggregates to be dumped on the road depression that accumulates standing water. As per Mrs. Correa, this is part of their contribution to the barangay of San Nicolas.

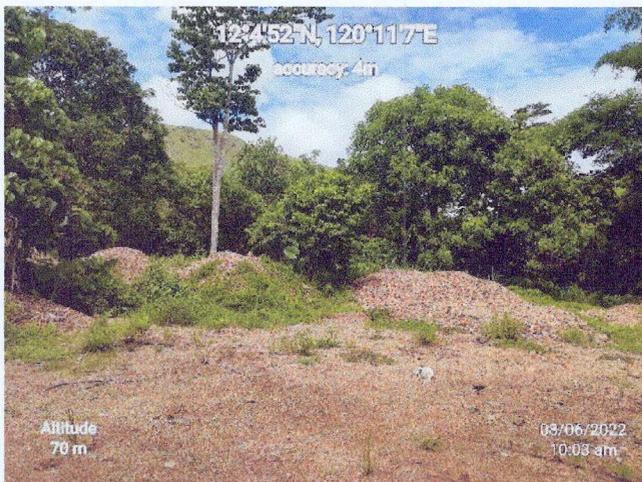
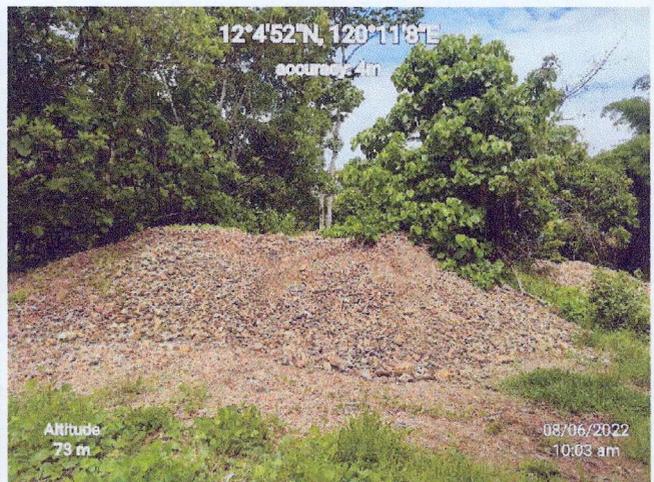
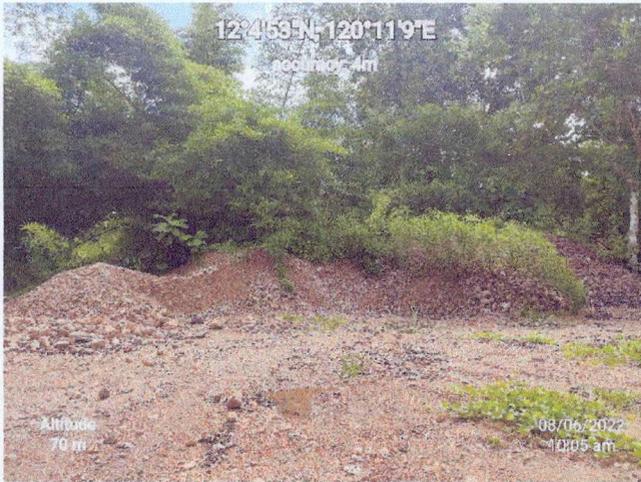
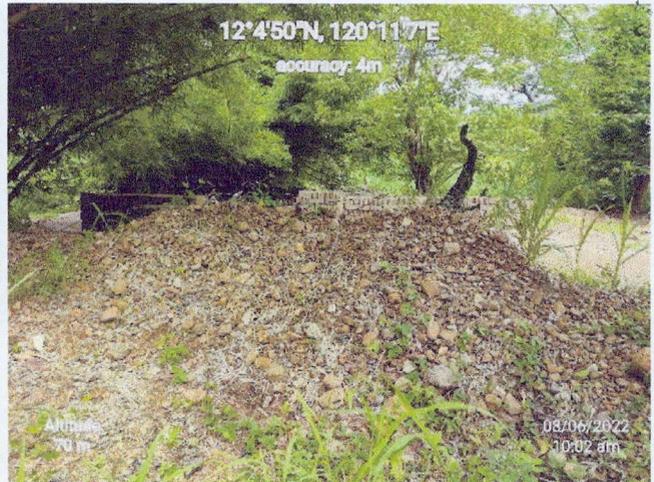
6. There is no extraction of new quarry material based on the undisturbed river channel and the lack of quarry equipment. Furthermore, testimonies from the interviewees also suggest that there was no commercial disposition of the aggregates.

Some of the old stockpiles of the proponent. These will be the source of the mentioned activity.

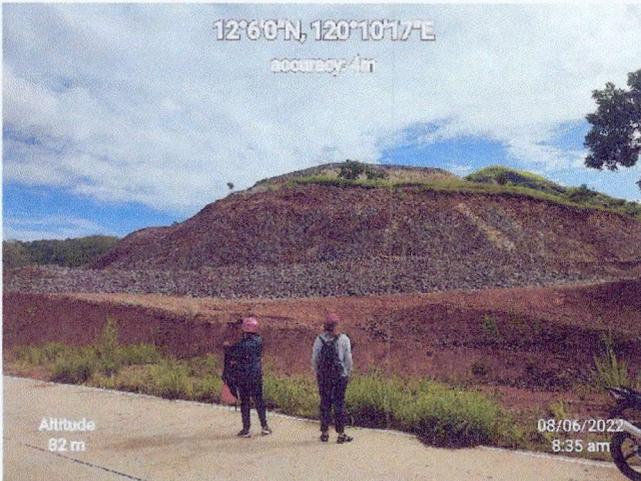
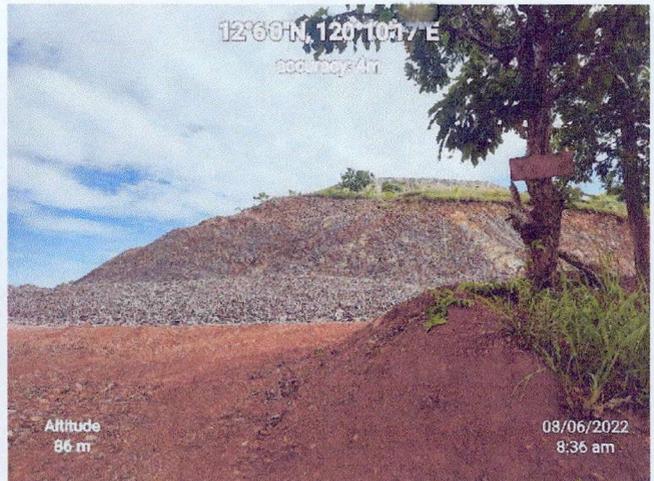
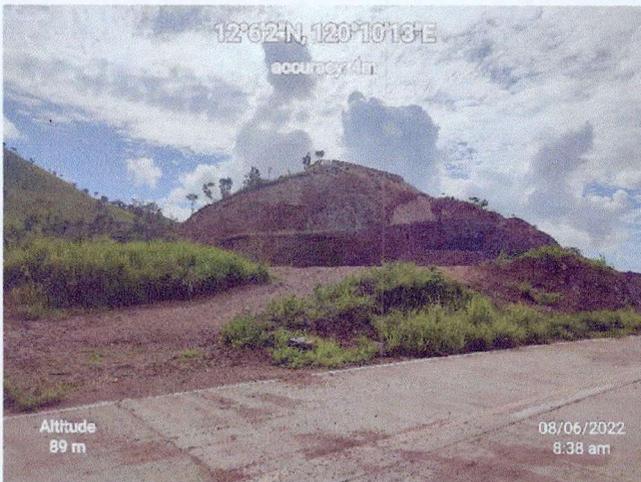
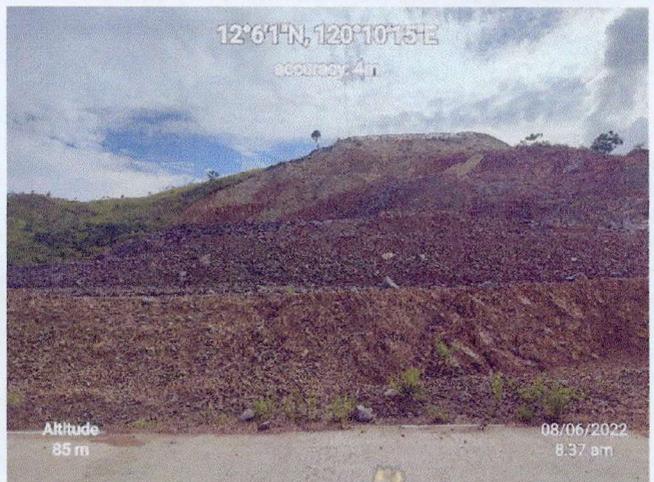
(Proponent: 428 Hi-Tech Group Inc. – Brgy. San Nicolas)

1. The subject area is located in Sitio Pakunan, Brgy. San Nicolas, Coron within the Busuanga Pasture Reserve. It is geographically situated at 12° 05' 60" N, 120° 10' 17" E. This is approximately 15 km away from CENRO Coron and can be reached within an approximately 25-minute motorcycle ride (Figure 1).
2. Upon arrival at the quarry site, no activity was observed. There were also no visible changes to the quarry site compared to the recent visit of some of the CENRO personnel. All heavy quarry equipment was also nowhere to be seen (*see Photo Documentation*).

State of the proponent's quarry upon site visit. No evidence of recent activity was observed in the area.
