SUBJECT : **INVESTIGATION REPORT ON THE LANDSLIDE IN THE
MOUNTAIN QUARRY IN SITIO LAMUD, BARANGAY
POBLACION 6, CORON, PALAWAN**

SUBJECT : INVESTIGATION REPORT ON THE LANDSLIDE IN THE
MOUNTAIN QUARRY IN SITIO LAMUD, BRGY. POBLACION
6, CORON, PALAWAN

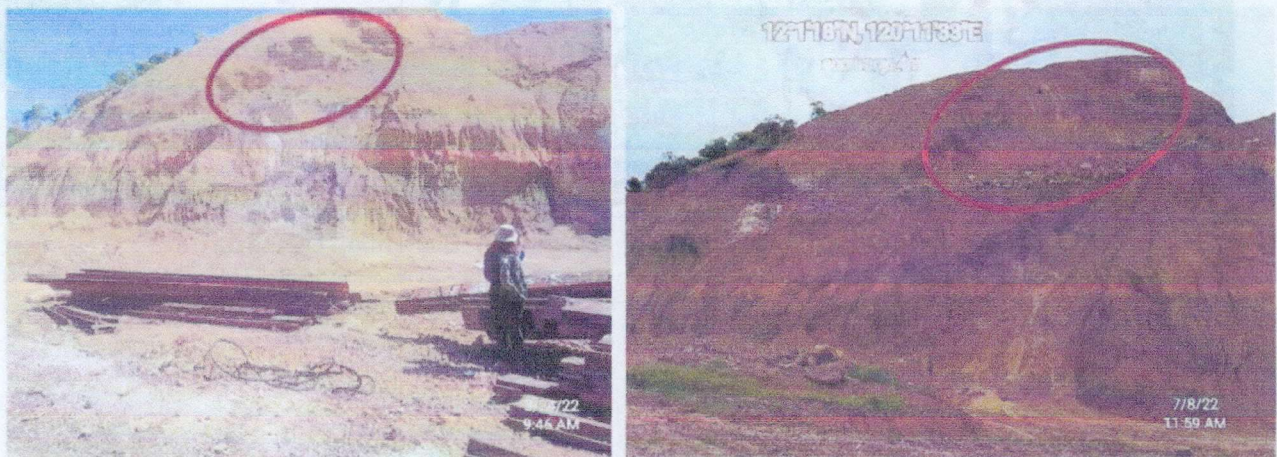
3. Looking at the slopes of the quarry, an area with a noticeable scarp can be seen. Below it, debris of rocks up to ~half a meter across and soil was also observed. Based on the lack of gullies on the scarp and the deposits lacking signs of compaction due to recent rains, it suggests that the movement happened quite recently (*see Photo Documentation*).
4. Comparing an image taken from 24 March 2022 to the recent image, it can be concluded that a portion of the quarry face is missing in the recent image. (Figure 2).

Figure 2. Comparison of the morphology of the area. The image on the left was taken in March whereas the image on the right was taken in July. Encircled is the area where evidence of mass movement was observed.

1. Although the slopes are made up mostly large of stable rock mass and there are no signs of a large-scale mass movement, the possible risks of mass movement cannot be understated. The company should hasten the rehabilitation of the area to minimize the possible hazards posed by the quarry site.
2. To CENRO, inform the company regarding this matter.

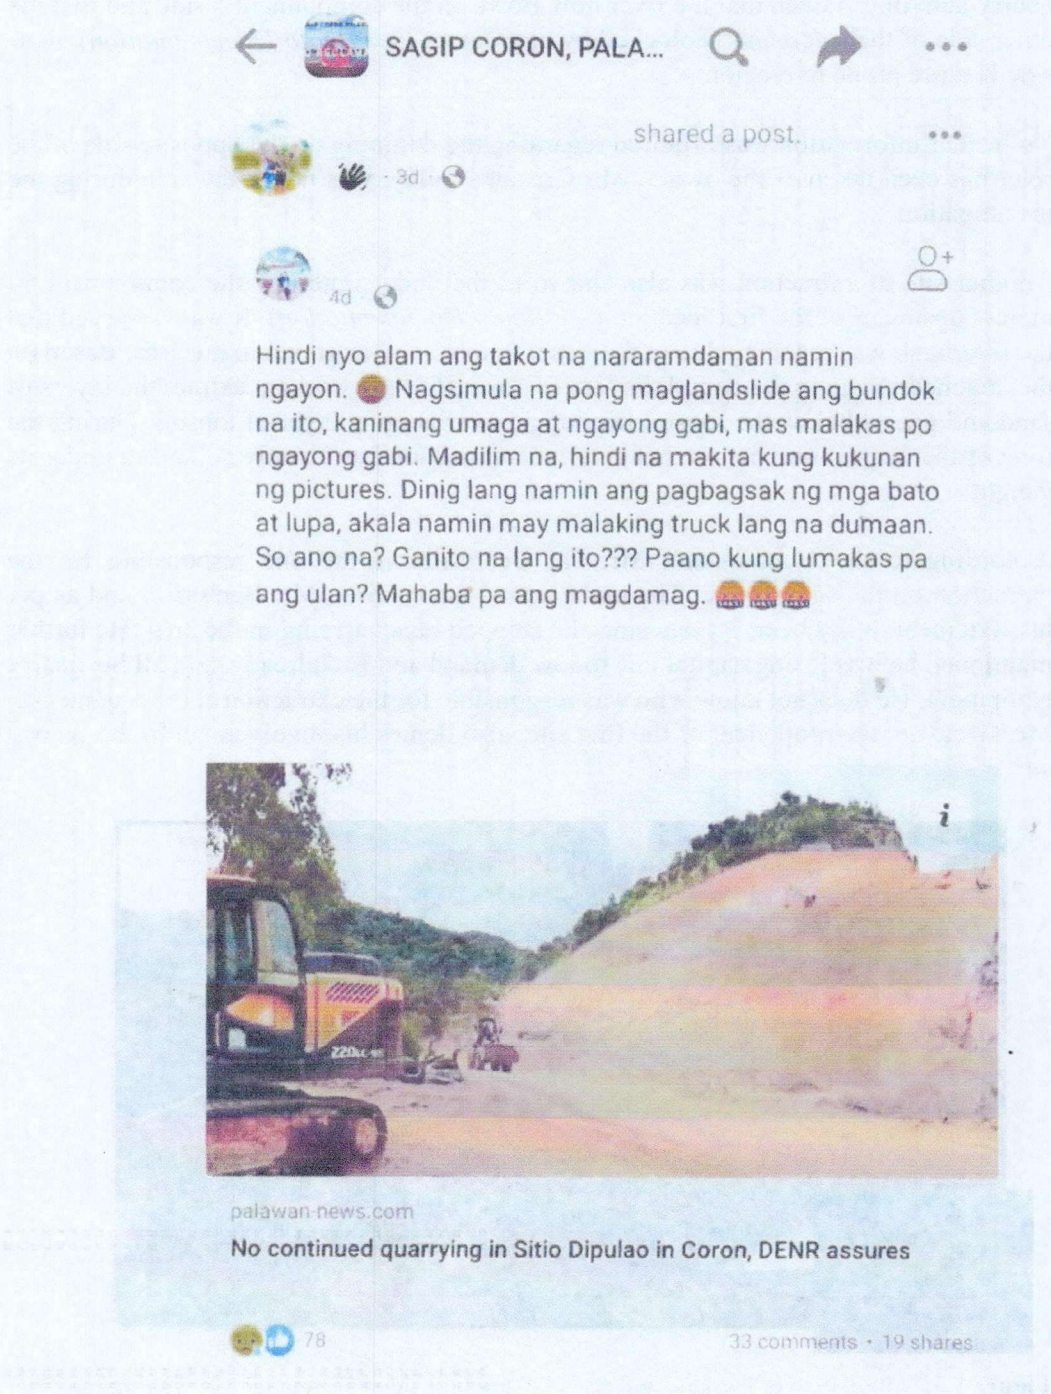
Annex-1

Last 08 July 2022, a concerned citizen posted a landslide incident on a social media platform (Annex-1). During the prior week, constant strong rains have been occurring daily in Coron. Based on the report of PAGASA from 04-08 July 2022, the Philippines were experiencing the effect of Southwest Monsoon or *Habagat*, Intertropical Convergence Zone (ITCZ), and a Low Pressure Area (LPA).

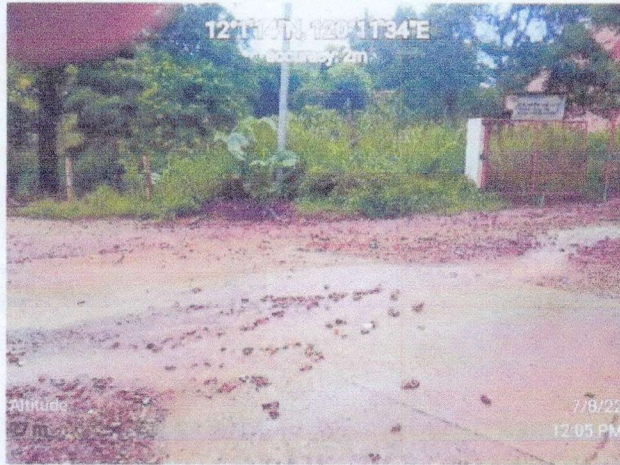
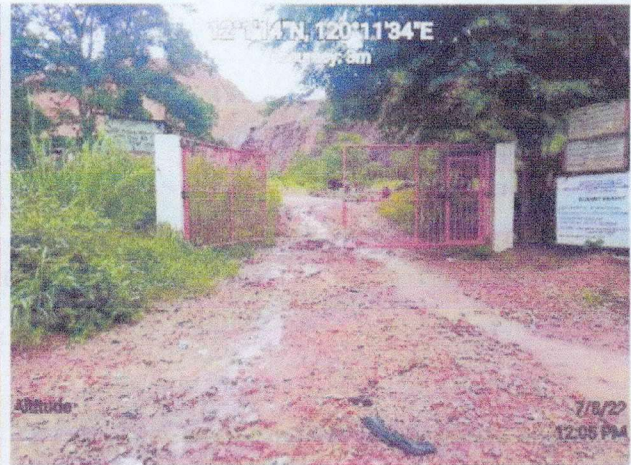
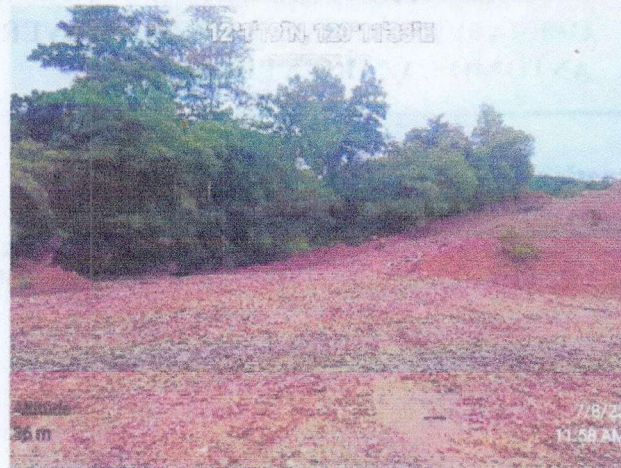
1. The subject area is geographically at 12° 01' 21" N, 120° 11' 39" E. It is within Sitio Lamud under the jurisdiction of Brgy. Poblacion 6. The area is approximately 3 km away from CENRO which can be reached by an approximately 5-minute motorcycle ride (Figure 1).
2. Upon arrival in the area, piles of eroded aggregates were observed along the access road and floor/base of the mountain quarry (*see Photo Documentation*). The sound of flowing water along the quarry wall was also heard.

The eroded aggregates which accumulated along the base of the area.

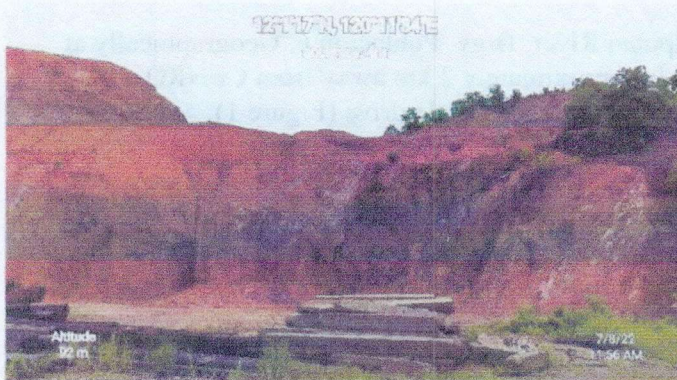
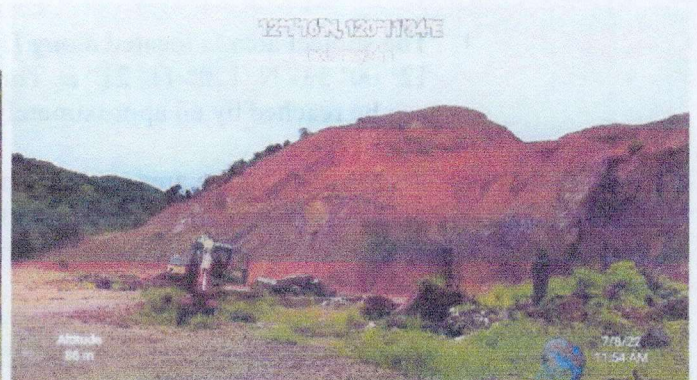
The current state of the mountain quarry.
