SUBJECT : **QUARTERLY REPORT ON THE WATERSHED
CHARACTERIZATION AND VULNERABILITY
ASSESSMENT (CRVA) OF AMNAY-PATRICK
WATERSHED**

SUBJECT : **QUARTERLY REPORT FOR THE WATERSHED CHARACTERIZATION AND VULNERABILITY ASSESSMENT (CRVA) OF AMNAY-PATRICK WATERSHED**

2. Updated GIS generated maps

- a. Infrastructure map,
- b. Climatic type,
- c. Geology map,
- d. Project map,
- e. Seismicity map,
- f. Settlement map,
- g. Soil erosion susceptibility map,
- h. Soil series map, and
- i. Tenurial map.

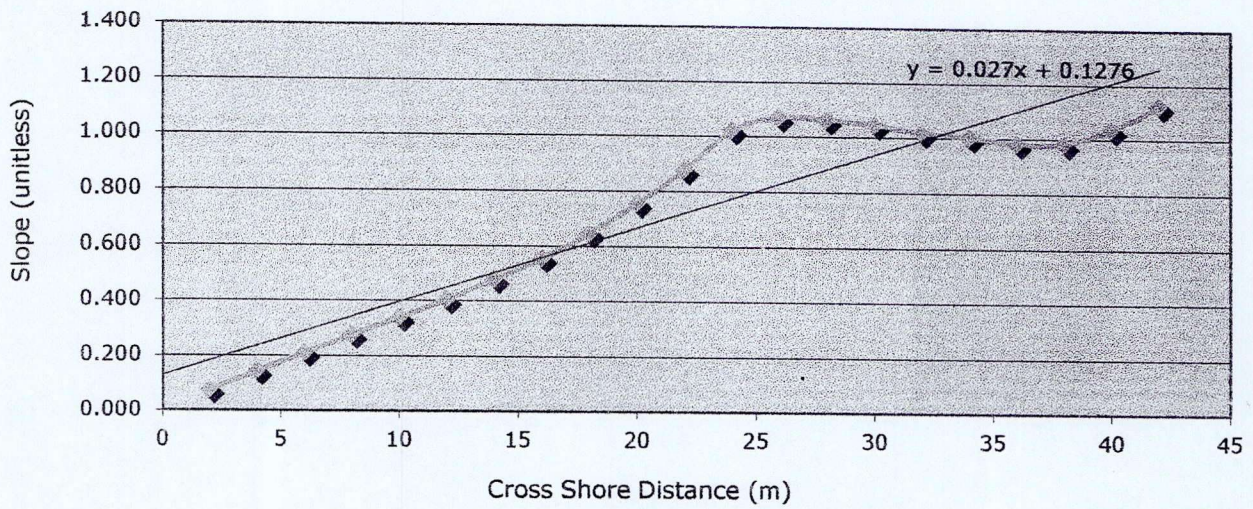
TRANSECT 19-CLAUDIO SALGADO

Beach Slope
