SUBJECT : **CONSOLIDATED REPORT ON THE SILTATION ALONG
MAREMEGMEG BEACH CAUSED BY ON-GOING
BENCHING OF BAYVIEW HOTEL AT BARANGAY
CORONG-CORONG, EL NIDO, PALAWAN**

SUBJECT : REPORT ON SILTATION ALONG MAREMEGMEG BEACH
CAUSED BY ON-GOING BENCHING OF BAYVIEW HOTEL AT
BARANGAY CORONG-CORONG, EL NIDO, PALAWAN

FOR : The Community Environment and Natural Resources Officer
THRU : The Protected Area Superintended ENTMRPA
FROM : The Chief, Enforcement and Monitoring Section
SUBJECT : **REPORT ON THE ALLEGED SILTATION BROUGHT ABOUT BY SOIL EROSION FROM THE LANDSLIDE PRONE AREA BESIDE THE BENCHING AREA OF BAY VIEW RESORT ALONG LAS CABAÑAS BEACH, CORONG-CORONG EL NIDO, PALAWAN**

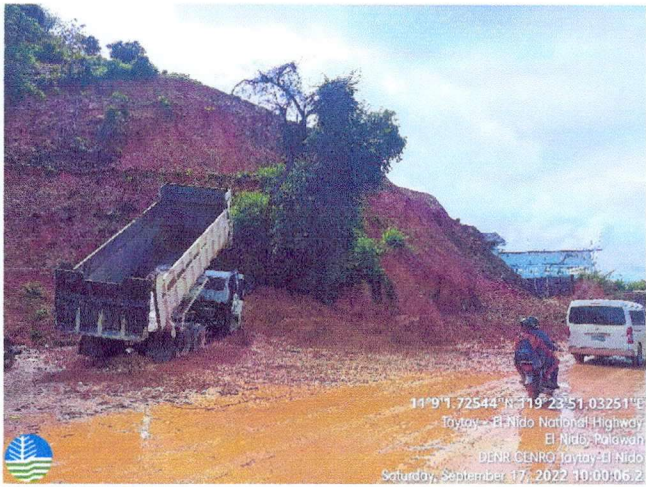
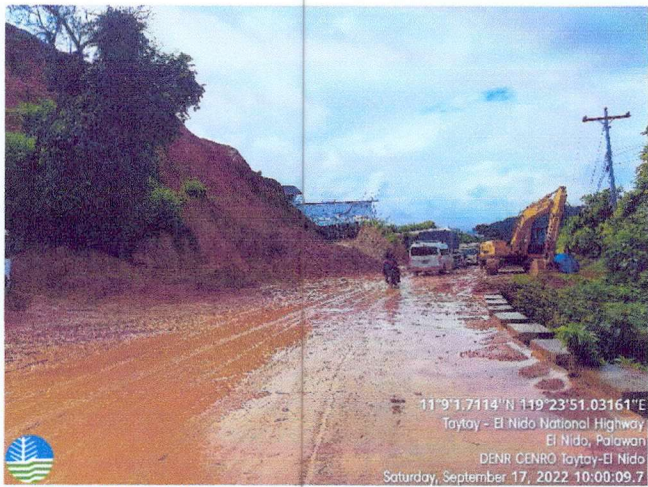
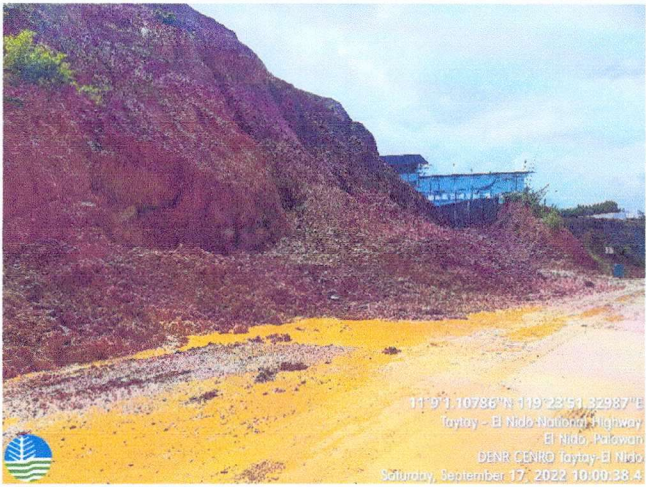
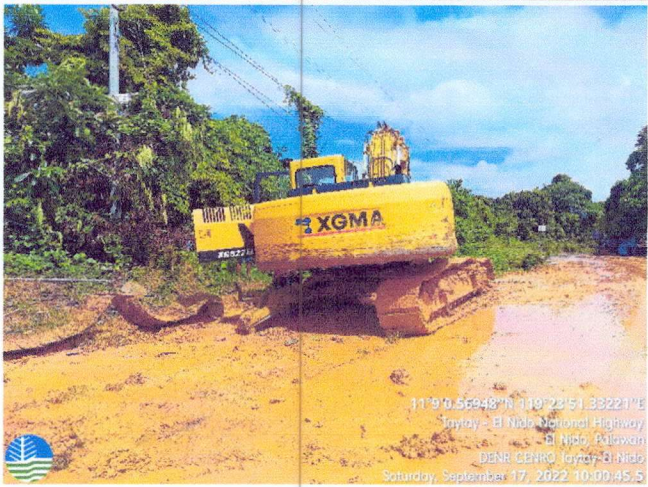
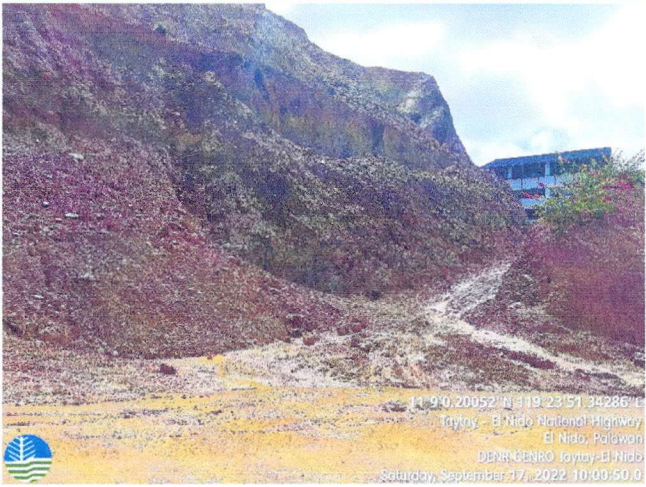
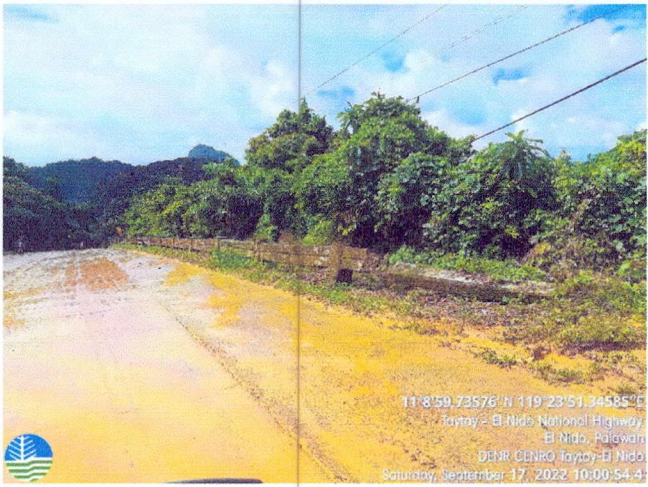
PHOTO DOCUMENTATION

During the ocular inspection, the undersigned noticed that the national road in front of Bayview Hotel was covered by mud caused by benching activity of the said establishment. Based on initial inspection, this event also causes siltation and discoloration along Maremegmeg Beach as the run-off flows to the nearby beach.

This is to certify that the above photos were true and correct and taken at the vicinity of Bayview Hotel and Maremegmeg Beach on September 17, 2022

1. Conduct continuous monitoring in the area;
2. Conduct follow up pertaining to the commitments of concerned agencies as a result of 2nd virtual conference dated February 17, 2022;
3. Conduct a follow up and require the proponent to submit their compliance on the recommendations during 2nd virtual conference dated February 17, 2022;

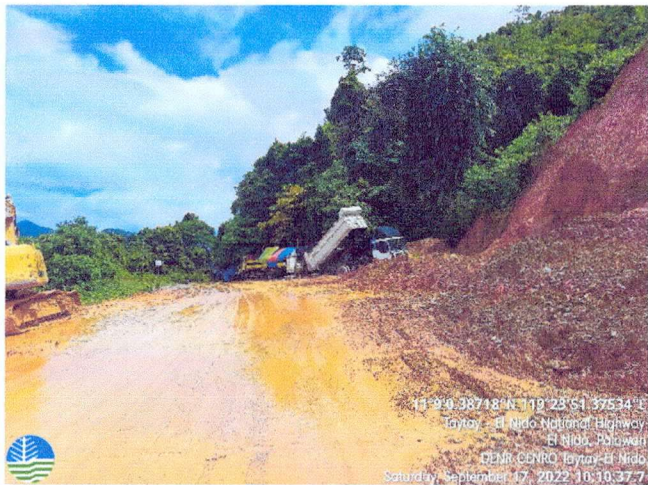
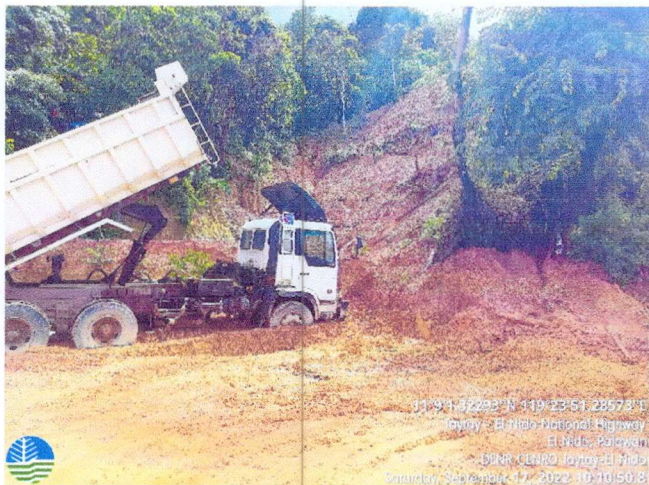
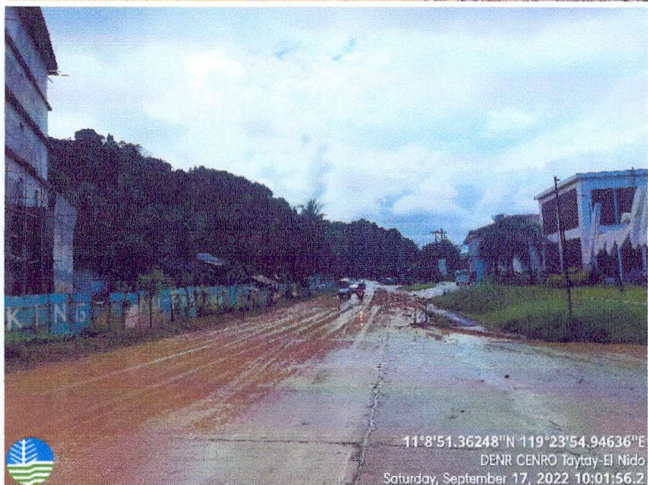
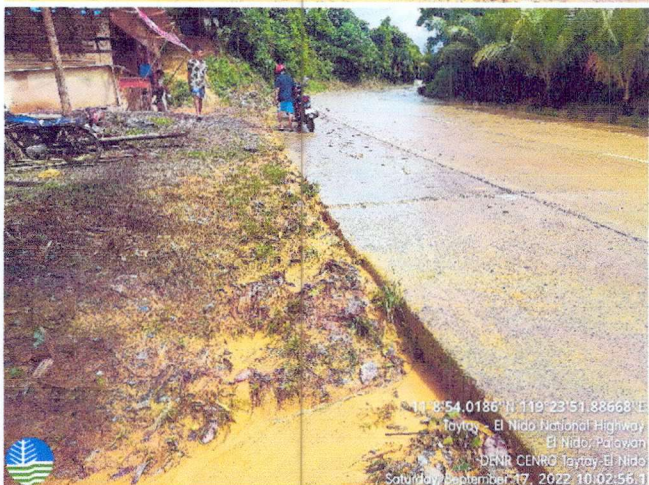
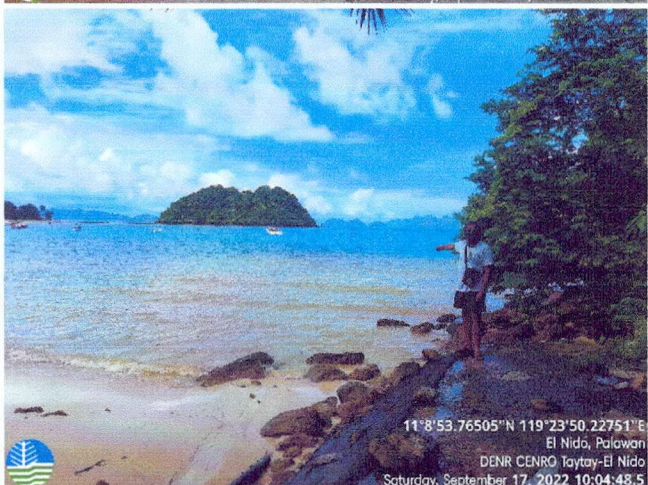
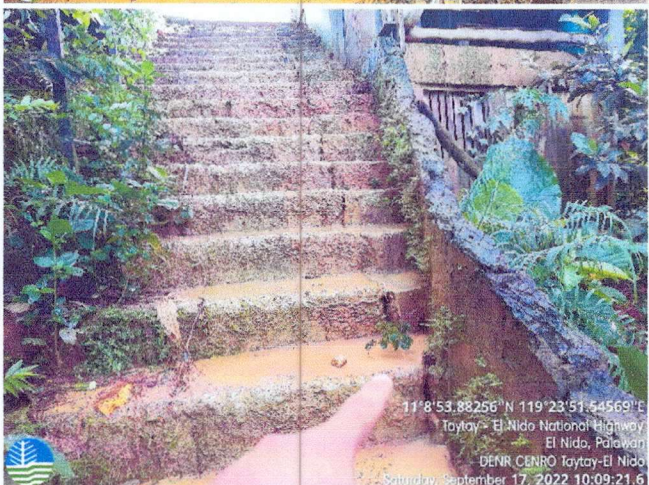
PHOTO DOCUMENTATION

This is to certify that the above photos were true and correct and taken at the vicinity of Bayview Hotel and Maremegmeg Beach on September 17, 2022

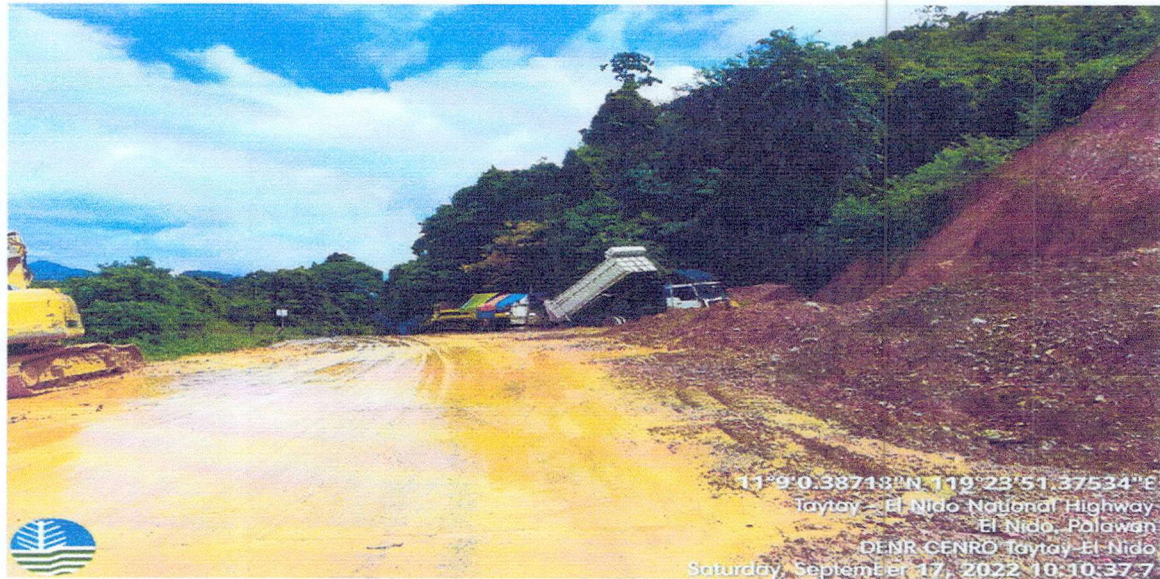
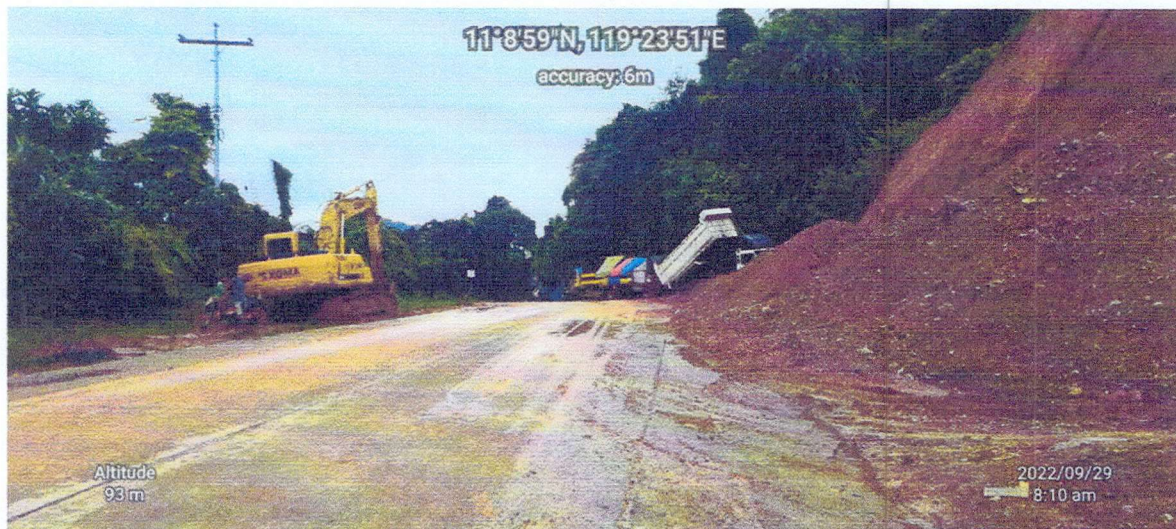
It can not be helped that surface run-off would occur during strong rains and for the road to get muddy during incidents of light to medium rain. Based on the ocular inspection conducted, last September 28-29, 2022 the proponent was able to immediately clean the road of debris and mud for motorist to pass safely. The surface run-off which drained to the adjacent coastal area was already dissolved.

Geotagged photos showing the road affected by the surface run-off from the benching project

The undersigned recommends a follow-up and submit the status on the actions recommended by the EMB and MGB relative to this matter. Furthermore, it is also recommended that Mr. Edgardo Trinidad be required to use additional porous or polymeric fiber on his benching project to avoid or minimize soil erosion in the area.

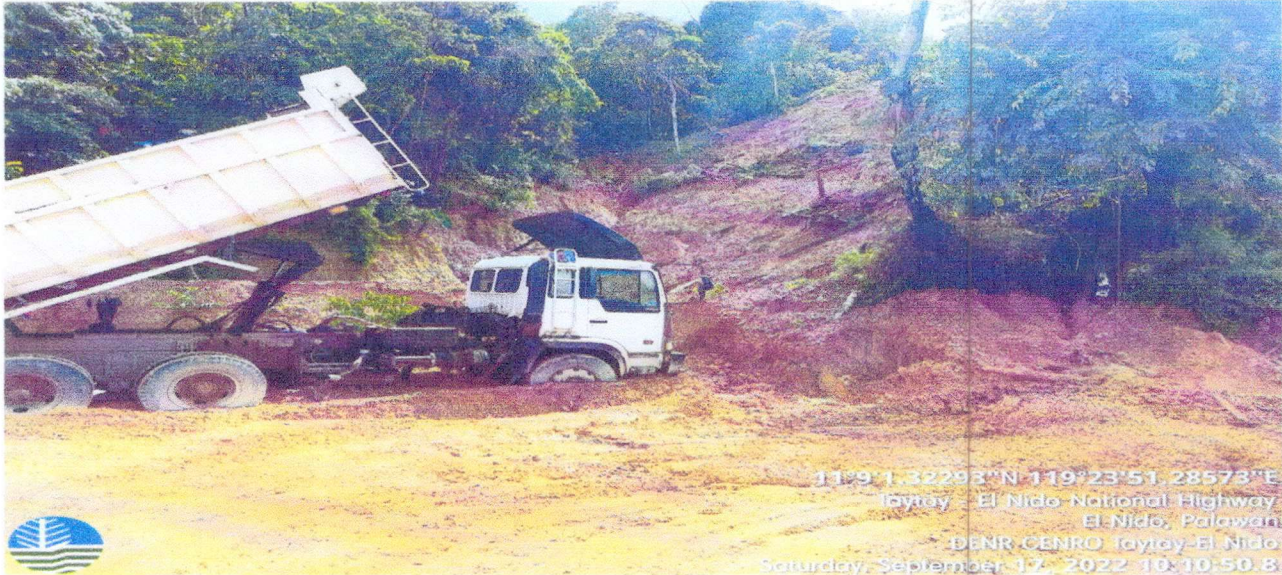
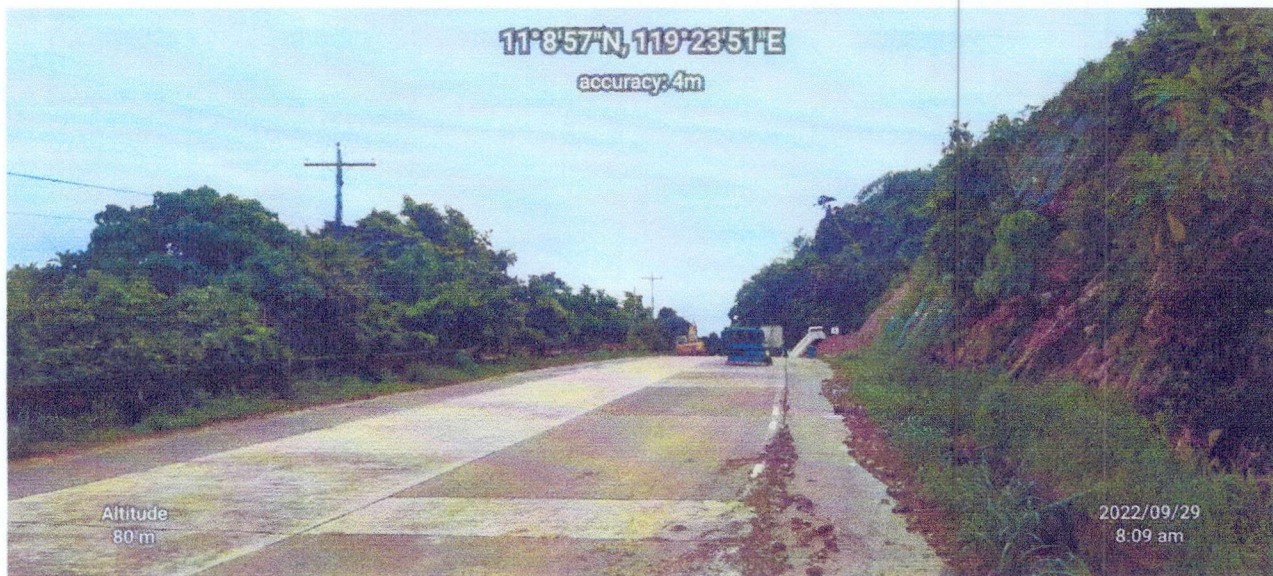
Geotagged photos showing the road affected by the surface run-off from the benching project

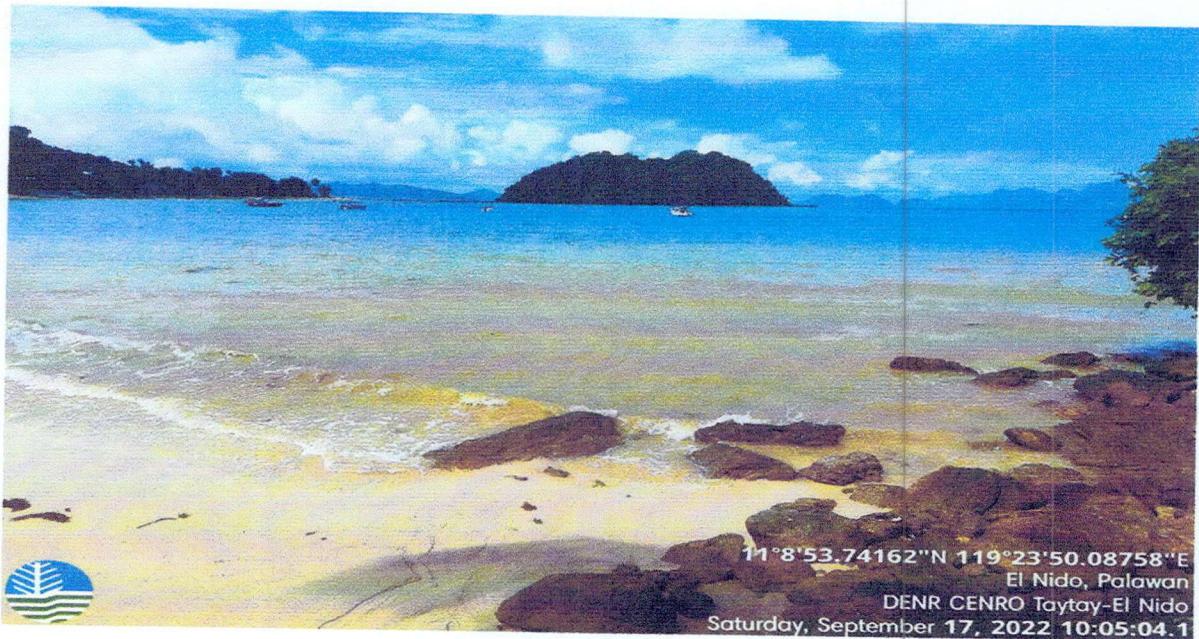
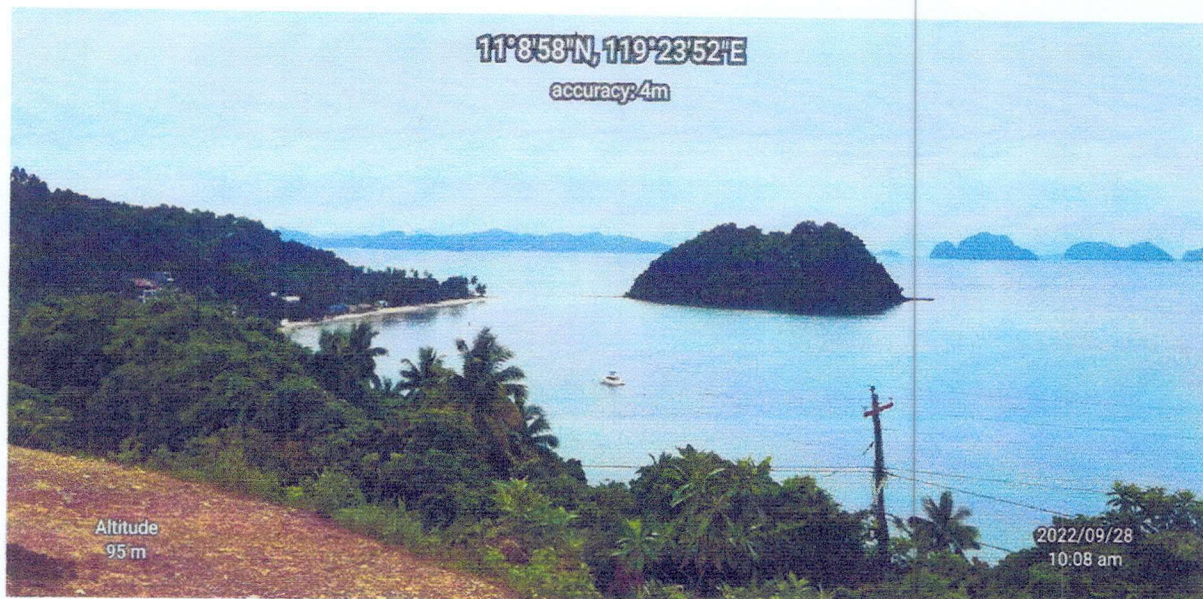
Please be informed that the undersigned conducted inspection on the area identified in the Facebook post. The alleged siltation came from the soil eroded from the benching project of Mr. Edgardo Trinidad, after the heavy rains brought about by heavy rains last September 16-17, 25-26, 2022.

Geotagged photos showing the area affected by siltation from the surface run-off
