SUBJECT : **ON THE SPOT REPORT PERTAINING TO SAND AND
GRAVEL EXTRACTION ALONG BENECAN RIVER IN BRGY.
DECALACHAO, CORON, PALAWAN**

SUBJECT : ON-THE-SPOT REPORT PERTAINING TO SAND AND
GRAVEL EXTRACTION ALONG BENECAN RIVER IN BRGY.
DECALACHAO, CORON, PALAWAN

Background Information

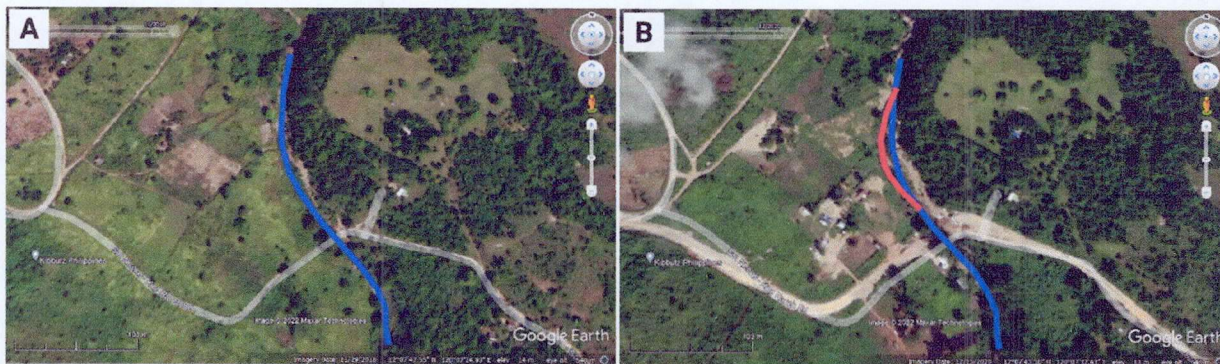
Figure 2. Comparison of Google Earth images of before and during the bridge construction in the area. The blue annotation shows the river original path of the river channel while the red annotation is the altered channel as an alleged result of the bridge construction. Image **A** shows a Google Earth Image taken on 29 November 2018 while image **B** was taken on 15 December 2020.

7. Mr. Tejada also mentioned about the plan, together with Mr. Fe Chi of Eleanor's Happy Farm, to rehabilitate the river back to its previous morphology prior to bridge construction (Figure 2).
