**SUBJECT :** FY 2022 WORK AND FINANCIAL PLAN FOR THE  
REPLACEMENT OF ZL6 DATA LOGGER OF GROUNDWATER  
MONITORING STATION INSTALLED AT MinSU, VICTORIA,  
ORIENTAL MINDORO

**SUBJECT** : **REPORT ON THE REGULAR MONITORING AND MANUAL UPDATING OF FIRMWARE OF THE DATA LOGGER OF THE INSTALLED WATERSHED INSTRUMENTS WITHIN THE PROVINCE OF ORIENTAL MINDORO**

**PHOTODOCUMENTATION OF THE DAMAGED ZL6 DATALOGGER OF GROUNDWATER MONITORING STATION (GWMS) INSTALLED AT MINDORO STATE UNIVERSITY (MinSU) DURING THE FIELD VISIT OF THE REGIONAL OFFICE ON DECEMBER 7-8, 2021**

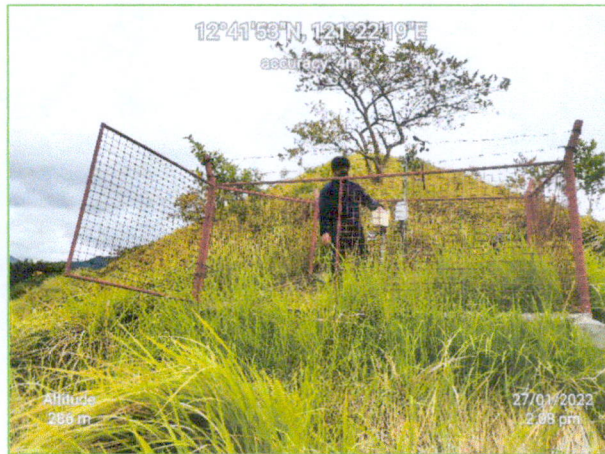
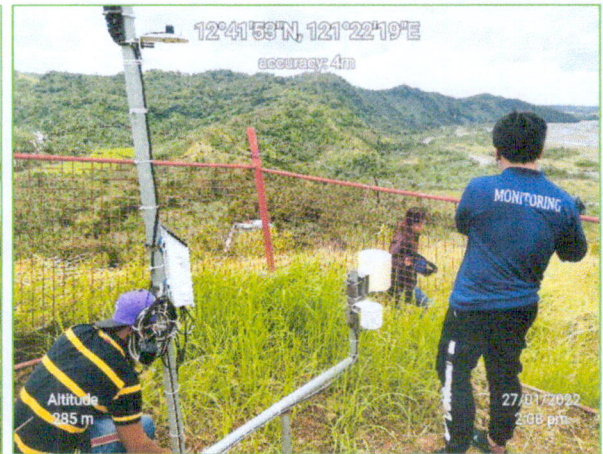
Figures 1: Photos showing the location site of the installed AWS in Brgy. Hagan, Bongabong, Oriental Mindoro

Further, the location site of the AWS was cleared of the grasses that infested the area. Multi-purpose grease was applied to the cables connected to the data logger to prevent any insects from crawling inside the data logger.

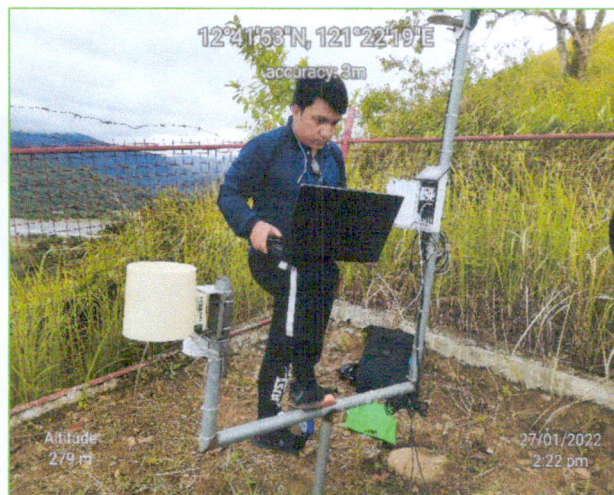
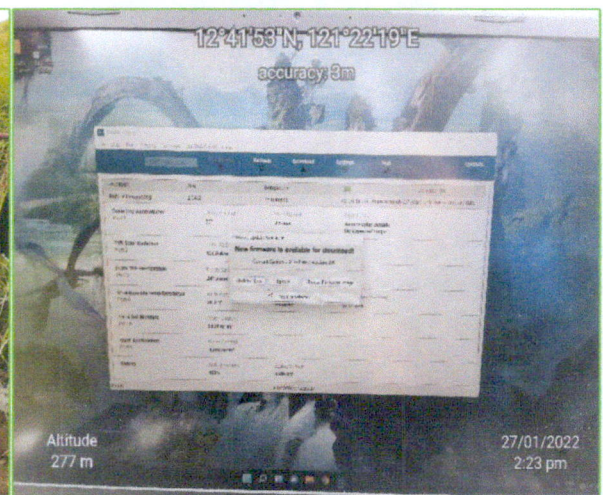
The data logger of the AWS was manually updated thru the use of a laptop with updated Zentra Utility application connecting to the data logger (*see Figures 2*) and the Cellular Upload Test was conducted to ensure that the data logger transmits data smoothly after the update (*see Figures 3*). Also, the rechargeable batteries were replaced with new ones to properly charge the previously used batteries.

Figures 2: Photos showing the manual updating of the firmware of data logger thru the use of a laptop with updated Zentra Utility app.

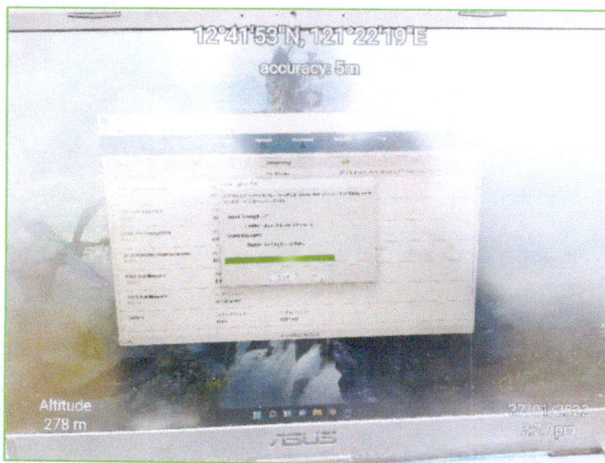
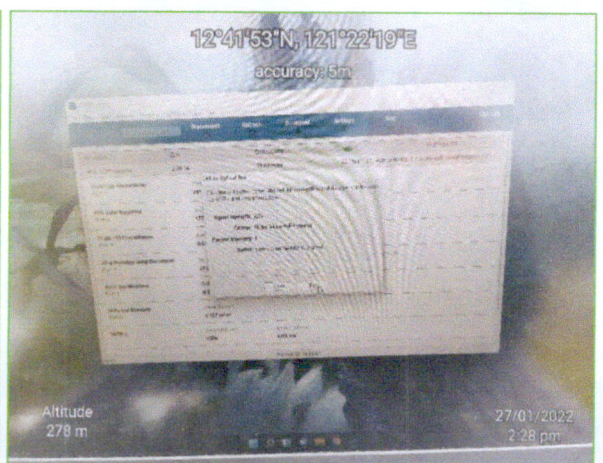
Figures 3: Photos showing the testing of Cellular Upload Test after the successful update of the firmware of the data logger

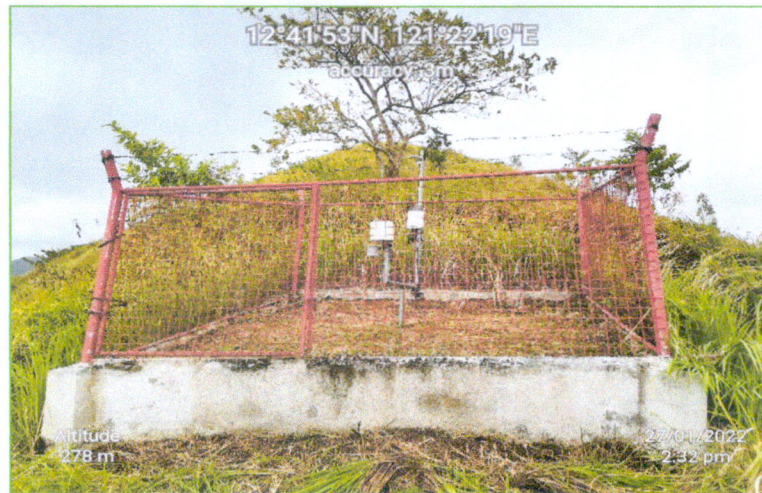
Figure 4: Photo showing the maintained site of the installed AWS after the monitoring activity

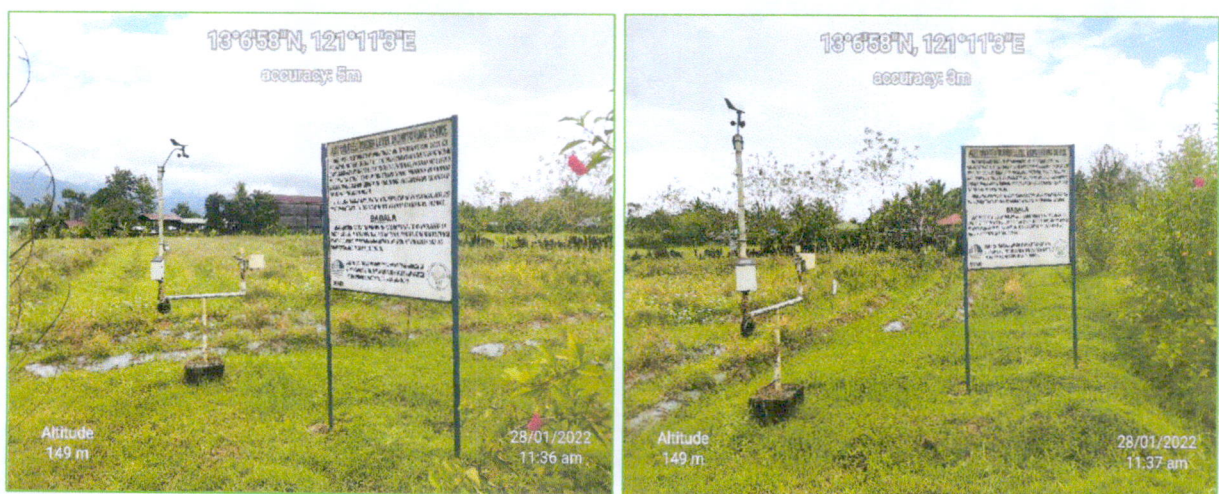
In DA-Regional Integrated Agricultural Research Center, the installed AWS is within the compound of the center and being maintained by DA staff assigned within the area. During the monitoring, the firmware of the data logger was manually updated thru the use of a laptop with installed Zentra Utility app and the Cellular Upload Test was conducted to ensure that the data logger transmits data smoothly. Also, the rechargeable batteries were replaced with new ones to properly charge the previously used batteries. The device was functioning properly after the successful updating of the firmware and other activities conducted.

Figures 5: Pictures showing the installed AWS within the vicinity of DA MIMAROPA Regional Integrated Agricultural Research Center

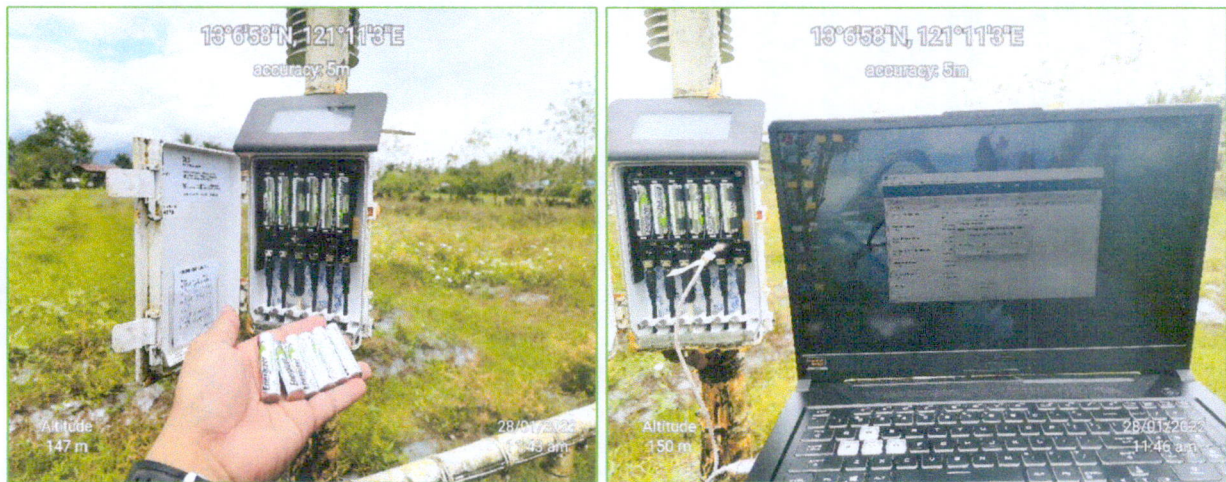
Figures 6: Pictures showing the rechargeable batteries for replacement to the old ones and the manual updating of the firmware of the data logger of the AWS

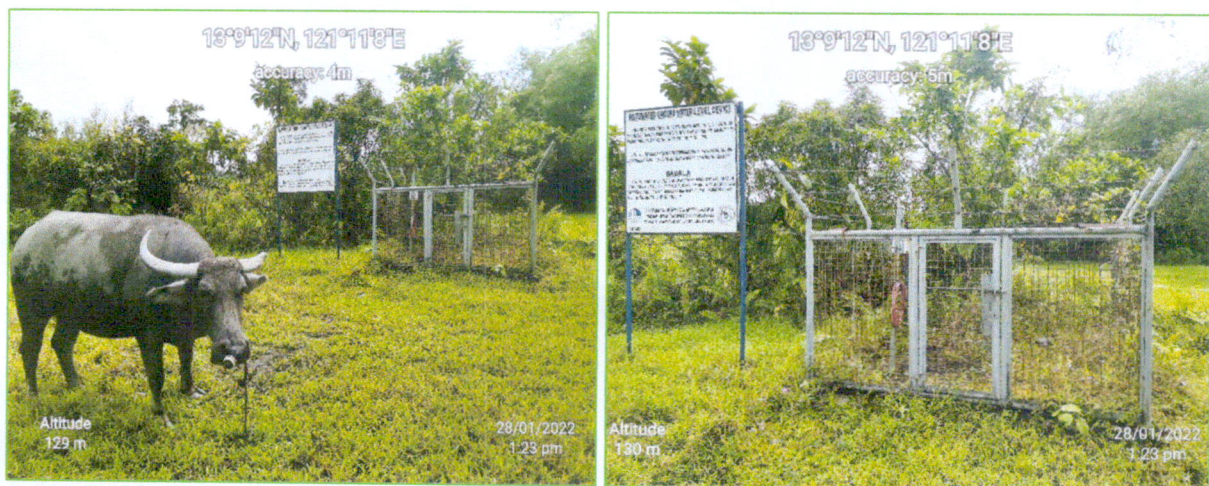
Meanwhile, in Mindoro State University, the installed groundwater monitoring instrument - CTD within the campus's vicinity was being maintained by Engr. Jackson, the focal person of the university. Upon opening of the data logger, it was observed that moisture penetrated the device as evident by the presence of rusts starting to infect the battery compartment and the moist in the batteries (*see Figures no. 8*).

Figures 7: Pictures showing the location site of the installed CTD (groundwater monitoring) within the vicinity of Mindoro State University (formerly Mindoro State College of Agriculture and Technology)

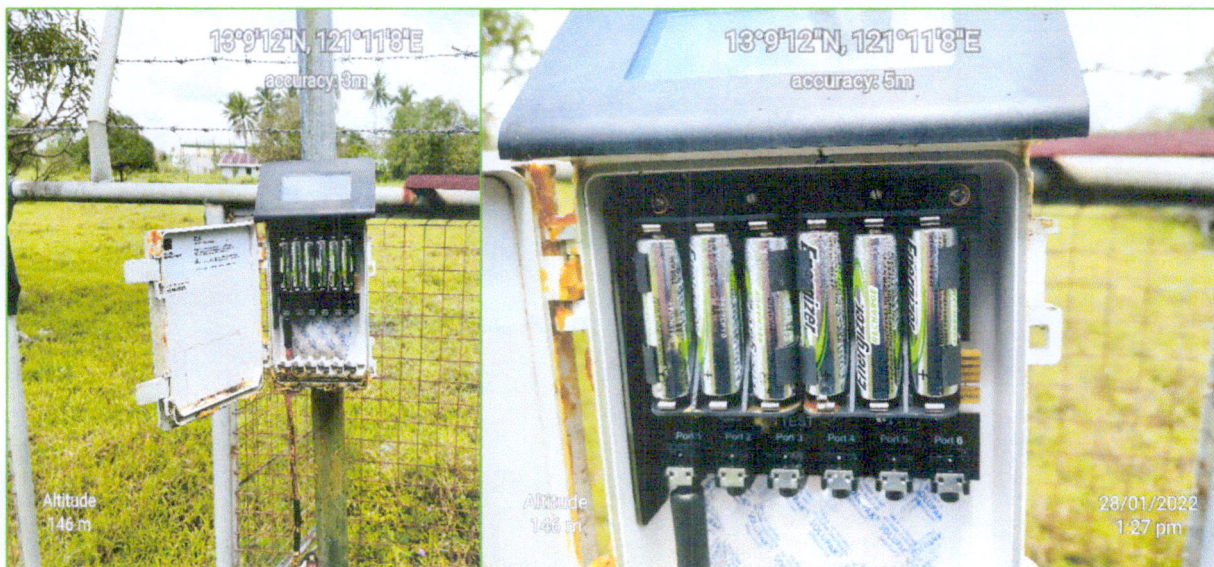
Unfortunately, the manual updating of the firmware of the data logger was unsuccessful because the logger does not respond when connected to the laptop and it's possible that the circuit board of the logger was damaged by the moisture that penetrated inside. Also, the rechargeable batteries were not replaced due to the presence of rusts within the battery compartment as it will damage the new batteries. Replacement of data logger will be requested to the Regional Office.

Figures 8: Pictures showing the inside of the data logger of the CTD with the battery compartment showing signs of rust due to the moisture that penetrated the device.

<b>Groundwater Monitoring Station - CTD</b> (within Mag-asawang Tubig Watershed – MinSCAT Main Campus, Brgy. Alcate, Victoria, Oriental Mindoro)	<ul style="list-style-type: none"> <li>The circuit board was damaged due to the moisture that leaked inside the data logger that resulted to the inability of the logger to send the data collected by the CTD sensors to the cloud server</li> </ul>	<ul style="list-style-type: none"> <li>For replacement of the data logger since its circuit board was damaged by the moisture as a result of the previously infesting of ants</li> </ul>	<ul style="list-style-type: none"> <li>Manual updating was not done as the data logger is not responding even after being connected to the laptop</li> <li>Data logger must be replaced and fund will be requested to the Regional Office</li> </ul>

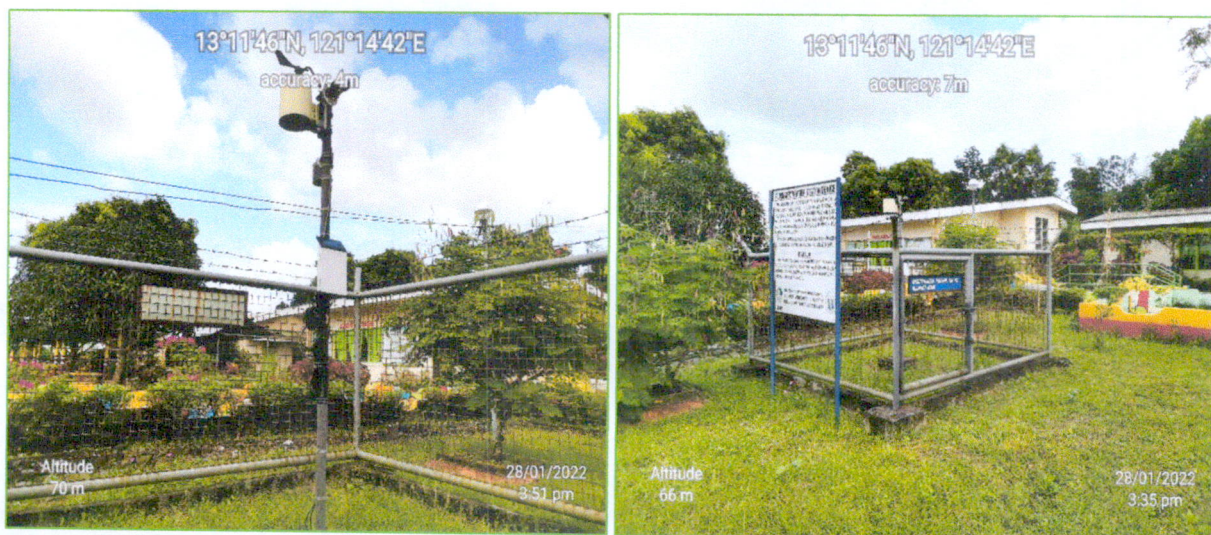
In Macatoc Elementary School, the area where the installed Automated Weather Station (AWS) located was maintained by the school's utility personnel. Manual updating of the firmware of the data logger and cellular upload test was done. Also, the rechargeable batteries were replaced with new ones to properly charge the previously used batteries. The device had no issue with regards to its functionality and its parts as of the time of the monitoring. The undersigned applied a multi-purpose grease to the cables as part of its maintenance.

Figure 9: The maintained area of the installed AWS in Macatoc Elementary School, Brgy. Macatoc, Victoria, Oriental Mindoro

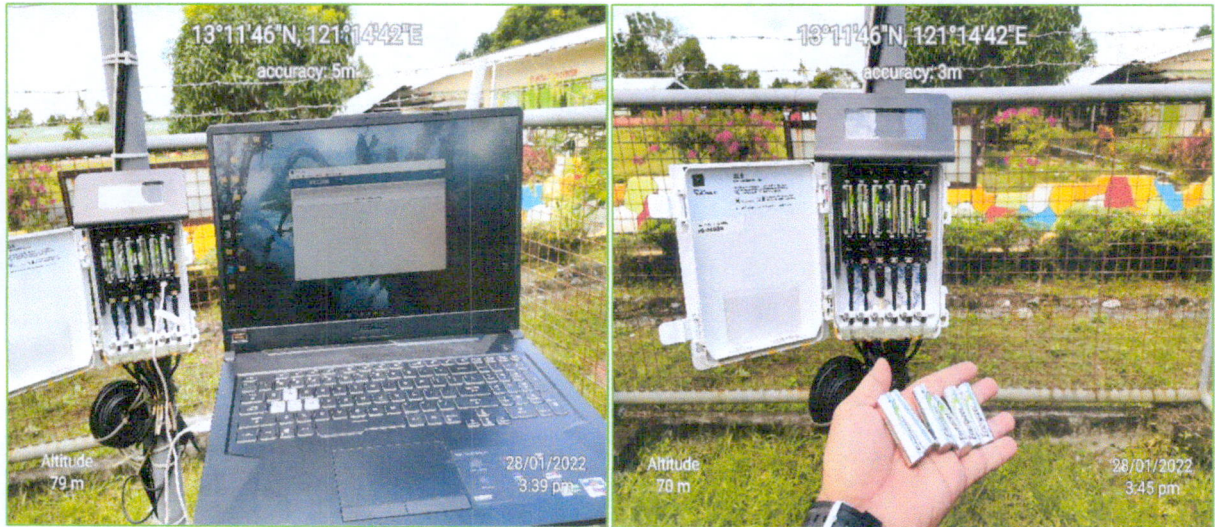
Figures 10: Pictures showing the rechargeable batteries for replacement to the old ones and the manual updating of the firmware of the data logger of the AWS

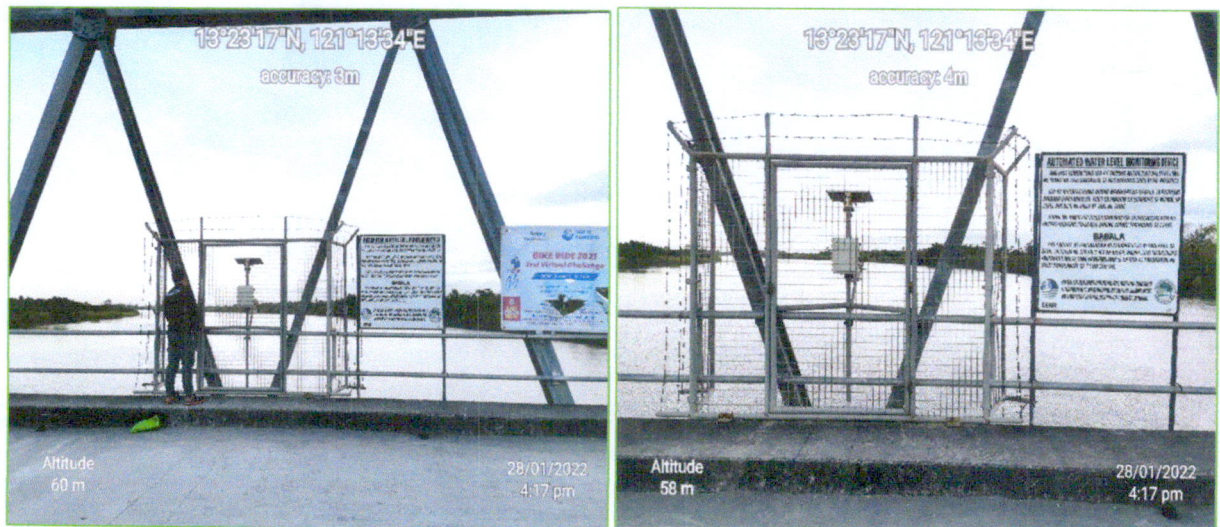
For the installed Automated Water Level Station located in Abaton bridge, Brgy. Parang, Calapan City, the device was functioning properly during the time of monitoring. Unfortunately, upon opening the gate of the AWLS, the welding of the middle hinge of the gate got broken due to the rusts that infecting it (see Figures no. 13). WD40 was sprayed to the other hinges of the gate to loosen the rusts. Manual updating of firmware was not done with the AWLS since it is from a different manufacturer as compare to the AWS.

Figures 11: Pictures showing the installed Automate Water Level Station in Abaton bridge, Brgy. Parang, Calapan City, Oriental Mindoro.

<b>Automated Water Level Station</b> (within Mag-asawang Tubig Watershed – Abaton Bridge, Brgy. Parang, Calapan City, Oriental Mindoro)	<ul style="list-style-type: none"><li>• The hinges of the fence were rusted that resulted to difficulty of opening the gate</li><li>• The welding of the middle hinge got broken after opening the gate</li></ul>	<ul style="list-style-type: none"><li>• The re-application of grease to the cables and re-spraying of WD40 lubricant will be part of the regular monitoring of the PENRO-CDS personnel</li></ul>	<ul style="list-style-type: none"><li>• The data logger's firmware is still up-to-date.</li><li>• Request fund to the Regional Office for the repair of the gate of the AWLS and replacement of its battery</li></ul>
--	---	--	---

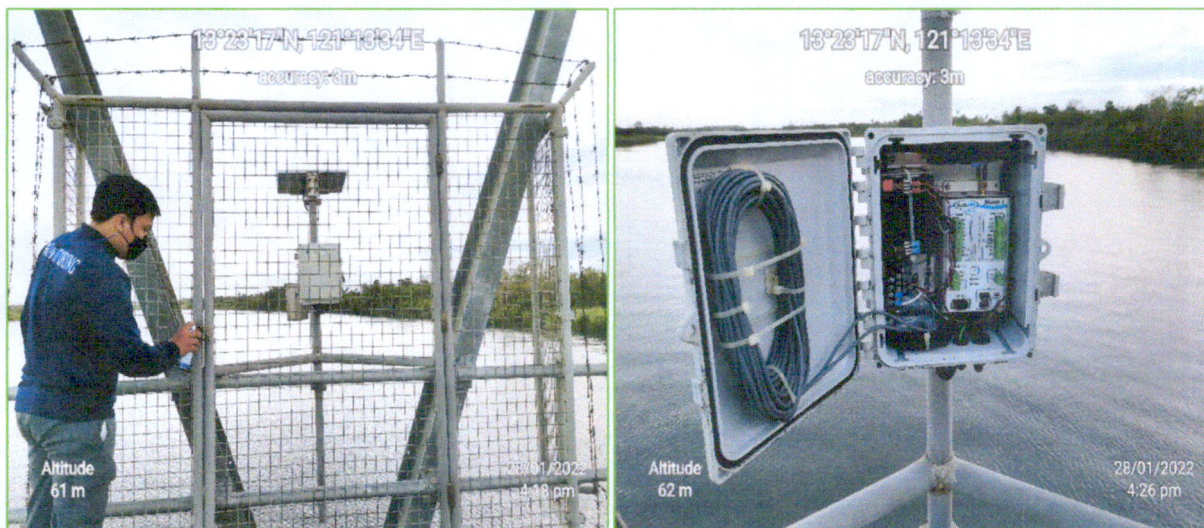
Figures 12: Pictures showing the spraying of WD40 to the lock of the gate (left) and the inside of the data logger of the Automated Water Level Station with no damage during the time of monitoring

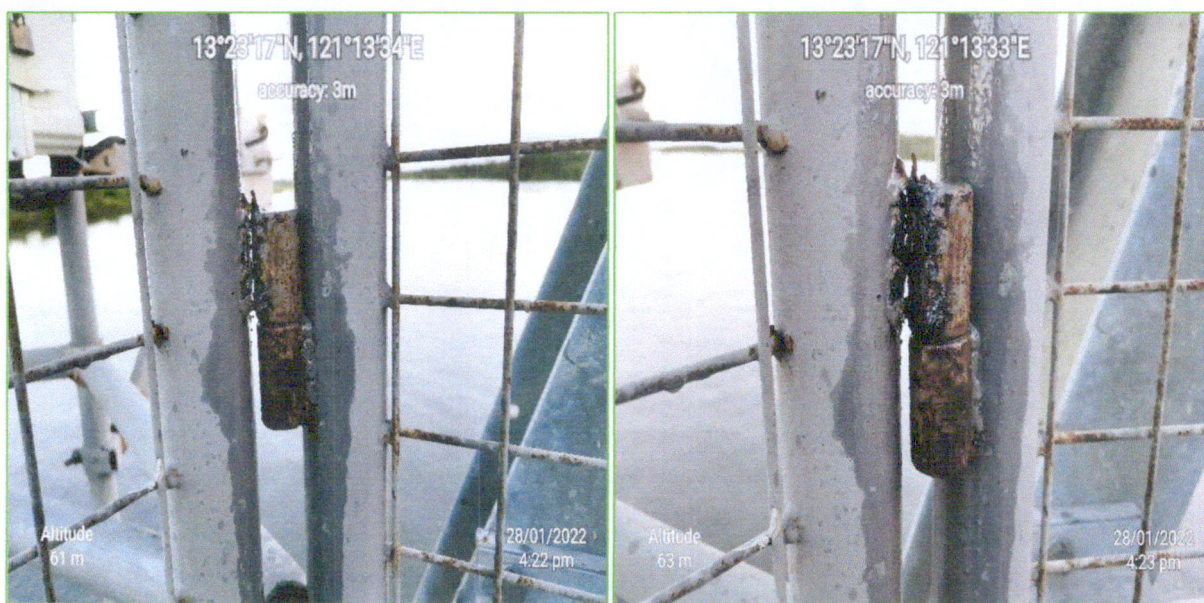
Figures 13: Pictures showing the broken welding of the middle hinge of the gate of the AWLS

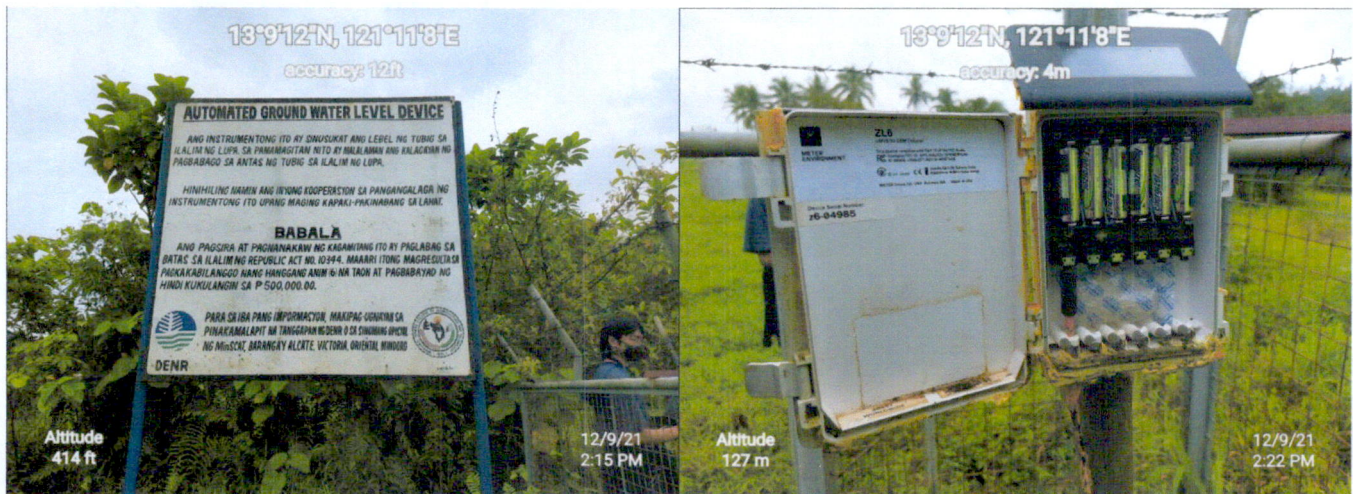
**Figure 1.** Datalogger of GWMS installed at MinSU, Oriental Mindoro.

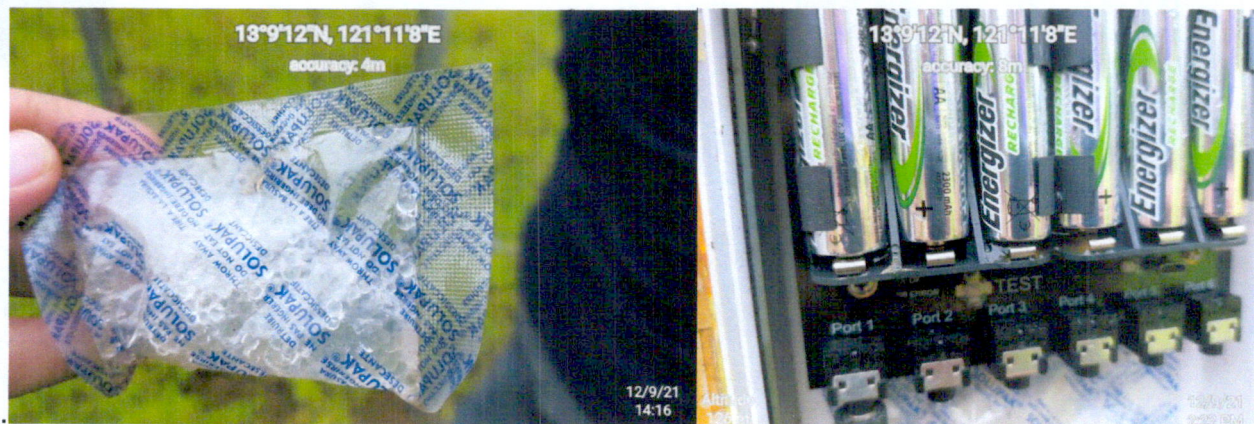
**Fig. 2.** Rainwater-soaked dessicant (right) and batteries (left) inside the datalogger of GWMS.

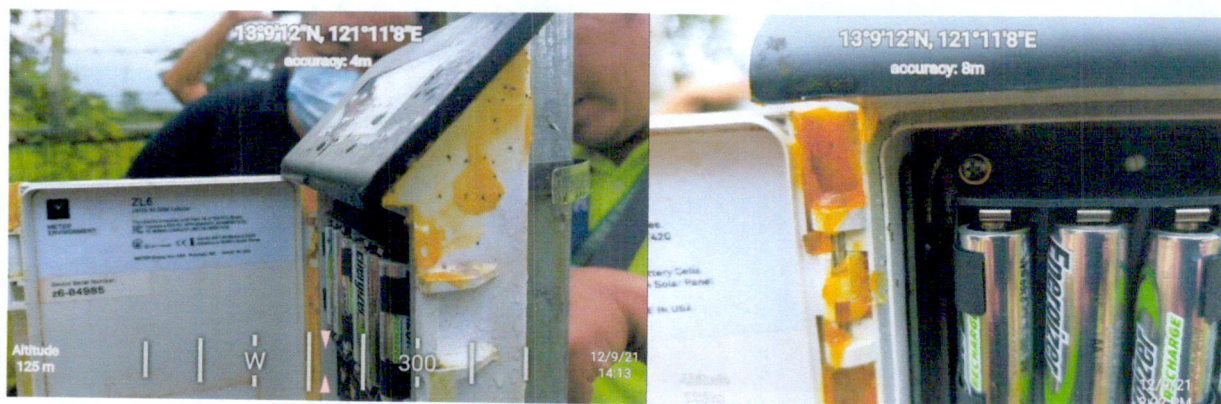
**Fig. 3.** Ant infestation in the datalogger of GWMS.
