**SUBJECT** : **CONDUCT OF LATEST MONITORING AND  
INSPECTION OF THE VICTORIA-AMNAY ROAD  
CONSTRUCTION PROJECT OF THE DEPARTMENT OF  
PUBLIC WORKS AND HIGHWAY (DPWH)**

SUBJECT : **CONDUCT OF LATEST MONITORING AND INSPECTION  
OF THE VICTORIA-AMNAY ROAD CONSTRUCTION  
PROJECT OF THE DEPARTMENT OF PUBLIC WORKS  
AND HIGHWAYS (DPWH)**

PHOTO DOCUMENTATION DURING THE CONDUCT OF ACTIVITY DATED  
NOVEMBER 02, 2022

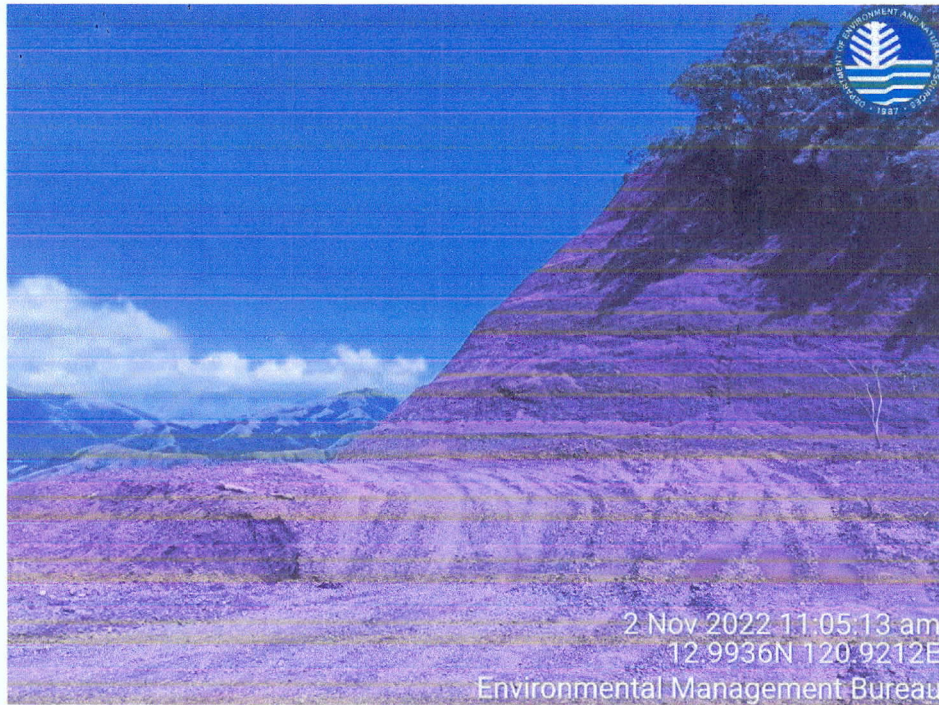
4. The phase 8 project has already opened its approximately 500 meters in length along the total length of 8.1 km, it lies between geo-coordinates 12.9936 N, 120.9212 E as starting point and 12.9954 N, 120.9251 E as ending point as to date.

**STARTING POINT OF PHASE 8 PROJECT**

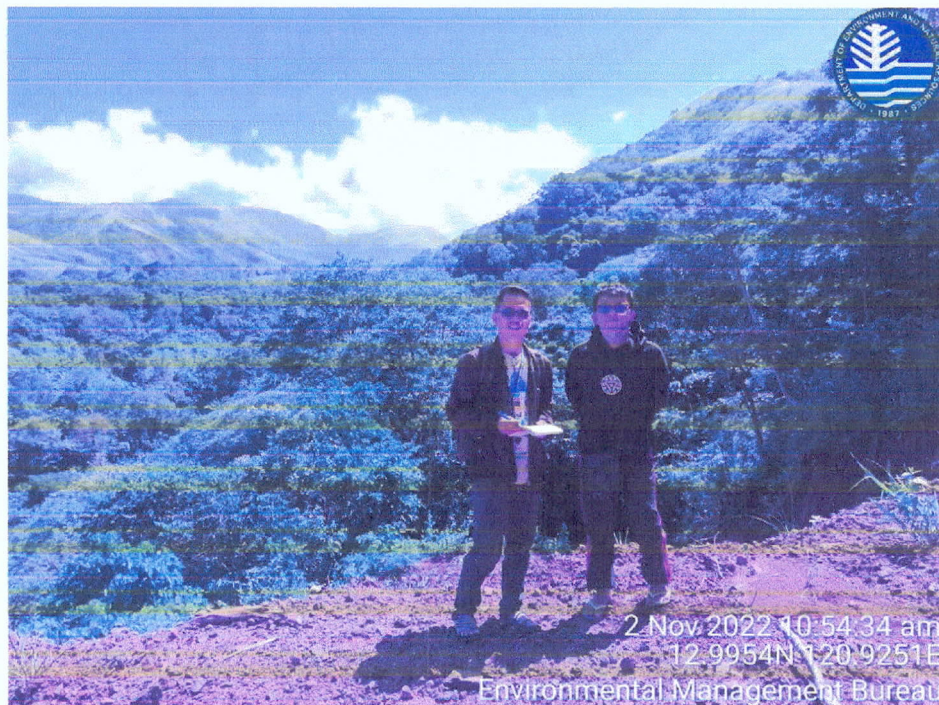
**ENDING POINT OF PHASE 8 PROJECT AS TO DATE**

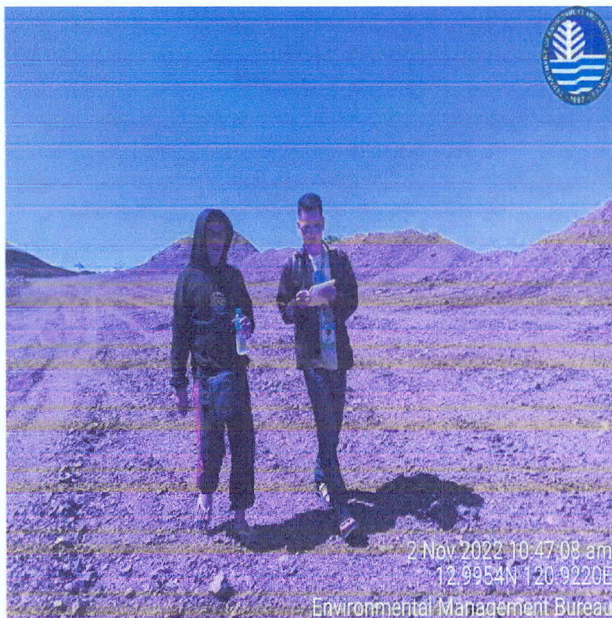
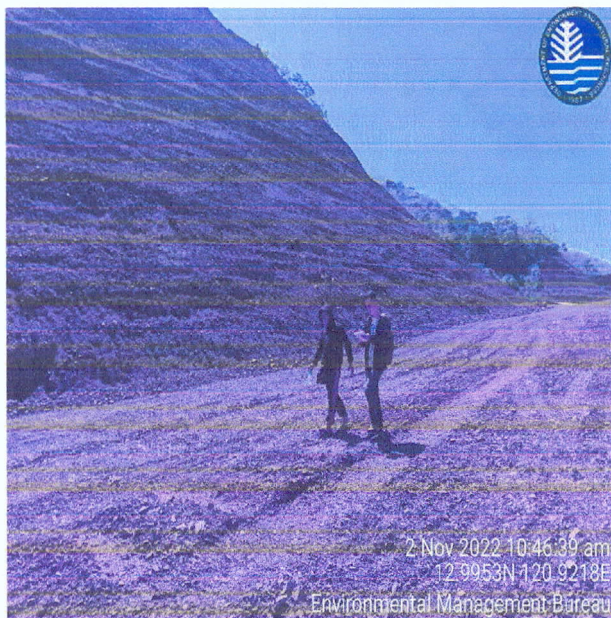
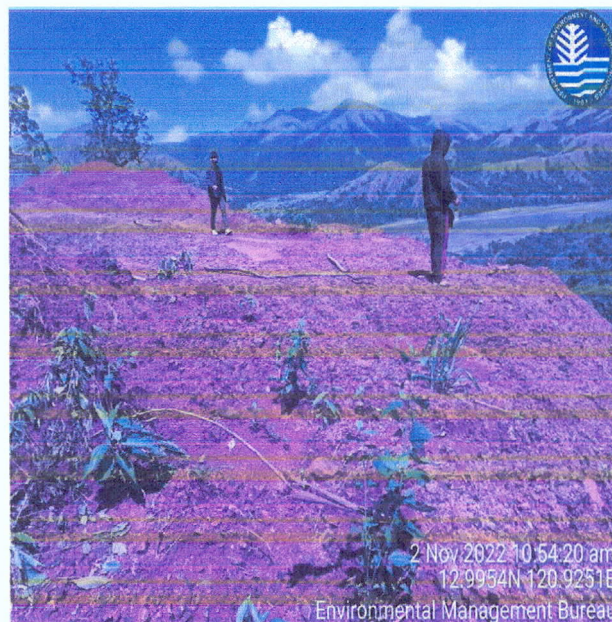
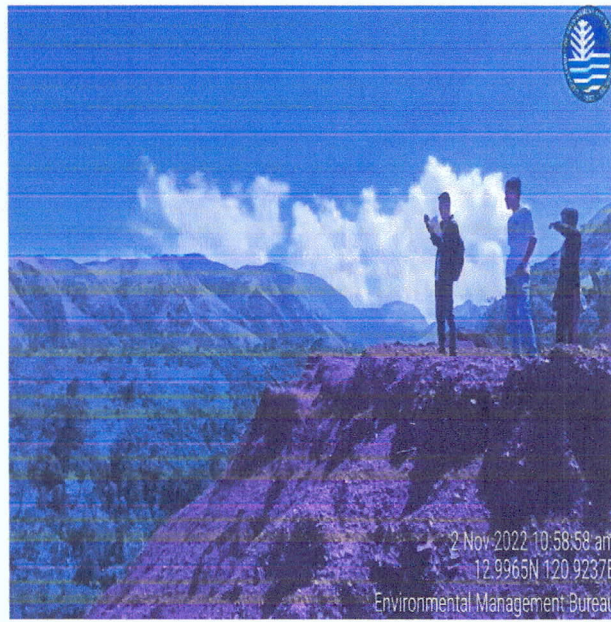
5. Some slope protection has already been applied. However, mostly of the project with steep slope has no slope protection which is vulnerable to landslide.

### SOME SLOPE WITH SLOPE PROTECTION

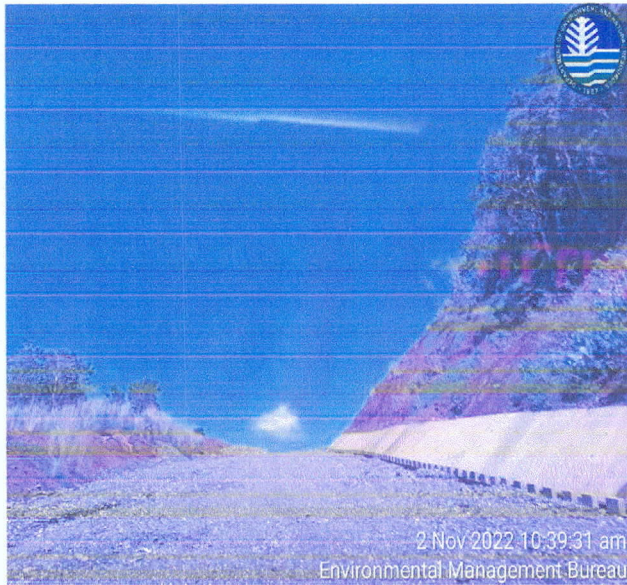
6. All portion of new opened road with steep slope was eroded.
7. Some box culvert and drainage canal were collapsed.
8. No records of submission of rehabilitation plan including slope protection measures on site.

### CRITICAL SLOPE WITHOUT SLOPE PROTECTION

1. Letter may be sent to the project proponent advising and reiterating them to immediately prioritize the implementation and rehabilitation of critical slopes in accordance with Environmental Management Plan (EMP).
2. It is also recommended that geohazard risk assessment by MGB be undertaken.
3. Submission of their effective rehabilitation plan.

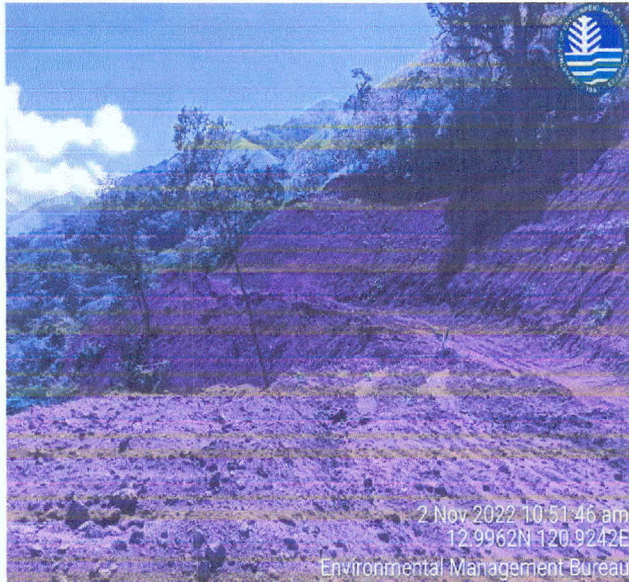
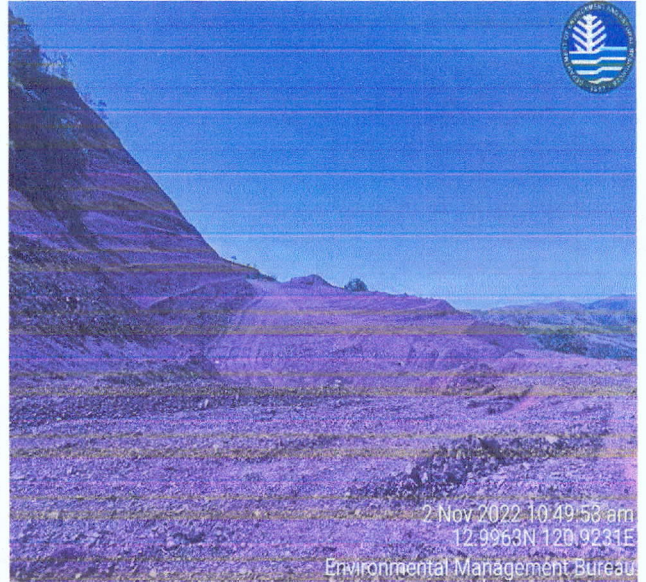
## CRITICAL SLOPE WITHOUT SLOPE PROTECTION

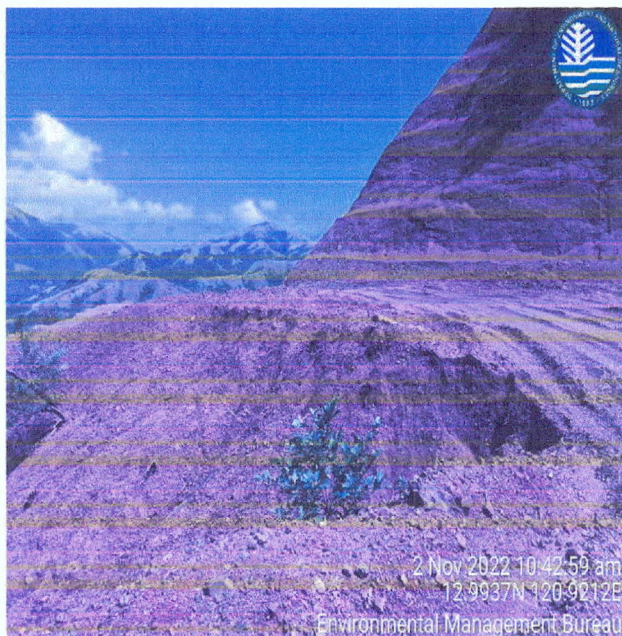
**BOX CULVERT, DRAINAGE CANAL, AND SOME SLOPE PROTECTION  
COLLAPSED**
